**NAVAL  
POSTGRADUATE  
SCHOOL**

**THESIS**

**DYNAMIC RESPONSE AND FAILURE  
OF 3D PRINTED CYLINDRICAL STRUCTURES  
SUBJECTED TO IMPACT LOADING**

June 2023

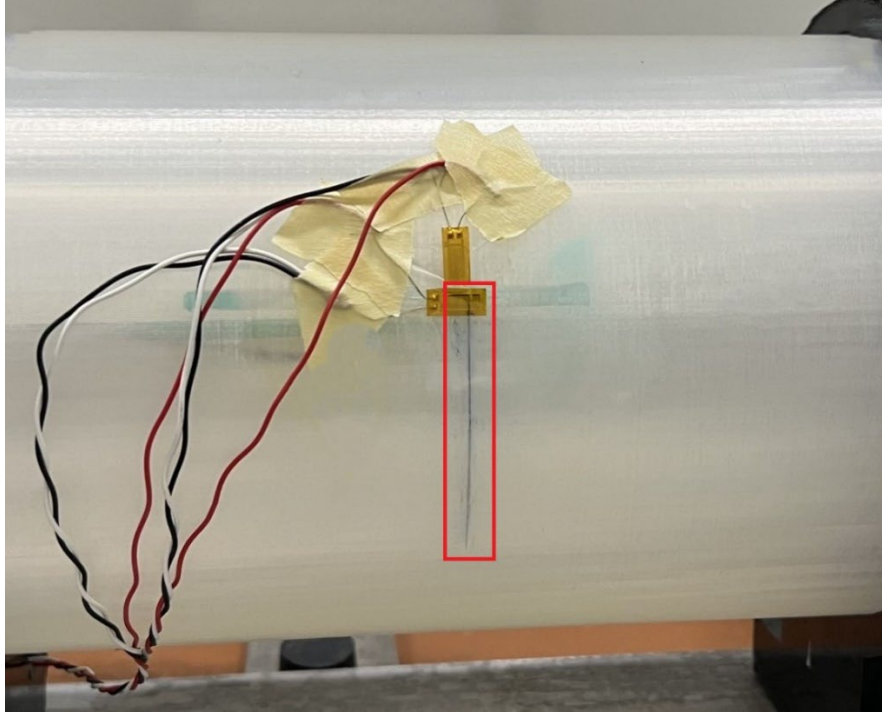
Figure 15. Failure Mode

The failure mode remained consistent, with little deviation, across all samples. As expected, the failure occurred in the hoop direction, perpendicular to the longitudinal axis of the sample as tested, between the printed layers of the cylinder. This is the result of the interlayer strength and stiffness of 3D printed materials being significantly less than that of the pre-production filament [12]. The failure crack propagated roughly  $\frac{1}{4}$  the circumference of the outer cylinder in each case tested.

The crack, denoted within the red rectangle and colored with blue ink in Figure 15, originated from the point of impact and propagated circumferentially around the outside cylinder. For some cases, as shown in Figure 15, the crack propagated through the FX strain gage, rendering the data from the last blow at that strain gage unusable
