**US Army Corps
of Engineers®**
Engineer Research and
Development Center

Burgess-Capps Cabin

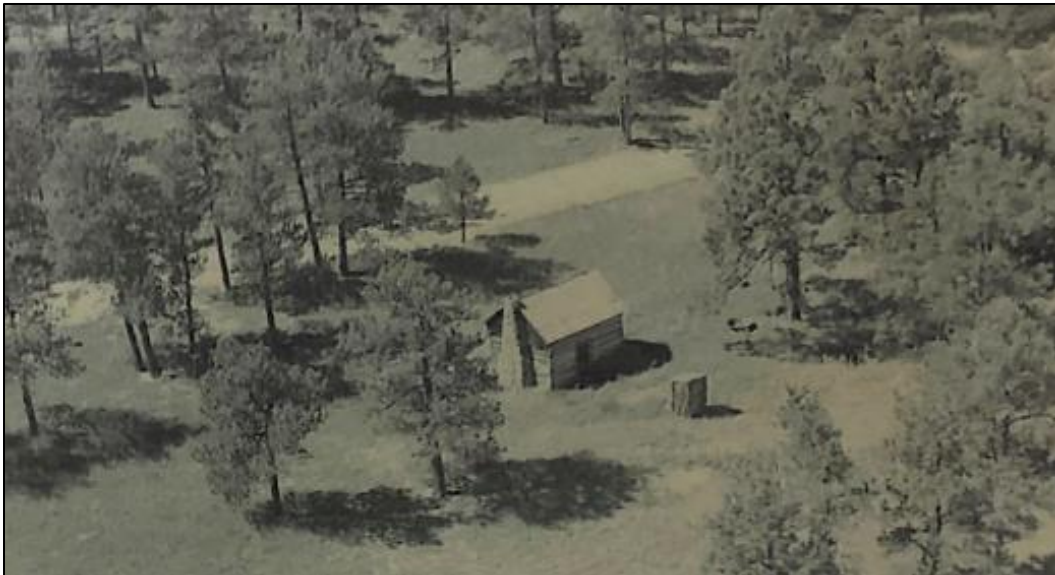
76. Trout, "Communities of Yesterday," 13–17.

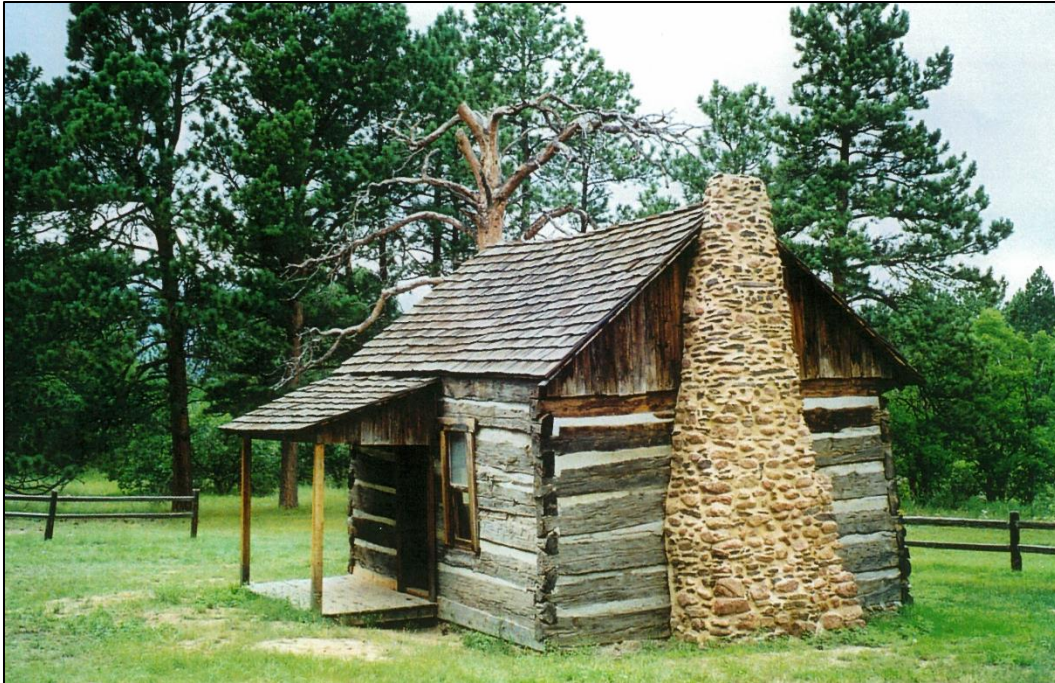
Figure 13. Replacement headstones, n.d. (C: Environmental & CATCODE Documentation, XQPZ04550, Real Property Office, US Air Force Academy, Colorado Springs, CO. Public domain.)

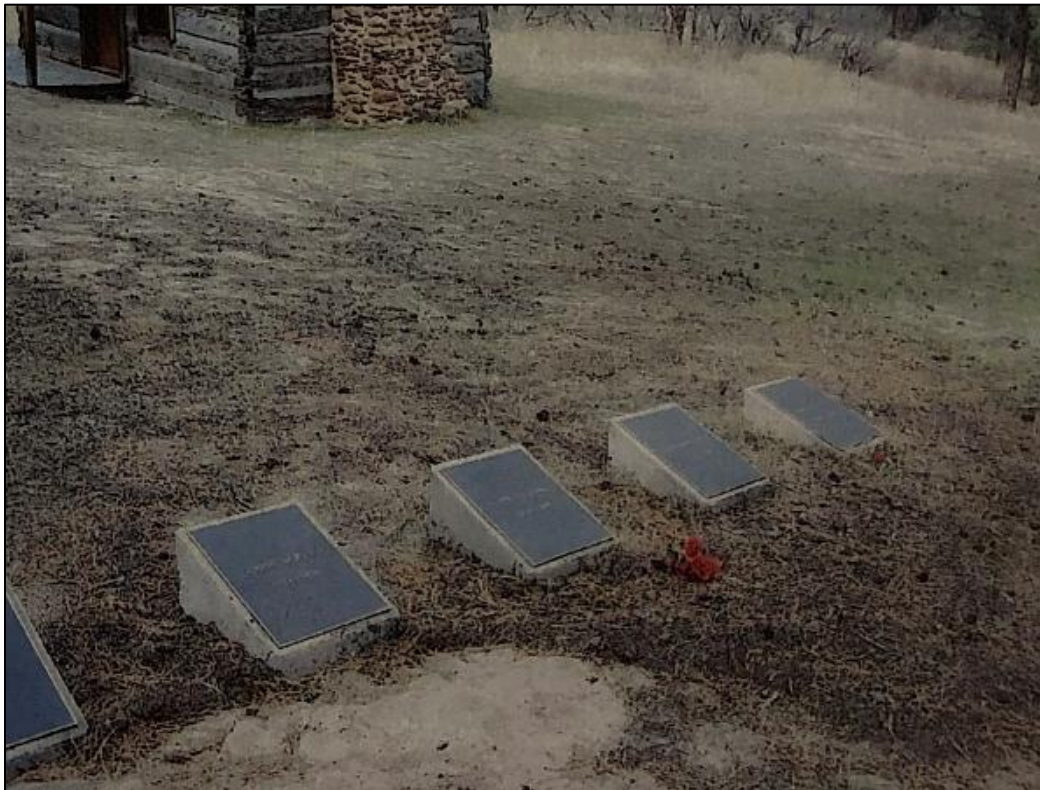
3 Stage II: Site Location, Site Information, and Architectural Description

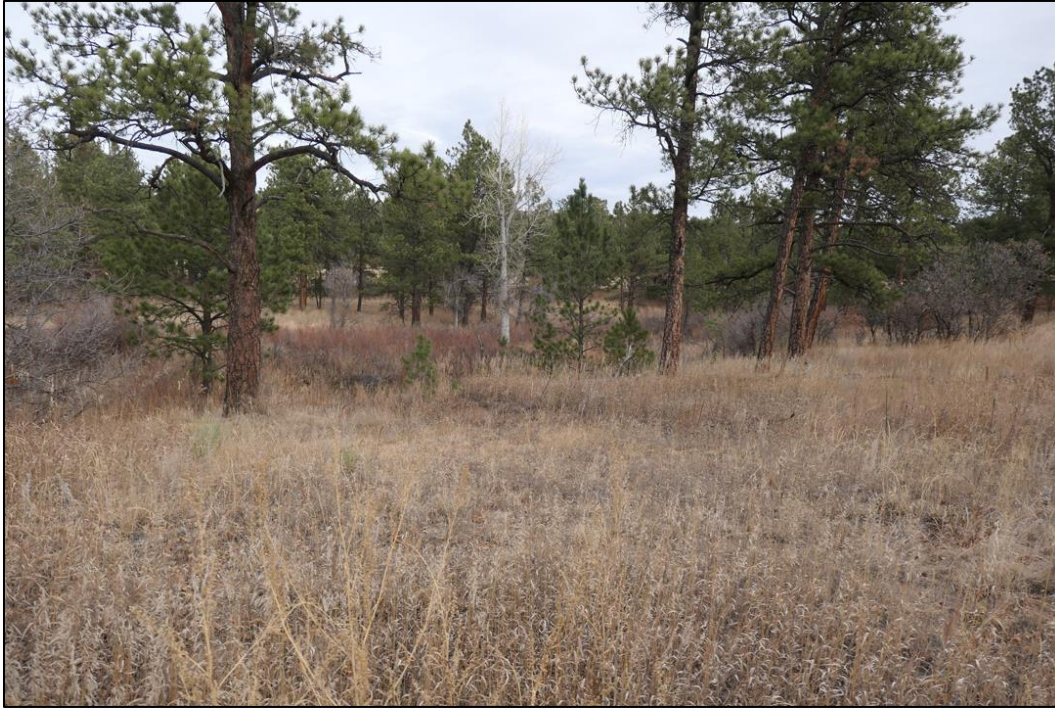
Figure 16. Ponderosa pine trees surrounding the Burgess-Capps Cabin (photo by ERDC-CERL researchers, 2021).

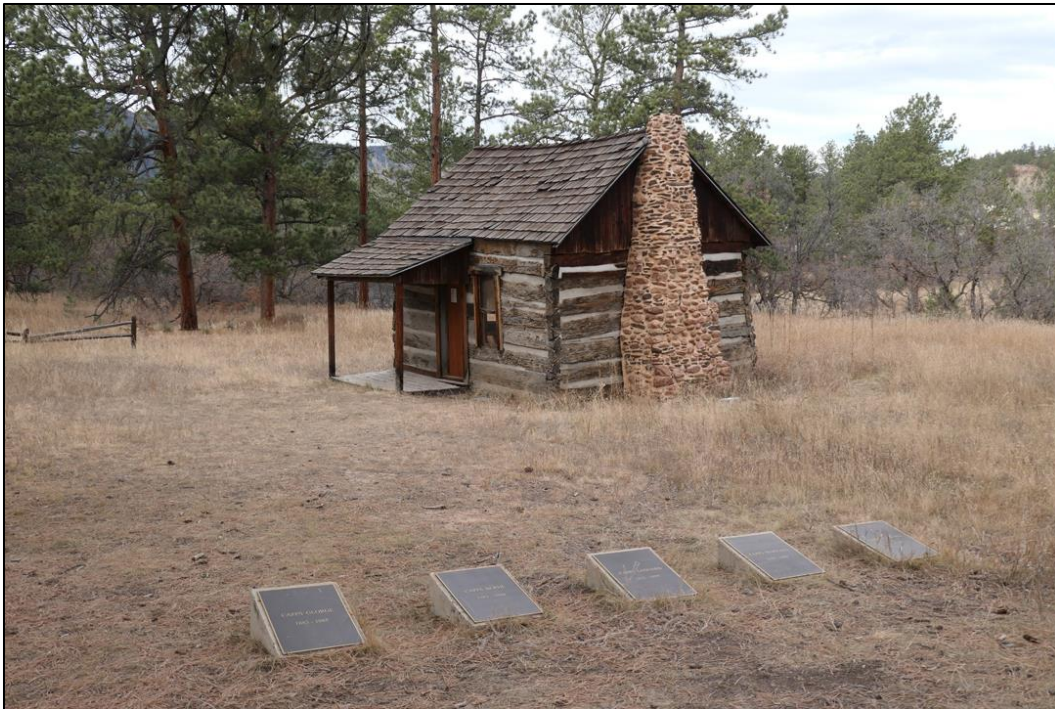
Figure 18. Looking at the replacement headstones that are southeast of the Burgess-Capps Cabin (photo by ERDC-CERL researchers, 2021).

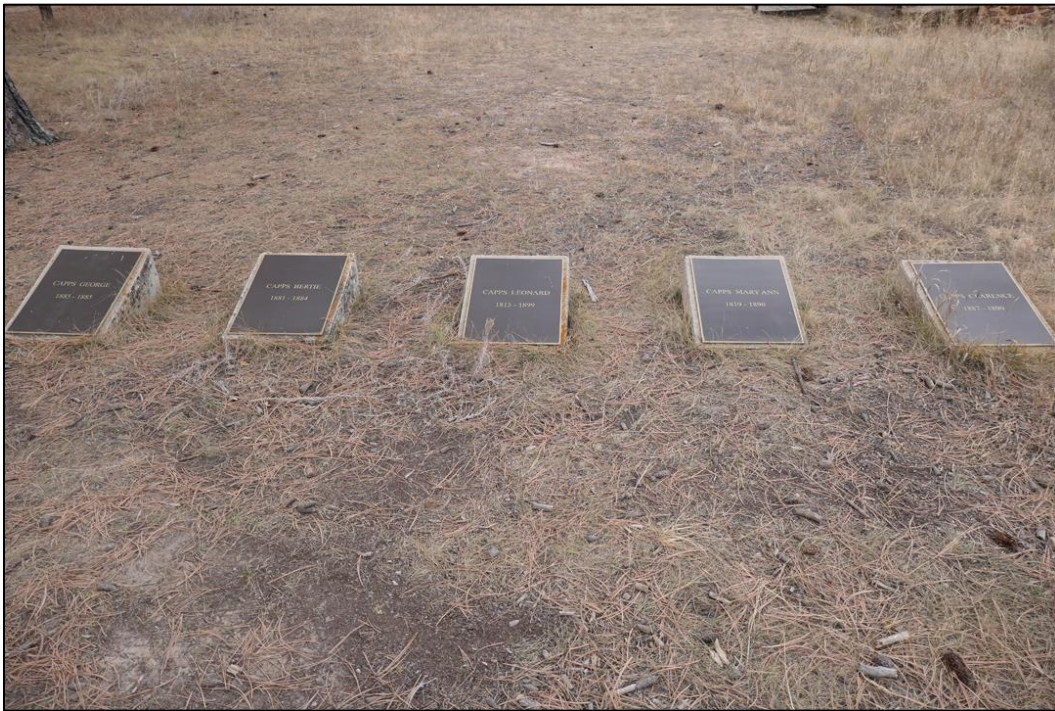
Figure 19. Cemetery memorial sign (photo by ERDC-CERL researchers, 2021).

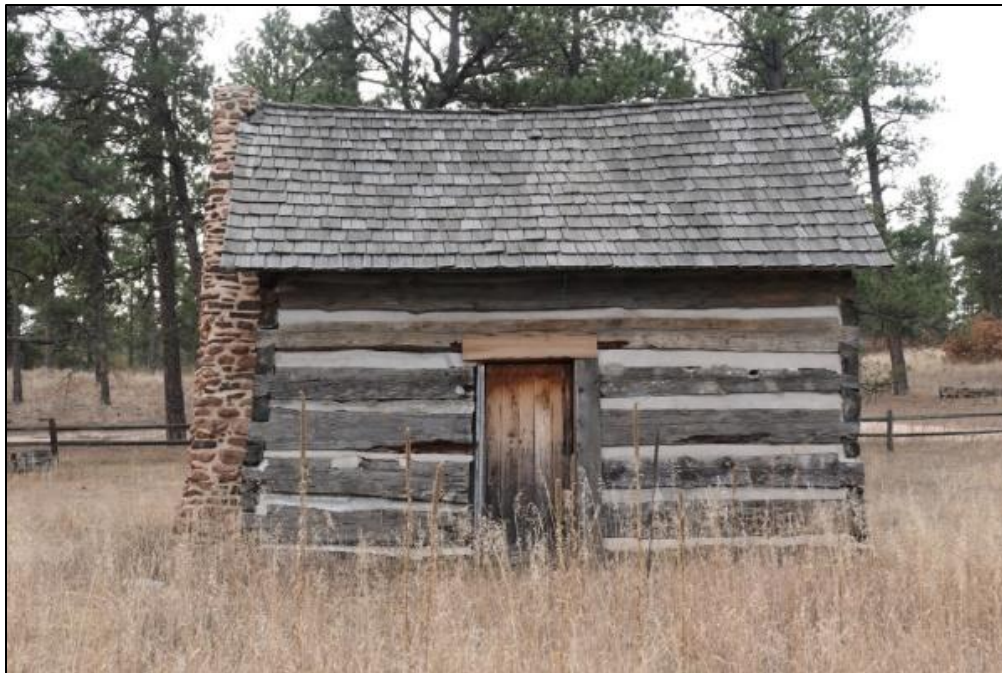
Wood shingles clad the roof and porch of the Burgess-Capps Cabin. Some shingles are missing, loose, or are curling. Some shingles appear to be many different sizes; however, this is due to splitting. The wood shingles can be seen in Figure 33 and Figure 34.

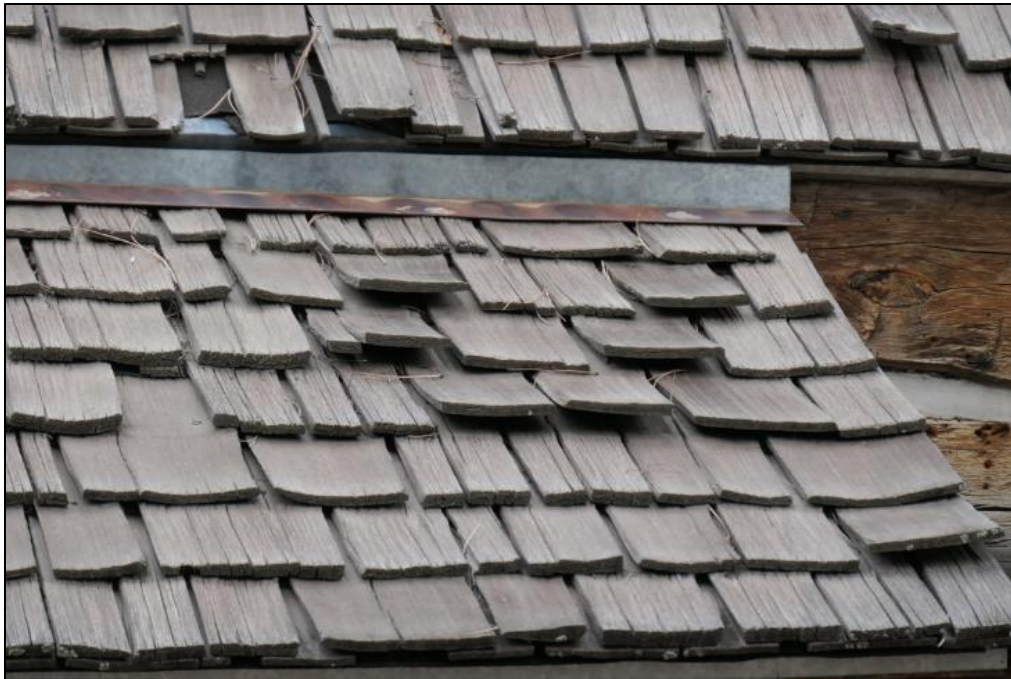
Figure 34. Looking at splitting and curling wood shingles on the south roof side of the Burgess-Capps Cabin (photo by ERDC-CERL researchers, 2021).

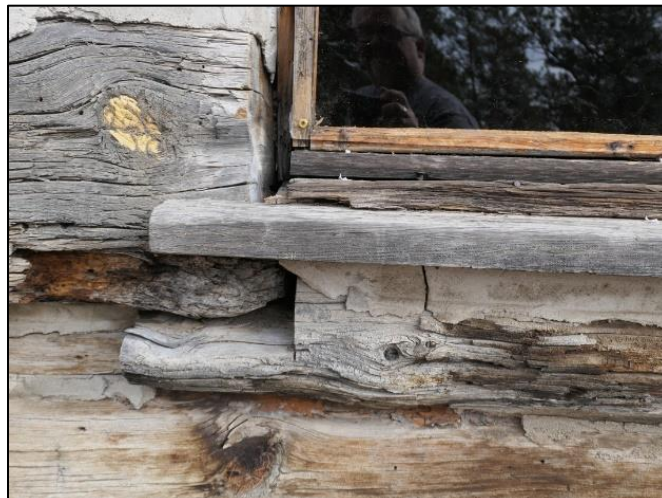
Figure 41. Looking at a combination of old and new wood door trim of different sizes on the north elevation of the Burgess-Capps Cabin. There is also a missing plank on the left side of the door (photo by ERDC-CERL researchers, 2021).

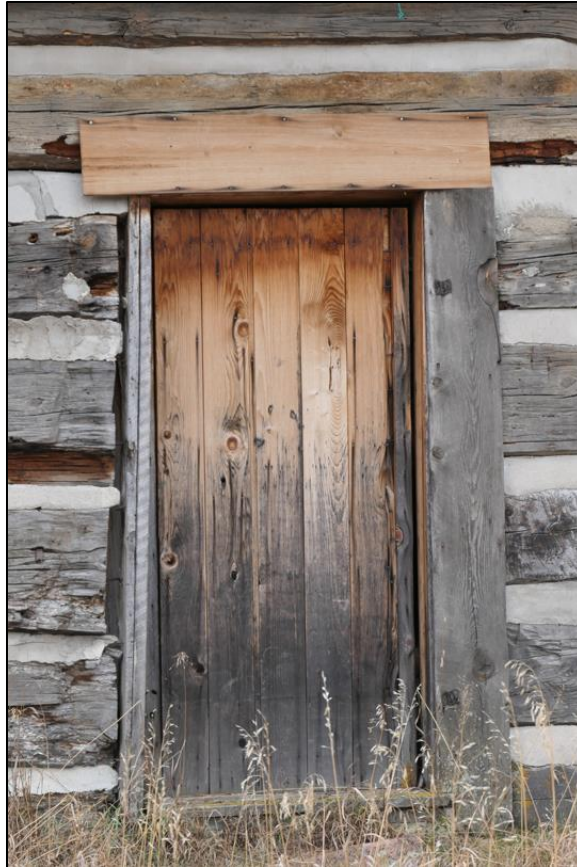
Figure 42. Wooden window trim on the south elevation of the Burgess-Capps Cabin (photo by ERDC-CERL researchers, 2021).

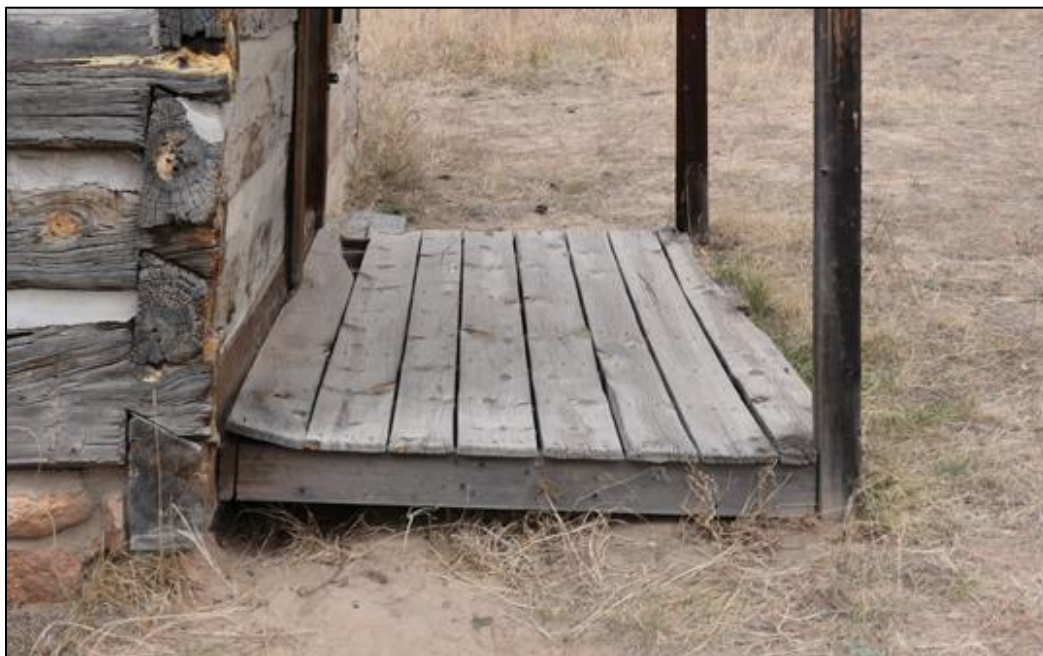
Figure 49. Split and broken wood planks and wood joists that make up the porch floor of the Burgess-Capps Cabin (photo by ERDC-CERL researchers, 2021).

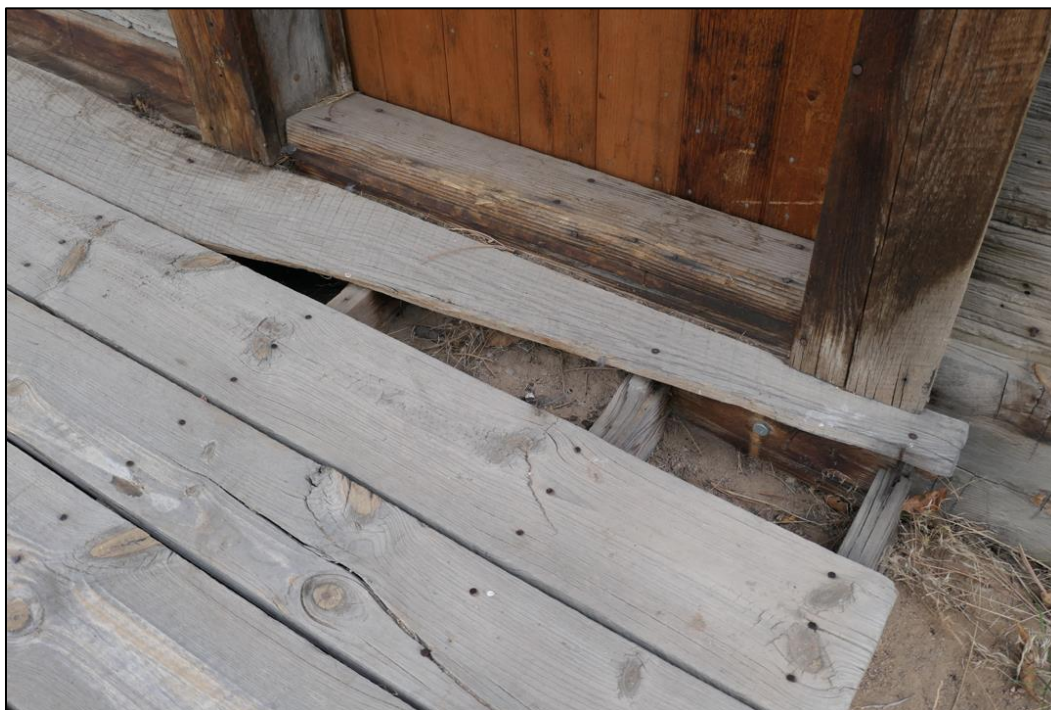
Figure 50. Wood threshold on the south door of the Burgess-Capps Cabin (photo by ERDC-CERL researchers, 2021).

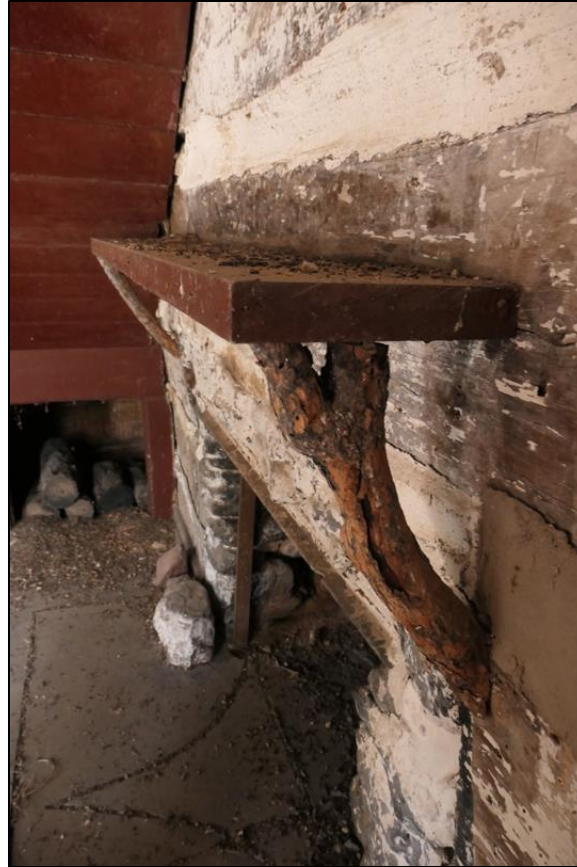
Within the loft of the Burgess-Capps Cabin are ample wood member structural reinforcements that were added at an unknown date (i.e., no documentation found), post original construction according to the USAFA cultural resource manager. Looking at these boards' condition and color, they appear fairly new, similar to the metal hardware's good condition discussed in Section 8. The wood gable structural reinforcements can be seen in Figure 60. The wood roof structural reinforcements can be seen in Figure 61.

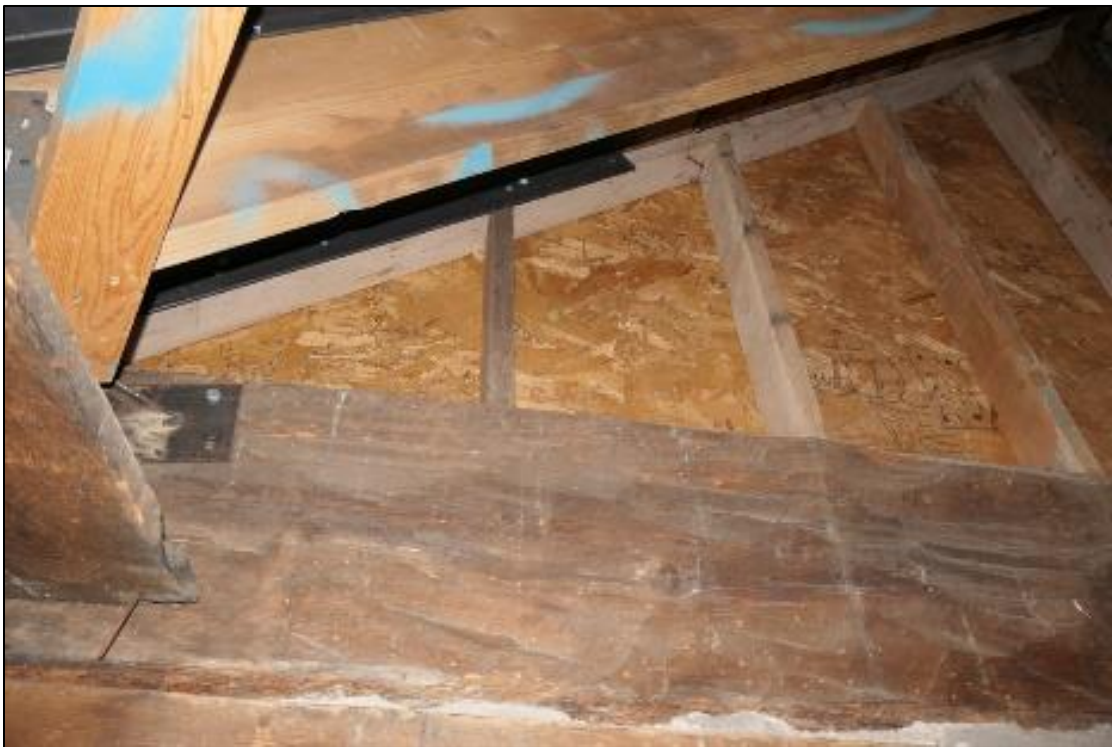
Figure 61. Wood structural reinforcements added to the roof of the Burgess-Capps Cabin at an unknown date (i.e., no documentation found) (photo by ERDC-CERL researchers, 2021).

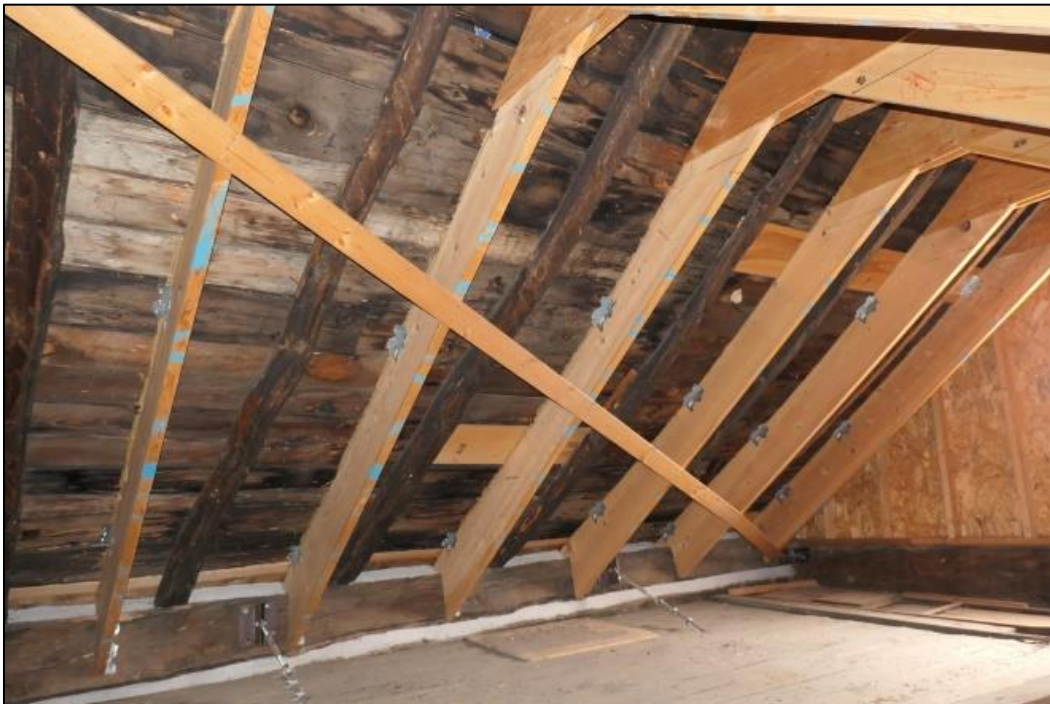
The loft floor is constructed of wood plank flooring that also acts as the ceiling of the first floor (see wood plank floor and gap to first floor in Figure 62). The wood plank floor is supported by wood floor joists (see Figure 63).

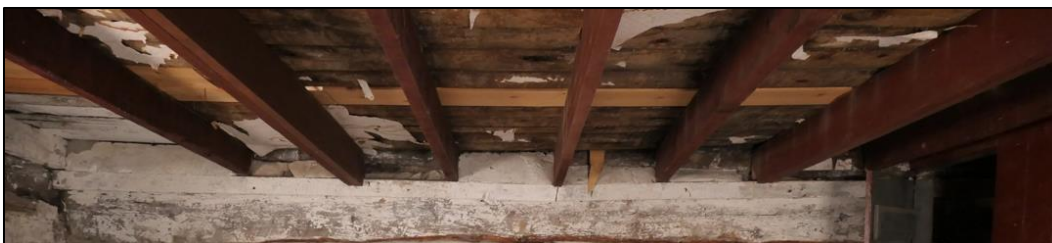
5.3 Treatment measures

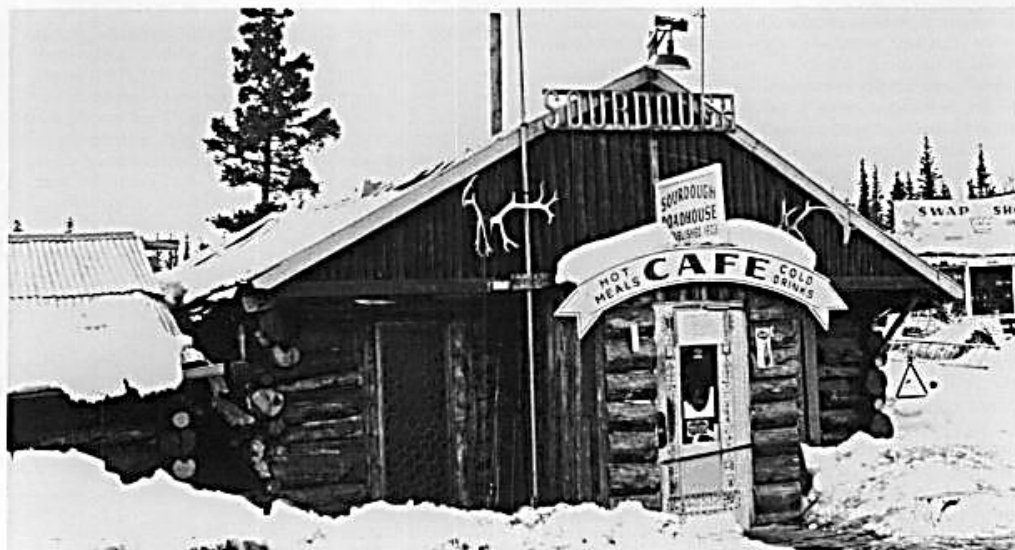
Fig. 1. Log construction was practical in the rough frontier and climate of Alaska, where it was used for a variety of structures such as the Sourdough Lodge (c. 1903) near Cakona. Built to serve the trail leading to the Klondike gold discoveries, this 1-story, L-shaped roadhouse is primarily of horizontal log construction with vertical logs in the front gable. Photo: National Park Service Files.

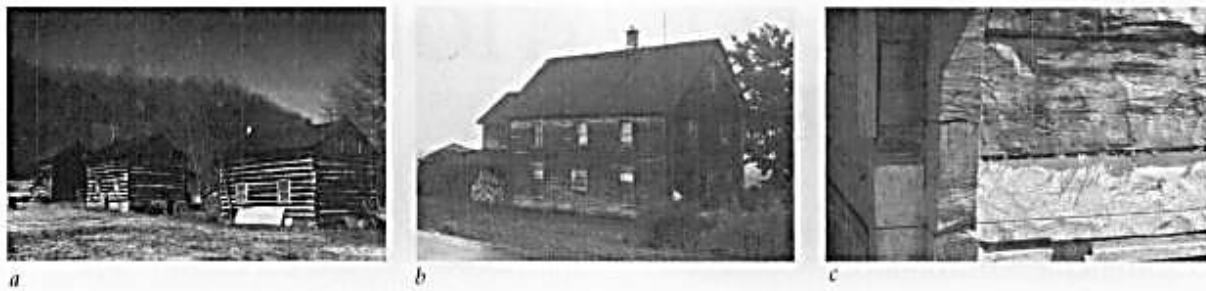
Fig. 2. Logs, both round and hewn, continued to be a basic construction material throughout much of the 19th century, here illustrated by (a) these c. 1831 industrial workers' houses for forgemen at the Mt. Etna Iron Furnace in Pennsylvania, and (b) the Larsson-Ostlund House built by Swedish immigrants in New Sweden, Maine, during the 1870s. (c) Corner detail of the Larsson-Ostlund House with the original clapboarding removed during restoration shows close-fitting log joints in the Scandinavian style that did not require chinking. Photos: (a) Jet Lowe, HAER Collection, (b-c) Maine Historic Preservation Commission.

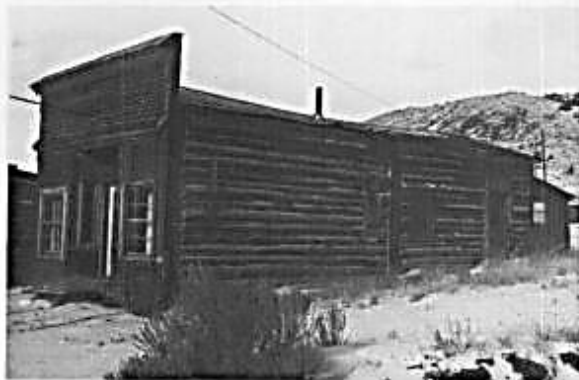
Fig. 4. Beginning around the mid-19th century, entire western boomtowns were hastily constructed of frame and log, such as the buildings in Bannack, Montana, the site of the State's first gold discovery. Photo: National Park Service Files.

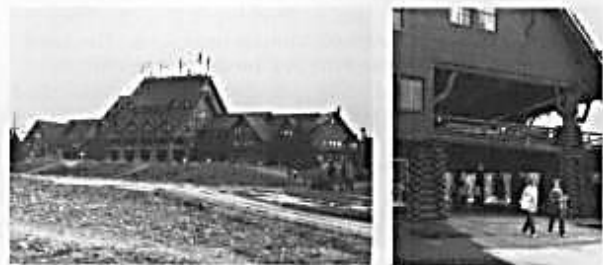
Fig. 6. (a) Old Faithful Inn, Yellowstone National Park, Wyoming, shown here in 1912, brought the Rustic style to the West in 1903 in an original design, and a scale befitting its setting. (b) Although only the first story is of horizontal log construction, the use of logs is striking in the trestle work and cribbed piers around the entrance. Photo: (a) Courtesy National Park Service, (b) Laura Soulliere Harrison.

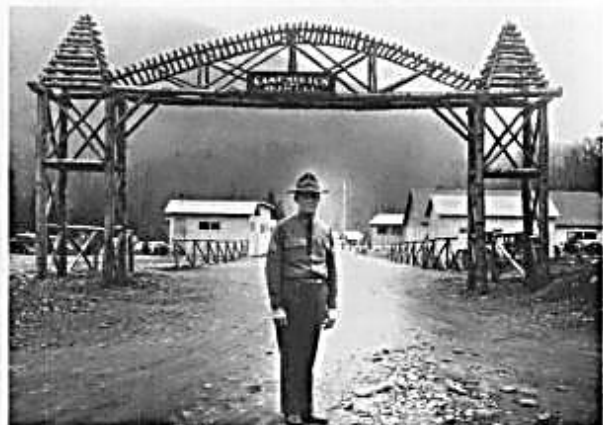
Fig. 7. The Civilian Conservation Corps built many recreational log structures across the country in the 1930s and 40s, including this rustic log gateway to Camp Morton, Lycoming County, Pennsylvania. Photo: Courtesy Lycoming County Historical Society and Museum.

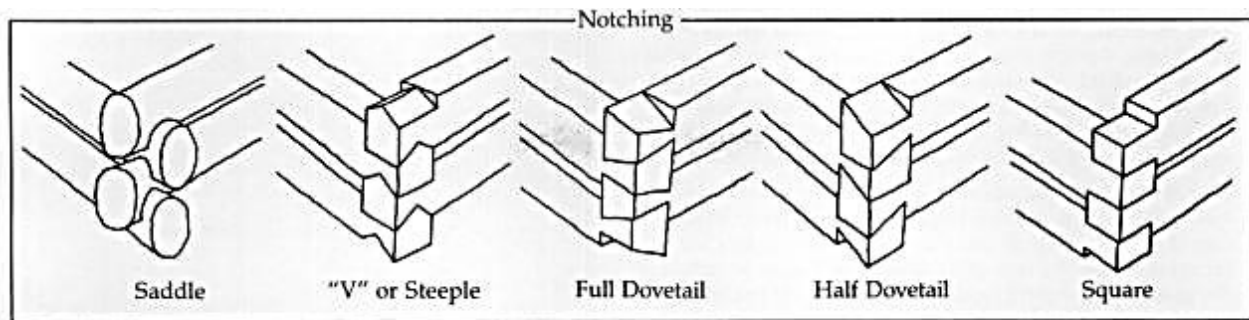
Fig. 10. Five examples of the more common historical methods of corner notching. Drawing: James Caufield.

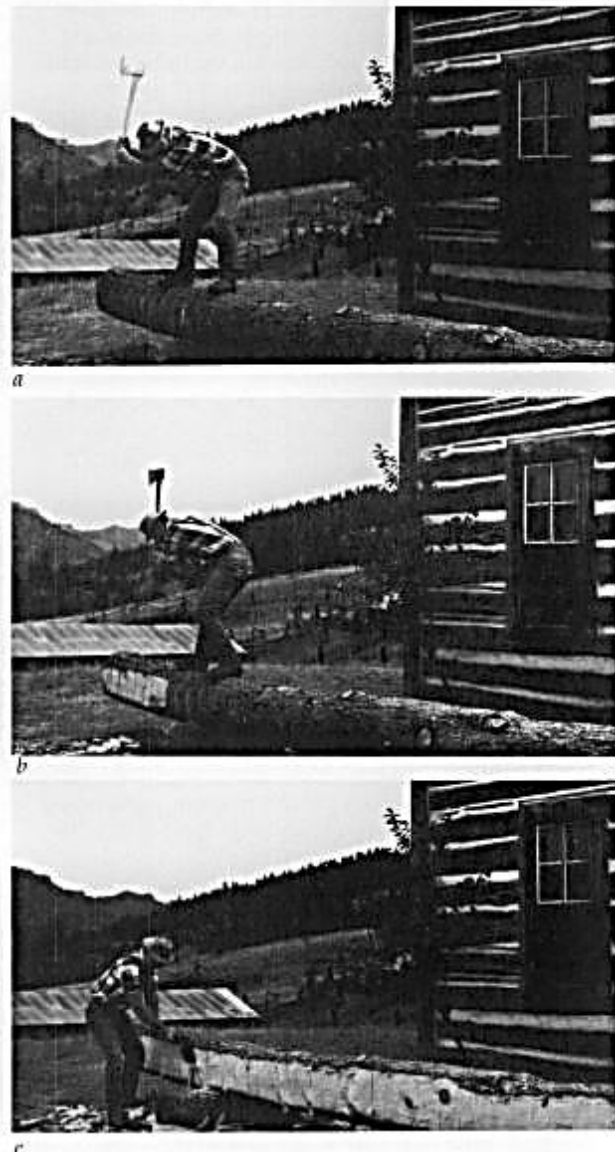
Fig. 11. Log-hewing tools and techniques: (a) scoring the log with a single-bladed felling axe, or "pole axe" in preparation for removing a uniform thickness of wood; (b) removal to depth of scoring; (c) finish hewing with a broad axe. Photos: Courtesy Bernard Weisgerber.

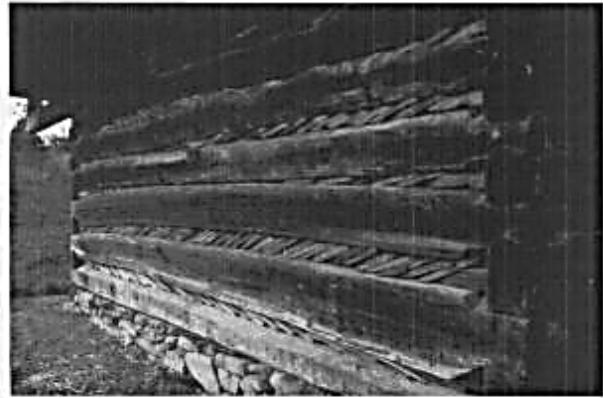
Fig. 12. The log joints have been cleaned out in preparation for new daubing exposing carefully laid stone chinking in this building in Virginia. Photo: Bernard Weisgerber.

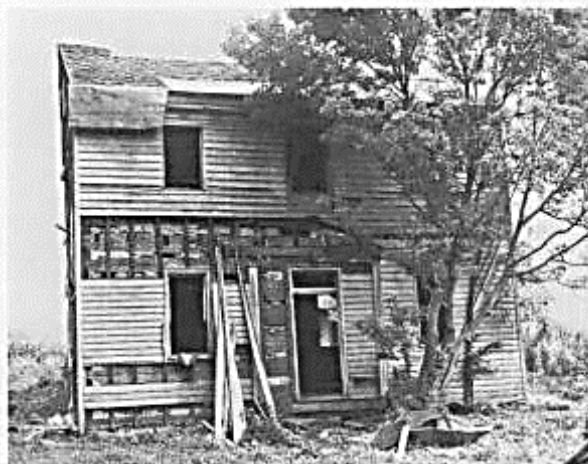
Fig. 14. Removal of the historic wood siding from the 1804 Zachariah Price DeWitt House in Butler County, Ohio, reveals that the clapboards were attached to vertical wood furring strips nailed to the logs. Photo: National Park Service Files.

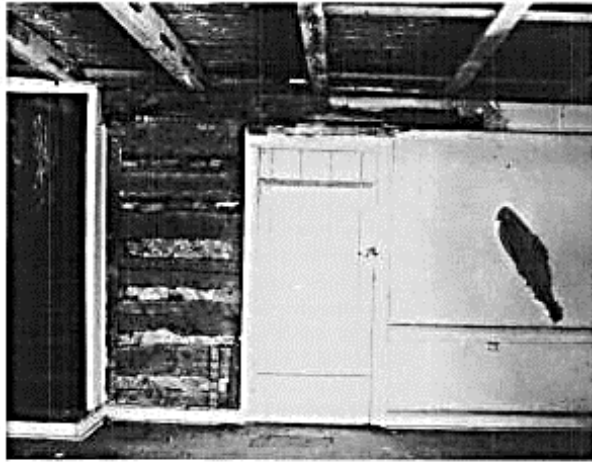
Fig. 16. This photograph of the interior of a 1793 log house in Maryland reveals much about historic log building construction and interior finish treatments. To the left of the plank door plaster has been removed exposing the stone chinking and daubing; remnants of vertical furring strips attached to the logs show evidence of traditional horizontal lath, while the hole broken through the plaster wall on the right shows the use of diagonal lath. The open door reveals a very steep, enclosed stairway typical of many early log houses. Although plaster has been removed from the ceiling, the wall to the right of the door shows the original plaster finish and fine woodwork including beaded chair rail, floor and door molding. Photo: National Park Service Files.

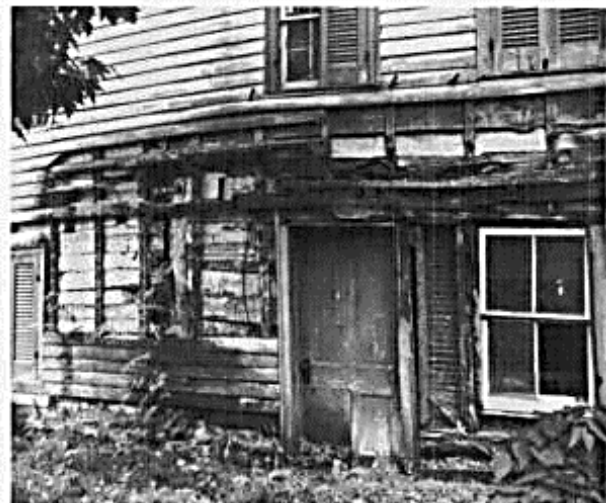
Fig. 17. Contact of this building's sill log with the ground has led to its decay, infestation by wood-destroying insects, and resulting building settlement. Photo: Anne Grimmer.

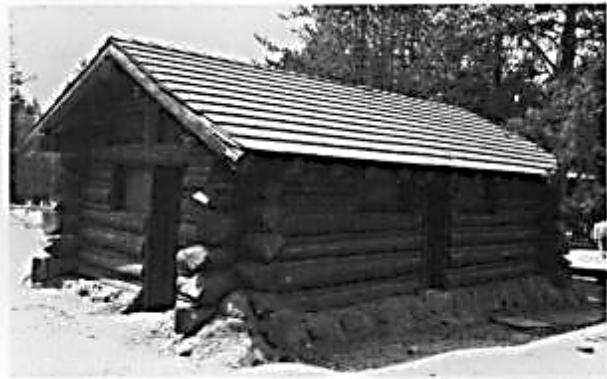
Fig. 18. Exposed roofing members of Rustic style buildings such as this structure at Yellowstone National Park are highly susceptible to deterioration. Photo: Laura Soulliere Harrison.

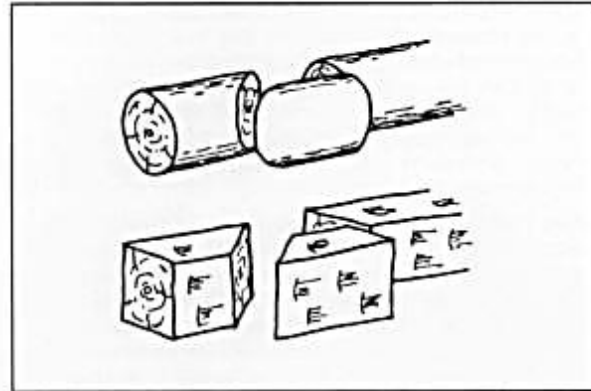
Fig. 19. Log splicing with scarf joints. Drawing: Harrison Goodall.

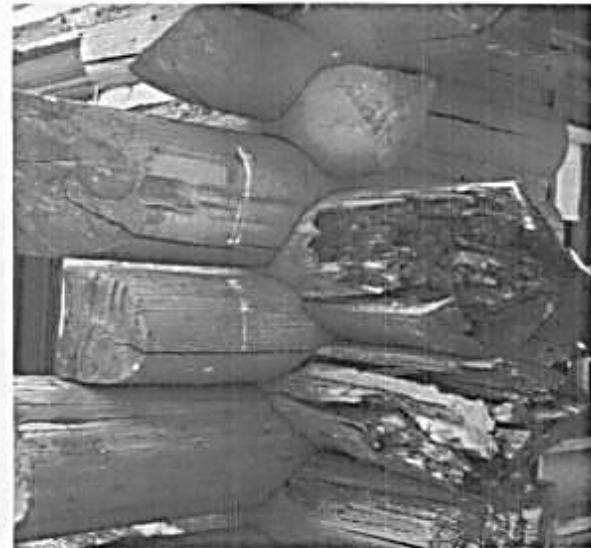
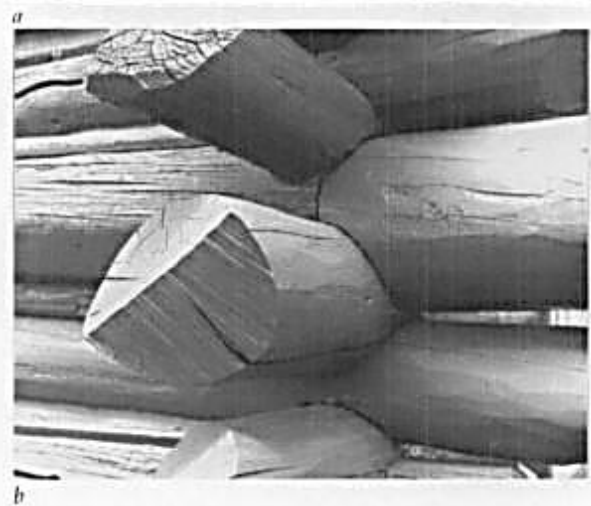
Fig. 20. (a) These deteriorated log crowns were (b) repaired with new crowns which were attached to the historic logs with reinforcing bars and epoxy. Epoxy repair of log crowns is most successful when the repaired crowns are protected from excess moisture by a roof overhang. Photos: Harrison Goodall.

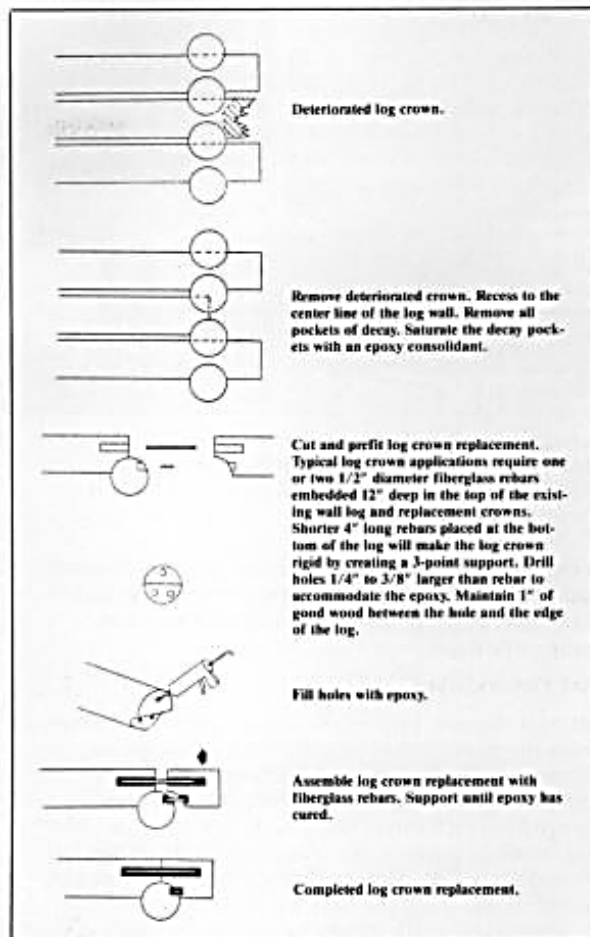
Fig. 21. Epoxy repair. Drawing: Harrison Goodall.

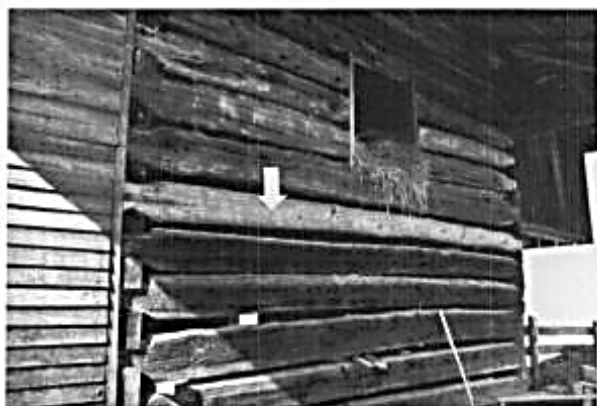
Fig. 22. The lighter-colored replacement log in this barn matches the dimensions and heaving marks of the original logs, and will darken in time to blend visually with the other logs. Photo: Bernard Weisgerber.

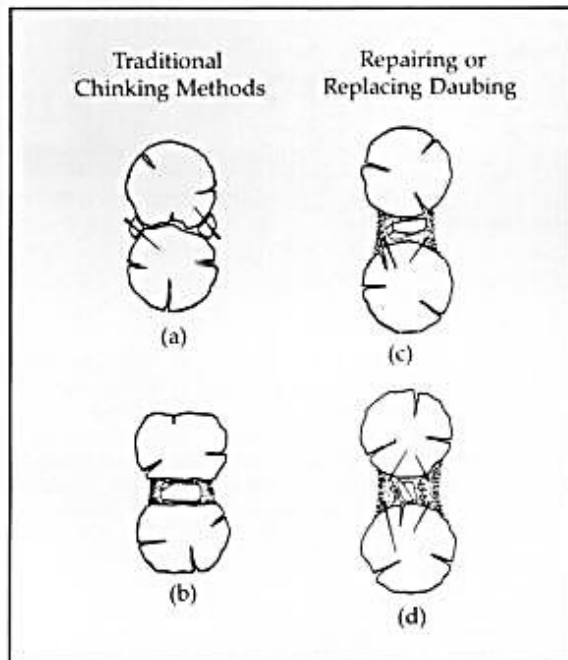
Fig. 23. Illustrated are various methods of chinking and daubing: (a) wood strips, or thin saplings nailed in place; and (b) 3-part system consisting of an inner blocking filler of stones or wood slabs, together with soft filler, such as clay, stuffed around the blocking, composes the chinking, and wet-applied daubing. Concealed aids that may improve the adherence of new daubing include (c) galvanized nails, or (d) galvanized mesh lath. Drawing: James Caufield.

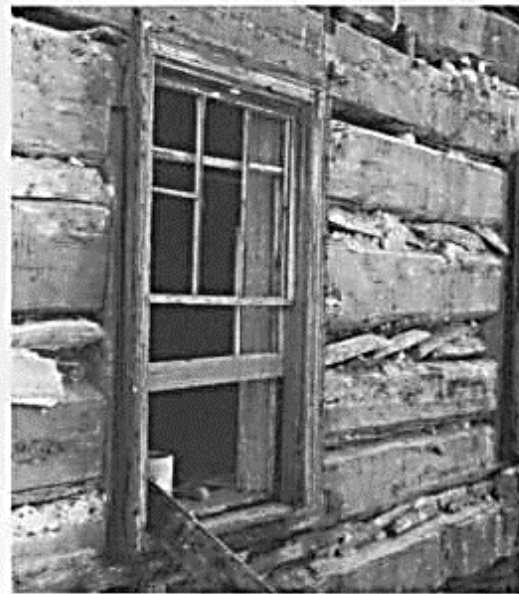
Fig. 25. (a) Prior to rehabilitation, the exterior of this late 18th century log house was sided with wood clapboard, which had been covered over by a later artificial siding, while the upper gallery of the second floor porch was stuccoed. (b) During the rehabilitation both the historic wood siding and stucco were removed to expose the logs, the gables were sided with wood shingles, and what would have originally been milled wood columns supporting the porch were replaced with rough, unmilled log posts. Collectively, these treatments diminished the building's architectural integrity, and gave it an appearance it never had. (c) The depth that the window frames extend out beyond the log surface allowing space for siding is an indication that cladding was part of the building's original construction. Photos: National Park Service Files.

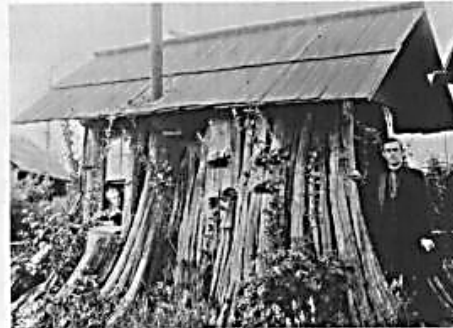
The Secretary of the Interior's "Standards for Rehabilitation" call for the repair or replacement of missing architectural features "based on accurate duplication of features, substantiated by historic, physical, or pictorial evidence rather than on conjectural designs." On a wooden shingle roof, it is important not only to match the size, shape, texture, and configuration of historic shingles, but also to match the craftsmanship and details that characterize the historic roof. Proper installation and maintenance will extend the life of the new roof.

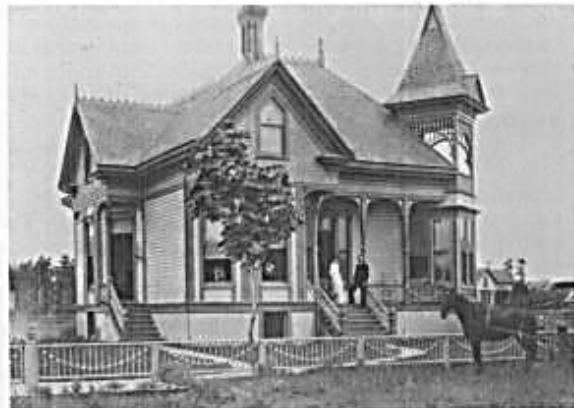
3. Readily available and inexpensive sawn shingles were used not only for roofs, but also for gables and wall surfaces. The circa 1891 Chambers House, Eugene, Oregon used straight sawn butts for the majority of the roof and hexagonal butts for the lower portion of the corner tower. Decorative shingles in the gable ends and an attractive wooden roof cresting feature were also used. Photo: Lane County Historical Society.

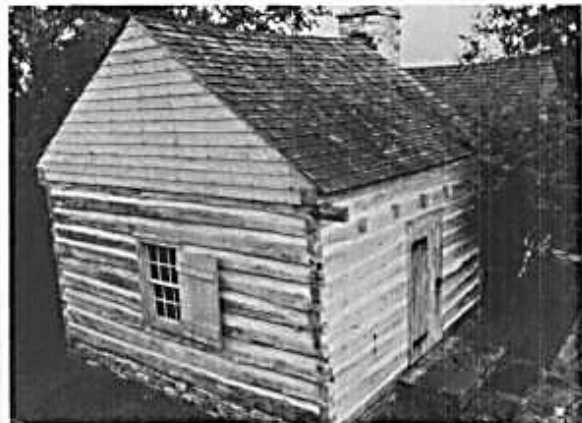
2. Handsplit and dressed shingles were also used on less elaborate buildings as seen in the restoration of the circa 1840 kitchen at the Winedale Inn, Texas. The uneven surfaces of the handsplit shingles were generally dressed or smoothed with a draw-knife to keep the rainwater from collecting in the wood grain and to ensure that the shingles lay flat on the sub-roof. Photo: Thomas Taylor.

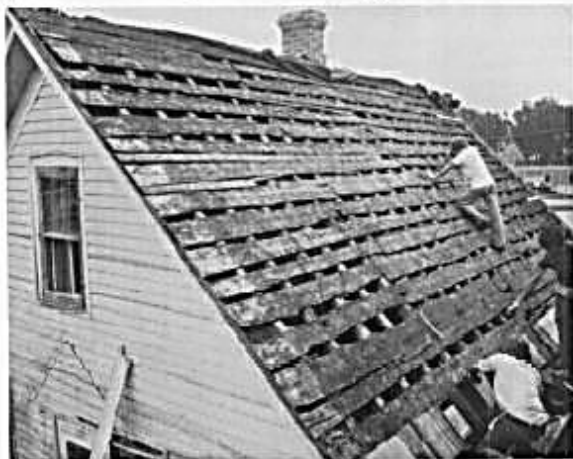
7. The reshingling of the circa 1856 Stovewood House in Decorah, Iowa, revealed the original open sheathing boards and pole rafters. Sawn cedar shingles were used as a replacement for the historic cedar shingles seen still in place at the ridge. A new starter course is being laid at the eaves. Photo: Norwegian-American Museum, Decorah, Iowa.

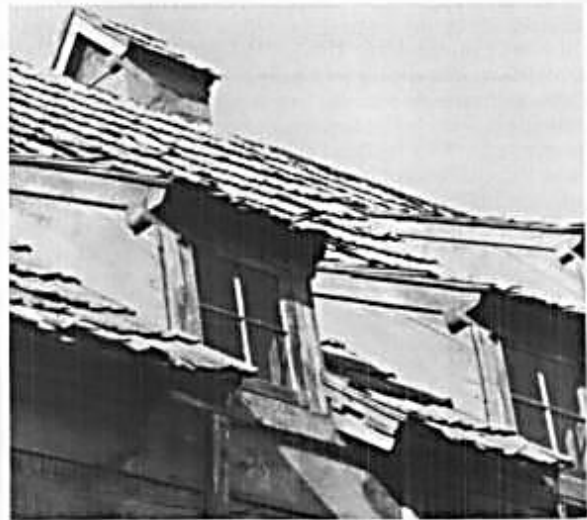
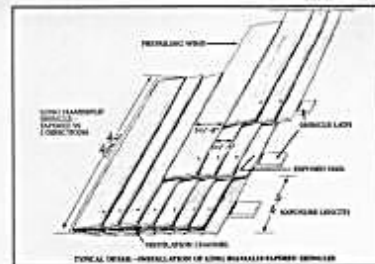
8. The long biaxially tapered handsplit shingles on the Ephrata Cloisters in Pennsylvania were overlapped both vertically and horizontally. The insert sketch shows channels under the shingles that provided ventilation and drainage of any trapped moisture. The aged appearance of these handsplit and dressed shingles belies their original smoothness. Replacement shingles should match the original, not the aged appearance. Photo: National Park Service; Sketch: Reed Engle.

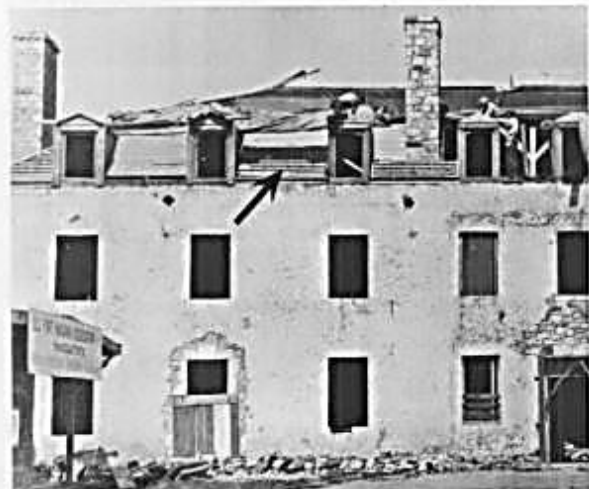
9. This 1927 view of the reshingling of the French Castle at Old Fort Niagara, N.Y., shows the wooden sleepers being laid (see arrow) over solid sheathing in order to raise the shingles up slightly to allow under-shingle ventilation. Note that the horizontal strips are not continuous to allow airflow and trapped moisture to drain away. This cedar roof has lasted for over 60 years in a harsh moist environment. Photo: Old Fort Niagara, Assoc. Inc.
