**US Army Corps
of Engineers®**
Engineer Research and
Development Center

Burgess-Capps Cabin

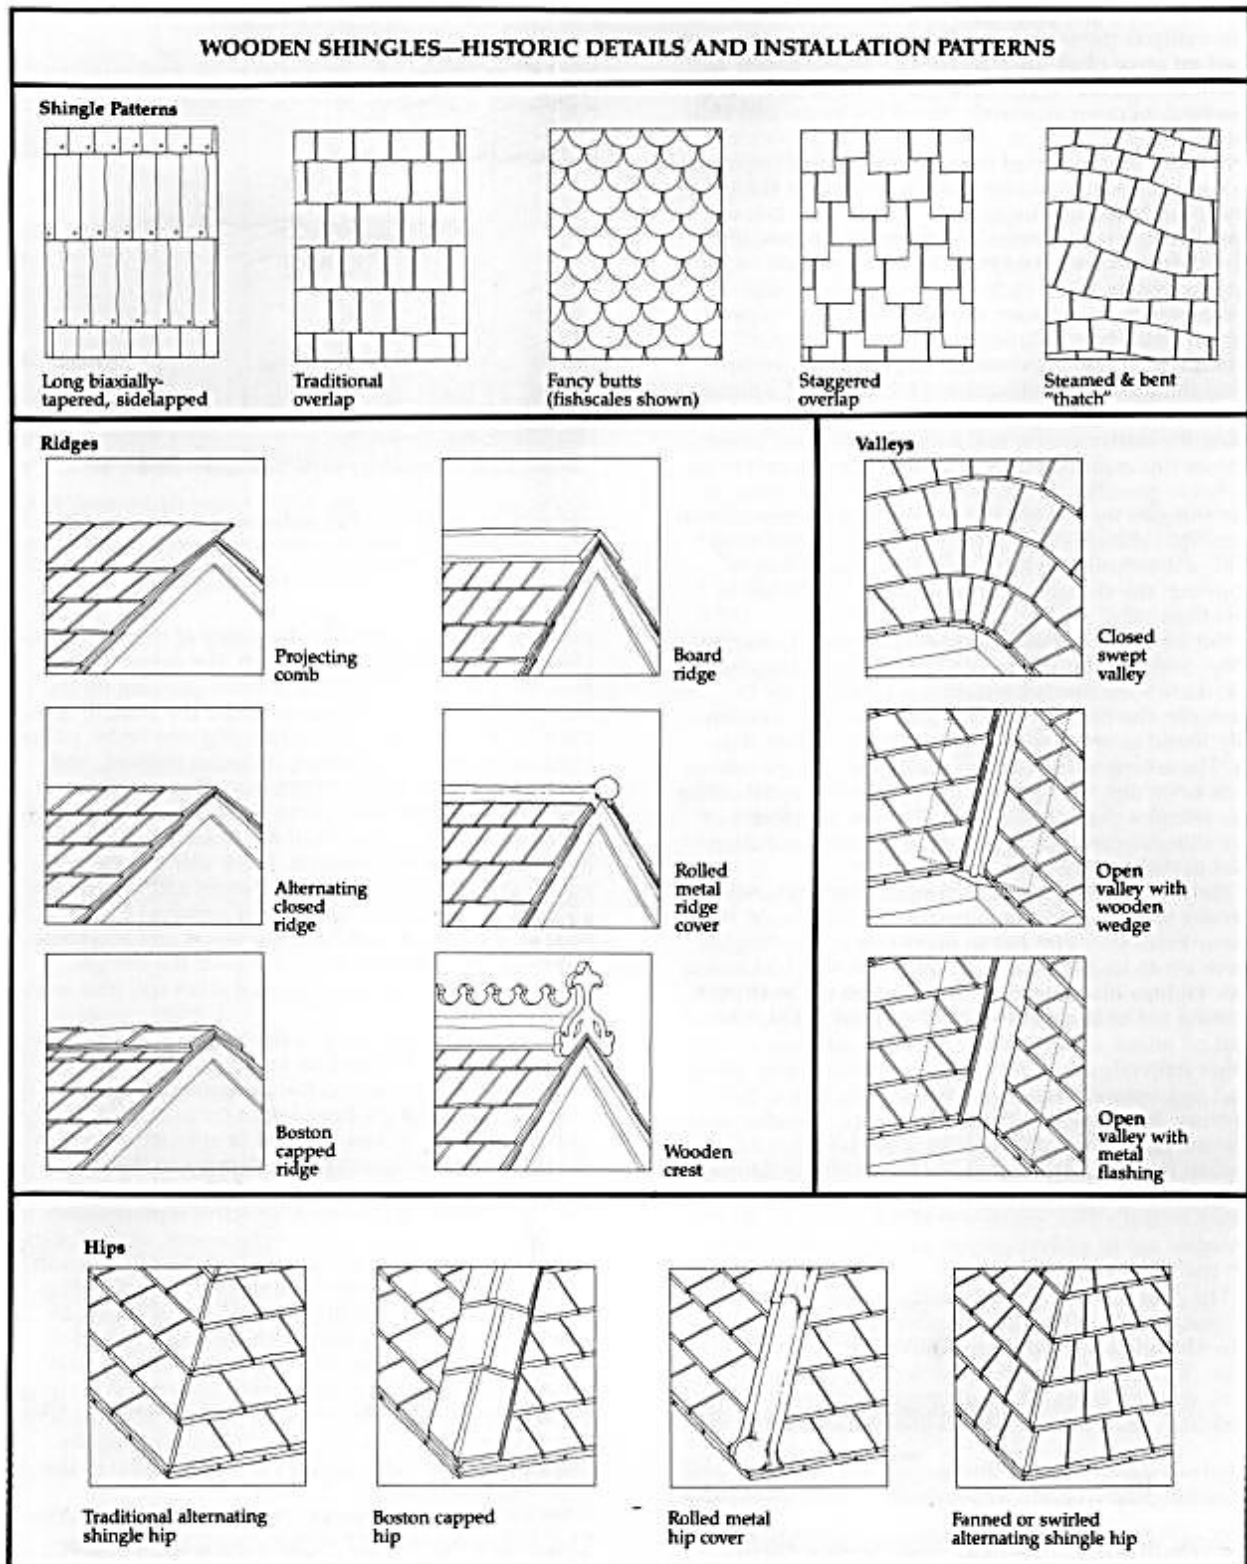
10. The Historic Details and Installation Patterns Chart illustrates a number of special features found on wooden roofs. Documented examples of these features, different for every building and often reflecting regional variations, should be accurately reproduced when a replacement roof is installed. Chart: Sharon C. Park; delineation by Kaye Ellen Simonson.

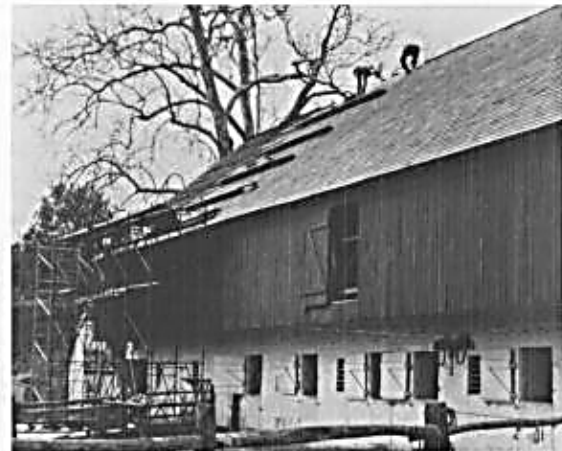
11. The replacement sawn red cedar shingles matched the deteriorated shingles exactly for this barn re-roofing. The old shingles, seen to the far left, were removed as the new shingles were installed. Even the horizontal coursing matched because the exposure length for both old and new shingles was the same. Photo: Williamsport Preservation Training Center.

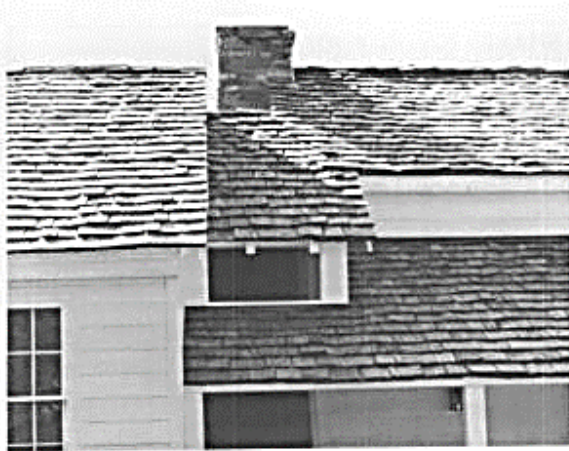
12. Inappropriately selected and installed wooden shingles can drastically alter the historic character of a building. This tavern historically was roofed with handsplit and dressed shingles of a relatively smooth appearance. In this case, a commercially available shake was used to effect a "rustic" appearance. Photo: National Park Service.

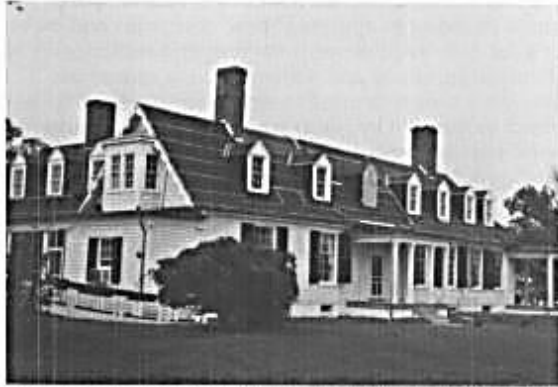
A. The later non-historic shingles were removed from Appomattox Manor (circa 1840 with later additions) and roofing paper was installed for temporary protection during the re-shingling.

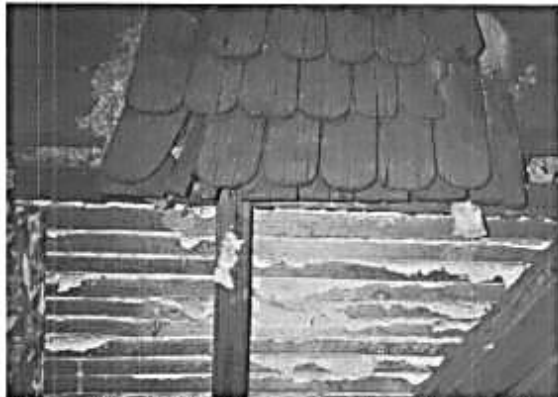
B. These weathered historic 19th-century handsplit and dressed shingles were found in place under a later altered roof. Note the straight butt eave shingles under the curved butts of the historic dormer shingles.

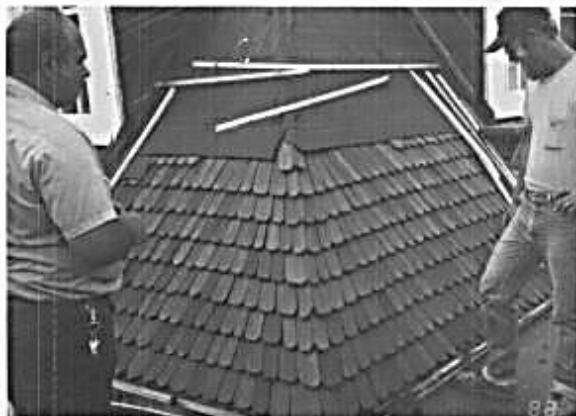
D. The fanned hips (seen here), swept valleys, and projecting ridge combs were installed as part of the re-roofing project. Special features, when documented, should be reproduced when re-shingling historic roofs.

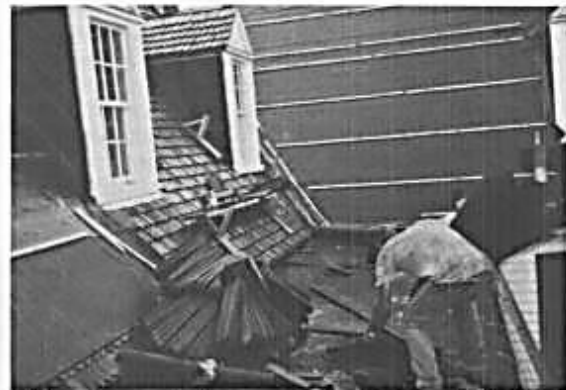
C. The replacement shingles (see specifications above), matched the historic shingles and were of such high quality that little hand dressing was needed at the site. The building paper, a temporary protection, was removed as the shingles were installed on the sheathing boards.

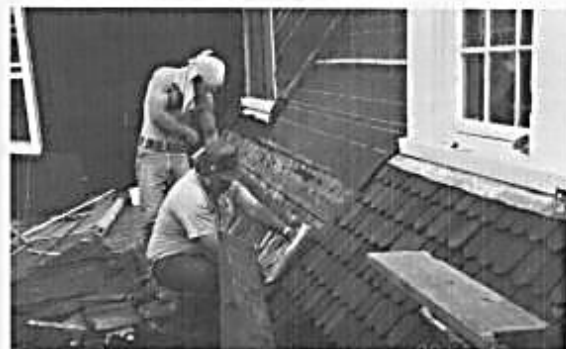
E. In order to achieve a "Class B" fire-rating, the shingles were dipped in fire-retardant chemicals and allowed to dry prior to installation. Iron oxide was added to this chemical dip to stain the shingles to match the historic red color. These coatings will need periodic reapplication.

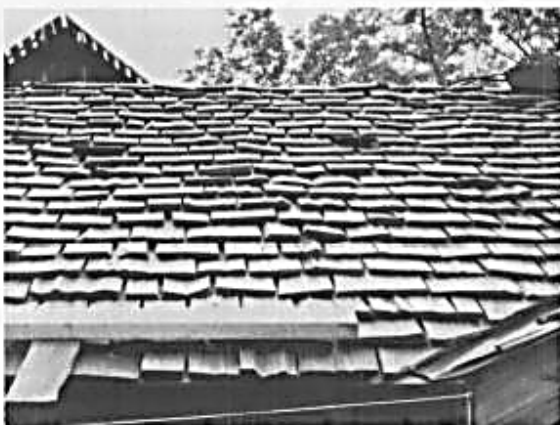
15. These commercially available roofing products with rustic split faces are not appropriate for historic preservation projects. In addition to the inaccurate appearance, the irregular surfaces and often wide spaces between shingles will allow wind-driven moisture to penetrate up and under them. The excessively wide boards will tend to cup, curl and crack. Moss, lichens and debris will have a tendency to collect on these irregular surfaces, further deteriorating the roofing. Photo: Sharon C. Park.

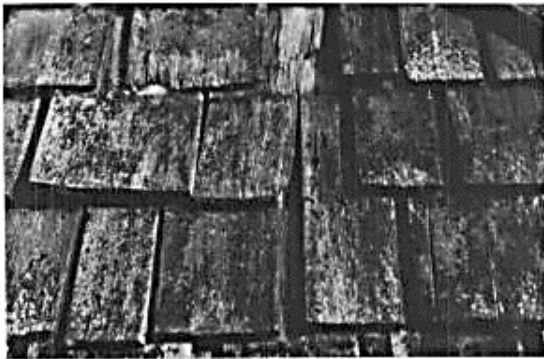
16. Routine maintenance is necessary to extend the life of the roof. On this roof, the shingles have not seriously eroded, but the presence of lichens and moss is becoming evident and there are a few cracked and missing shingles. The moss spores should be removed, missing shingles replaced, and small pieces of metal flashing slipped under cracked shingles to keep moisture from penetrating. Photo: Williamsport Preservation Training Center.

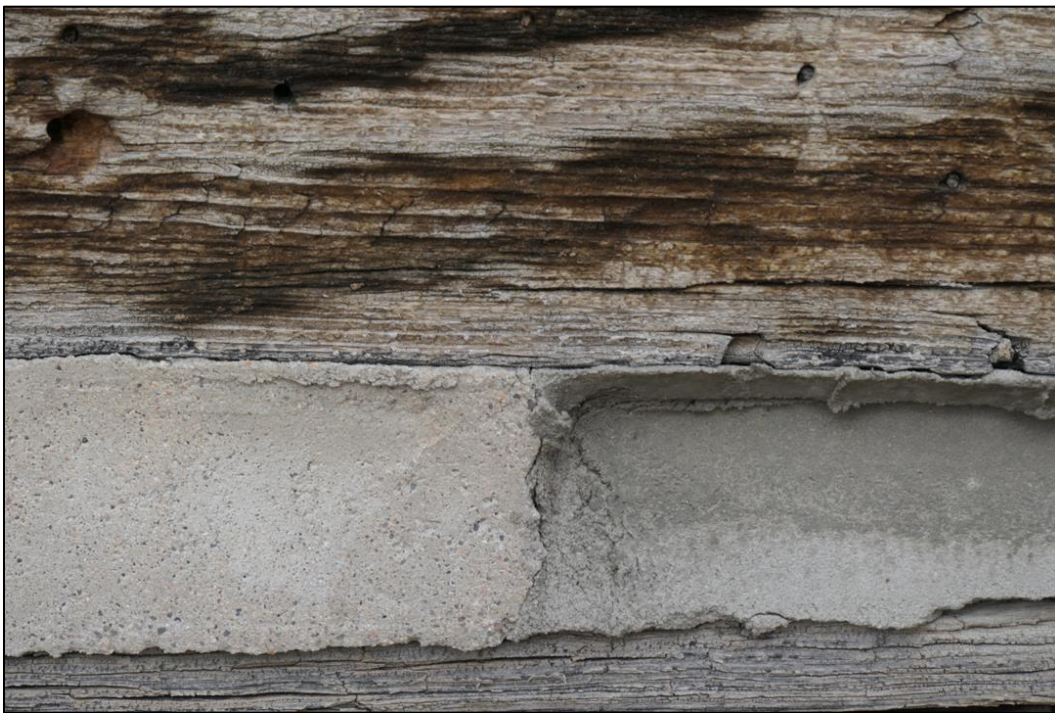
There are mortar joints in the stone wall foundation of the Burgess-Capps Cabin (see Figure 67). The stone chimney on the east side of the building is also secured with mortar (see Figure 68 and Figure 69).

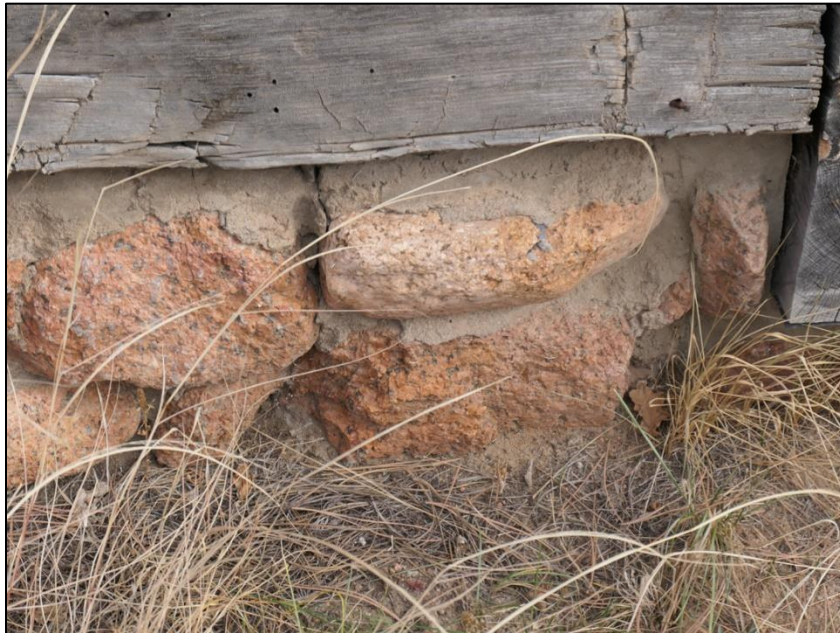
Figure 68. Mortar in the stone chimney on the east elevation of the Burgess-Capps Cabin (photo by ERDC-CERL researchers, 2021).

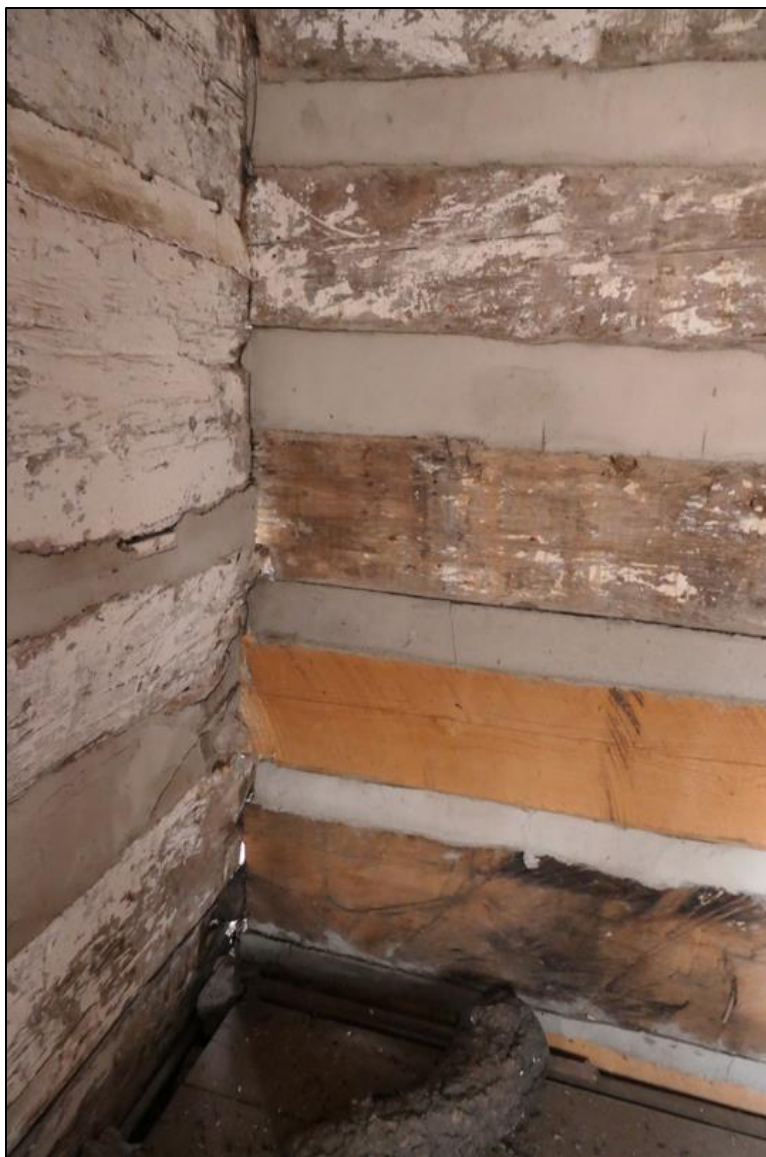
6.3 Treatment measures: “Chinking Repair” section of Preservation Brief 26: The Preservation and Repair of Historic Log Buildings, 1978¹¹⁴

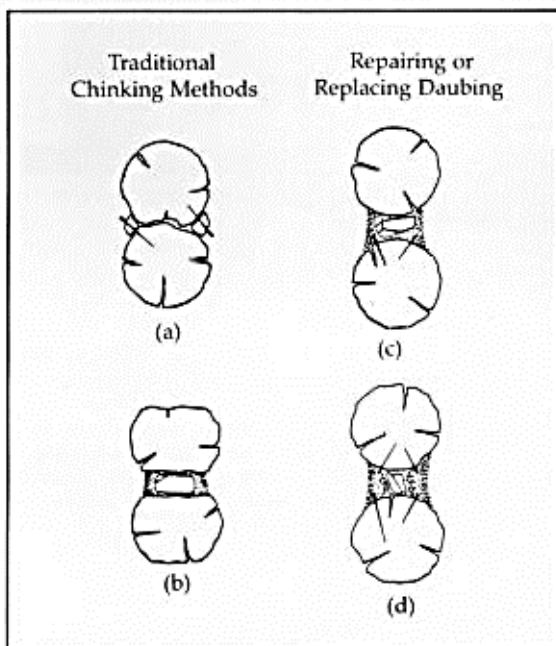
Fig. 23. Illustrated are various methods of chinking and daubing: (a) wood strips, or thin saplings nailed in place; and (b) 3-part system consisting of an inner blocking filler of stones or wood slabs, together with soft filler, such as clay, stuffed around the blocking, and wet-applied daubing. Concealed aids that may improve the adherence of new daubing include (c) galvanized nails, or (d) galvanized mesh lath. Drawing: James Caufield.

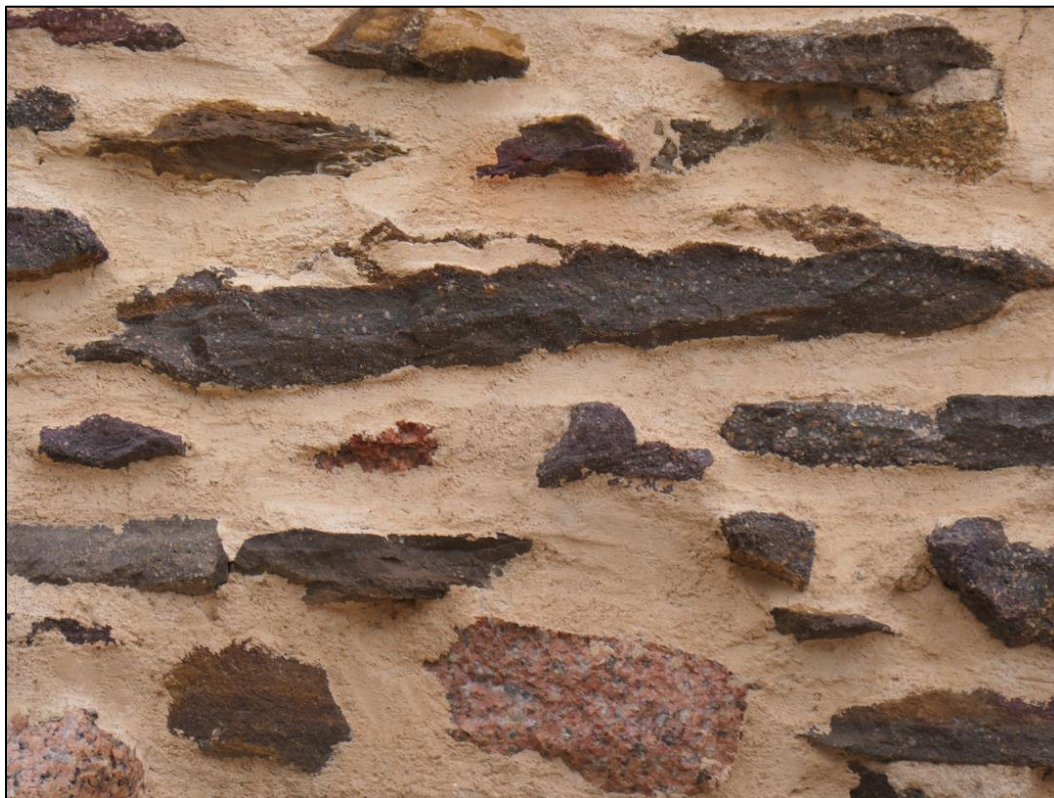
The structural stone of the Burgess-Capps Cabin is the stone foundation (see Figure 76). The foundation is visible on only one side of the cabin due to the unevenness of the cabin floor and the grade levels. There are also tall grasses that surround the building. The stone foundation is wall-like and is secured with mortar joints and galvanized metal flashing atop the stone that provides a surface for the logs to rest on. Similar to the stone chimney, the stone foundation is made up of multiple stone sizes (see Figure 77).

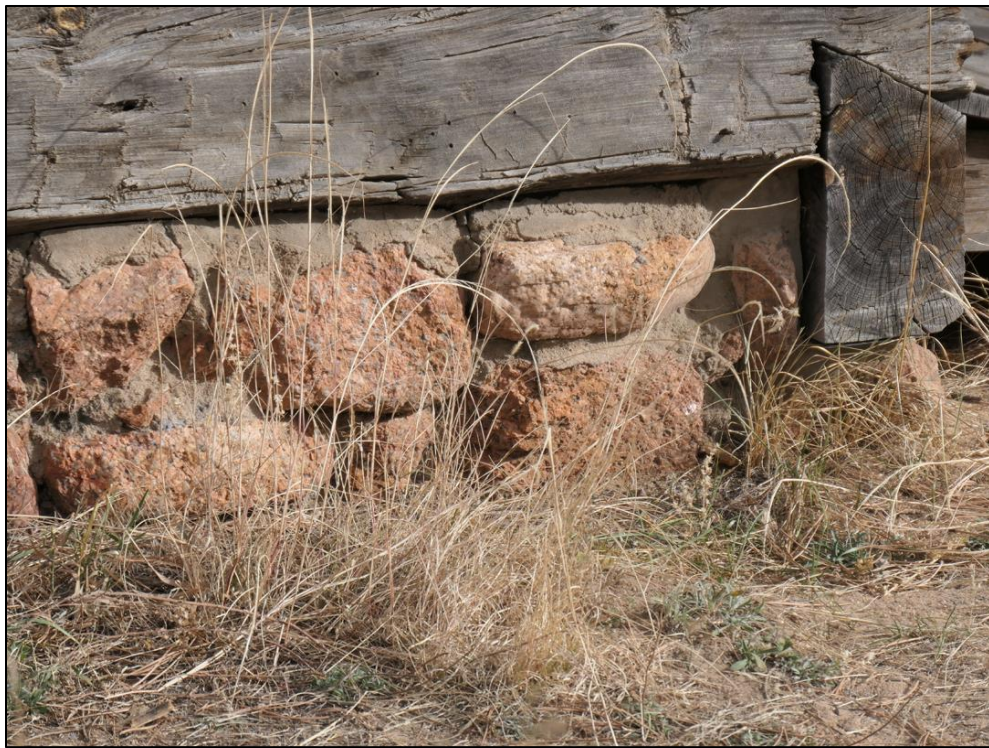
Figure 77. Close-up of multiple stone sizes secured in mortar on the foundation of the Burgess-Capps Cabin (photo by ERDC-CERL researchers, 2021).

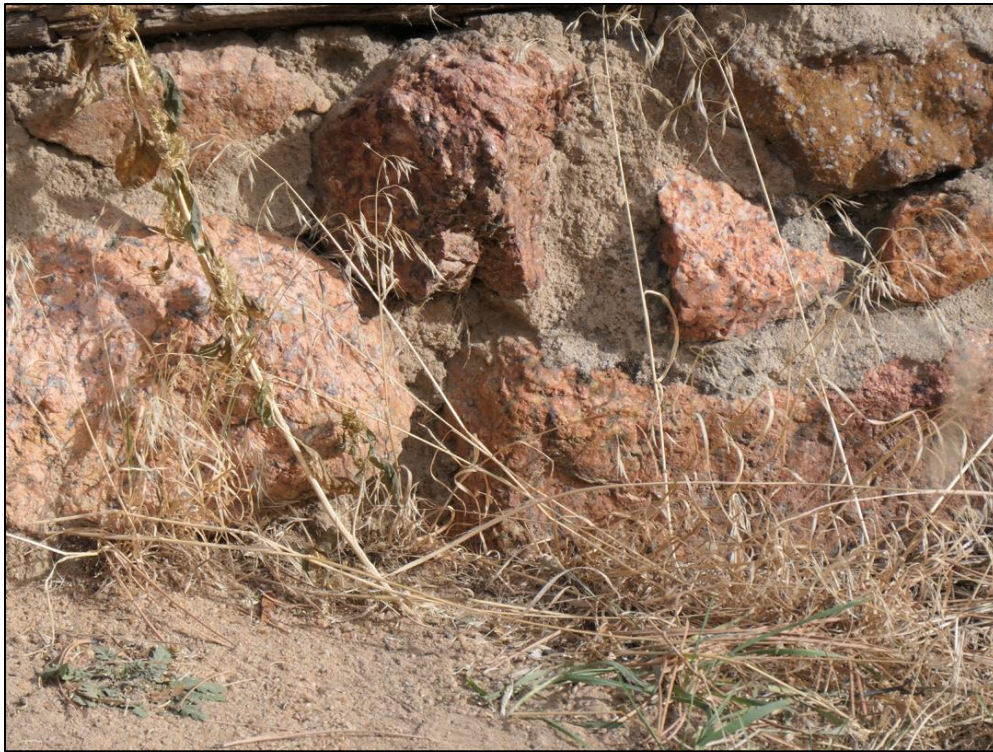
7.2 Interior stone features

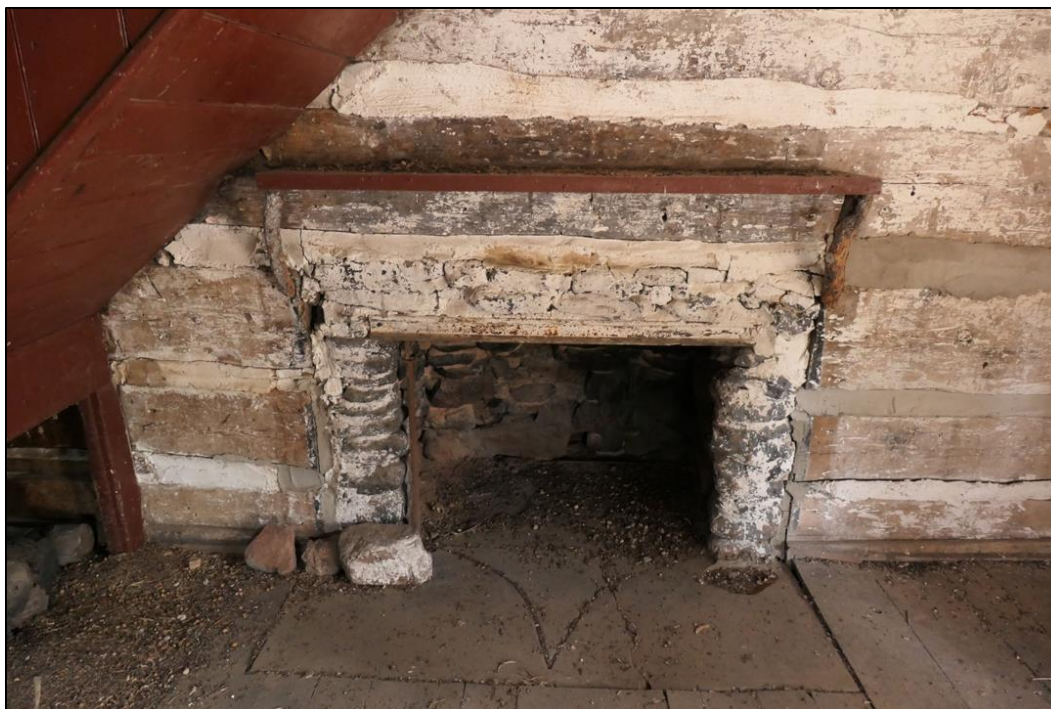
Figure 79. Stone hearth inside the Burgess-Capps Cabin (photo by ERDC-CERL researchers, 2021).

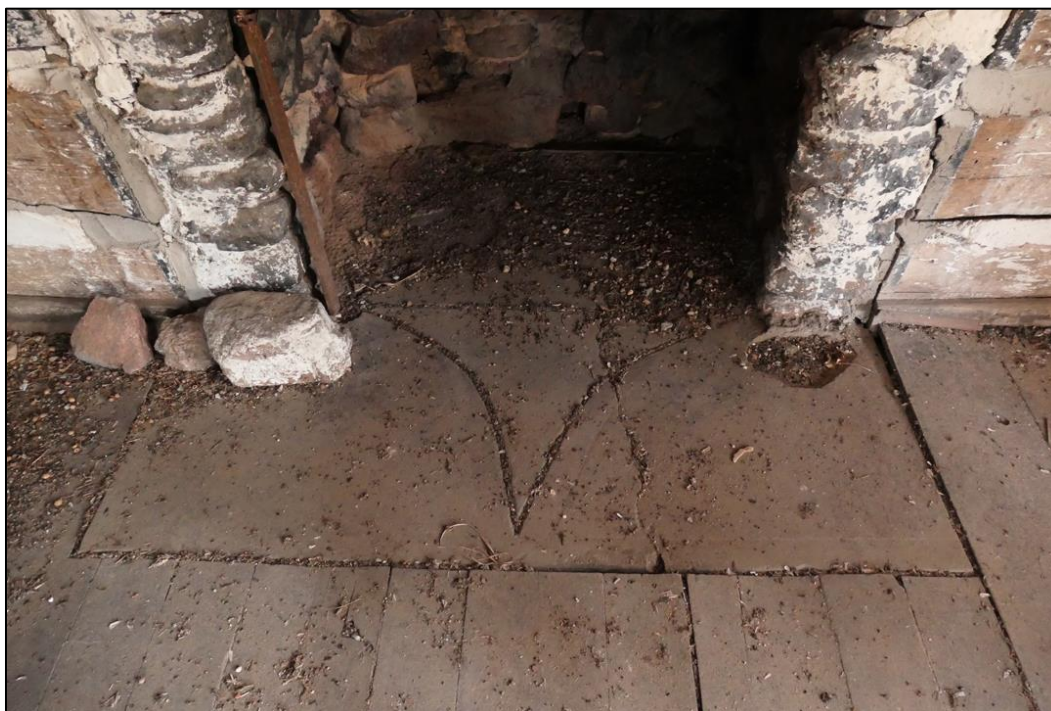
7.3 Treatment measures¹¹⁵

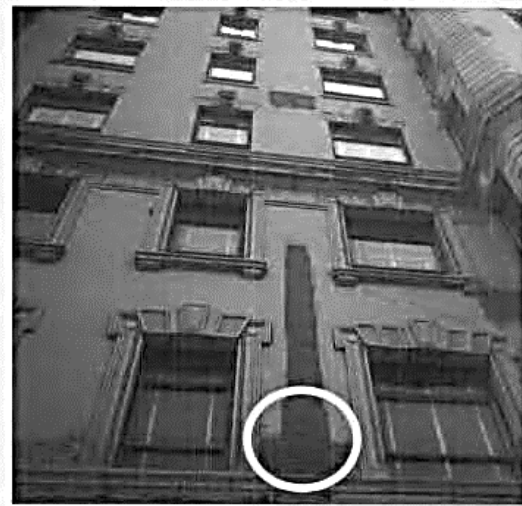
Figure 3. This small test area has revealed a red brick patch that does not match the original beige brick. This may explain why the building was painted, and may suggest to the owner that it may be preferable to keep it painted.

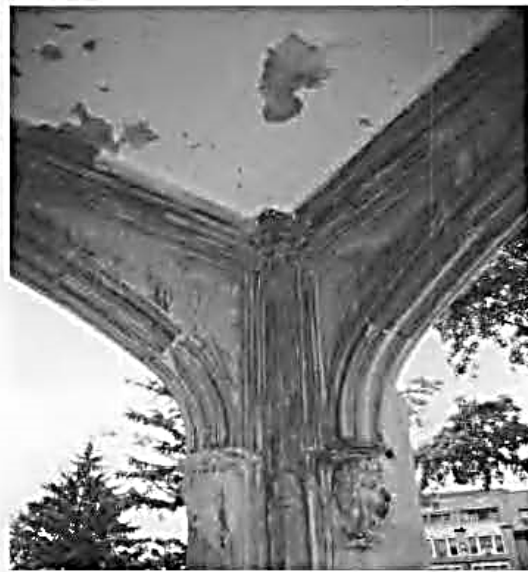
Figure 5. Repeated water washing did not remove the staining inside this limestone porte cochere. Upon closer examination, it was determined to be a water-repellent coating that had been applied many years earlier. An alkaline cleaner may be effective in removing it.

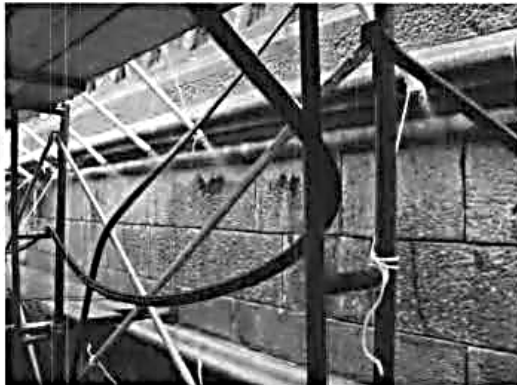
Figure 6. Timed water soaking can be very effective for cleaning limestone and marble as shown here at the Marble Collegiate Church in New York City. In this case, a twelve-hour water soak using a multi-nozzle manifold was followed by a final water rinse. Photo: Diane S. Kaese, Wiss, Janney, Elstner Associates, Inc., N.Y., N.Y.

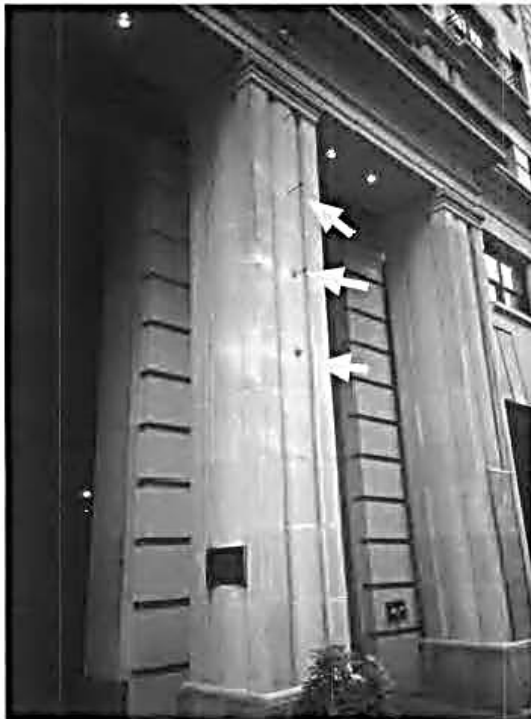
Figure 10. High-pressure water washing too close to the surface has abraded and, consequently, marred the limestone on this early-20th century building.

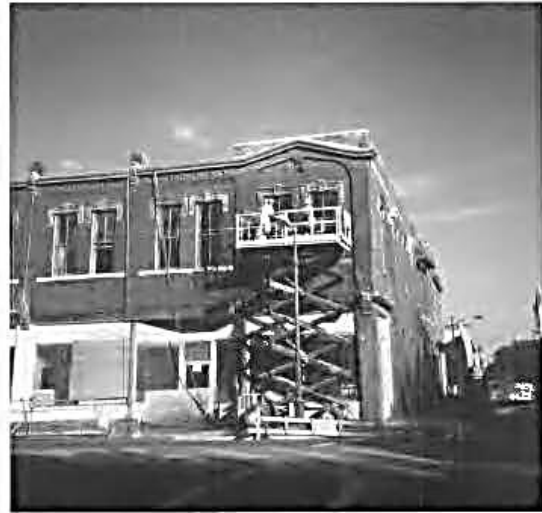
Figure 14. Chemical removal of paint from this brick building has revealed that the cornice and window hoods are metal rather than masonry.

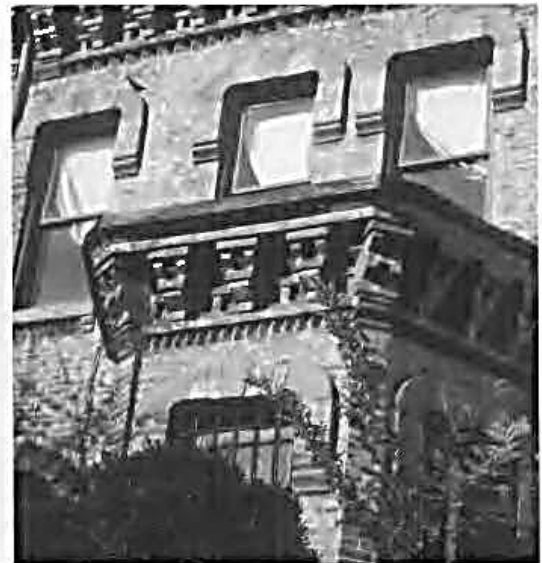
Figure 15. The whitish deposits left on the brick by a chemical paint remover may have resulted from inadequate rinsing or from the chemical being left on the surface too long and may be impossible to remove.

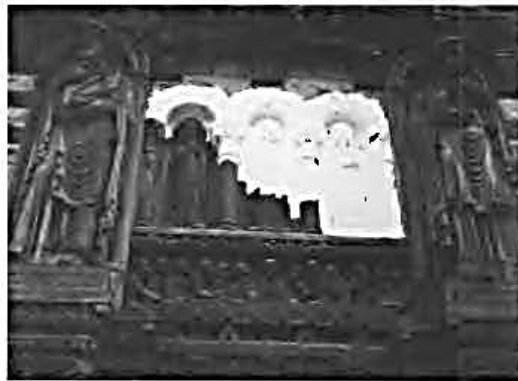
Figure 17. A poultice is being used to remove salts from the brownstone statuary on the facade of this late-19th century stone church. Photo: National Park Service Files.

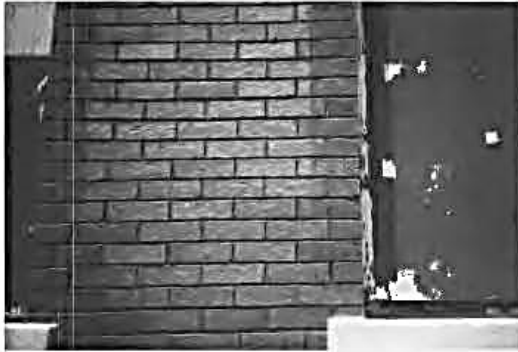
Figure 18. The glazed bricks in the center of the pier were covered by a signboard that protected them being damaged by the sandblasting which removed the glaze from the surrounding bricks.

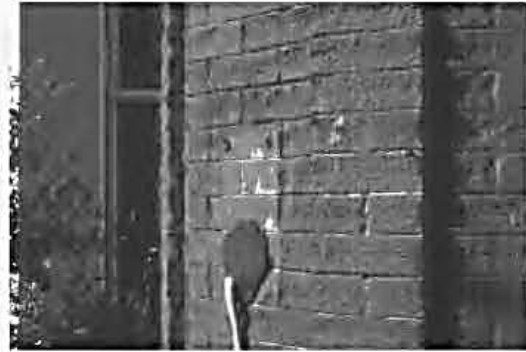
Figure 19. A comparison of undamaged bricks surrounding the electrical conduit with the rest of the brick facade emphasizes the severity of the erosion caused by sandblasting.

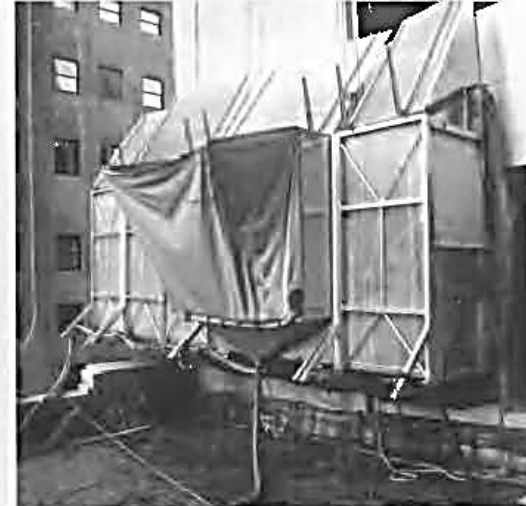
Figure 20. (Left) A comparison of the limestone surface of a 1920s office building before and after "cleaning" with a proprietary abrasive process using fine glass powder clearly shows the effectiveness of this method. But this is an abrasive technique and it has "cleaned" by removing part of the masonry surface with the dirt. Because it is abrasive, it is generally not recommended for large-scale cleaning of historic masonry, although it may be suitable to use in certain, very limited cases under controlled circumstances. (Right) A vacuum chamber where the used glass powder is collected for environmentally safe disposal is a unique feature of this particular process. The specially-trained operators in the chamber wear protective clothing, masks and breathing equipment. Photos: Tom Keohan.

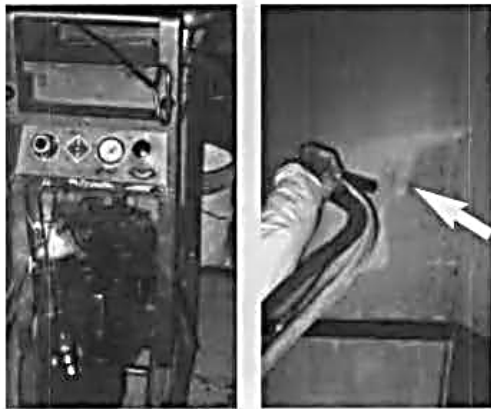
Figure 21. Low-pressure blasting with ice pellets or ice crystals (left) is an abrasive cleaning method that is sometimes recommended for use on interior masonry because it does not involve large amounts of water. However, like other abrasive materials, ice crystals "clean" by removing a portion of the masonry surface with the dirt, and may not remove some stains that have penetrated into the masonry without causing further abrasion (right). Photos: Audrey T. Tepper.

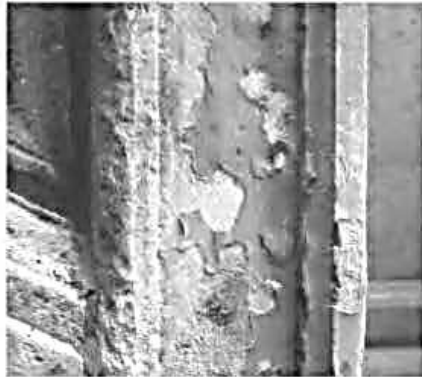
Figure 25. The clear coating applied to this limestone molding has failed and is taking off some of the stone surface as it peels. Photo: Frances Gale.

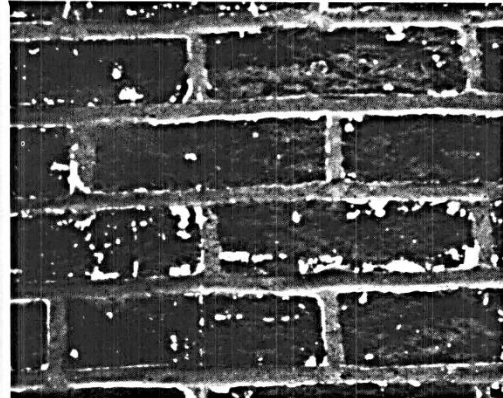
Abrading the Surface without Removing the Paint. Even though the entire outer surface layer of the brick has been sandblasted off, spots of paint still cling to the masonry. Sandblasting or other similarly abrasive methods are not always a successful means of removing paint.

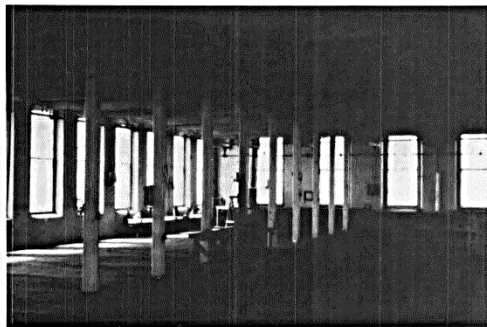
Permissible Abrasive Cleaning. In accordance with the Secretary of the Interior's Guidelines for Rehabilitation Projects, it may be acceptable to use abrasive techniques to clean an industrial interior space such as that illustrated here, because the masonry surfaces do not have significant design, detailing, tooling or finish, and the wooden architectural features are not finished, molded, beaded or worked by hand.

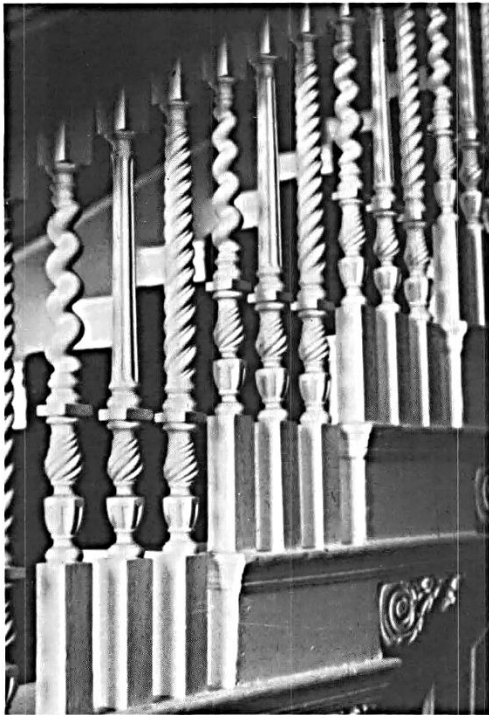
Do not Abrasively Clean these Interiors. Most historic residential and some commercial interior spaces contain finished plaster and wooden elements such as this stair balustrade and paneling which contribute to the historic and architectural character of the structure. Such interiors should not be subjected to abrasive techniques for the purpose of removing paint, dirt, discoloration or plaster.

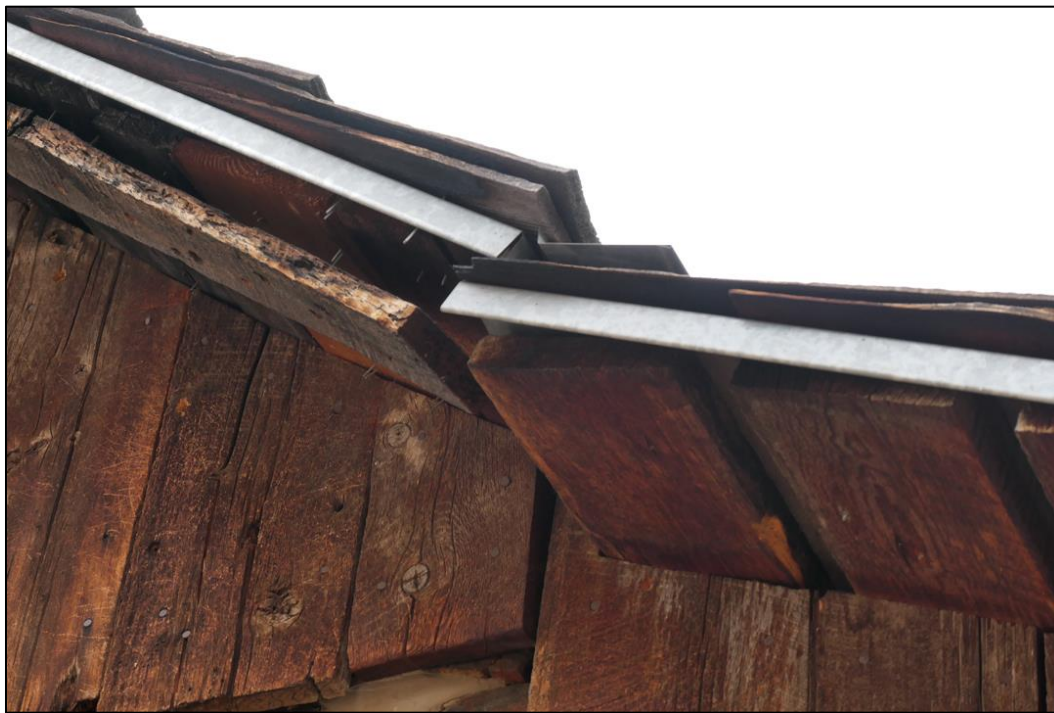
Atop the stone foundation is also galvanized metal flashing (see Figure 83). Throughout the exterior of the Burgess-Capps Cabin are visible hardware that are both potentially original and newer, such as nails and other structural reinforcements (see, for instance, the bolt in Figure 84).

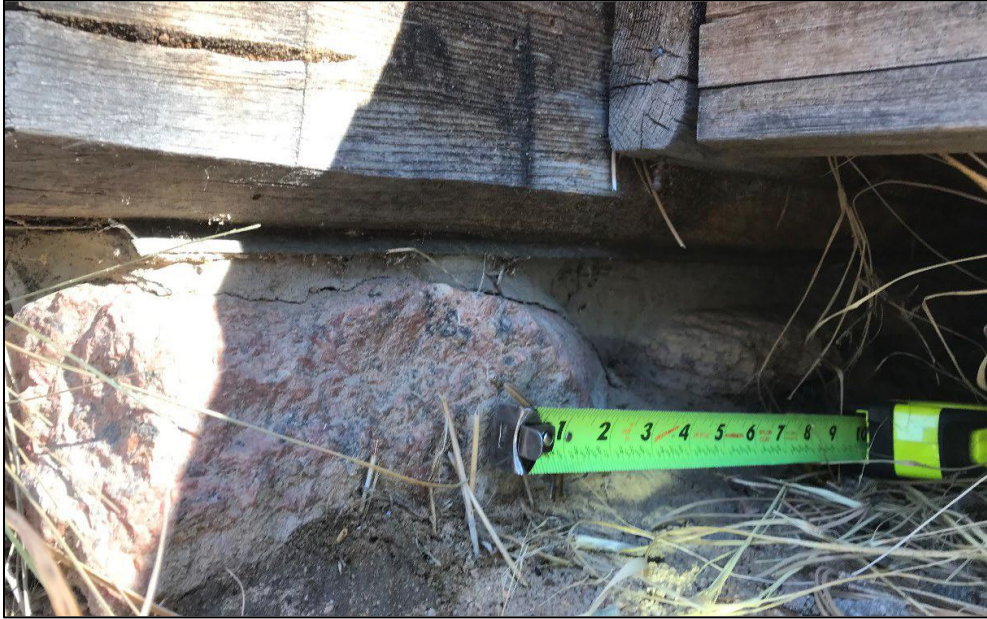
Figure 84. Bolt and double-headed nail near the foundation of the Burgess-Capps Cabin (photo by ERDC-CERL researchers, 2021).

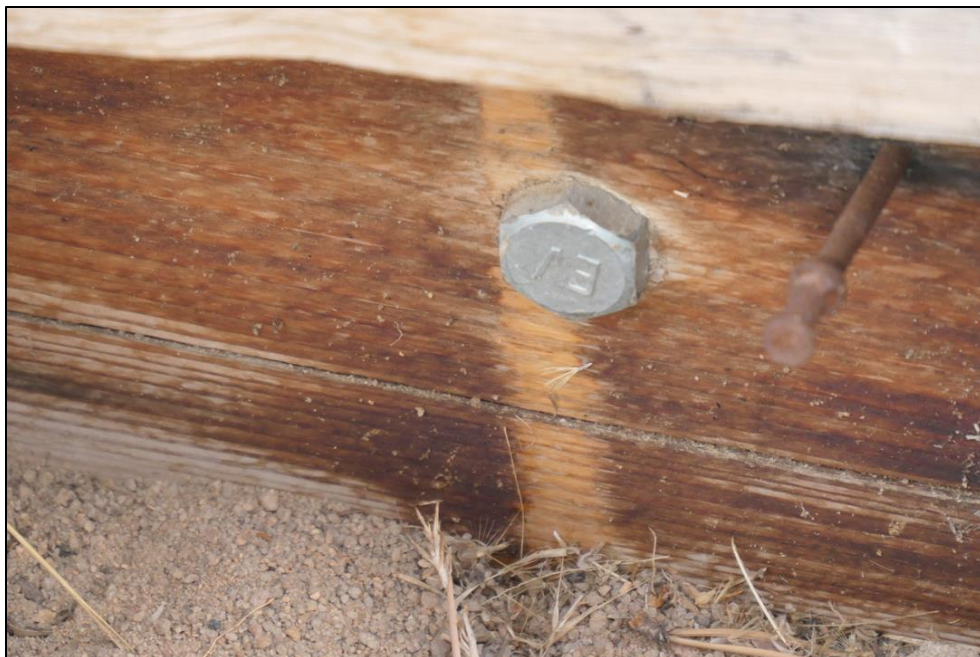
8.2 Interior metal features

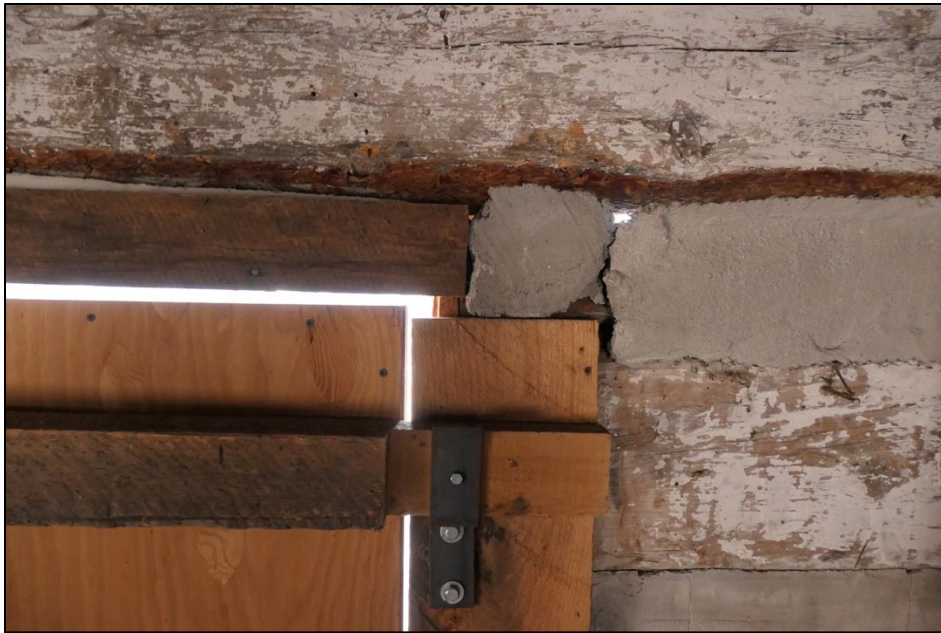
In the loft of the Burgess-Capps Cabin are multiple fasteners that were installed at an unknown date (i.e., no documentation found), according to the USAFA cultural resource manager. There are also turn-buckles (seen in Figure 90 and Figure 91), strong ties (seen in Figure 92), and L-beams (seen in Figure 93).

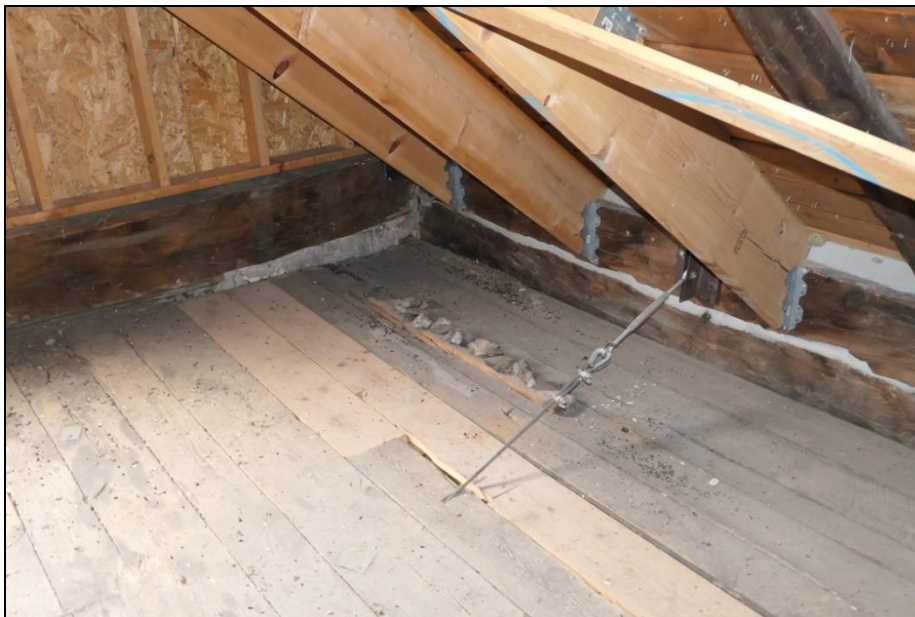
Figure 91. Multiple turnbuckle and cables that are fastened to a double 2 × 8 board below the loft floor, which connects to a turnbuckle, which is bolted to two steel angle brackets, which are lag bolted to the top wall timber in the loft of the Burgess-Capps Cabin (photo by ERDC-CERL researchers, 2021).

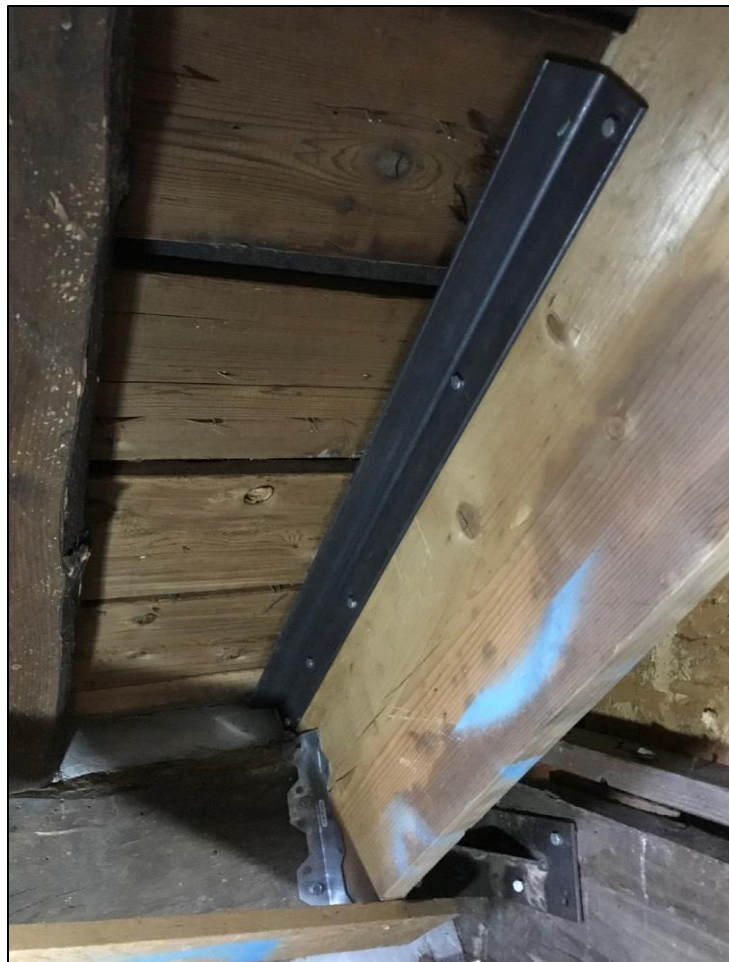
8.3 Treatment measures: “Cleaning Door Hardware,” 2017¹¹⁸

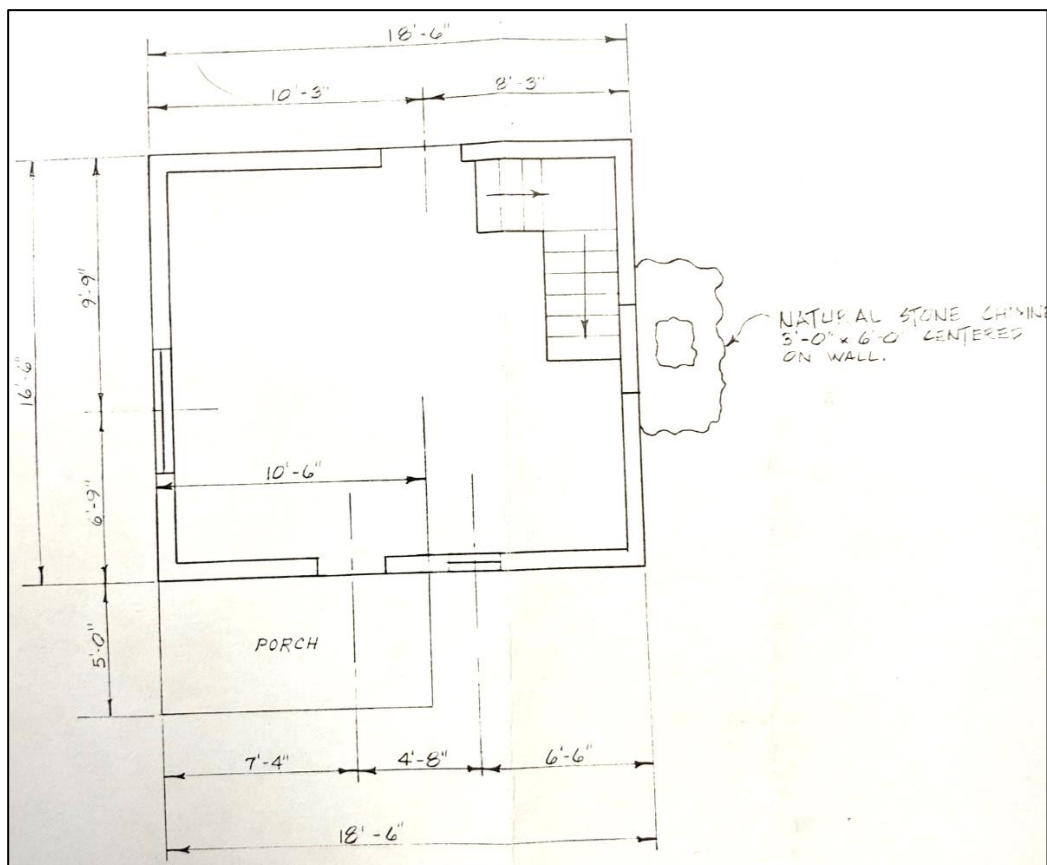
9.3.1 Foundation condition and observations

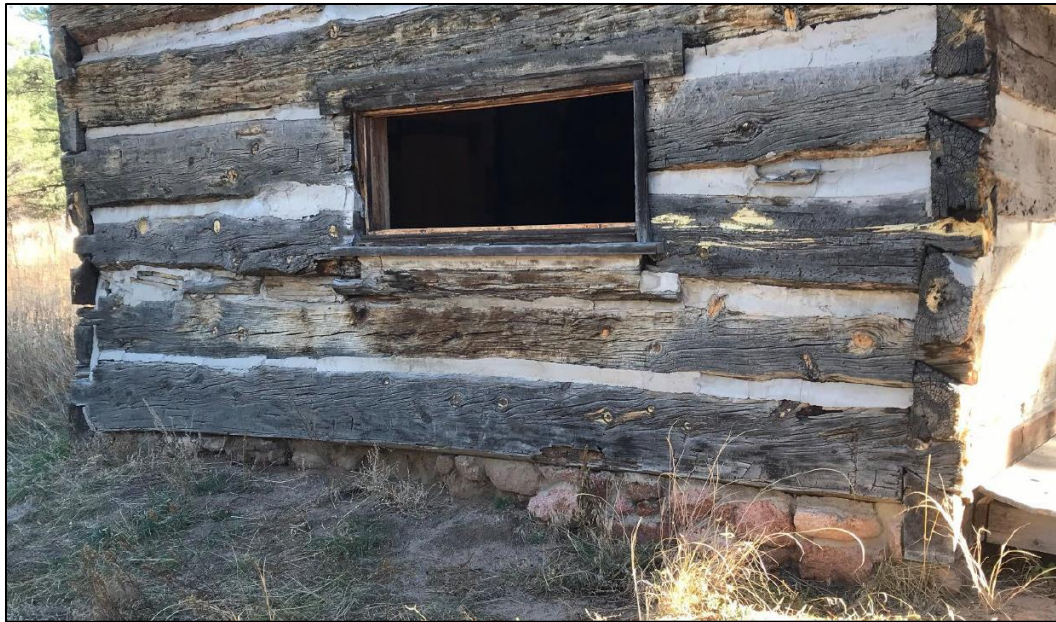
¹²⁰ Roberts Thorne Architects, “Capp’s/Burgess Cabin Preservation Stabilization and Archaeological Report.”
