**US Army Corps
of Engineers®**
Engineer Research and
Development Center

Burgess-Capps Cabin

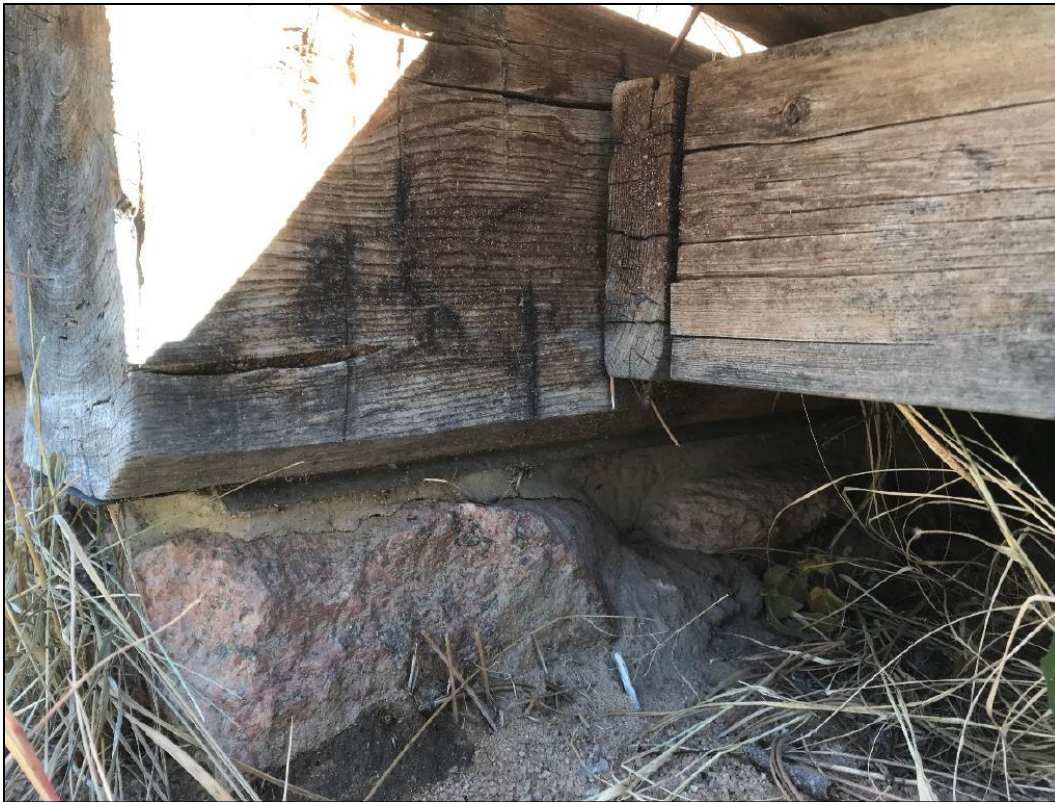
Figure 99. Closeup view of the foundation wall at the west end of the south wall showing galvanized metal flashing (photo by ERDC-CERL researchers, 2021).

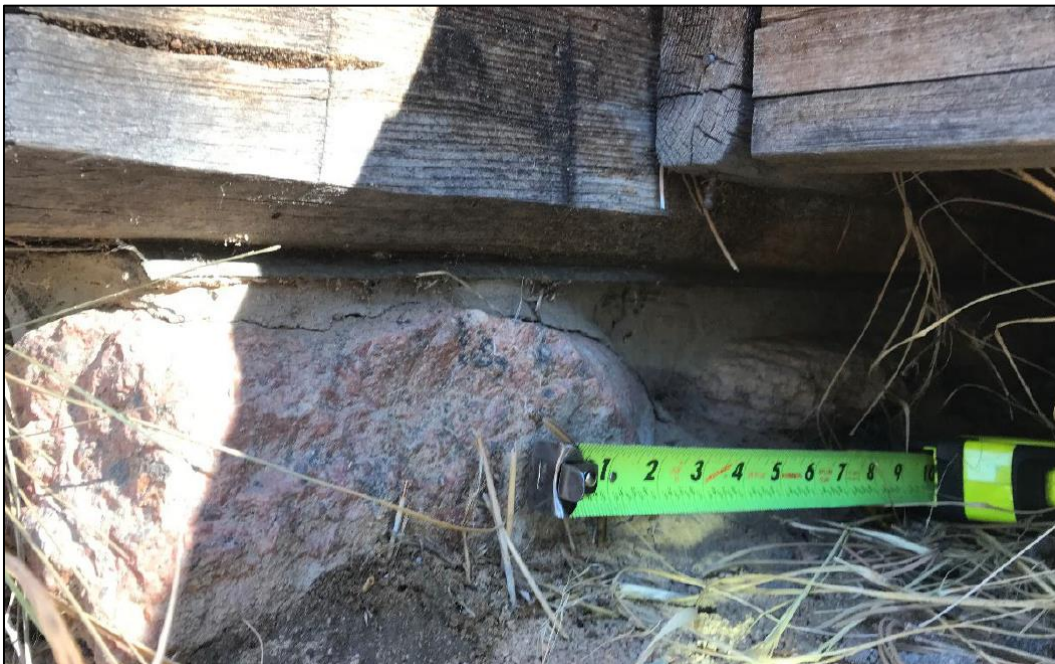
Figure 100. Foundation at the west end of the north wall (photo by ERDC-CERL researchers, 2021).

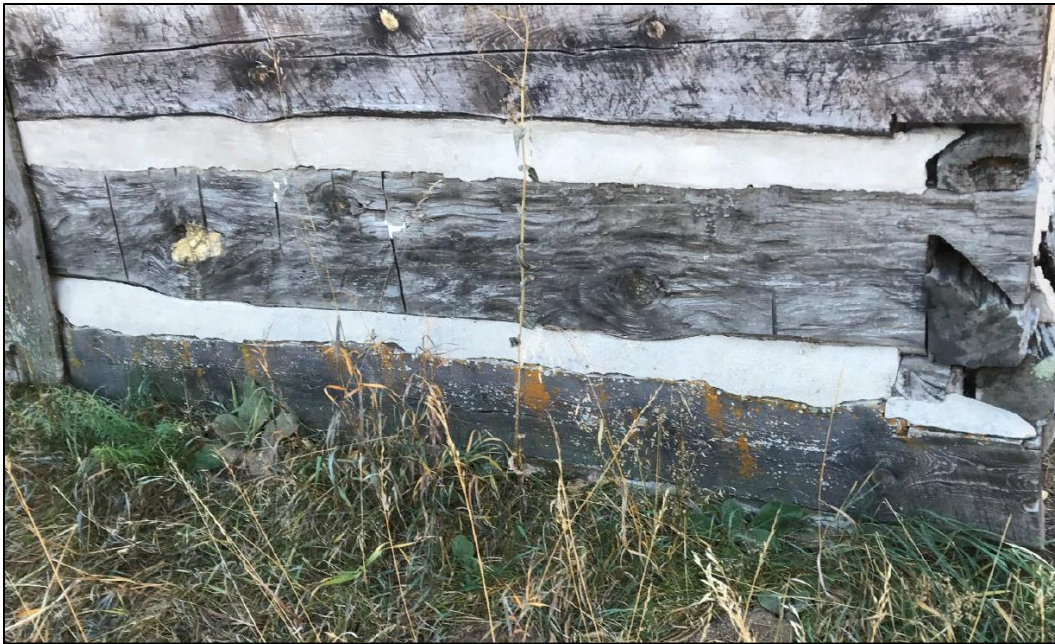
Figure 101. Foundation below the east wall, near the south wall, where mortar and possibly stone is below the lowest timber (photo by ERDC-CERL researchers, 2021).

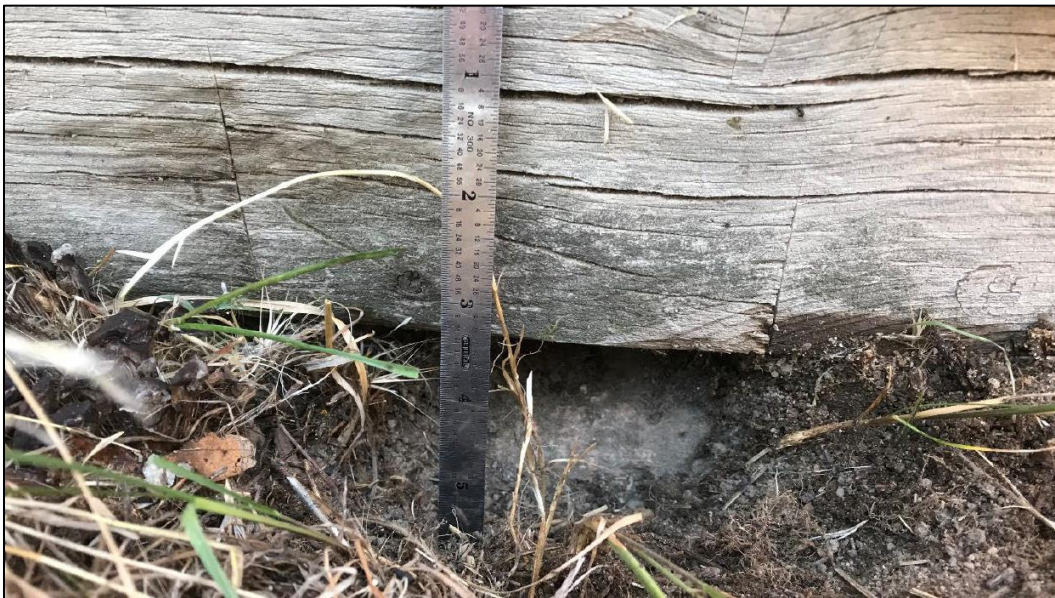
Figure 99 shows galvanized metal flashing installed between the stone foundation and the bottom of the first timber at the west end of the south wall. Similar flashing can be felt along the east end of the south wall. The interior surface of the timbers near the bottom of the west portion of the north wall look relatively new with little weathering. The presence of the metal flashing and lack of weathered timber near the bottom of the

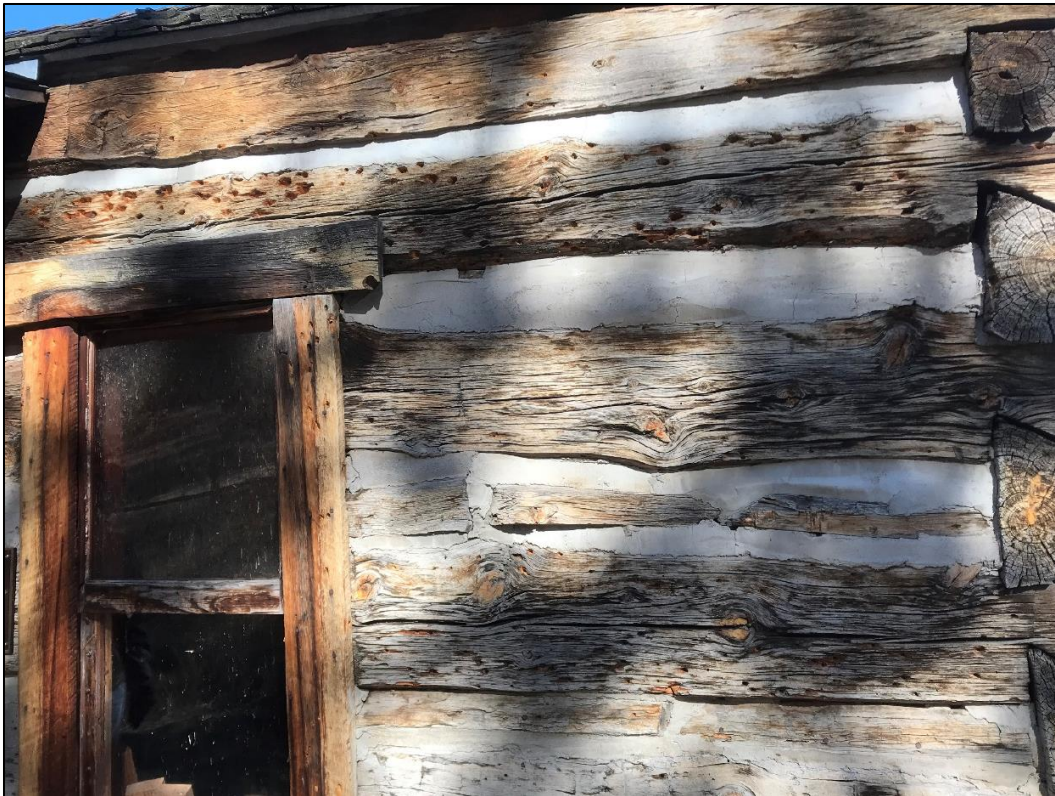
Figure 102. East side of the south wall showing the timber and mortar condition (photo by ERDC-CERL researchers, 2021).

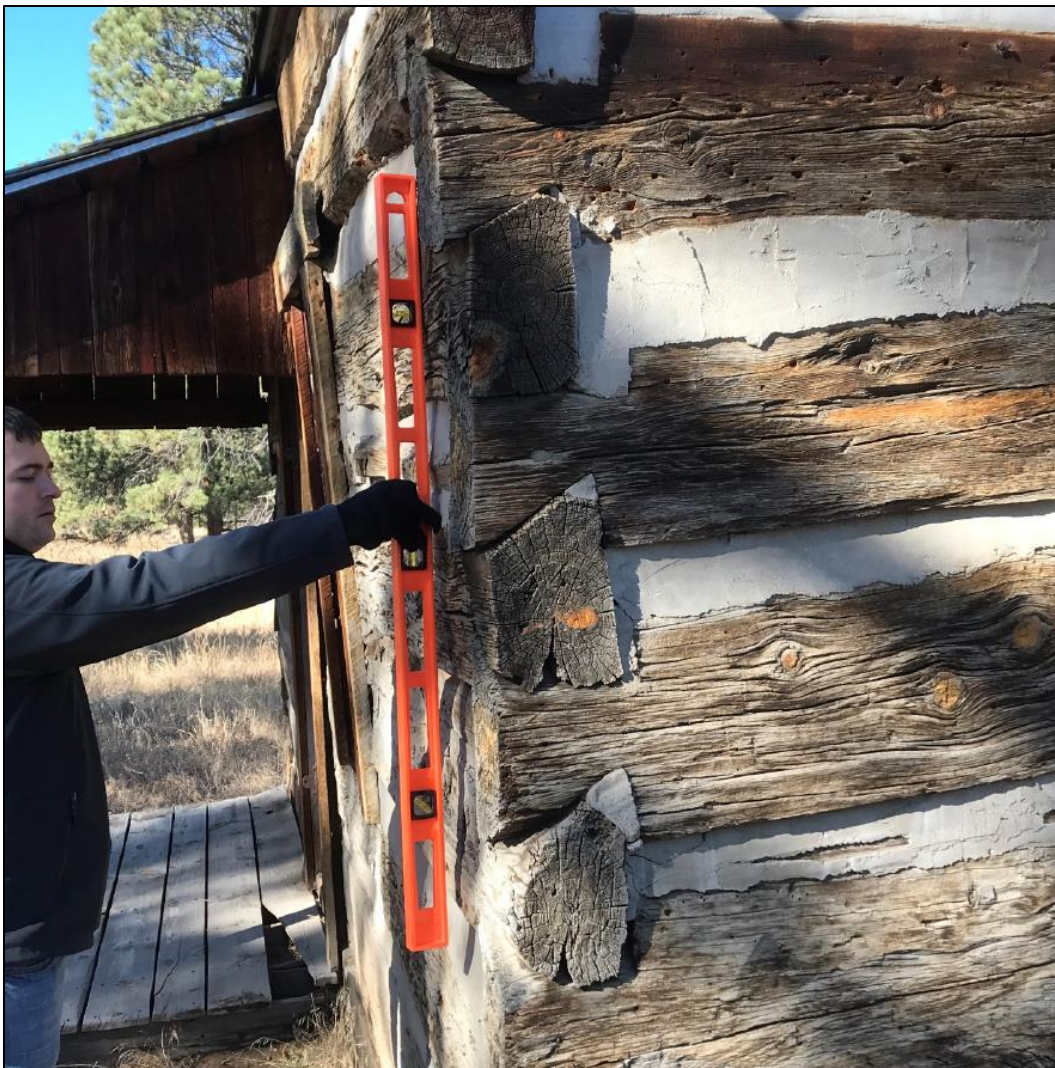
The stone chimney appears to lean slightly toward the building, where the cabin would support it, but there is no evidence of cracking. The stone chimney is well supported by the cabin, including near the top where the upgraded roof system supports it. The top of the chimney extends approximately only 1 ft above the roof peak, providing further confidence that it is well supported.

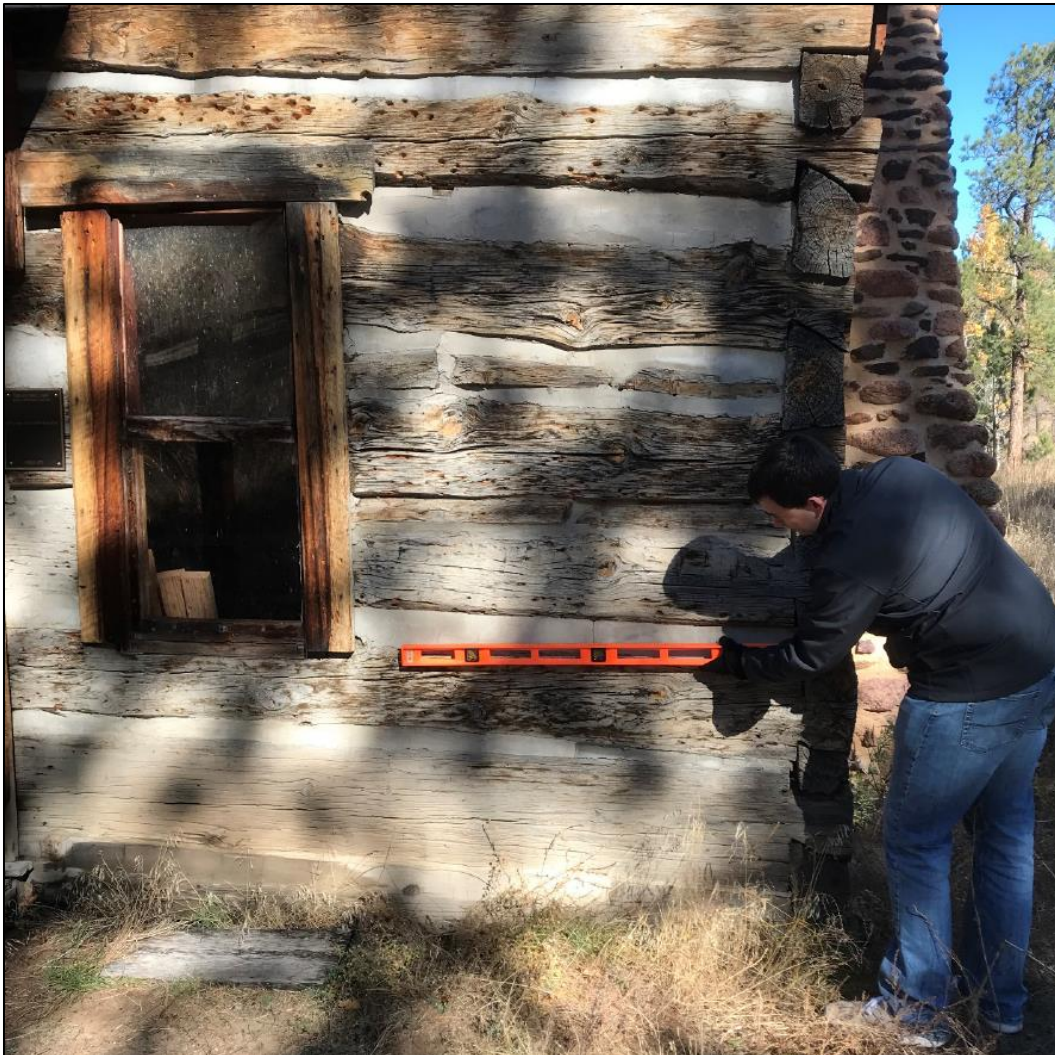
Figure 104. The south wall at the southeast corner of the cabin showing wall timbers sloped to the east (photo by ERDC-CERL researchers, 2021).

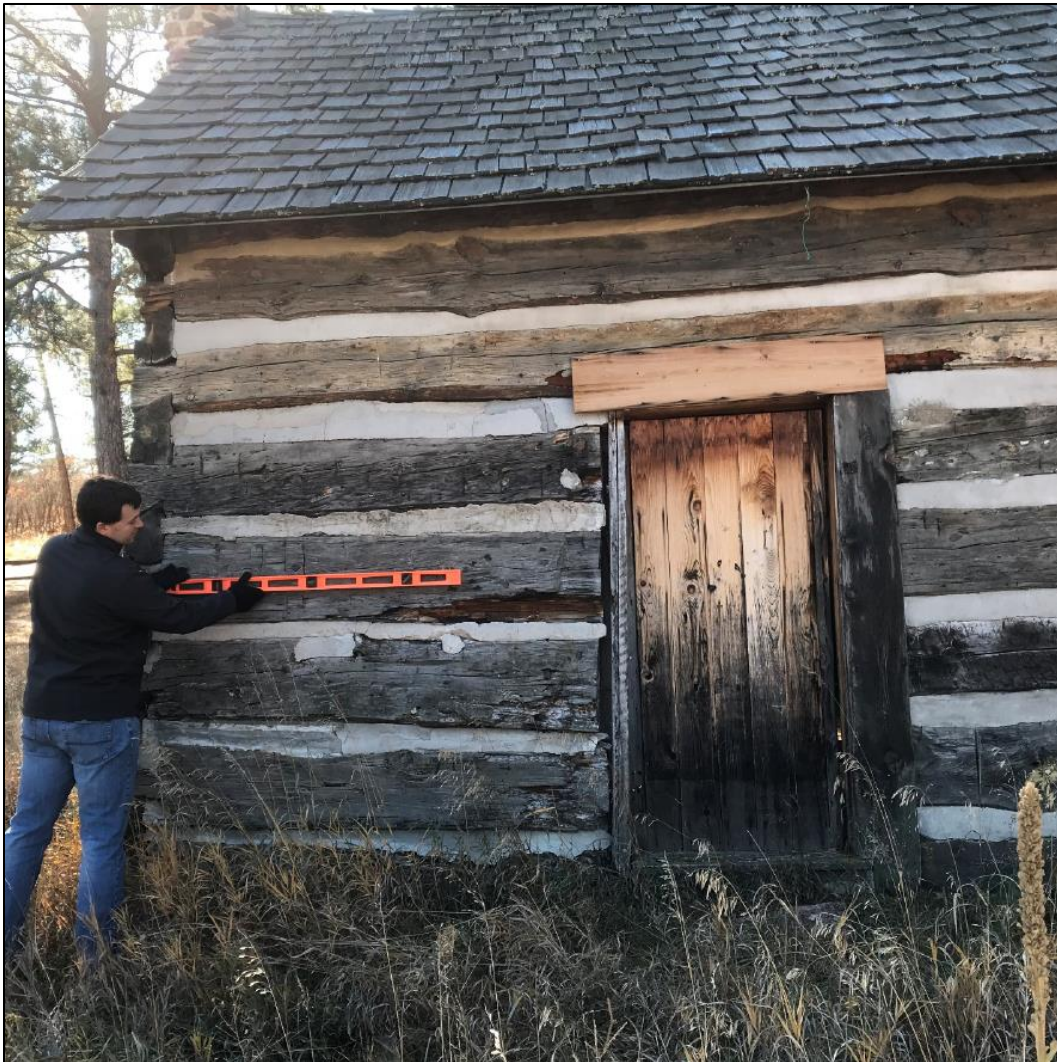
Figure 106. Wall crack (3/4 inch thick) measured just east of the door lintel on the north wall (photo by ERDC-CERL researchers, 2021).

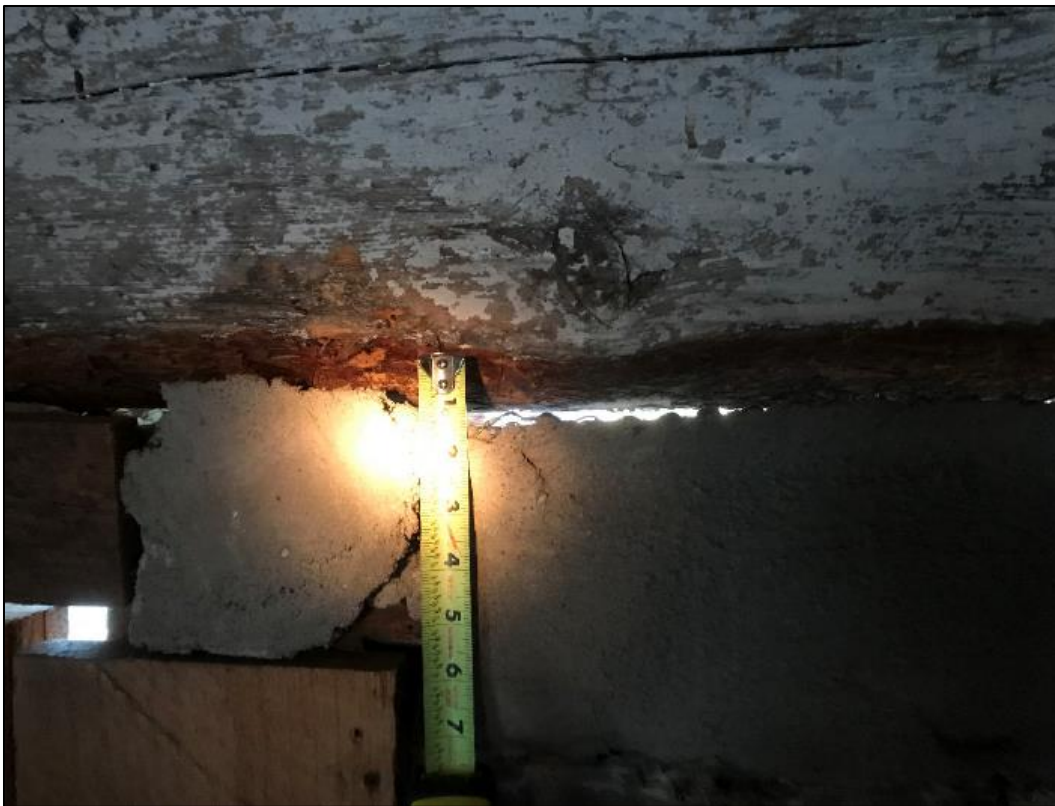
Figure 105 further shows the north door framing is rotted, including the door threshold shown in Figure 107.

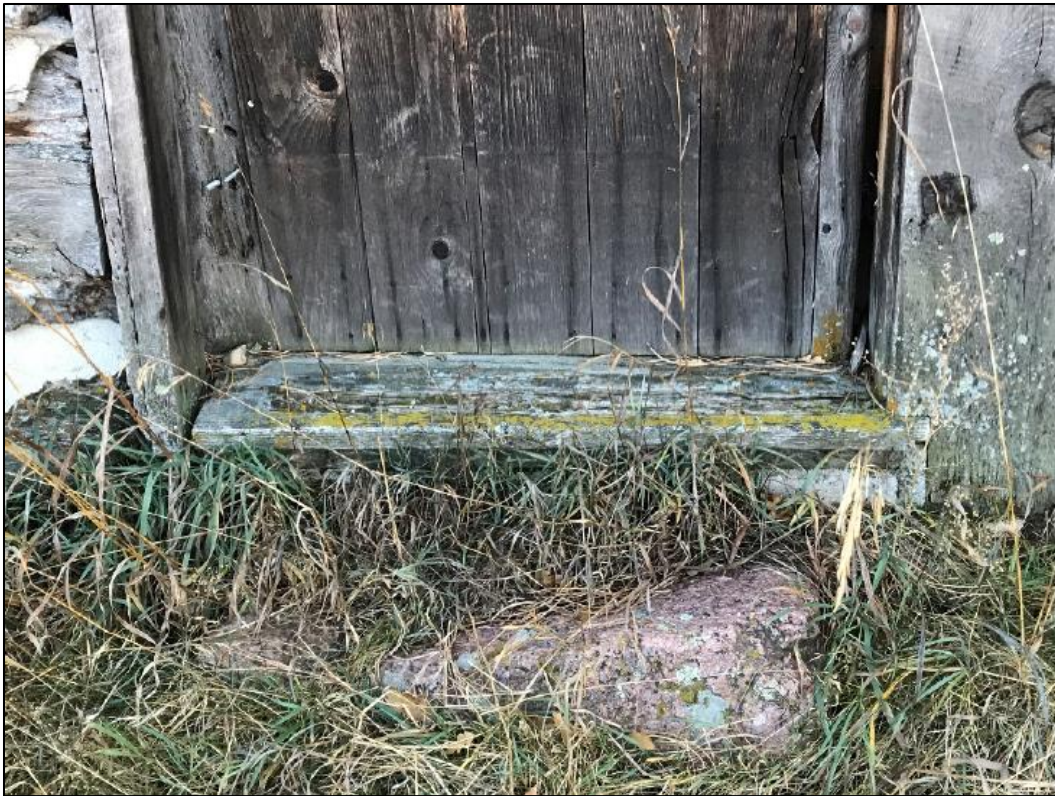
9.3.3 Cabin floor's condition and observations

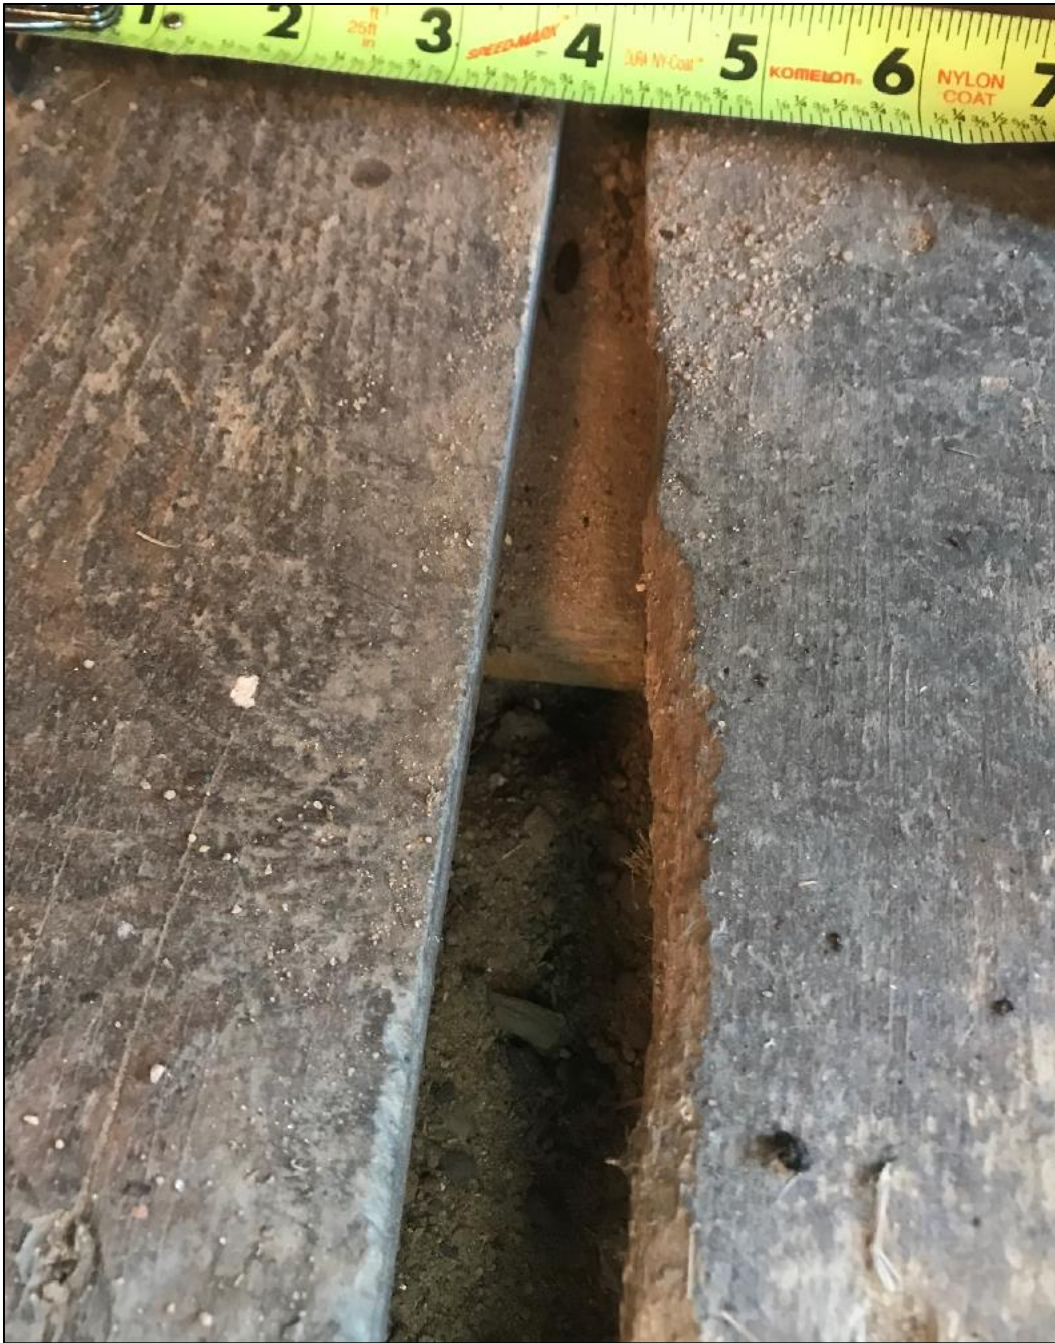
The floor joists are likely continuously supported by the soil below, as shown in Figure 109, because the floor planks do not sag, and the floor joists are shallow. The sawn lumber used in the floor planks indicates these and most joists below are not original construction. The lack of floor joist sagging and good condition of the planks and joists below indicate this floor should have sufficient capacity for normal residential

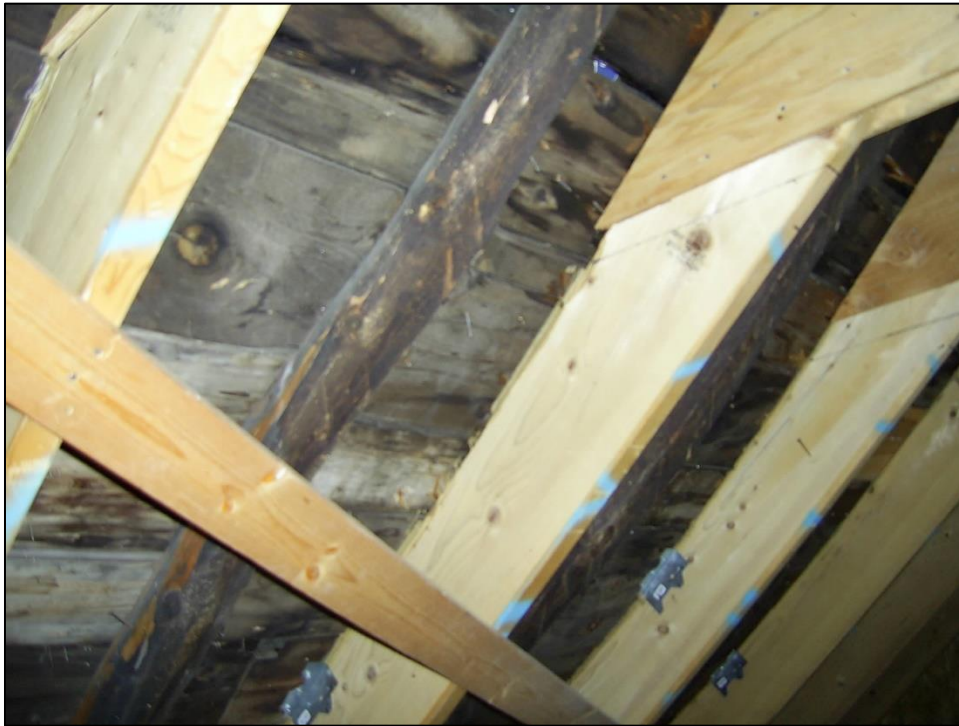
9.3.4 Cabin loft floor's condition and observations

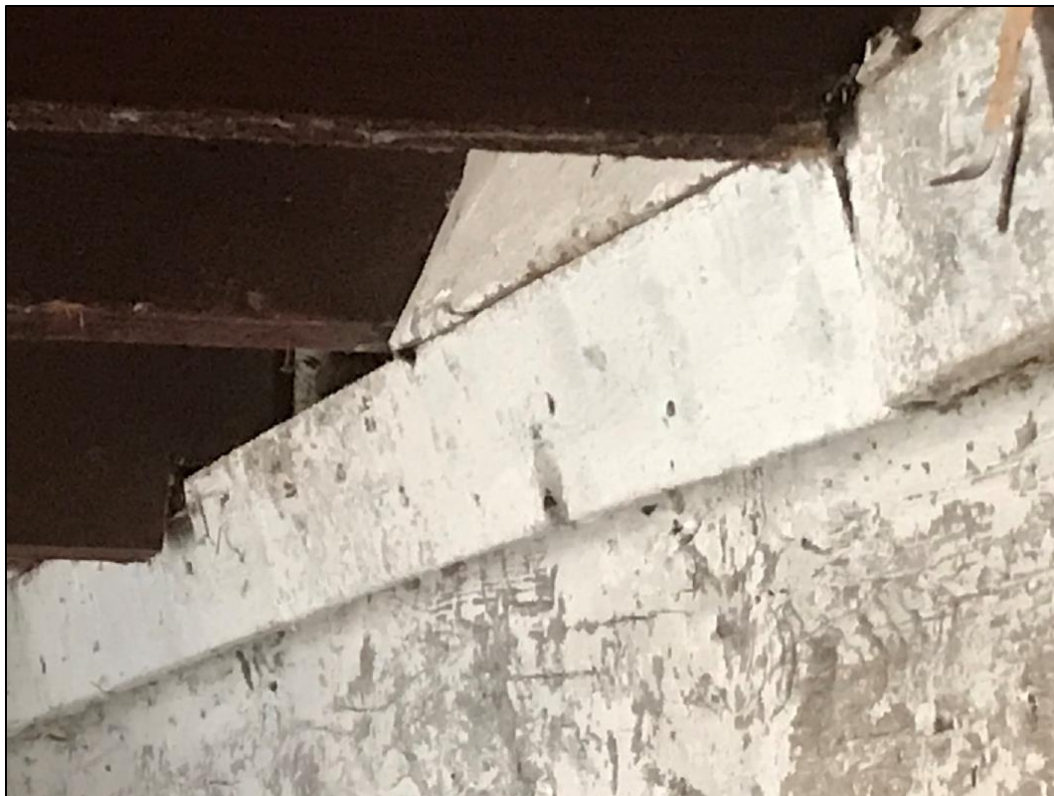
9.3.5 Roof system's condition and observations

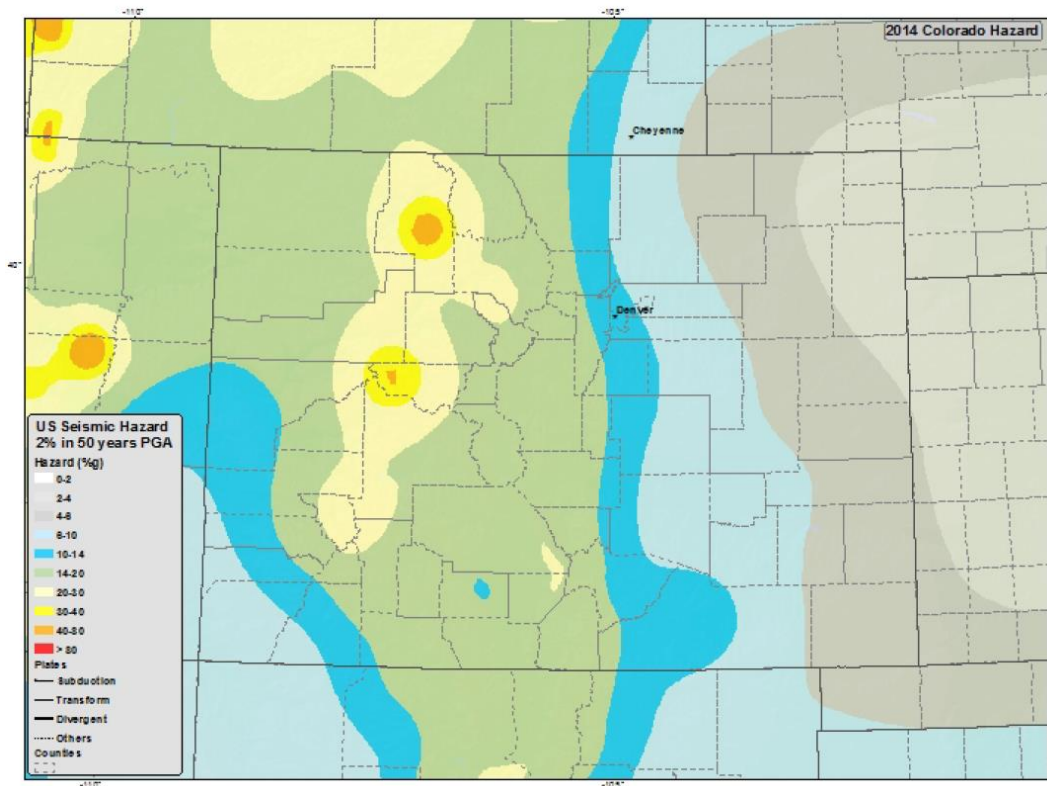
The adequacy of the roof to resist the snow loads will be confirmed. Figure 119 shows that the bottoms of the new roof joists are anchored to what appears to be the top timber of the wall. However, it may be possible for the top wall timbers to be lifted off the building under the very strong 130 mph design wind speed. Under strong wind loads, the entire roof could uplift, pulling the roof off. This would remove the out-of-plane bracing of the walls, potentially causing complete collapse of the building. The recent upgrade to the roof would have strengthened it. However, this may have made the roof more vulnerable to tear-off because the entire roof could uplift as a single intact unit, and this value will be used to assess the uplift forces on the roof and perhaps the adequacy of the anchorage of the wall timbers to one another.

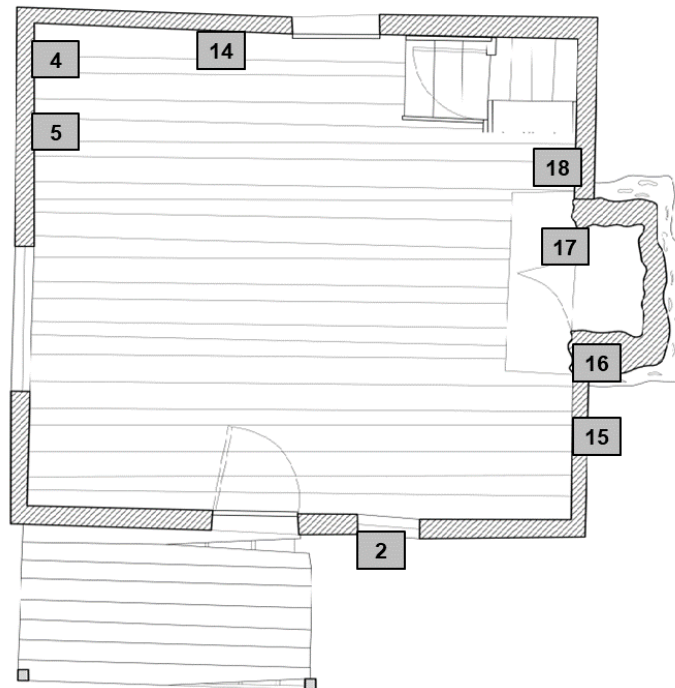
Table 1. Material sample locations and descriptions.

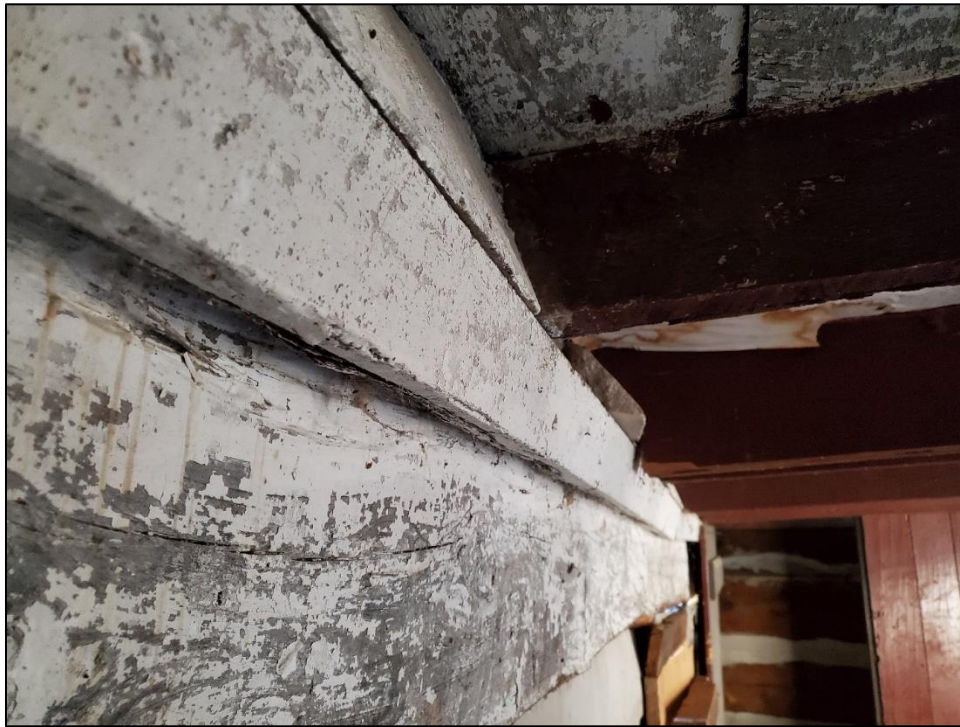
128. Jeffrey L. Erdly and Gregg M. Bekelja, "The History of Flashing and Its Importance in Both Modern and Historic Masonry Construction," in *Building Envelope Technology Symposium* (Raleigh, NC: International Institute of Building Enclosure Consultants [IIBEC], 2008), 97–104, <https://iibec.org/wp-content/uploads/2016/04/2008-BES-erdly-bekelja.pdf>.

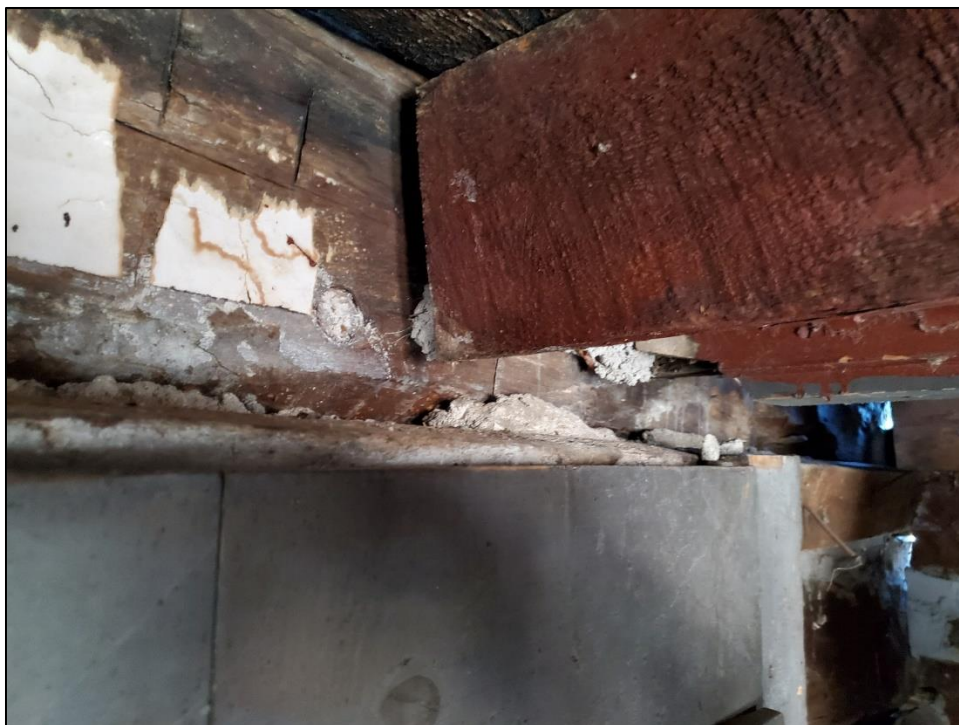
Figure 152. Timber found in the attic that appears cut to fit as a header over the north doorway (photo by ERDC-CERL researchers, 2021).

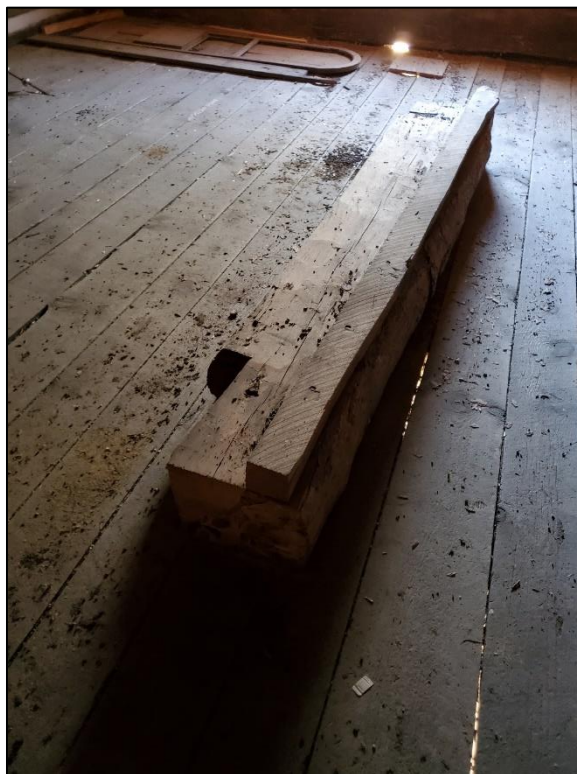
We further concur with the 1992 report that waterproofing should be monitored and addressed immediately, as we observed significant gaps between the chimney and the east timber wall (Figure 153 and Figure 154). Due to settlement of the foundation and natural “breathing” of the timbers in the structure, it would be difficult to permanently close this gap using historically relevant materials, such as coal tar. Replacing timbers due to inadequate treatment can result in a harsh color difference (see Figure 155). Fire-rated elastomer or silicone sealants designed for outdoor use may provide the longest-lasting repair between the chimney and the timbers.

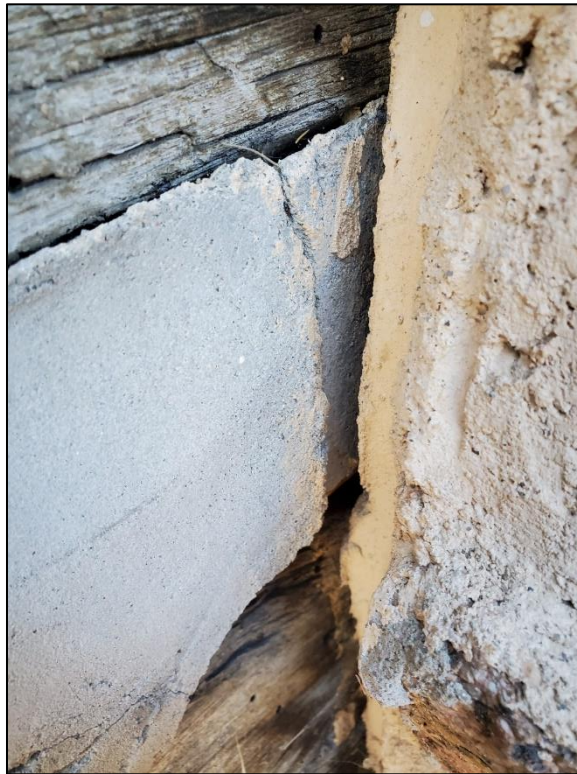
Figure 154. Poor connection between east exterior wall and chimney (photo by ERDC-CERL researchers, 2021).

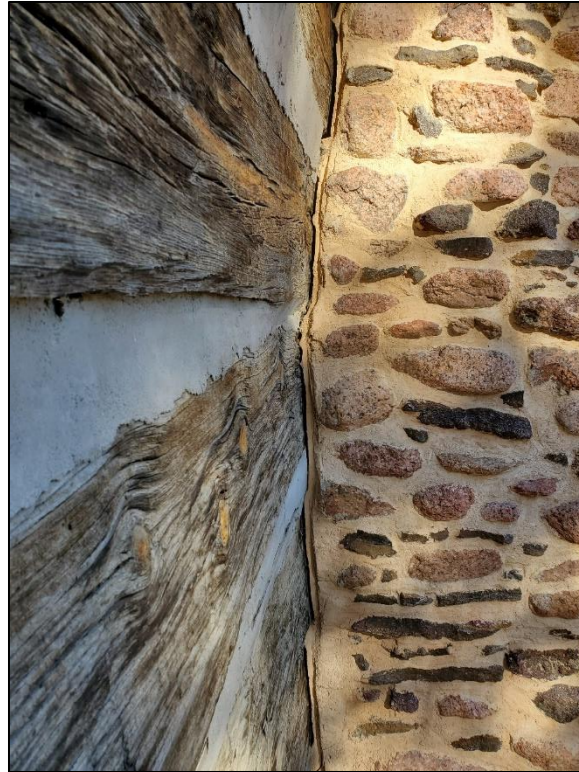
The beetle and woodpecker damage referenced in the 1992 report continues to the present day, especially on the south wall. Material samples of a few timbers were taken for typing analysis. A full investigation of the wood species and age of each timber composing this cabin would require between \$40,000 to \$80,000 of focused financial support, sample analysis, and reporting efforts. If desired, we recommend engaging the USDA Forest Products Laboratory regarding a comprehensive effort of typing and dating.

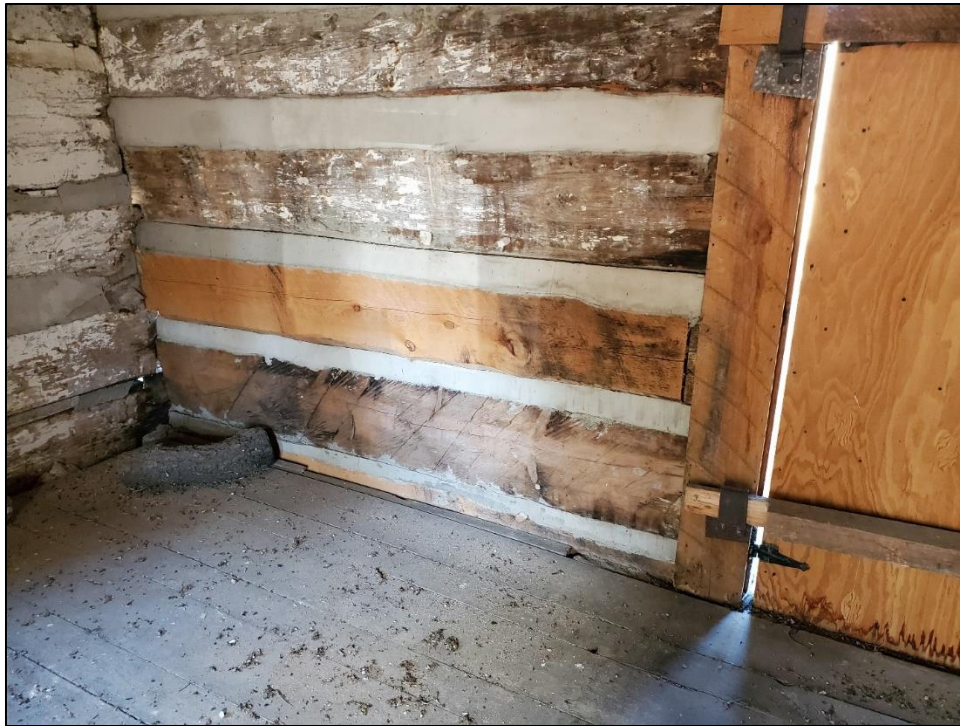
We found at least five different mortars in the exterior chinking, as well as expanded metal lath (commonplace in North American construction from approximately the 1900s onward) providing reinforcement in numerous, but not all, timber joints. The north wall provides the best example of this complicated assortment of chinking formulas and reinforcements (Figure 156 and Figure 157). We located a small quantity of soil-based chinking in the northwest corner of the interior that might represent the original chinking, which would have been installed prior to commonplace use of Portland cement for this application (Figure 158).

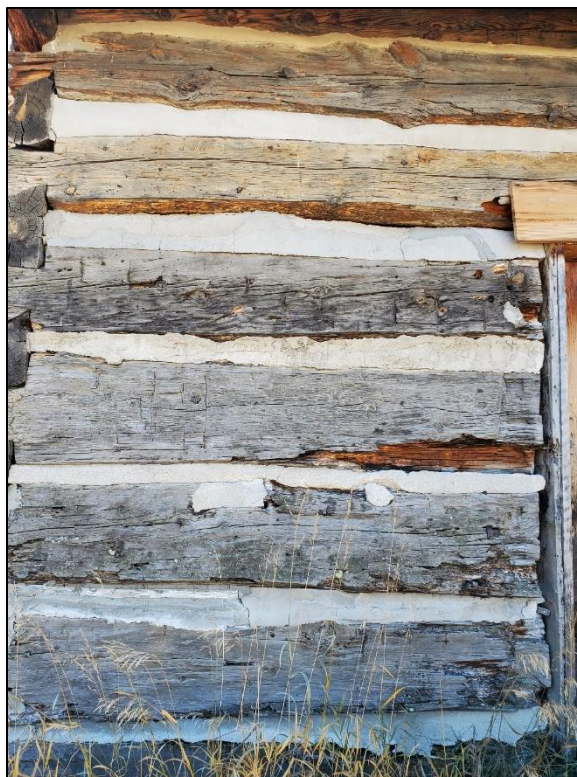
Figure 157. Example of nails and wire lath used as reinforcement for various layers of chinking (photo by ERDC-CERL researchers, 2021).

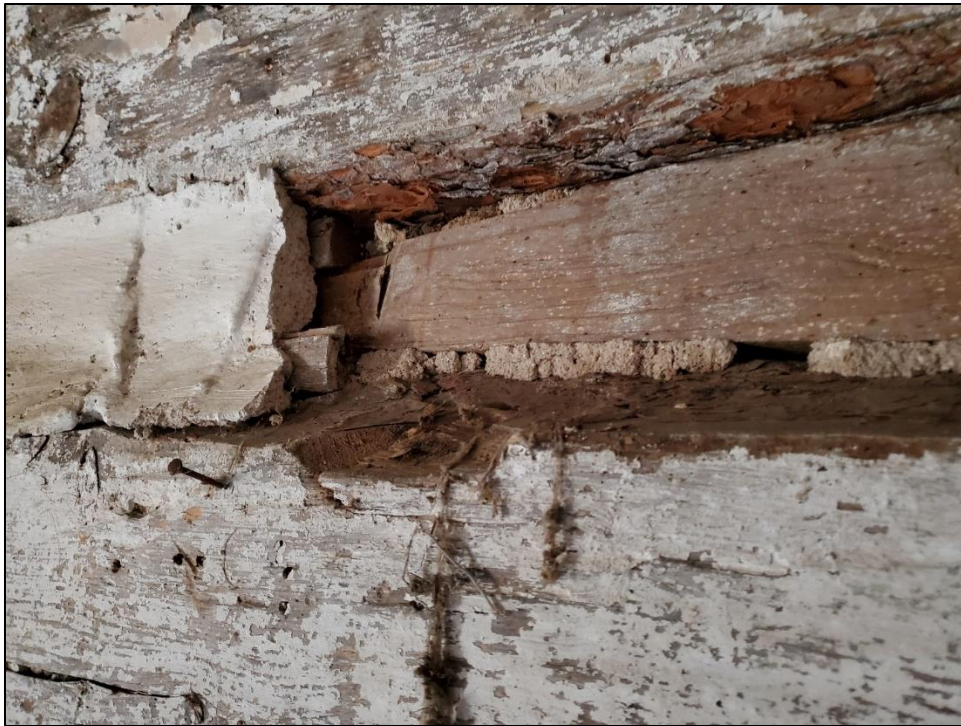
The visible foundation under the east wall, south of the chimney, has a small section of friable material that could be lime or gypsum plaster (Figure 159). The west wall foundation is composed of granite stones and mortar that carry the same color, composition, and construction style as the chimney (Figure 160). The chinking at the top plate appears to have the same pigment as the pointing on the external faces of the chimney, so it is likely that the roof was repaired and anchored at the same time as the chimney was pointed.

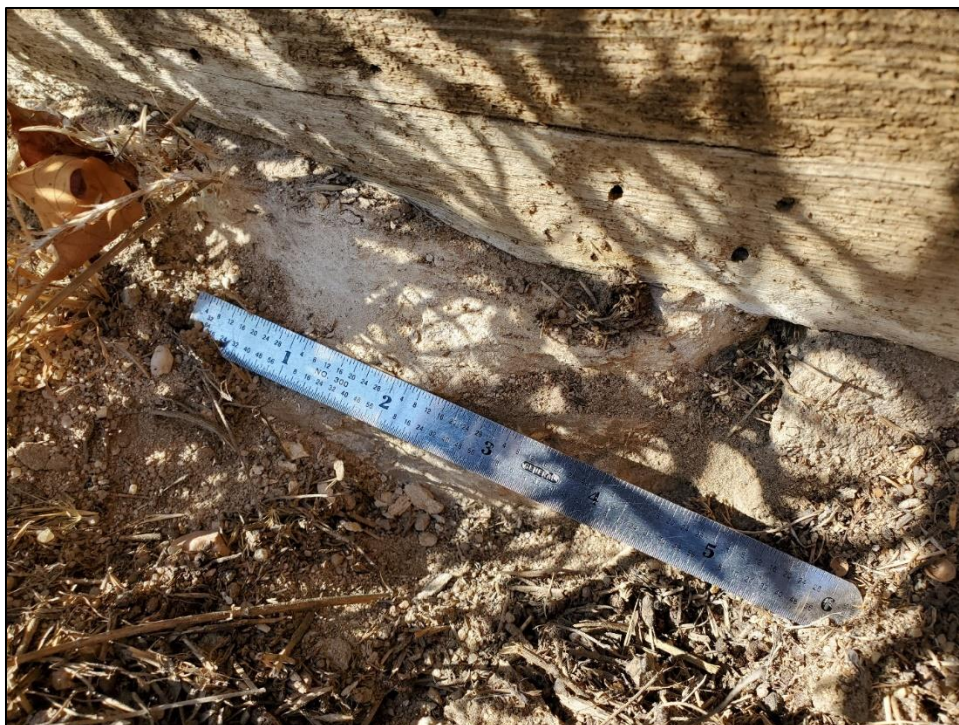
Figure 160. Example interface between the stone foundation and the west wall timbers (photo by ERDC-CERL researchers, 2021).

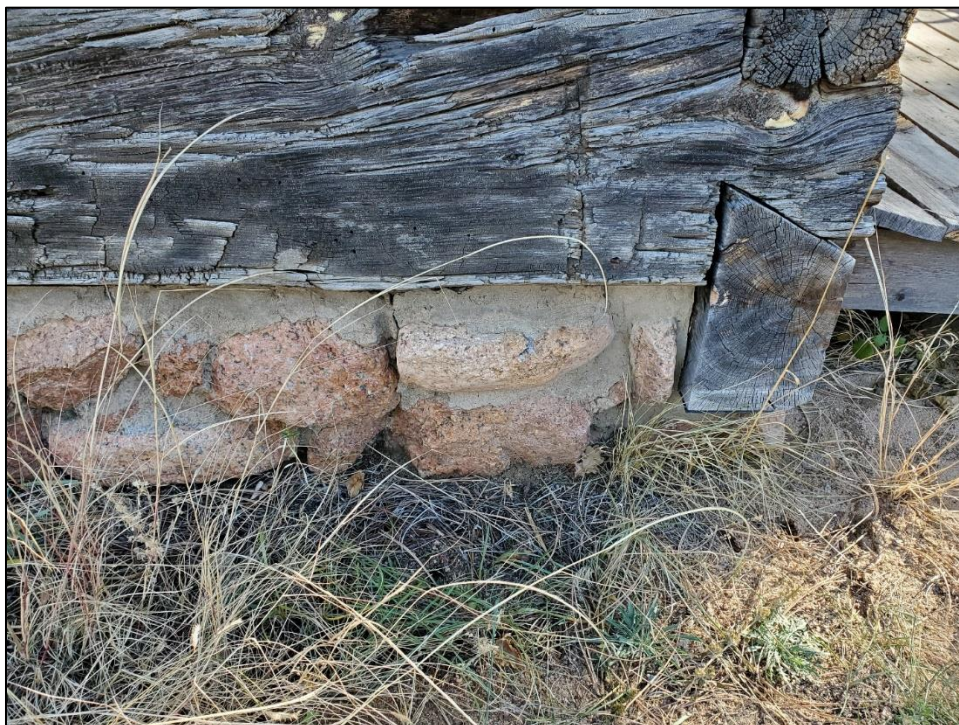
10.2 Wood-typing analysis (limited)

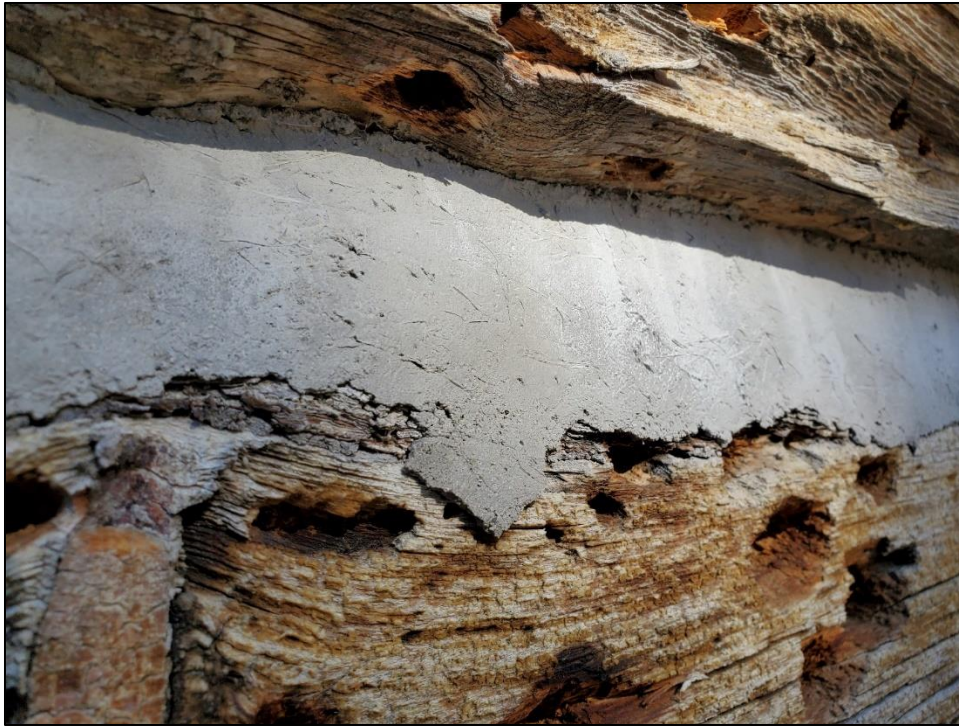
10.4.2 Chimney pointing
