## Finite Element, Petrographic, and Mechanical Analyses of Field-Cored Concrete Fairlead Beam Anchor Rods from Luke Air Force Base

May 2024

Final Technical Report (TR)

Prepared for US Air Force Civil Engineer Center  
139 Barnes Drive Suite 1  
Tyndall AFB, FL 32403

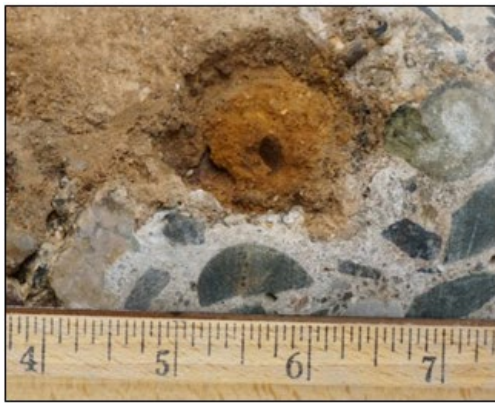
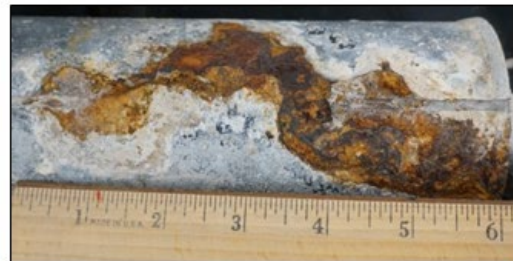
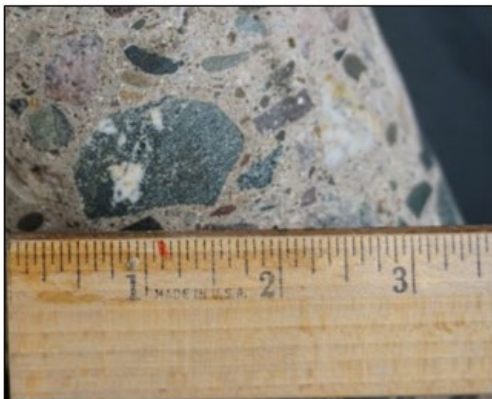
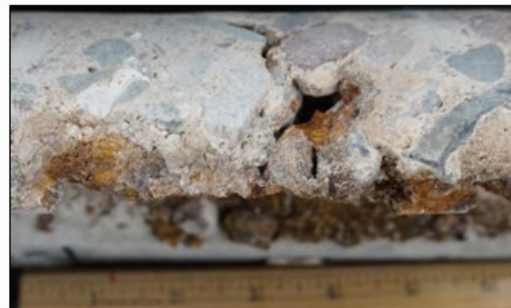
Figure 21. Visual examination of as-received core 210043-1.

Visual inspection images of core 210043-1 are provided in Figure 21, and detailed photomicrographs of the core's microstructure are shown in Figure 22. Cracking was seen in the concrete, running a depth of about 2 in. and extending through the mortar cap. Friable concrete in the bottom third of the core was seen along with discoloration from corrosion. The coarse aggregate had a nominal size of 1.5 in. (3.8 cm). Silicate phases dominated the coarse aggregate fraction and were sub-round to round, indicative of a natural stone. The coarse aggregate made up approximately 30% of the concrete volume and was uniformly dispersed within the concrete. The paste was discolored in multiple areas from bolt corrosion. At

the top of the core, the corrosion was more pronounced at 2 to 3 in. measured from below the mortar cap. The concrete was friable in multiple locations, most notably at a depth of 30 in. from the surface. Corrosion of the pipe sleeve was noted extending 6.5 in.

(a) Corrosions and deterioration of concrete

(b) Corrosion of pipe sleeve

(d) Corrosion penetrating the lower core concrete

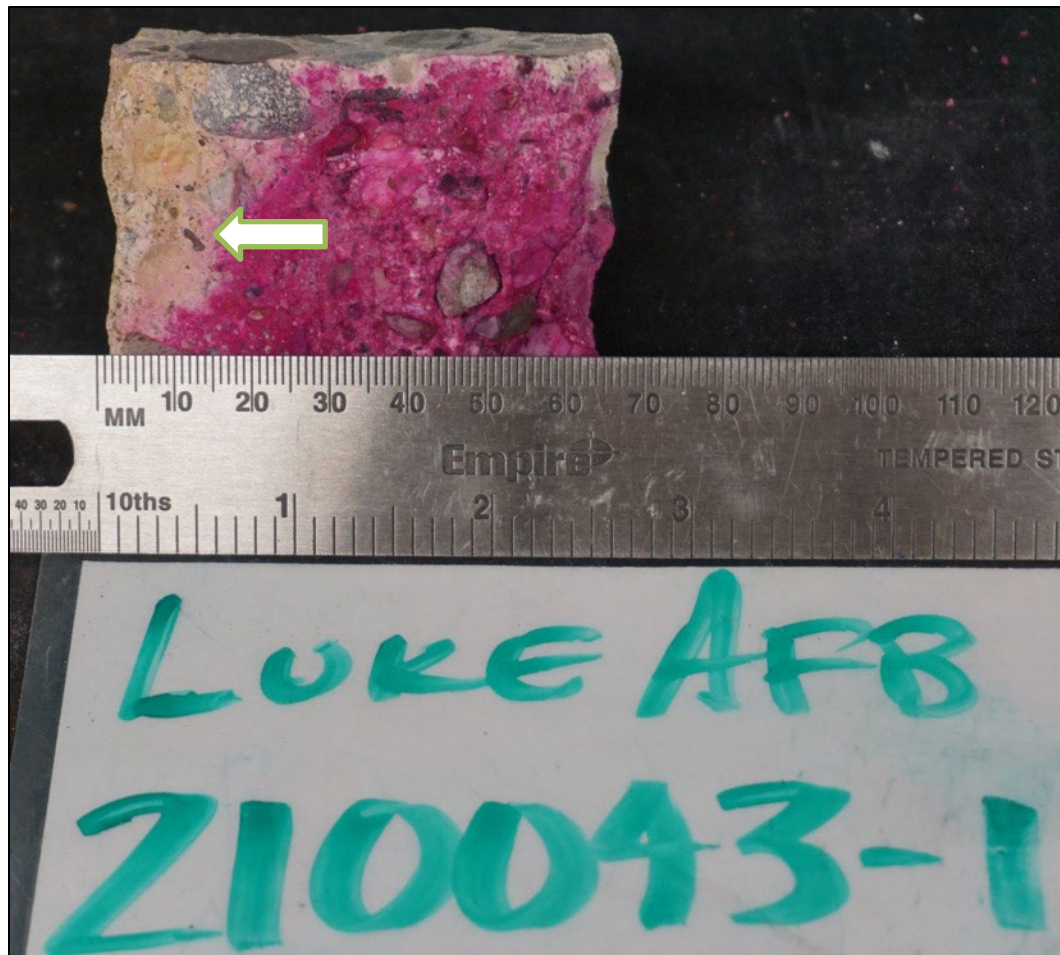
Figure 23. Phenolphthalein application for sample 210043-1.

Figure 23 provides a photo of a freshly broken sample from 210043-1 with phenolphthalein applied to ascertain the degree of carbonation that occurred. Purple coloring indicates a pH of 10 and above. If the cement is uncolored, the sample tests for carbonation and the pH is below 10. The sample shows significant carbonation up to 15 mm (depth indicated by arrow).

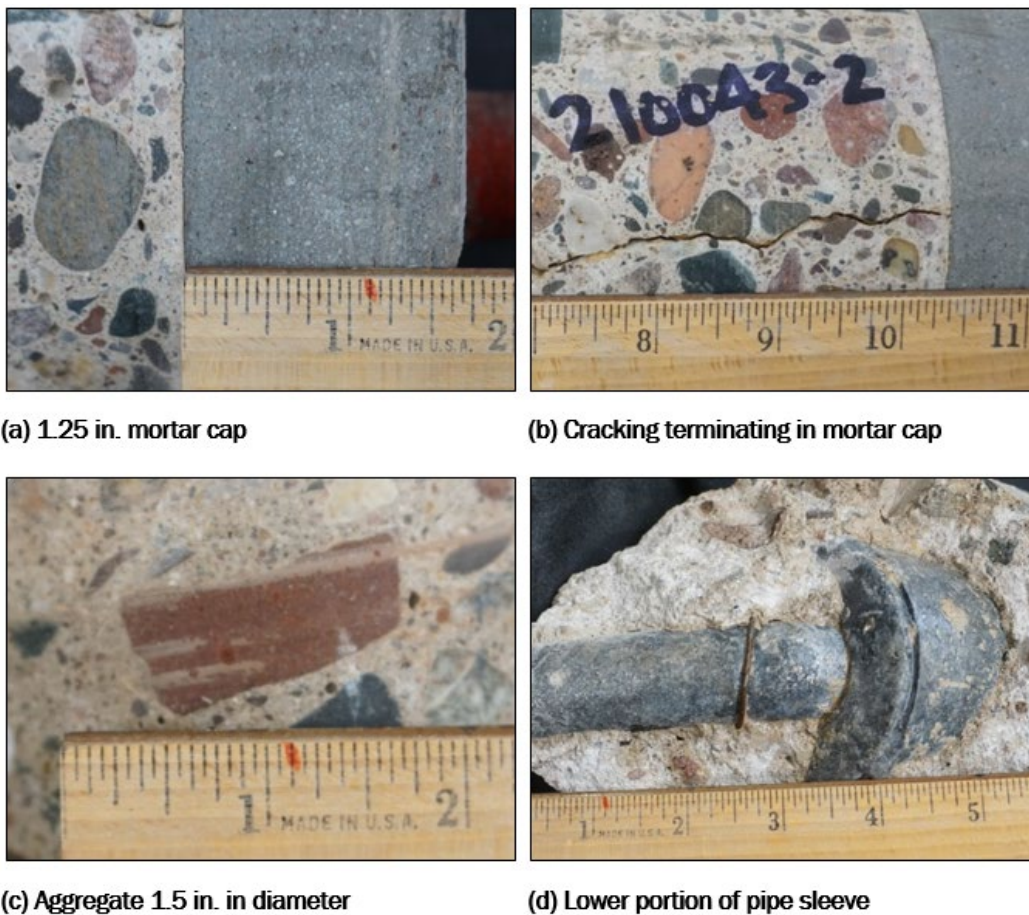
Figure 27. Visual examination of core 210043-2.

Visual inspection images for core 210043-2 are provided in Figure 27, and detailed photomicrographs of the core's microstructure are shown in Figure 28. Under the 2 in. mortar cap, cracking was seen in the concrete, running a depth of about 9 in. and terminating in the mortar cap. Corrosion

was seen only in the observable cracks, but after bisection the top 6 in. had corrosion close to the bolt. The coarse aggregate had a nominal size of 1.75 in. (4.45 cm). Silicate phases dominated the coarse aggregate fraction and were sub-round to round, indicative of a natural stone. The coarse aggregate made up approximately 30% of the concrete volume and was uniformly dispersed within the concrete. The paste was discolored in multiple areas from bolt corrosion and friable in multiple locations. Large voids above the top nut of the Y-bolt were observed.

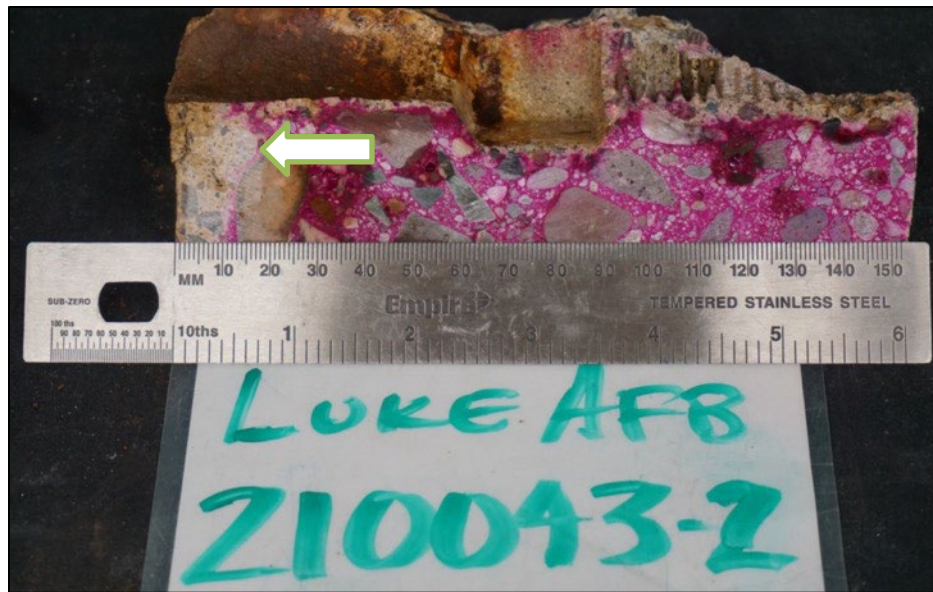
*Figure 29. Phenolphthalein applied to sample 210043-2.*

Figure 29 shows a freshly broken sample from 210043-2 with phenolphthalein applied to ascertain the degree of carbonation that occurred. Purple coloring indicates a pH of 10 and above. If the cement is uncolored, the sample tests for carbonation and the pH is below 10. The sample shows carbonation up to 17 mm (depth indicated by arrows).

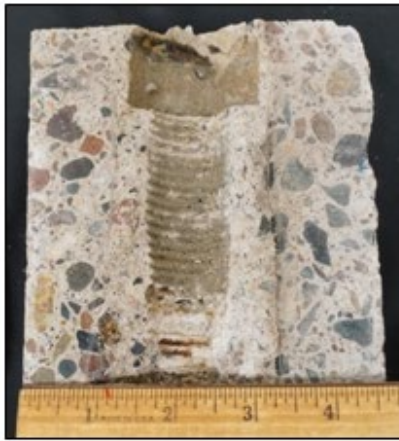
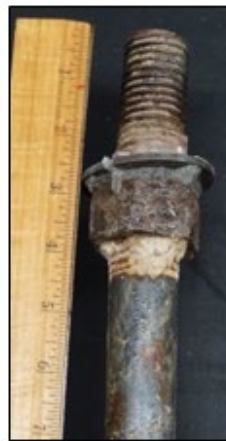
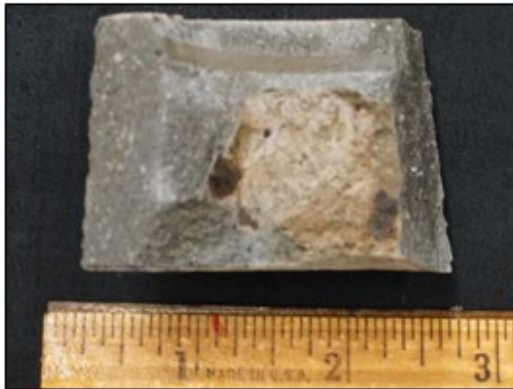
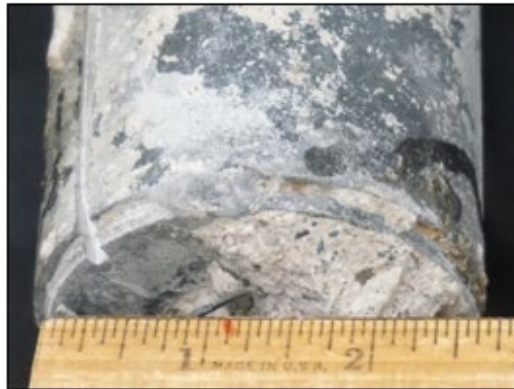
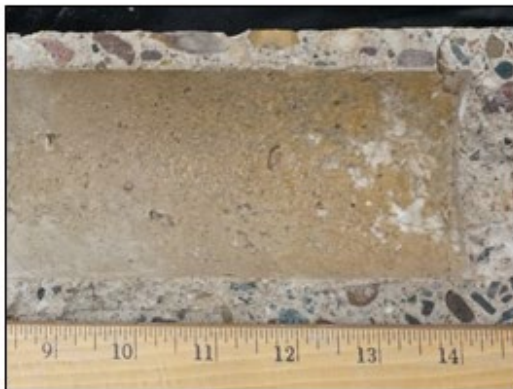
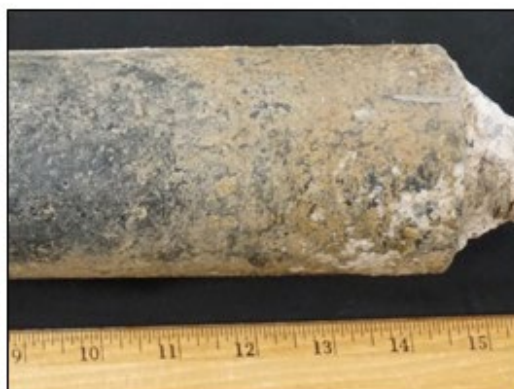
Figure 32. Visual inspection and bisection of 210043-3.

(a) Heavy deterioration around the second nut

(b) Cracking and deterioration at the surface

(c) Cracking around the bolt with corrosion

(e) Concrete after extraction of pipe sleeve showing discoloration at the top

(f) Top of the pipe sleeve with discoloration

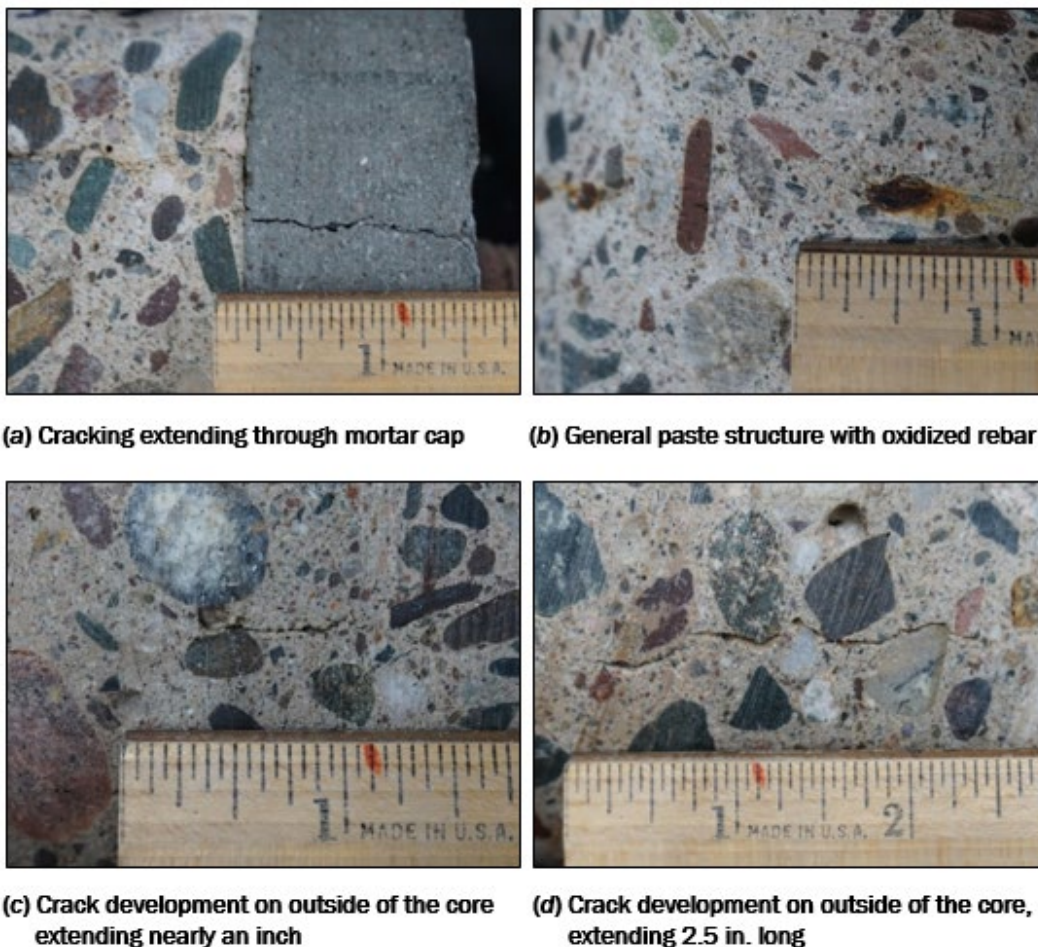
Figure 33. Visual examination of as-received core 210043-3.

Visual inspection images for core 210043-3 are provided in Figure 33. Note that the top of the core was degraded during bisection and preparation; thus, optical petrography was not performed. Observations indicated that the paste was friable in multiple locations and discolored in multiple areas from bolt corrosion. Large air voids above the top of the nut of the Y-bolt were observed. Cracking was developing on the sides of the core, extending 1 in. to 2.5 in. long in two locations. The coarse aggregate had a nominal size of 1 in. Silicate phases dominated the coarse aggregate fraction and were sub-round to round, indicative of a natural stone.

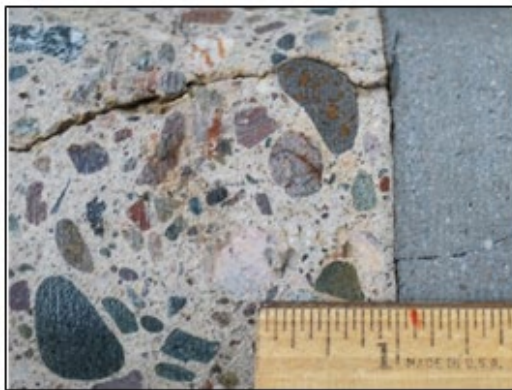
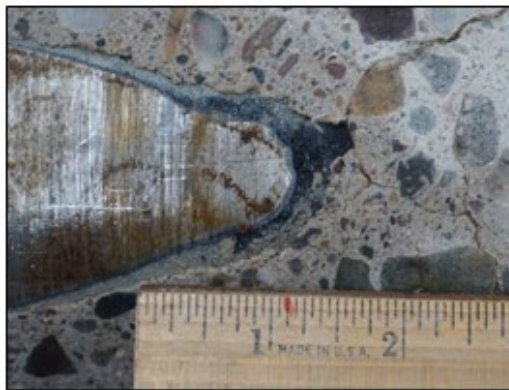
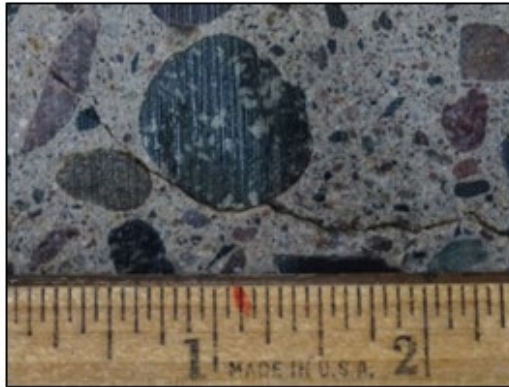
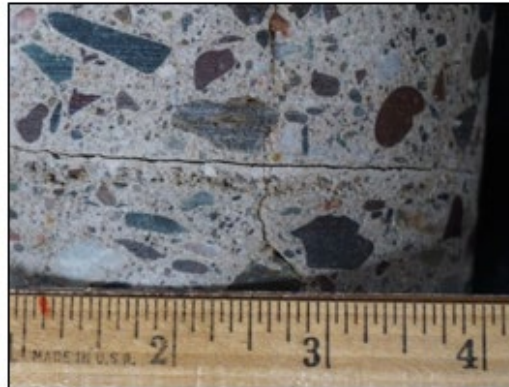
Figure 38. Visual examination of 210043-4.

Visual inspection images for core 210043-4 are provided in Figure 38, and detailed photomicrographs of the core's microstructure are shown in Figure 39. Cracking had developed in the concrete, extending throughout the

core as well as through the 2 in. mortar cap. Corrosion was seen only in the observable cracks, but after bisection, the top 6 in. had corrosion close to the bolt and extended into voids and paste proximate to the cracking. The coarse aggregate had a nominal size of 0.75 in. and a maximum entrapped air size of 0.5 in. Silicate phases dominated the coarse aggregate fraction and were sub-round to round, indicative of a natural stone.

(a) Cracking terminating in cap

(b) Cracking terminating in lower pipe sleeve

(c) Cracking around large aggregate

(d) Lateral cracking

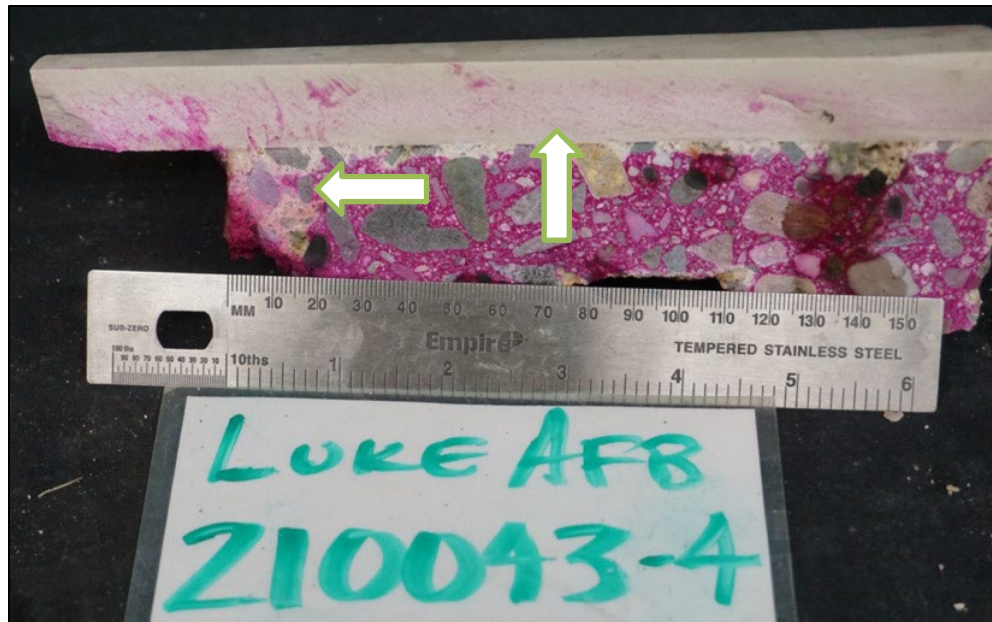
Figure 40. Phenolphthalein applied to sample 210043-4.

Figure 40 provides a photo of a freshly broken sample from Section A1 with phenolphthalein applied to ascertain the degree of carbonation that occurred. Purple coloring indicates a pH of 10 and above. If the cement is uncolored, the sample tests for carbonation and the pH is below 10. The sample shows carbonation up to 20 mm (depth indicated by arrows).

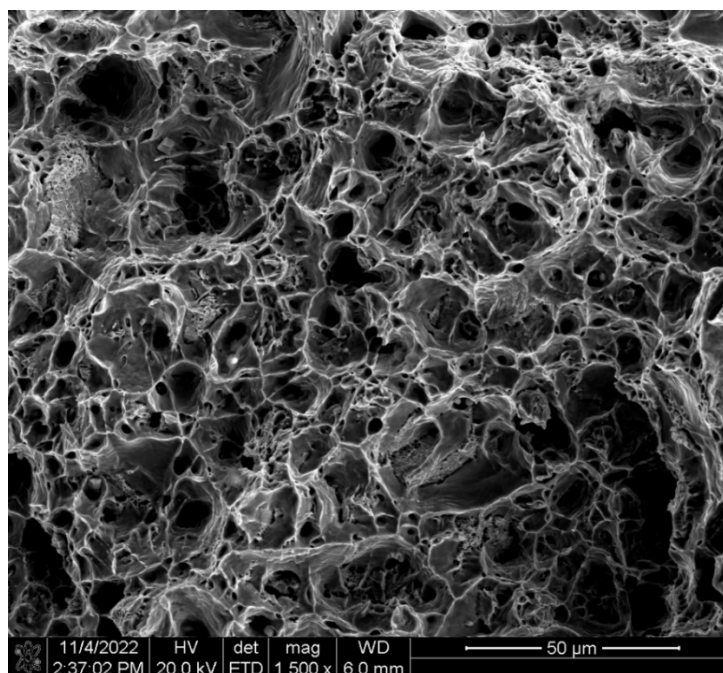
Figure 46. Micrograph of 210043-3E fracture surface.

Oxidation and discoloration on the bolt surface were apparent by inspection prior to sample processing on the CNC machine. Additionally, based on the service length and relatively low corrosive environment expected to be present at Luke AFB, it is not likely that corrosive degradation occurred near the centerline of the anchor rods. This is further reinforced by the ductile failure mode discussed previously in conjunction with the low variability within the data set since corrosively degraded test specimens would have been expected to exhibit a more brittle failure mode. Based on these factors, it is highly likely that the anchor bolts were fabricated with an inferior grade of steel.

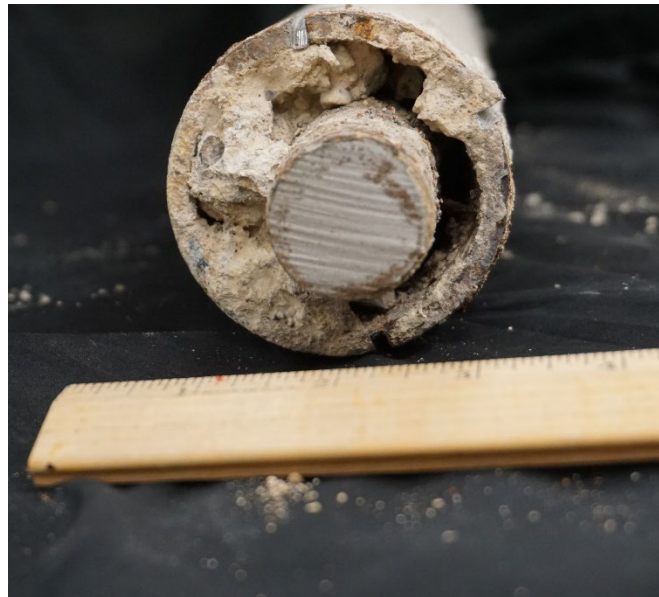
Figure 48. Core 210043-1 pipe sleeve end-on view.

Upon bisection of the upper portion of the four received PCC cores with the fairlead beam anchor rods, the team observed that the galvanized pipe sleeves did not extend to flush with the surface of the concrete placed for the fairlead beam foundation pad (see Figure 20, Figure 26, Figure 32, and Figure 37), which deviates from the design intention of Drawing Number 67F2013A. Additionally, voids in the concrete mixture were observed around the galvanized pipe sleeve, indicating inadequate or inconsistent consolidation of the concrete mixture around the anchor assemblies. Furthermore, the removal of the grout layer and PCC above the top of the galvanized pipe sleeve revealed that concrete mixture—and not grout—had been placed inside the pipe sleeve. Figure 48 shows an end-on view of the top of the galvanized pipe sleeve of core 210043-1 with the grout layer and PCC removed. It appears that the same concrete mixture used to place the fairlead beam foundation pad was crudely placed into the pipe sleeves. Similar observations were made across the other three field-cored anchor rods. The presence of voids and coarse aggregate within the pipe sleeves would be expected to negatively affect the mechanical performance of the
