SS V. A. FOGG; SINKING IN THE GULF OF  
MEXICO ON 1 FEBRUARY 1972 WITH LOSS  
OF LIFE

13 September 1974

| 1. Report No.<br>USCG/NTSB-MAR-74-8 | 2. Government Accession No. | 3. Recipient's Catalog No. | |
| 4. Title and Subtitle<br><u>Marine Casualty Report</u> -- SS V.A. FOGG<br>Gulf of Mexico<br>1 February 1972 | | 5. Report Date<br>September 13, 1974 | |

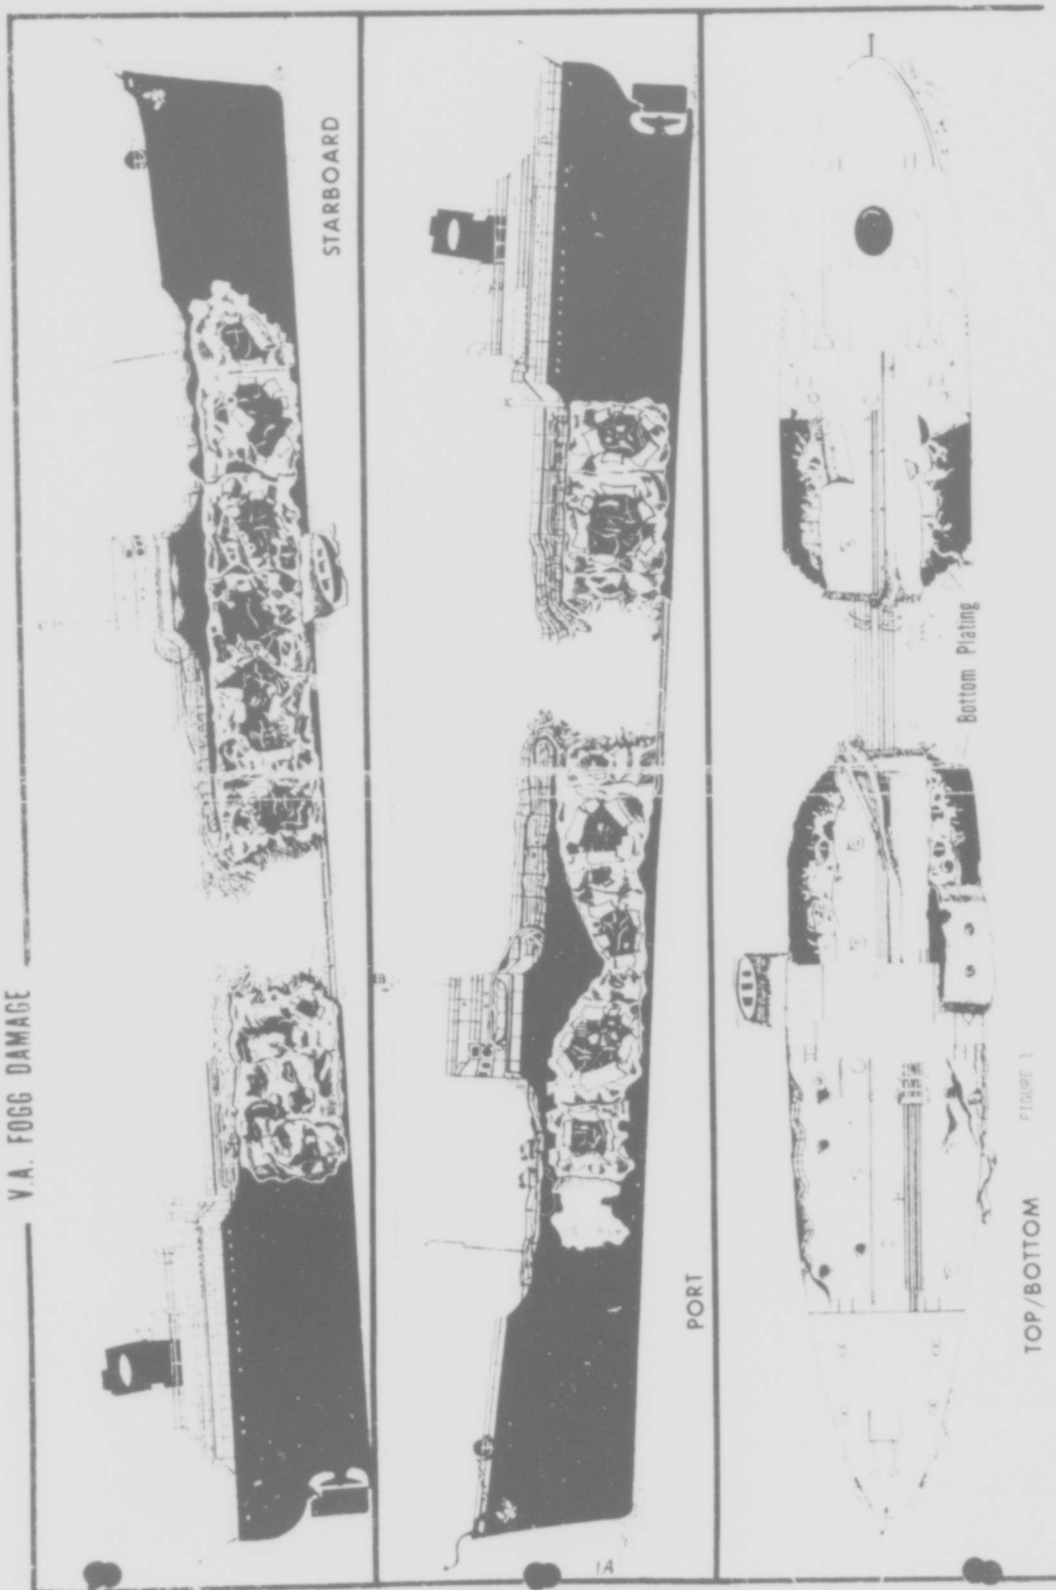
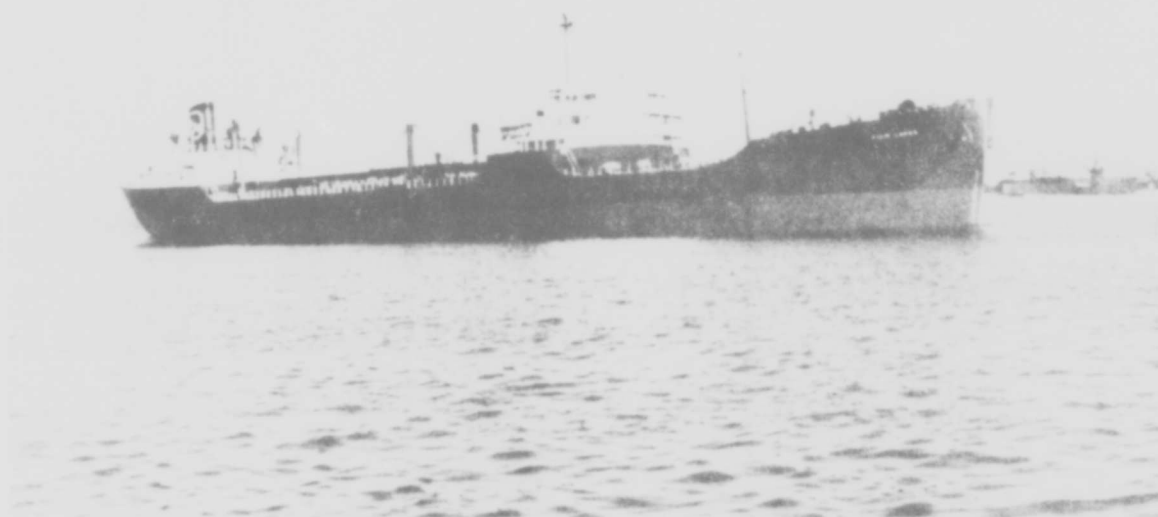
FIGURE 2

Only by viewing the vessel or the exhibits to this report can a true appreciation of the extent of vessel damage be gathered. To help the reader appreciate the gross damage an artist's interpretation is attached. This interpretation does not claim complete accuracy but is illustrative of the massive damage sustained by the vessel. Attached for reference purposes is a photograph of the vessel taken prior to the casualty.

# V.A. FOGG DAMAGE
