SHRIKE AND SPARROW MISSILE BASELINE  
COOKOFF TESTS

Naval Weapons Center

October 1974

NWC Technical Publication 5672  
NMC Technical Publication 74-36

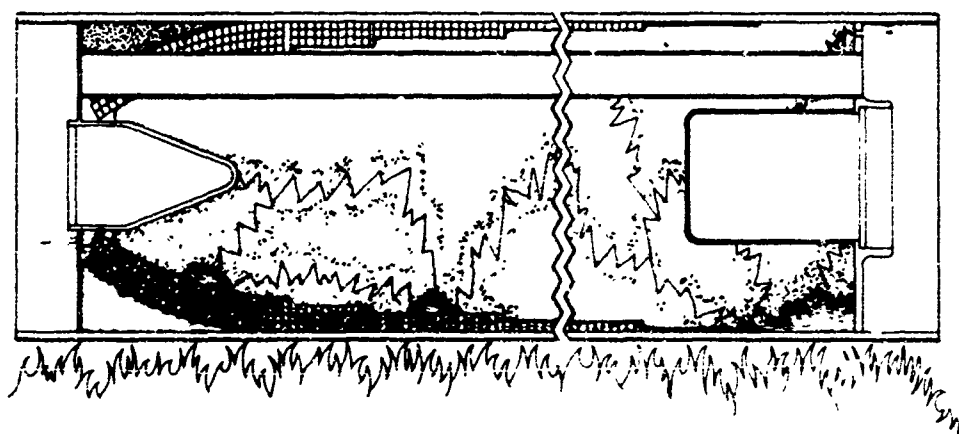
The failure of the SHRIKE warhead is hypothesized to be due to over-pressurization within the steel casing, which causes the crack as shown in Figure 4b. Inadequate venting exists for the SHRIKE warhead, and it explodes before 169 sec, e.g., SH-13A, 128 sec; SH-14A, 109 sec; SH-16A, 169 sec. If the excess explosive-gas can be vented, then there may be deflagrations instead of explosions. Both types of reaction are illustrated in Figures 4c and 4d.

FIGURE 4b. Possible SHRIKE Warhead Explosive Cracking Creating New Burning Surfaces.

In the SHRIKE warhead section such ventilation is recommended, particularly for the aft bulkhead and also in the steel casing itself. Also the forward cone should be uncrimped and refastened with an adhesive. The aft fuze cavity should be removed by chemically milling the weld joint, and refastened with a suitable adhesive. Holes could also be drilled in the fuze booster cup itself, which should then be relined with a suitable sealant.

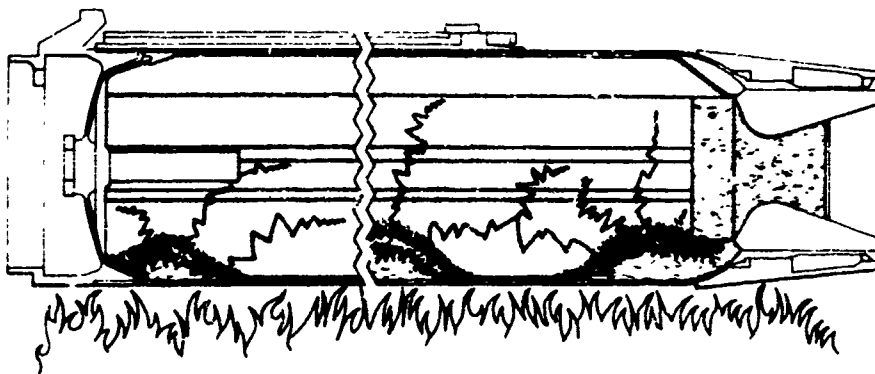
The failure of the SHRIKE rocket motor is hypothesized to be due to over-pressurization within the steel casing, which causes solid propellant cracks (Figure 5b). If the excess propellant gas can be vented (e.g., SH-7A, SH-8A, SH-12A) then the reaction will be one of deflagration; otherwise an explosion may result (e.g., SH-16A). Both types of reactions are illustrated in Figures 5c and 5d.

FIGURE 5b. Possible SHRIKE Motor Propellant Grain Cracking Creating New Burning Surfaces.

*Ventilation* of the bottom portion of the rocket motor case is recommended and can be realized by machining or chemical milling, which would weaken the casing at high temperatures. A glass/resin doubler with suitable heat diffusion filler would then be applied to maintain its external configuration and low-temperature strength. This retrofit is applicable to both the SHRIKE Mk 39 Mod 7 and SPARROW Mk 39 Mod 0 motors.

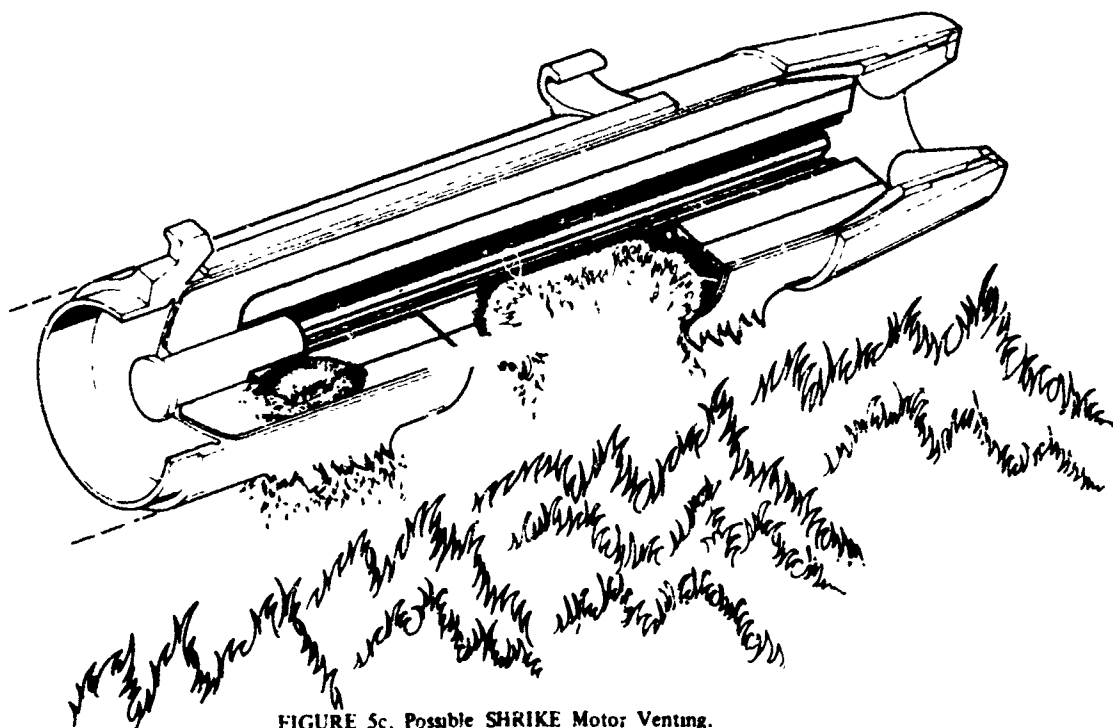
FIGURE 5c. Possible SHRIKE Motor Venting.

The SHRIKE motor Mk 78 Mod 0 burned and then deflagrated mildly so no retrofit is recommended as this reaction is acceptable. It is hypothesized that the liner experiences exothermic behavior very soon (Table 1), ignites the solid propellant which burns through the motor casing, and thus provides adequate venting (Figure 5c).

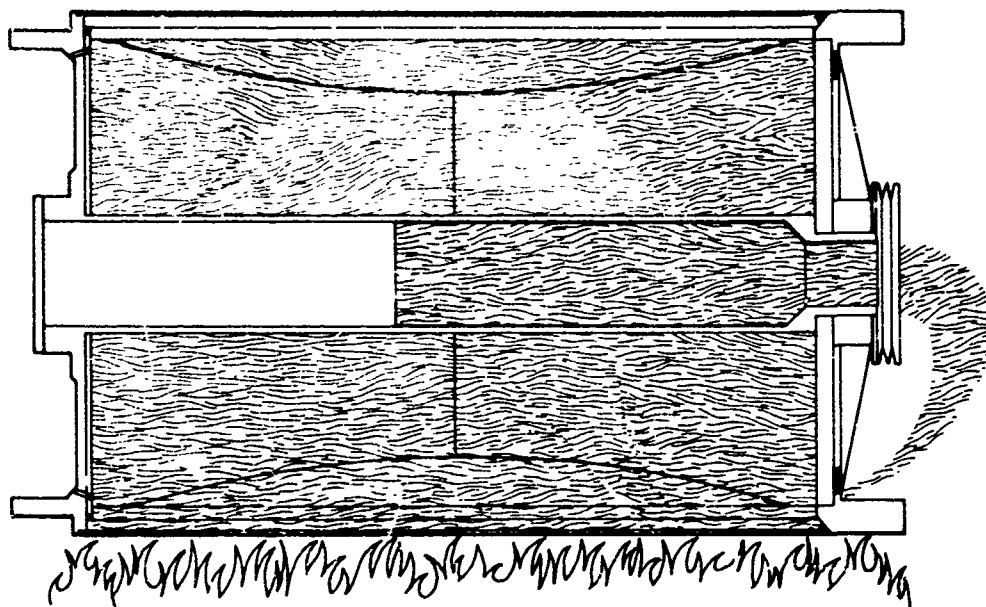
FIGURE 6c. Possible SPARROW Warhead Explosive Completely Burned With Safe/Arm Not Ejected.

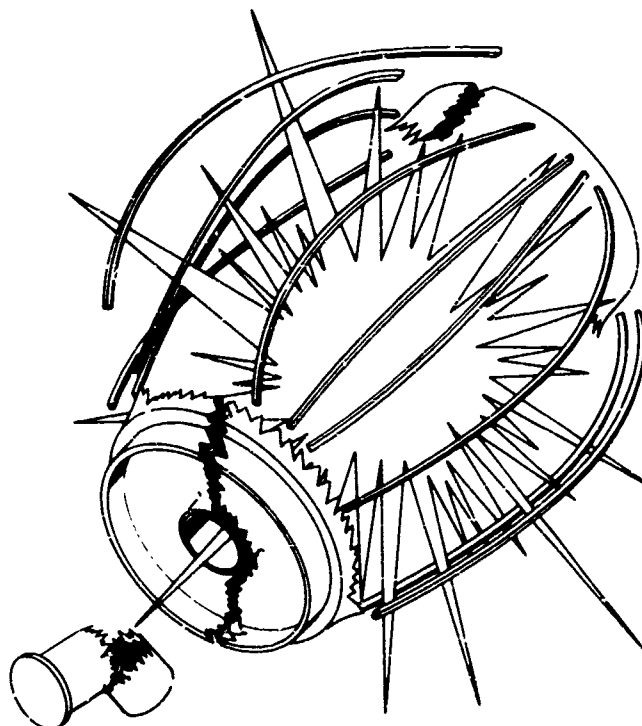
FIGURE 6d. Possible SPARROW Warhead Explosion Due to Safe/Arm Exploding.

In the SPARROW warhead section the same procedure is recommended. Holes should be made in the bulkheads and in the weld fillets on the interior periphery of the warheads. Further venting could be attained by weakening the flange attachment of the safe/arm device by use of plastic screws. Venting of the center cavity also appears feasible.

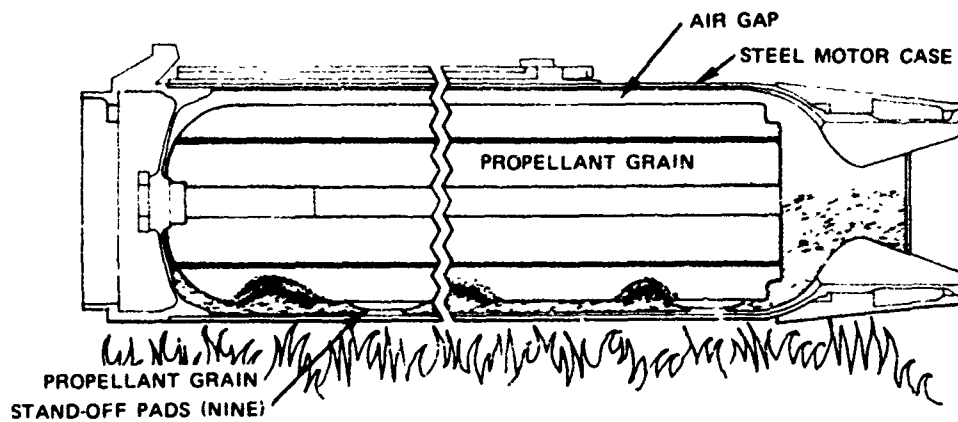
The exothermic heating produced from the liner and/or other material used to prepare the steel case for graining ignited the propellant sooner than if heating only by conduction from the fire existed without chemical reactions. The solid propellant is shown burning at the lower surface in Figure 7a.

FIGURE 7a. SPARROW Motor Propellant Igniting at Lower Surface.

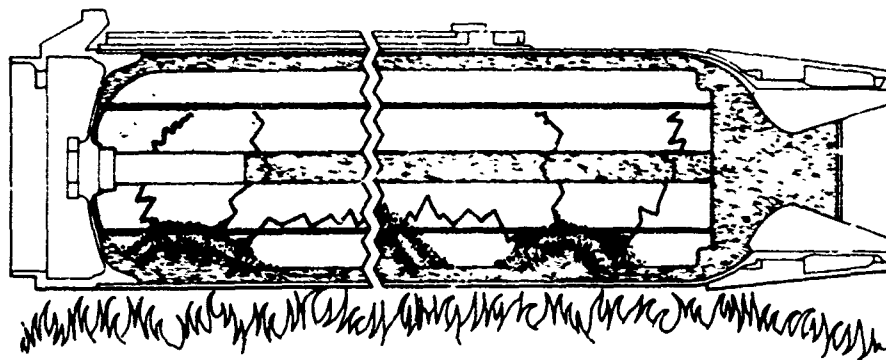
The failure of the Mk 38 Mod 0 SPARROW rocket motor is hypothesized to be due to over-pressurization within the steel casing, which causes the solid propellant to crack, as shown in Figure 7b. If the propellant gas can vent, then the reaction may be one of deflagration, as shown in Figure 7c. Otherwise an explosion may result, as shown in Figure 7d.

FIGURE 7b. Possible SPARROW Motor Propellant Grain Cracking Creating New Burning Surfaces.

*Surface modification* of the propellant grain by chemical means is recommended to reduce the mechanical modulus near the surface at areas of stress concentration. The fiberglass liner of the SPARROW Mk 38 Mod C motor is functional, and chemical modification does not seem warranted. However, mechanical venting is recommended. The existing epoxy liner could be coated with a chemically inert material with longitudinal grooves to conduct any gases from the epoxy liner aft through the weather seal.

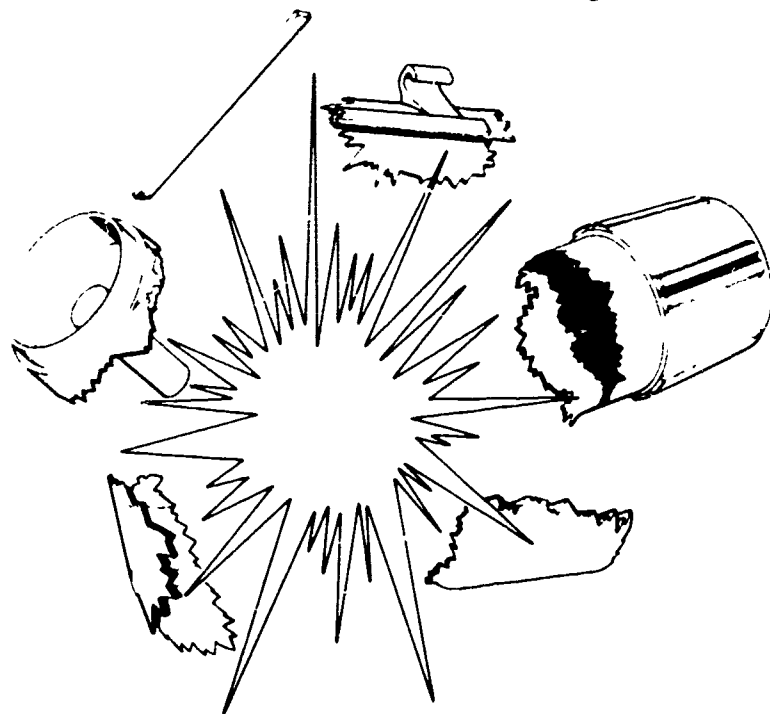
FIGURE 7d. Possible SPARROW Motor Propellant Explosion Due to Overpressurization.
