INVESTIGATION OF HELICOPTER DOOR,  
WINDOW, AND ACCESS PANEL LOSSES

Naval Air Development Center

15 January 1975

| REPORT DOCUMENTATION PAGE | | READ INSTRUCTIONS<br>BEFORE COMPLETING FORM |
|---|---|---|
| 1. REPORT NUMBER<br>NADC-74169-30 | 2. GOVT ACCESSION NO. | 3. RECIPIENT'S CATALOG NUMBER<br>AD/A-005882 |

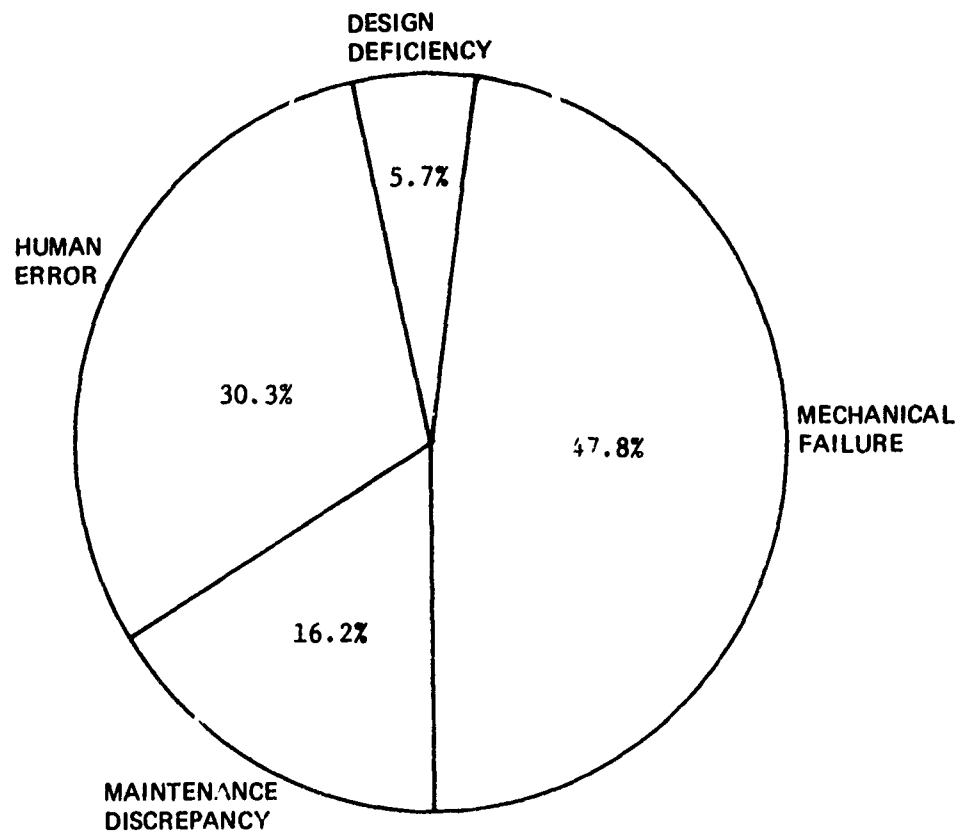
FIGURE 1. GENERAL FINDINGS FROM NAVSAFECEN REPORTS

Figure 1 illustrates the proportional distribution of the results. It is significant to note that the basic causes can almost be equally divided between equipment (1 and 2) and personnel (3 and 4).

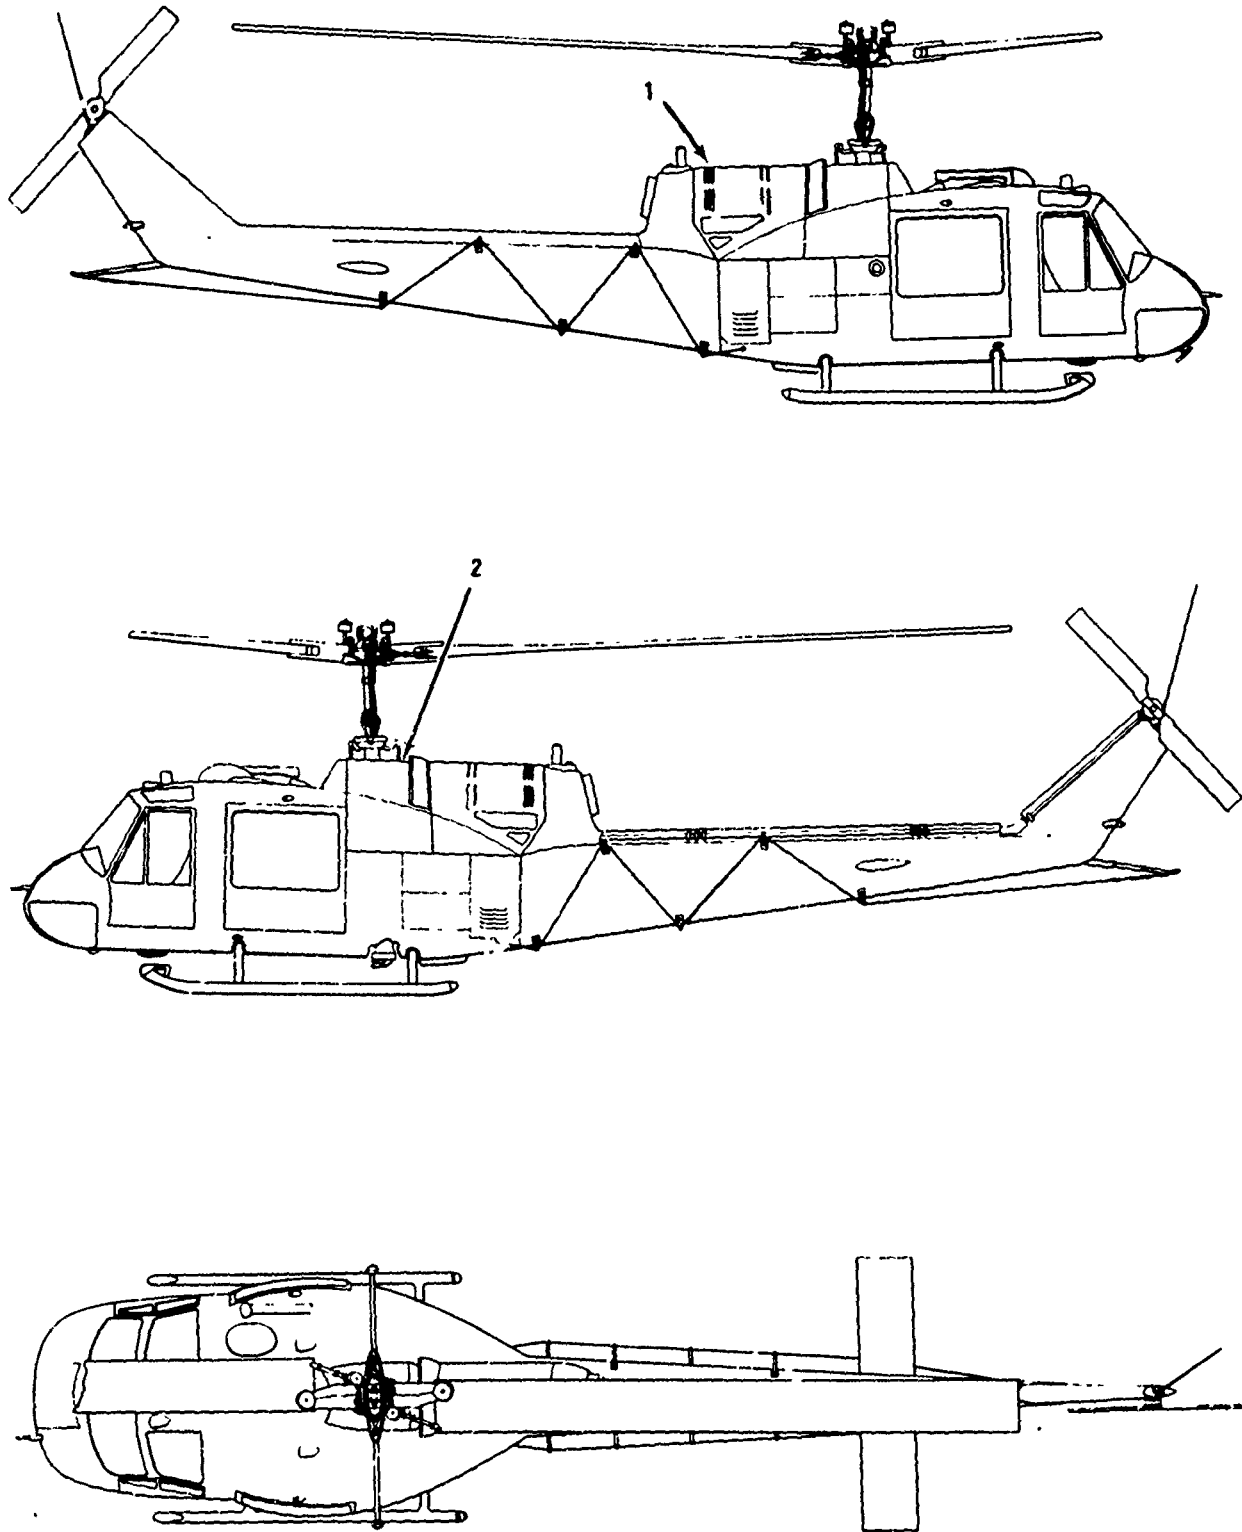
FIGURE B-2. UH-1E HELICOPTER - AIRFRAME GROUP

Information obtained from the NAVSAFECEN computer compilation demonstrated that the Transmission Cowling Panel is the primary problem area on this aircraft. Specifically, material failure of the latch mechanism was most critical. History indicates the need for a positive retention feature for the Transmission Cowling. In-flight Transmission Cowling problems accounted for 55% of the UH-1E reports. Figure B-1 provides a general view of the UH-1E aircraft, and the panel details are highlighted in Figure B-2. Figure B-3 summarizes the findings of the analysis of the NAVSAFECEN reports on the H-1 helicopters.

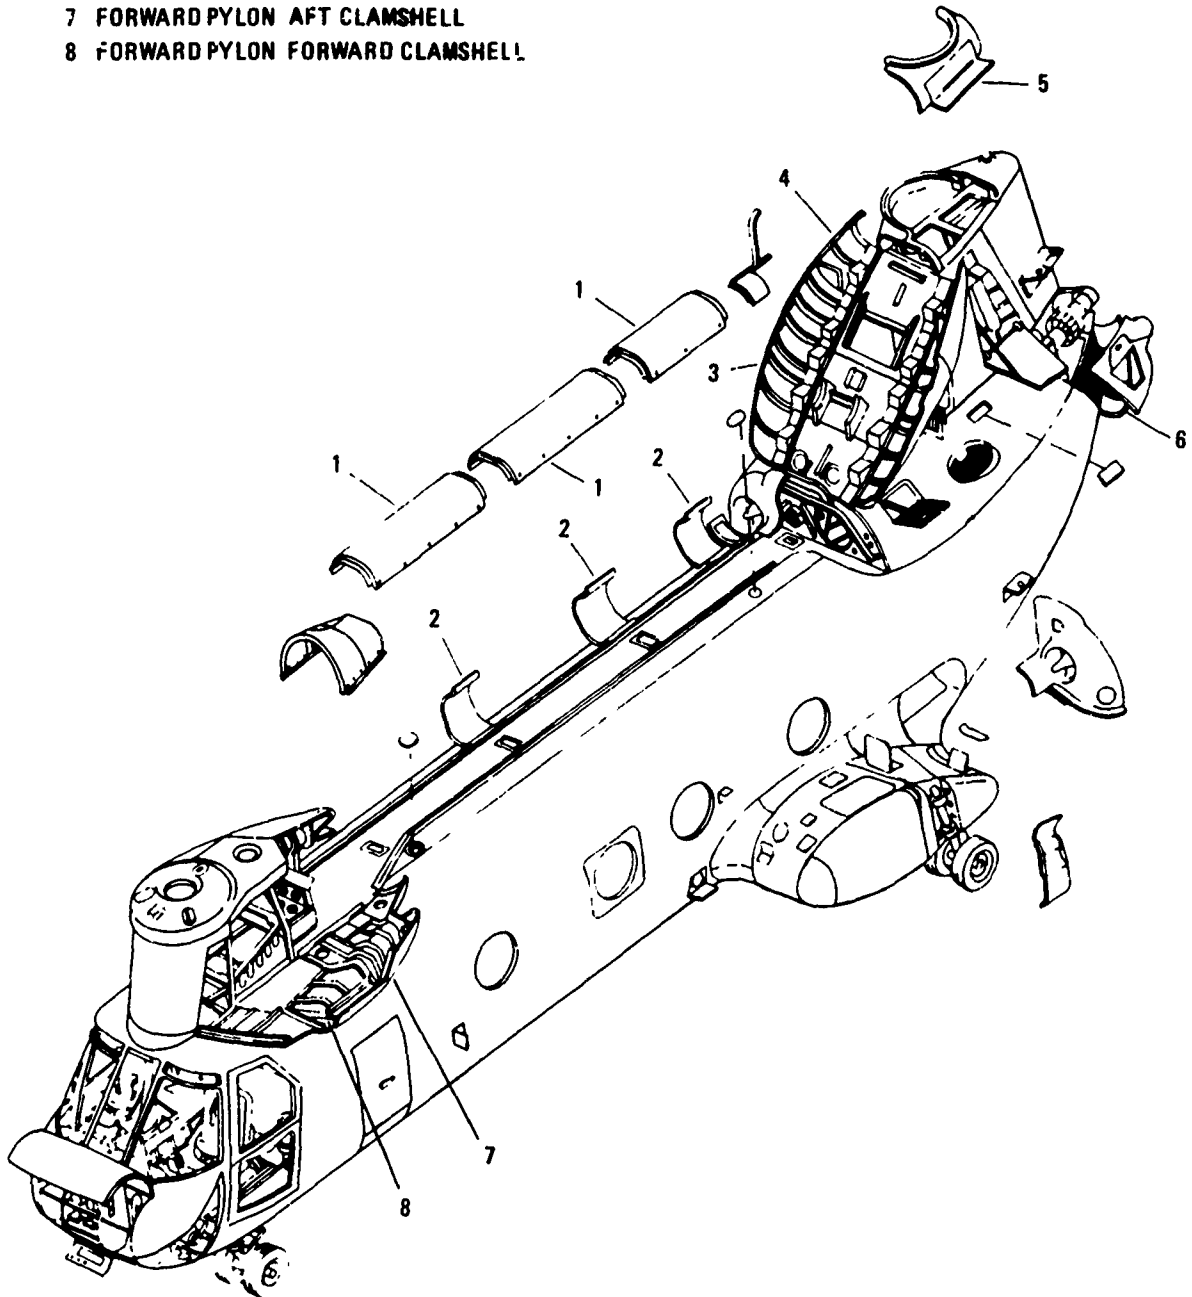
FIGURE E-2. H-46 HELICOPTER ACCESS DOORS

The Aft Pylon Clamshell doors (Reference: Figure E-2, Annotations 3 and 4) provide another problem area on the H-46. According to the NAVSAFECEN data, Aft Pylon Forward Clamshell Doors are lost more frequently than the Aft Pylon Aft Clamshell Doors. However, the aft doors are more dangerous to lose because of their proximity to the rotors. Those who cite the latches as the main cause say that flexing of the doors causes the latches to fail or that the latches are not properly adjusted causing the failure. Those who report the hinges as the main cause contend that the hinges become loose allowing excessive vibration in the doors and that either the hinges fail first followed by the latches failing, or that vibration causes the latches to fail.

The Swashplate Access Panel (Reference: Figure E-2, Annotation 5) accounts for a significant number of losses. It does have a potential for striking the Rotor Blades (two out of the 21 NAVSAFECEN reports indicated this). The panel is relatively small and light and the possibility of seriously damaging the Rotor Blade and causing the aircraft to go out of control is small, but it does exist. The problem with the Swashplate Access Panel is that the Camloc fasteners are not securing the panel adequately. Failure could be caused by not using enough fasteners, the inability of the fasteners to withstand vibration, or incorrect fastener size.

The synchronous Shaft Inspection Panels (Reference: Figure E-2, Annotation 2) have been troublesome. They usually open in flight and hit the fuselage. They have separated from the aircraft but no cases of them striking the Rotor Blades have been reported. Fastener failure has been the problem. These panels become distorted from either coming open and being banged against the fuselage or by personnel walking on them. They can become so distorted that they rub against the synchronous shaft. Their frequent need for repair or replacement makes them an appreciable maintenance problem.

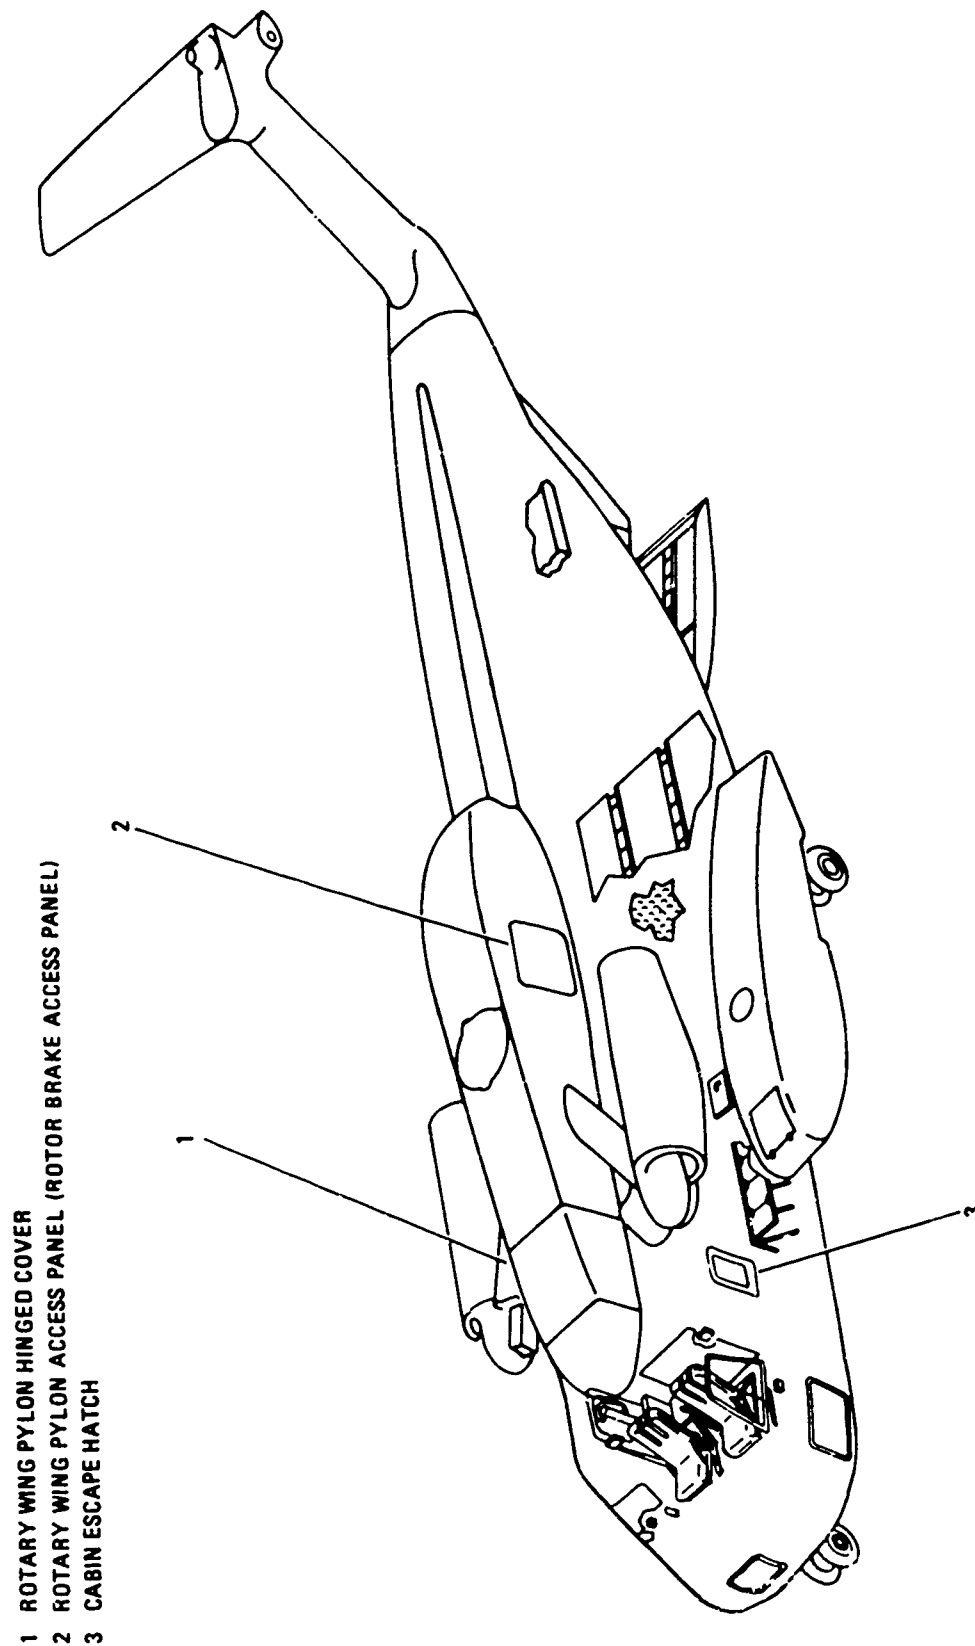
FIGURE F-2. CH-53A AIRFRAME EQUIPMENT AND FURNISHINGS

The Rotor Brake Access Panel which is just aft of the Work Platform (Reference: Figure F-2, Annotation 2) stands out in all three data sources as being the major problem on the H-53. The NAVSAFECEN data shows the Rotor Brake Access Panel to be the constant contributor to in-flight incident reports (22.4% for all H-53's, 37.2% for H-53D). The 3-M data indicates it is the panel most frequently in need of maintenance action. This panel was also emphasized by squadron

personnel. Problems with this panel are caused by its size, lack of weight and flexibility which make it susceptible to being torn off the aircraft if air is allowed to get under it. The Camloc fasteners which secure the Rotor Brake Access Panel do not keep the leading edge flush enough to prevent air from getting under the panel. The fasteners are too loose either due to wear in the receptacles or an improper size being used. The frequency of loss of the Rotor Brake Access Panel is alarming considering this panel's potential of hitting the Rotor Blades. Because of the windstream around the aircraft, the port panel is more apt to strike the Rotor Blades than the starboard panel. Fortunately, the starboard panel is lost more frequently than the port panel.

The Escape Hatch (Reference: Figure F-2, Annotation 3) accounted for nine percent of the incidents reported in NAVSAFECEN reports. The mass of the Escape Hatch makes it a potential hazard because it would cause extensive damage to the Rotors if it was to strike them (No such occurrence has been reported). The hatch would also cause personnel or property damage if it fell in a populated area. Frequently the hatch is removed for better in-flight cabin ventilation, for weapon installation or for gravity fueling of internal tanks. Frequent removal causes the hatch to become insecure. With age the latching mechanism flexes allowing the securing pins to drop out of their guides. Also it is difficult to see if the pins have properly seated in the side of the frame. If a crewmember attempts to remove the hatch in-flight, the wind blast will most likely tear it from his grasp. Squadron personnel have suggested the possibility of forward-hinging the hatch to improve the ability to secure the hatch while still retaining the opening capability. The design philosophy of the H-53E is to maximize commonality of parts with earlier models. Consequently, the H-53E port Emergency Escape Hatch is designed the same as the earlier models.

The Hinged Doghouse Cover (Reference: Figure F-2, Annotation 1) represents only 2.2 percent (3 cases) of the NAVSAFECEN reported incidents, although each case has resulted in the cover hitting the Rotor Blades. Two of the three reported cases were due to improperly securing the cover prior to flight. The cover is hinged on its leading edge, and even if the cover is not secured it should not open in level flight. Certain maneuvers could cause it to open and hit the Rotors. The squadrons visited have indicated that it sometimes takes an excessive amount of time to close and secure the hinged cover. This problem is caused by the cover being large and flexible and the frame being very susceptible to distortion.
