ENTANGLEMENT OF THE SUBMERSIBLE  
JOHNSON SEA LINK WITH SUBMERGED WRECK-  
AGE OFF KEY WEST, FLORIDA ON OR ABOUT  
17 JUNE 1973 WITH LOSS OF LIFE

Coast Guard  
Washington, D. C.

15 January 1975

| 4. Title and Subtitle<br>Marine Casualty Report - Submersible JOHNSON SEA LINK<br>Entanglement off Key West,<br>Florida, 17 June 1973 | | 5. Report Date<br>January 15, 1975 | |

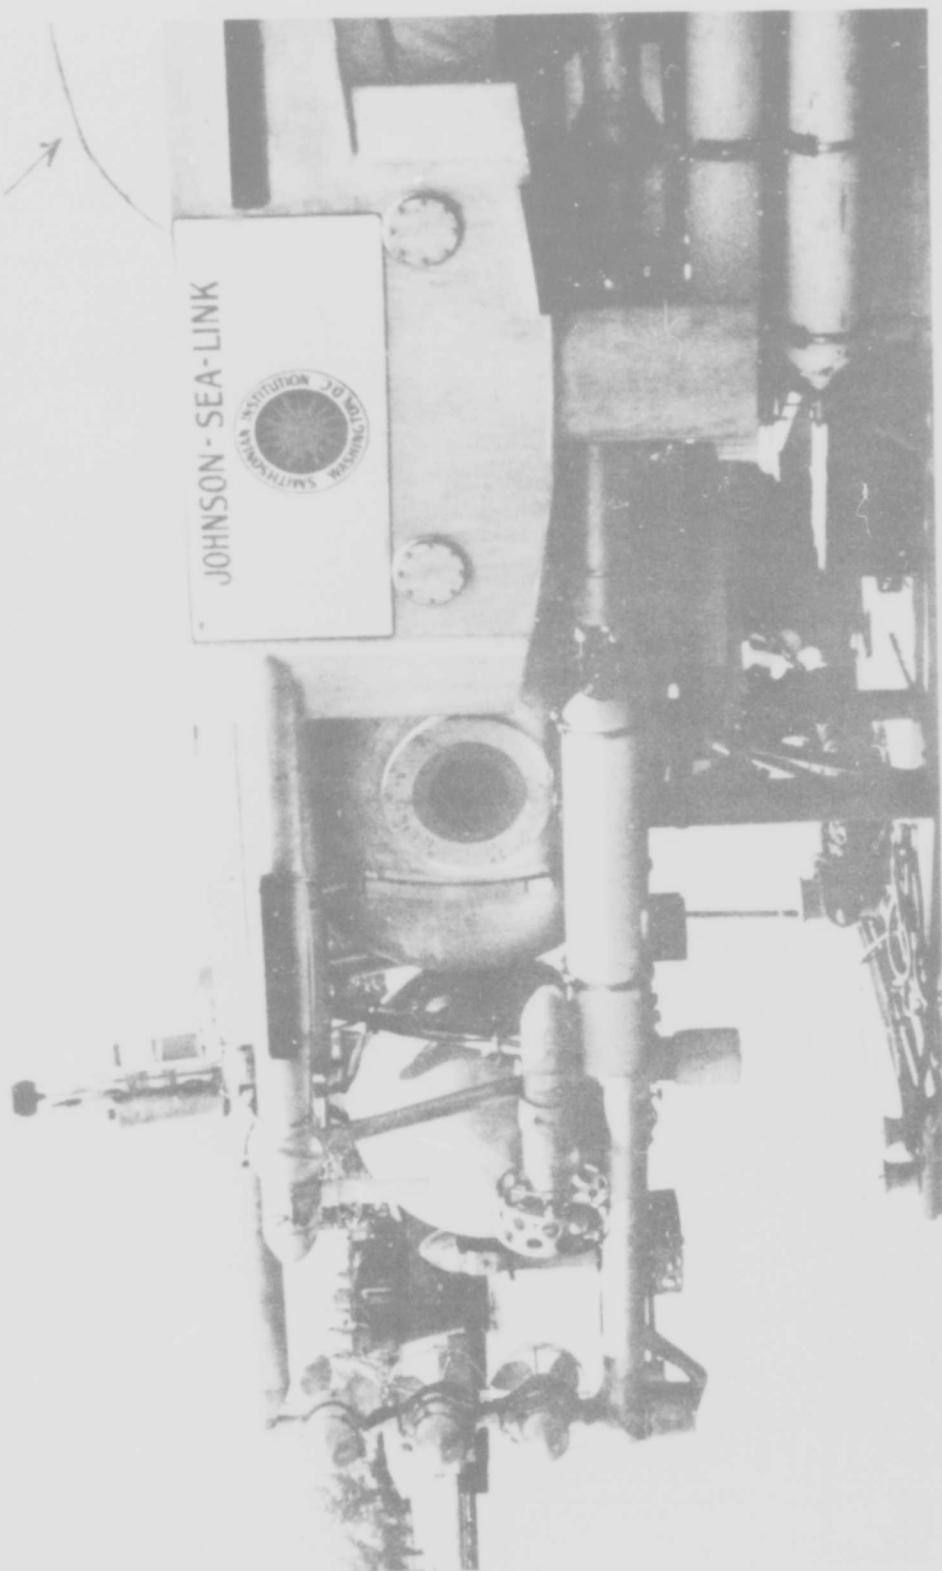
c. The submersible, as a complete unit, defies comparison with any conventional ship or boat shape. Its modular construction lacks the symmetry or "fairing" normally found in both surface and subsurface vessels. This submersible can best be described as an ill defined network consisting of an aluminum framework to which various shapes, containers and appendages have been attached according to their functional value rather than a concern for symmetry. (Photograph appended)
