**A STUDY OF IN-REACTOR DENSIFICATION
OF UO₂ FUEL IN THE MH-1A REACTOR**

Battelle Columbus Laboratories

FINAL REPORT

December 23, 1974

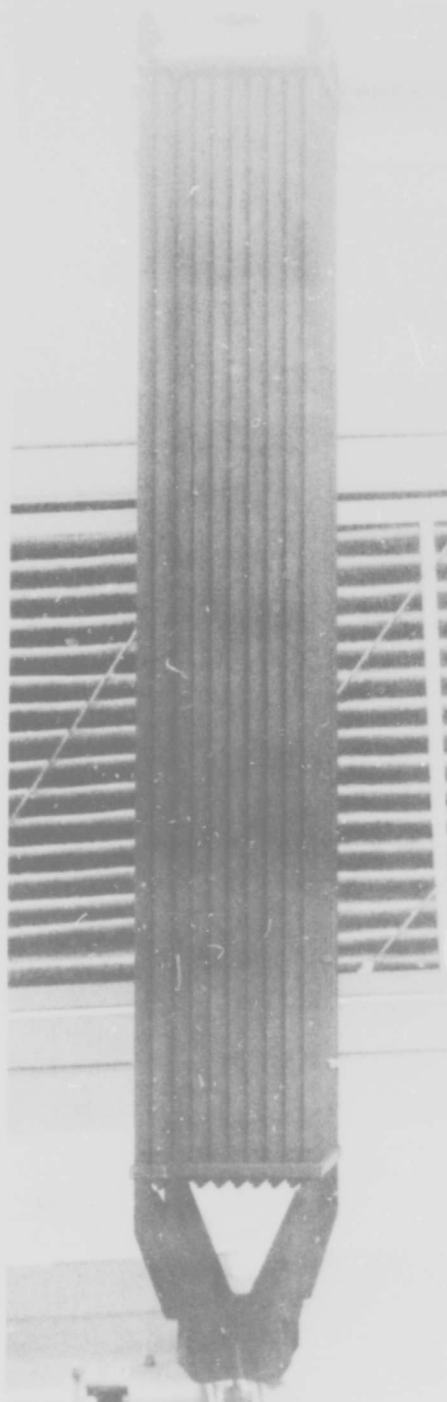
The fuel assembly was visually examined to assess its general condition. This examination showed the assembly to be in good condition with no evidence of extensive rod bowing, clad collapse, or any other type of damage. A photograph of one side of the assembly is shown in Figure 2.

FIGURE 2. VIEW OF AS-RECEIVED MH-1A FUEL ASSEMBLY NO. 46 THROUGH HOT CELL WINDOW. The assembly appears sound in all respects.

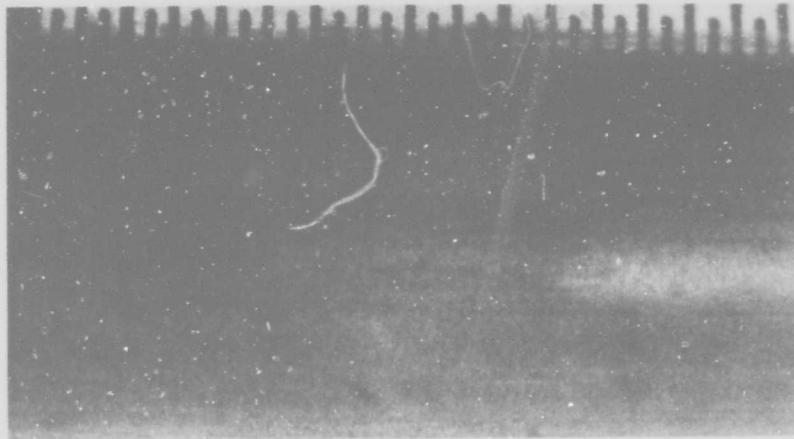
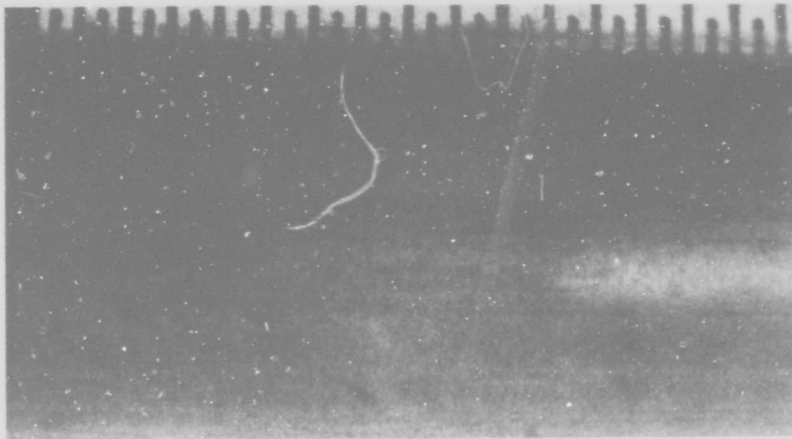
Each of the six removed fuel rods were examined visually using a stereoviewer. No evidence of clad collapse, distortion, or excessive corrosion was observed. Figures 3 and 4 show the highest performance region of Rods A-2 and A-9. As can be seen the cladding appears to be completely sound. The oxide coating on the rods was typical of that formed on stainless steel on exposure to high-temperature water. Figure 5 shows the bottom region of Rod E-5 where neutron radiography revealed an absence of fuel. If the fuel was missing during operation, it had no obvious deleterious effect on the cladding.

FIGURE 3. VIEW OF HIGH PERFORMANCE REGION OF ROD A-2,
(HIGHEST BURNUP ROD EXAMINED) 8-1/2 - 9-1/2
IN. ABOVE THE BOTTOM OF THE FUEL COLUMN

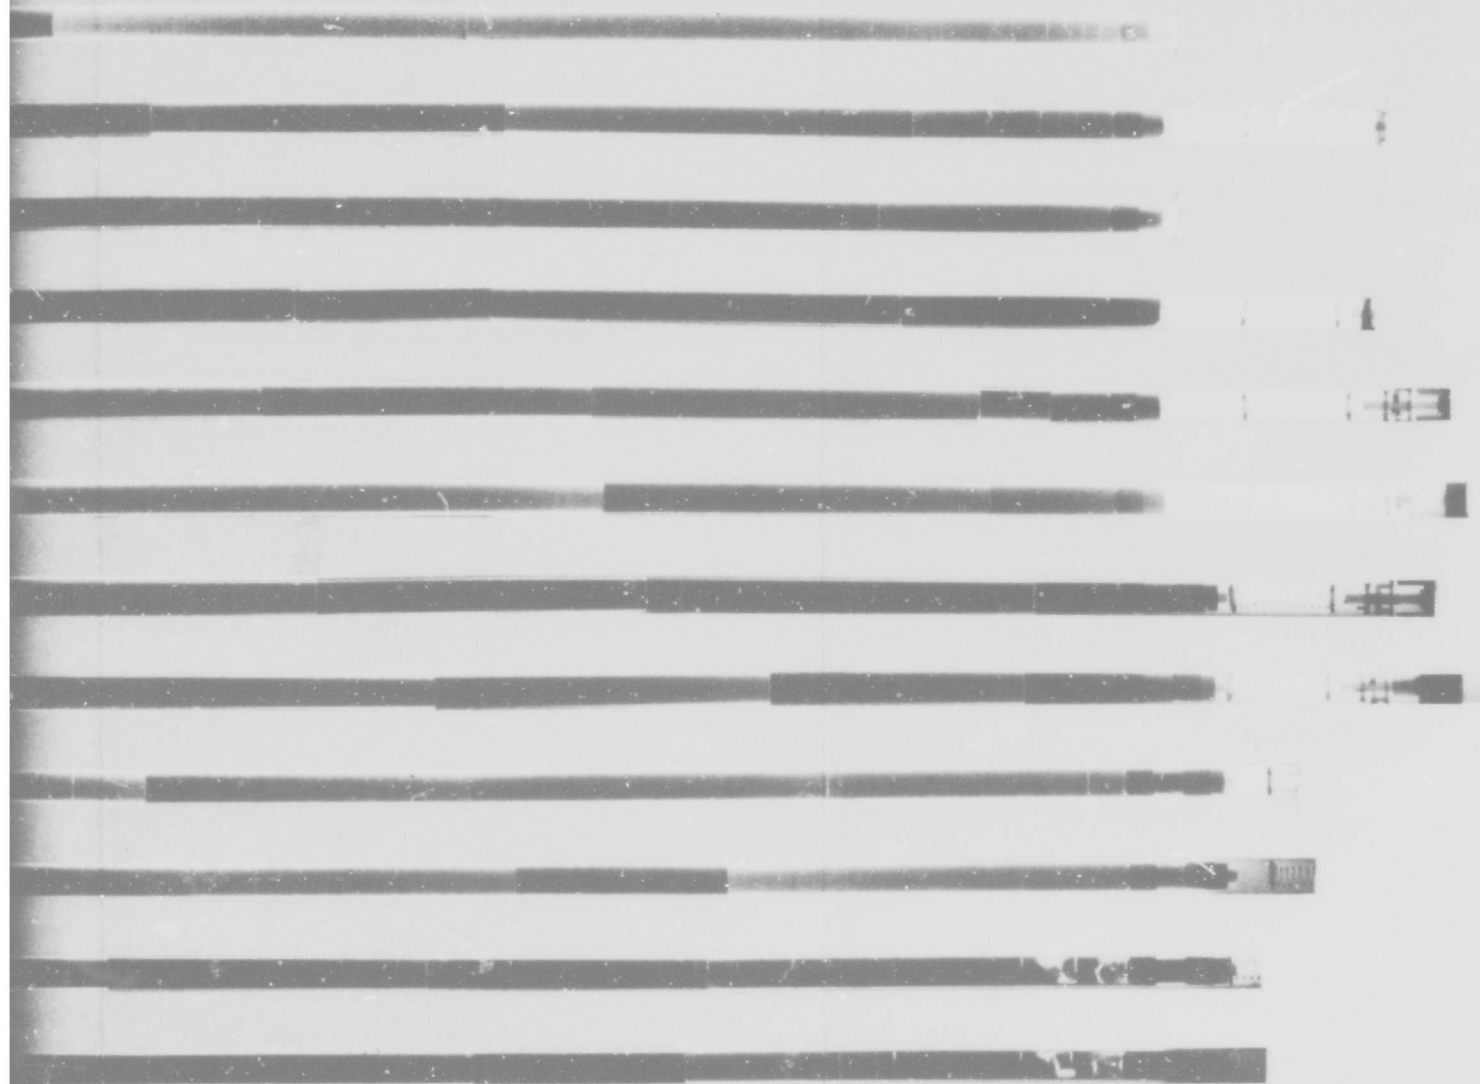
The neutron radiographs, Figure 6, did reveal gaps in the fuel columns. Also, cracking of fuel pellets appeared to be moderately severe. However, movement of fuel within the rod was observed upon moving the rod from one radial position to another, suggesting a loose fit of fuel in the cladding. This looseness was later observed during sectioning and metallographic examination. In light of this loose fit and the absence of a holddown spring, the gap formation could have been caused by movement of the fuel during transport and handling. Similarly, the freedom of pellet movement could allow fuel fragments to slip out of normal pellet positions and make the fuel cracking appear more severe than usual. As will be seen later in this report, metallographic examination showed that the degree of cracking was typical of that resulting from thermal stresses in UO_2 fuel.

It is uncertain whether the fuel column gaps occurred before, during, or after operation. If any of the gaps were present during operation, they did not lead to any clad collapse. The stainless steel cladding apparently was strong enough to resist the clad collapse observed in similar situations with Zircaloy clad rods. Evidence of high clad strength is provided by the loose fit of the fuel in the cladding. Zircaloy clad tends to creep down under the pressure of the reactor water and eventually contact the fuel, at least in spots. The loose fuel fit in the MH-1A fuel rods indicates that no significant creep down of the stainless steel clad occurred.

FIGURE 6. NEUTRON RADIOGRAPHS OF REMOVED MH-1A FUEL RODS. Note the cracked fuel. Also, note that some fuel moved within the rods when the rods were rotated (0 to 90 degrees). This movement is indicative of a very loose fit of

Note the cracked fuel and the gaps in some of the fuel columns, when the rods were rotated from one radial position to another of a very loose fit of fuel within the cladding.

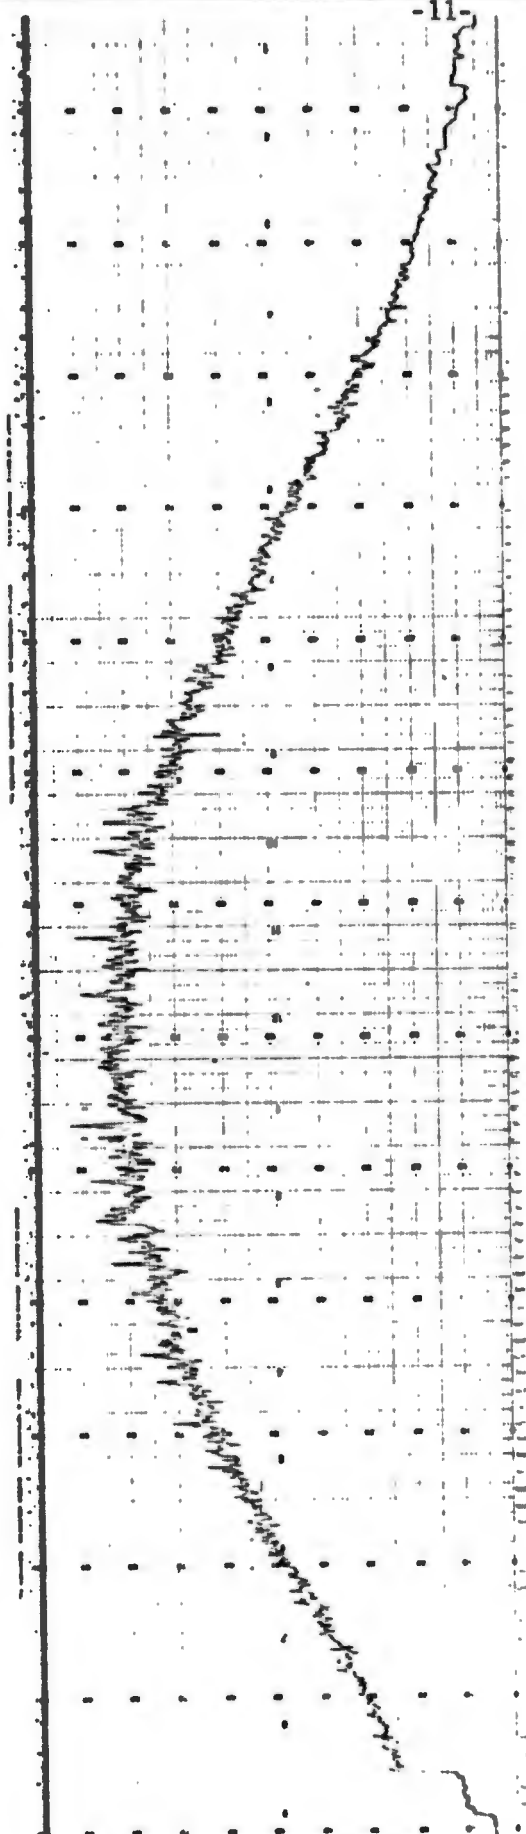
The gamma scan of Rod A-2 revealed activity spikes, apparently at pellet interfaces, in the high performance region. This type of behavior is usually attributed to migration of cesium to the pellet interfaces and is evidence of relatively high operating temperatures.

FIGURE 7. GAMMA SCAN OF RODS A-2. This is the highest burnup rod examined in this program.
Note the activity spikes in the high performance region of the rod.
Spikes of this type are generally attributed to migration of cesium to the pellet ends.

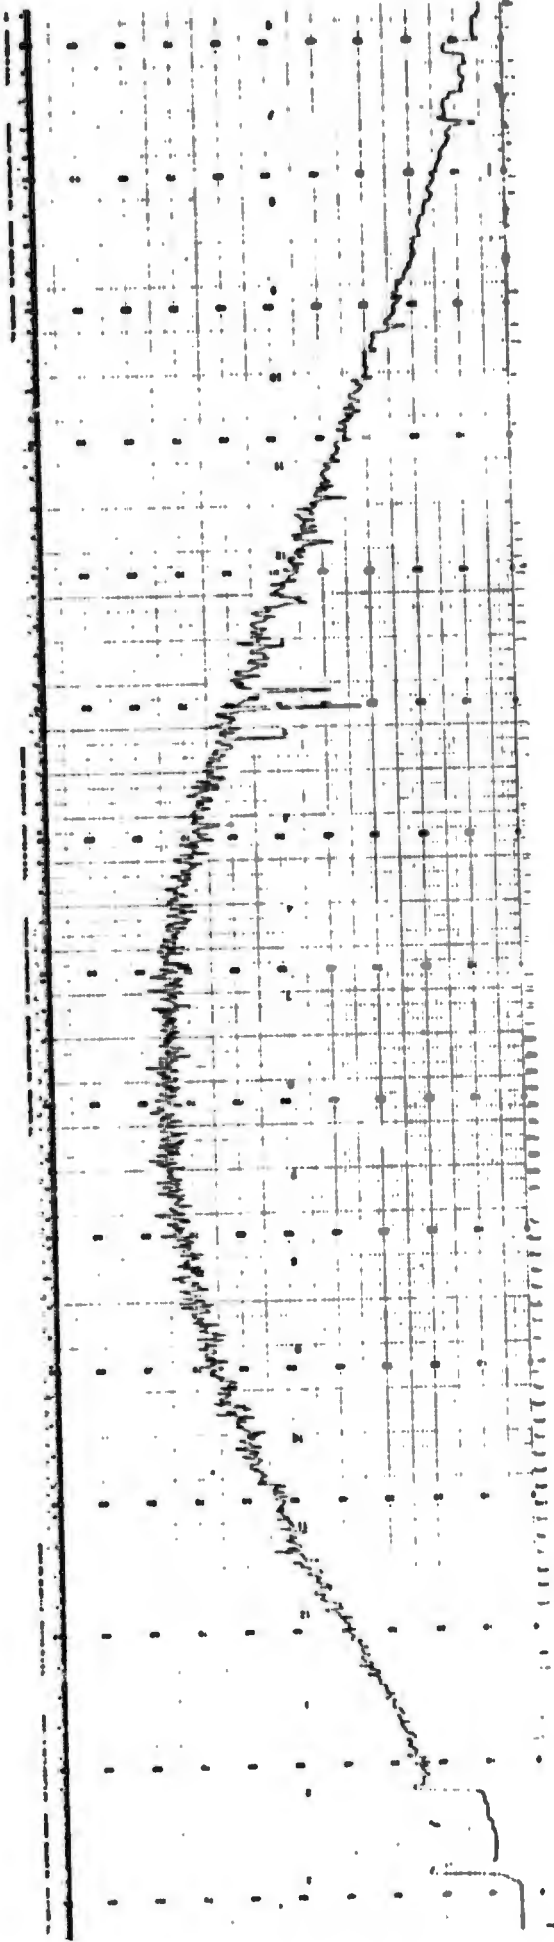
Localized dips in the gamma activity indicate gaps in some of the fuel columns, notably in Rods J-11, E-5, and A-9. In light of evidence that the fuel pellets fit very loosely in the cladding, it is possible that these gaps formed because of shifting of pellets during transit and handling rather than because of fuel densification.

FIGURE 8. GAMMA SCAN OF ROD A-9. This is the second highest burnup rod examined. The dips in activity toward the top of the rod are indicative of gaps in the fuel column.

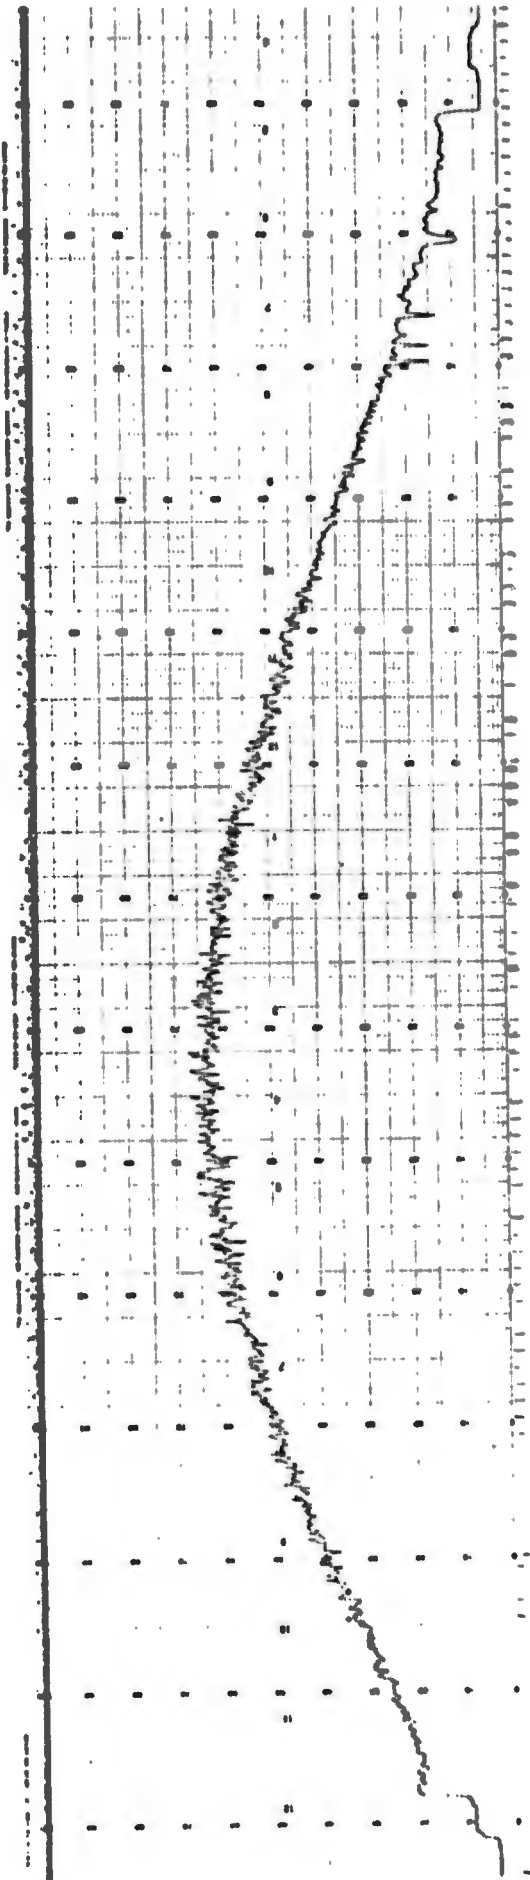
FIGURE 10. GAMMA SCAN OF ROD A-12. A few small gaps in the fuel column are evident near the top of the rod.

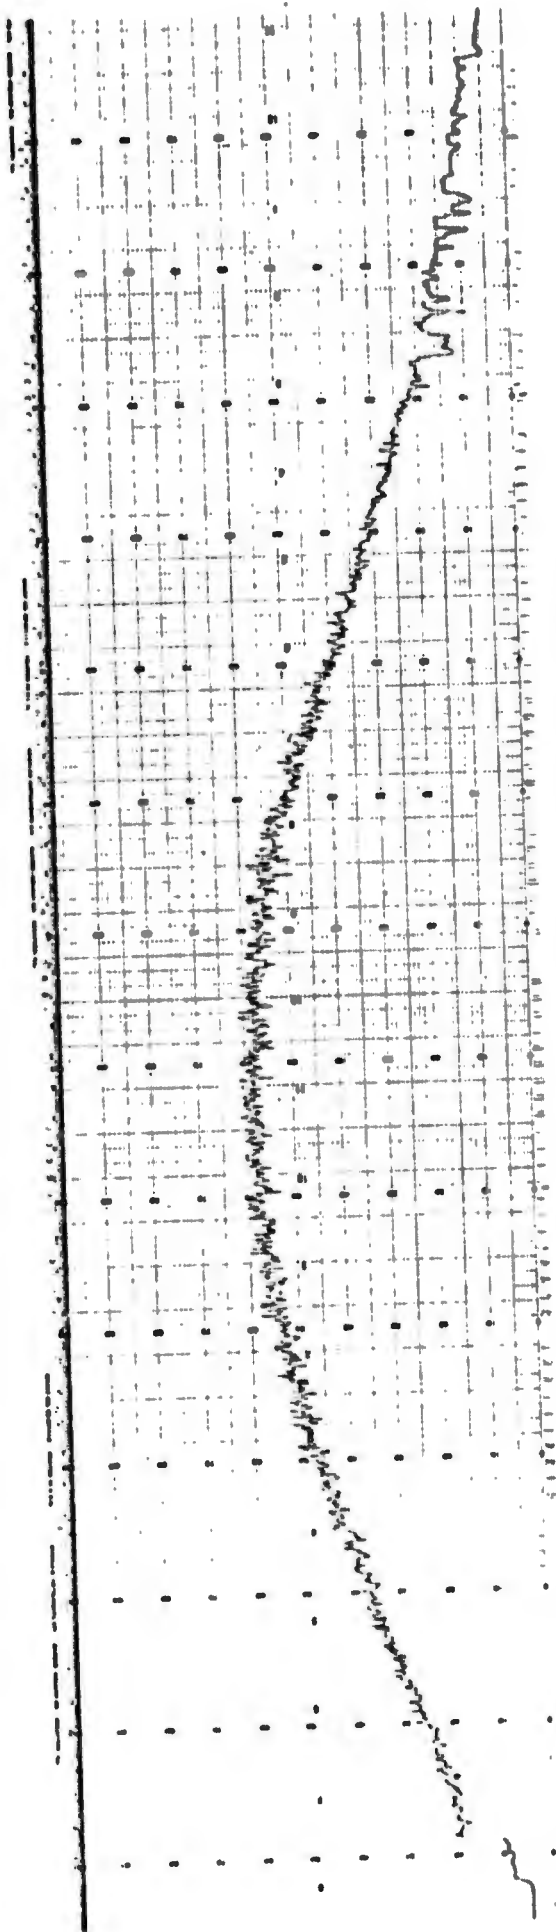
FIGURE 11. GAMMA SCANS OF ROD J-11. Dips near the top of the fuel column suggest gaps and possible fuel pellet fragmentation.

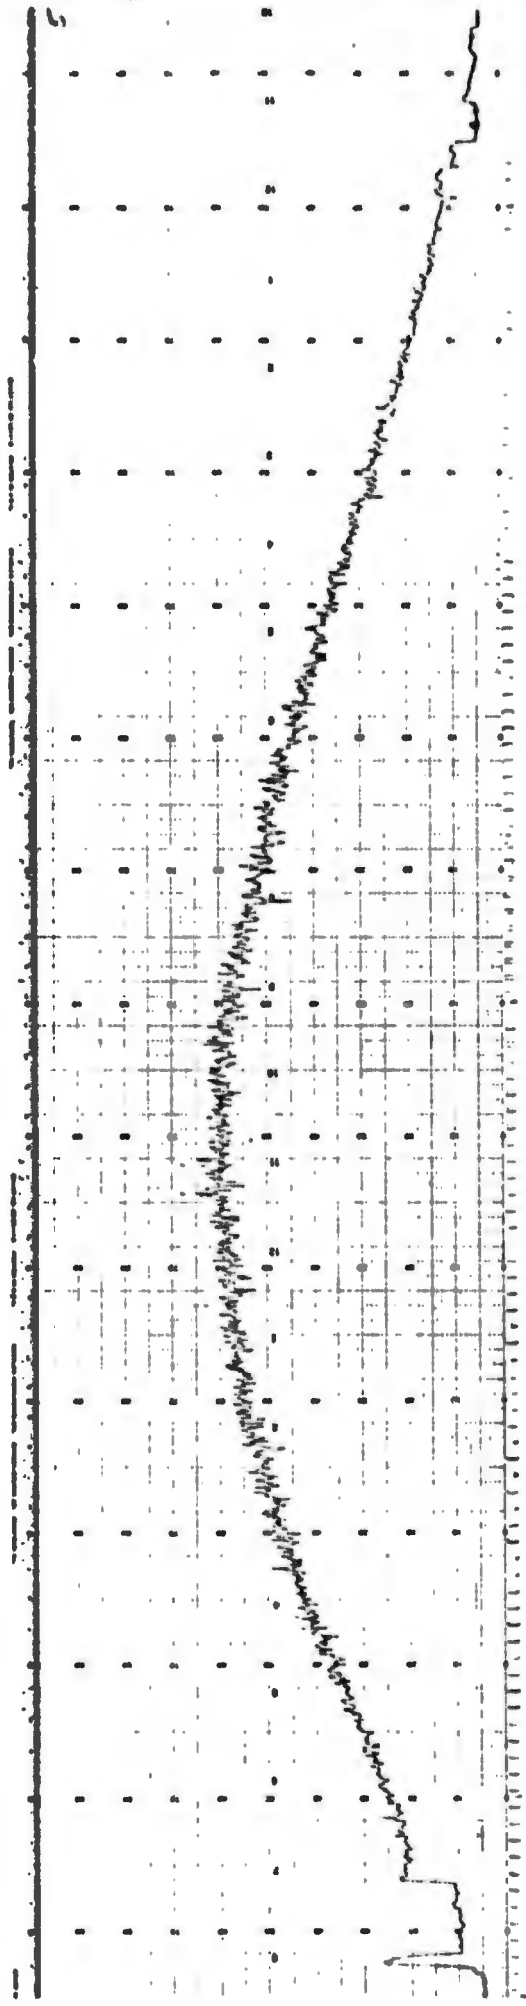
FIGURE 12. GAMMA SCAN OF ROD F-8. Fuel pellet column appears to be intact.

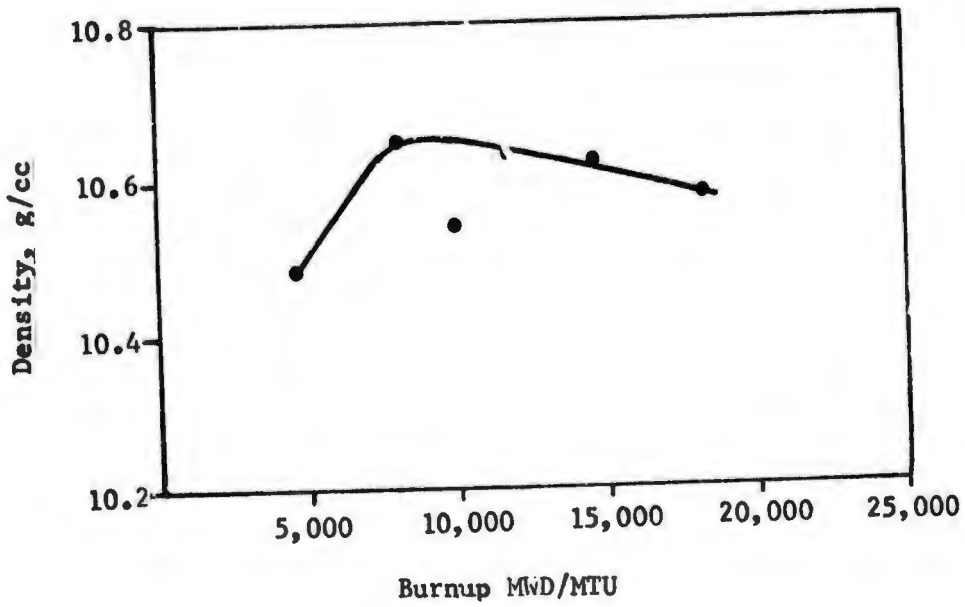
The fuel density data show that five out of six fuel samples had densities beyond the specified maximum as-fabricated fuel density (10.5 g/cc). This is regarded as conclusive evidence that the fuel densified during irradiation.

Because of the broad range of specified as-fabricated densities (10.2 to 10.5 g/cc) it is difficult to make any solid quantitative conclusions regarding the densification. On a conservative basis, assuming a starting density of 10.5 g/cc it can be stated that the maximum measured fuel density of 10.650 g/cc represents a 1.5 percent density increase. In a more speculative vein, a plot of density versus burnup, Figure 13, suggests that densification continued to a burnup of about 8000 MWD/MTU. The fuel then started to swell at a low rate as burnup continued. If it could be established that all of the fuel started life at approximately the same density, the validity of conclusions drawn from this plot would be strengthened. Behavior of this type would be expected, however. Early in life, when fission product inventory is low, densification should be the dominant process. Later, as the fuel approaches its maximum attainable density and as fission products buildup, the fuel should start to swell.

FIGURE 13. PLOT OF DENSITY VERSUS BURNUP.
This plot suggests that density increases with burnup with additional burnup, the fuel starts to swell at a low rate.

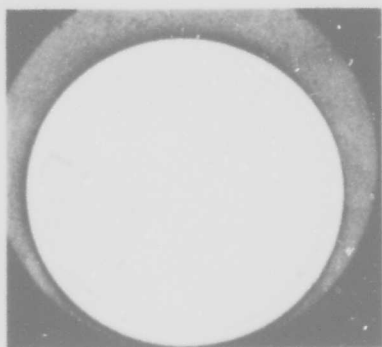
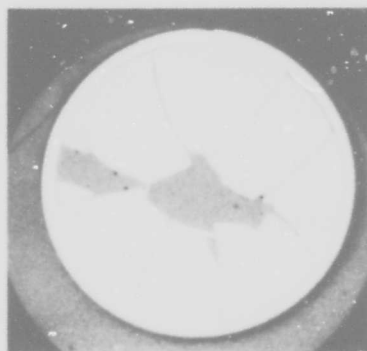
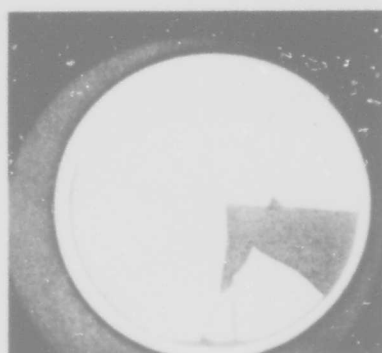
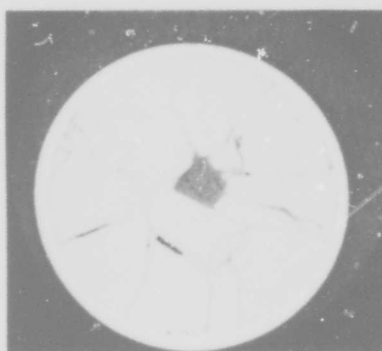
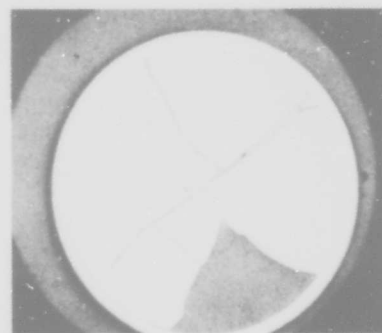
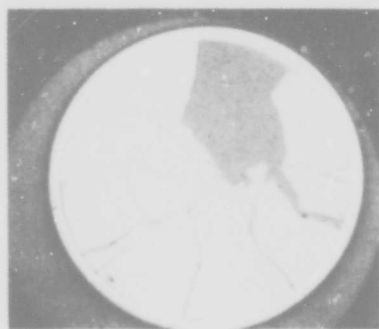
The macroviews, Figure 14, show the usual cracking patterns that result from thermal stress in the UO_2 . Some loss of fuel has been experienced but this can be attributed to the loose fit of fuel in the cladding.

FIGURE 14. MACROVIEW OF METALLOGRAPHIC SPECIMENS.
Cracking patterns are typical of these caused by thermal stresses in UO_2 .

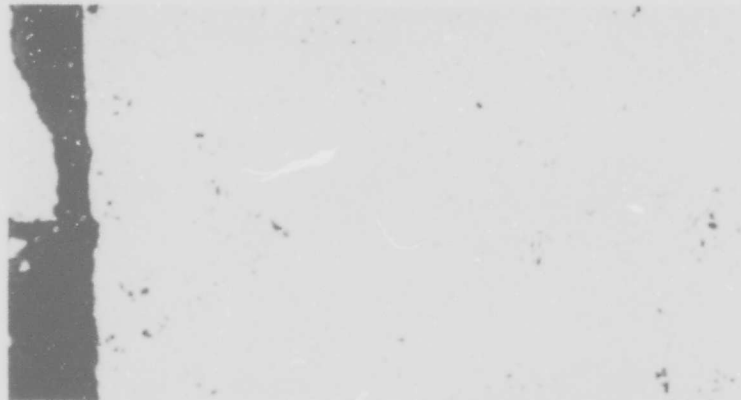
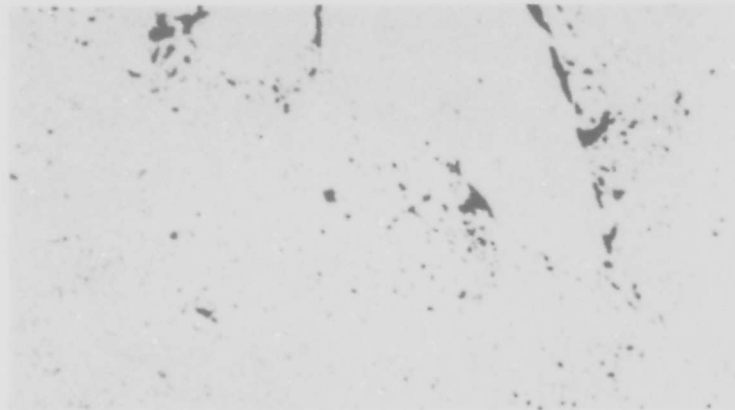
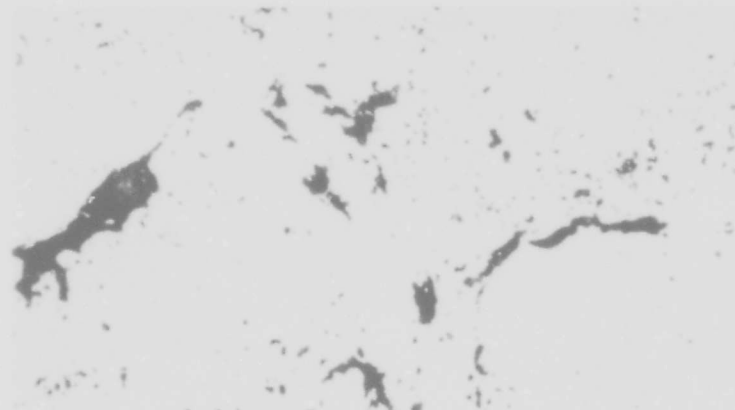
As-polished 500X photomicrographs of the fuel are presented in order of increasing burnup, Figures 15 through 20. Note that the lowest burnup sample contains a large number of small round pores plus a small number of large angular pores. With its low burnup, this sample probably best represents the as-fabricated pore structure. As burnup increases, the distribution of large pores stays about the same while the population of small pores decreases. Note that the high burnup specimens contain very few small pores. On the basis of these observations, it appears that densification occurred via annihilation of the small as-fabricated porosity. This same type of small pore annihilation has been observed in densified commercial reactor fuel.

FIGURE 15. AS POLISHED MICROSTRUCTURE OF ROD F-8 AT 32-1/2 - 33-1/8 IN. FROM BOTTOM OF FUEL COLUMN. Burnup 5,400 MWD/MTU. Note the relative large population of small pores.

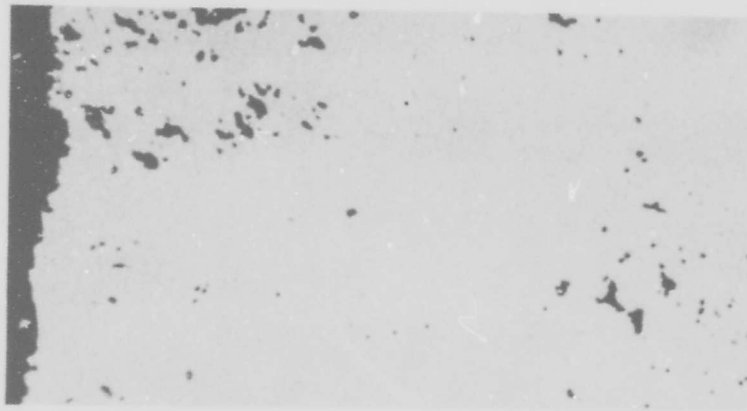
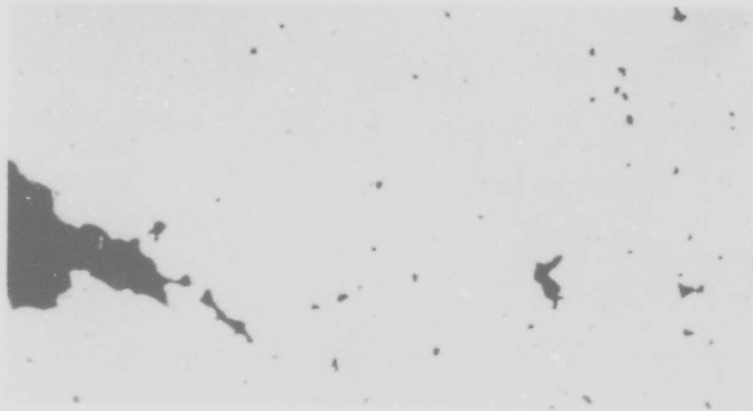
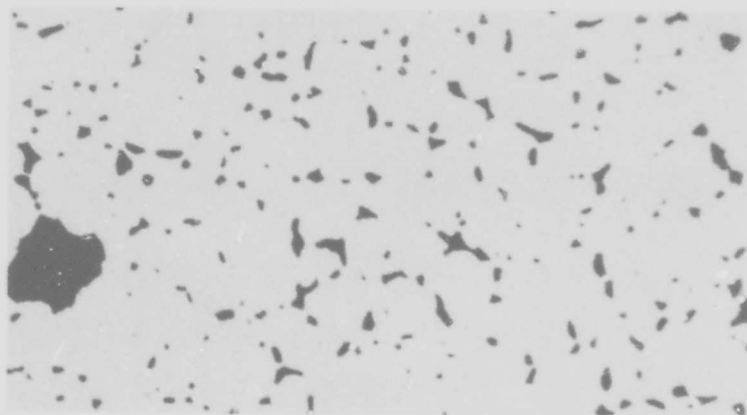
Note that the center region of Specimen A-2 13-11/16 - 14-9/32 in. (highest burnup metallography sample) has enlarged grains and relatively large pores decorating the grain boundaries, Figures 21 and 22. This region of fuel operated at temperatures high enough to promote grain growth and fission gas migration. Recall that fission gas release from Rod A-2 was much higher than from the other rods. On the basis of the grain size, it appears that temperatures in the fuel center were on the order of 1300 to 1400 C. Grain growth was not apparent in Rod F-8 at 13-25/32 - 14-3/8 in., Figures 23 and 24, or in any lower burnup samples, suggesting that the maximum operating temperatures in the other regions examined were less than 1000 or 1100 C.

FIGURE 20. AS POLISHED MICROSTRUCTURE OF ROD A-2 AT 13-11/16 - 14-9/32 IN. FROM BOTTOM OF FUEL COLUMN. Burnup 18,200 MWD/MTU. Note the small population of small pores in the fuel surface and mid-radius positions. In fuel center, grains have grown and fission gas porosity decorates grain boundaries.

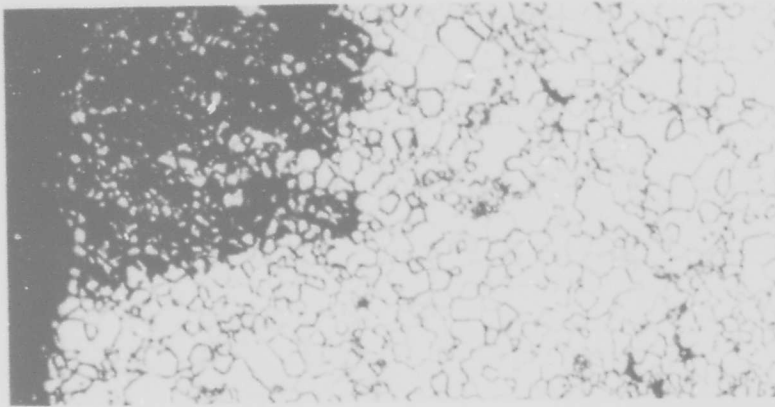
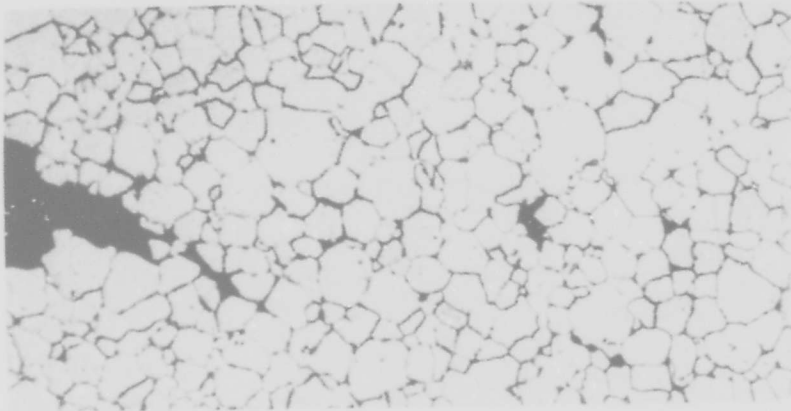
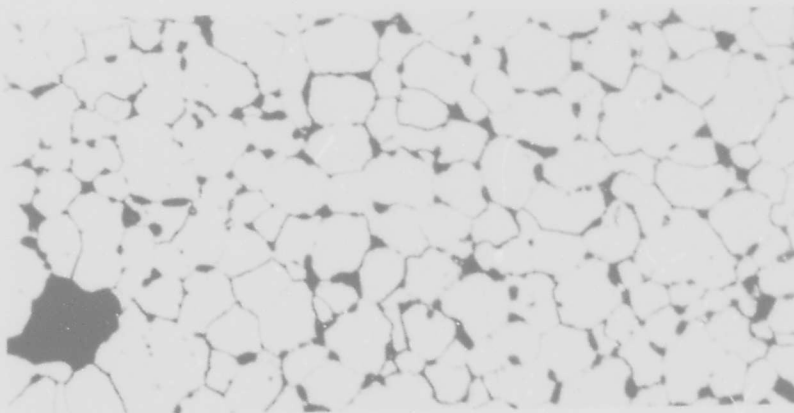
FIGURE 21. ETCHED MICROSTRUCTURE OF ROD A-2 AT 13-11/16 TO 14-9/32 IN. FROM BOTTOM OF FUEL COLUMN. Note that grain growth has occurred in the fuel center and mid radius regions.

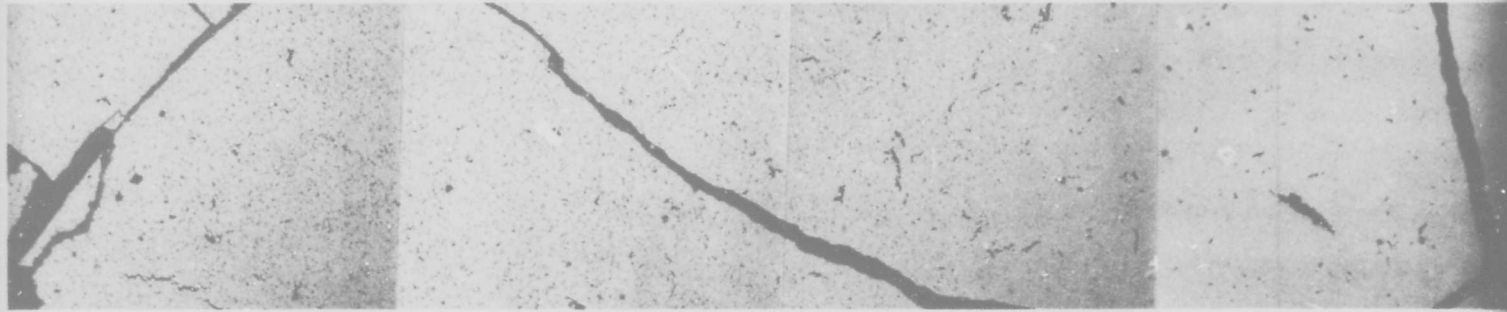
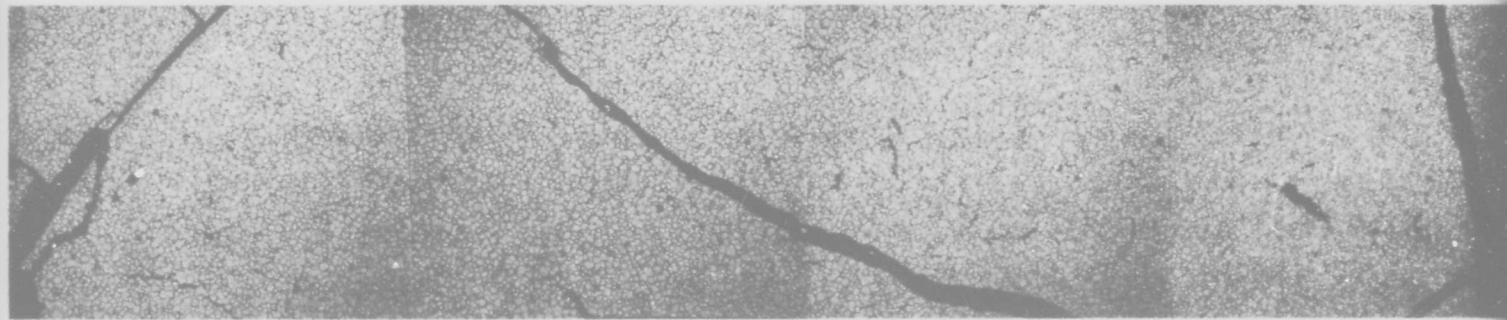
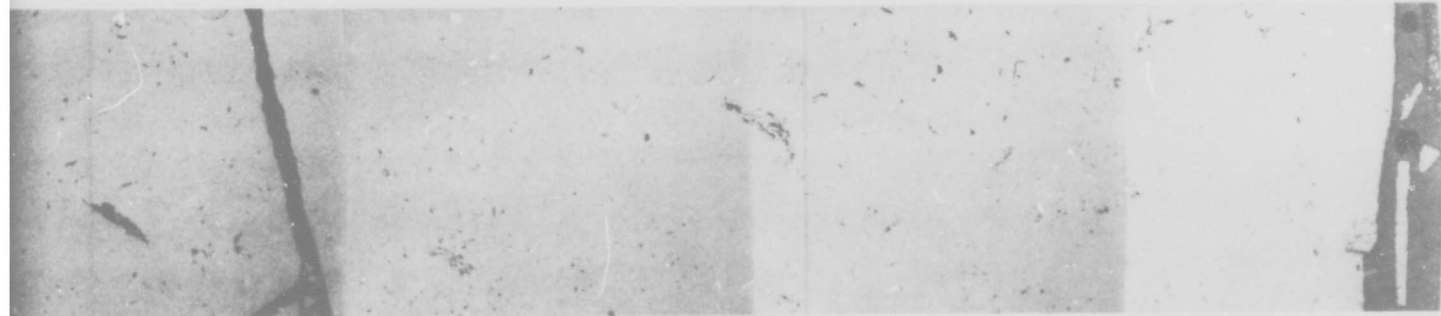
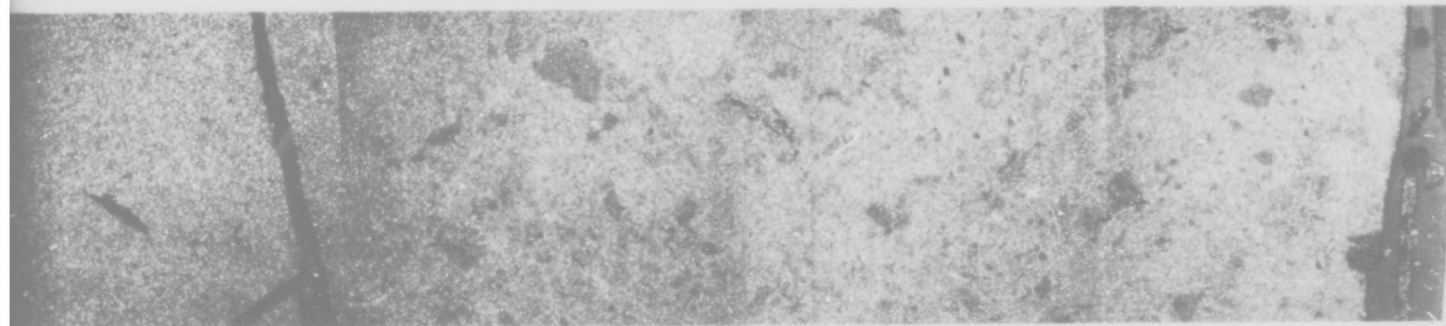
FIGURE 22. LOW MAGNIFICATION RADIAL TRAVERSES OF METALLOGRAPHIC SAMPLE FROM ROD A. This illustrates the microstructural changes that have occurred in the

GRAPHIC SAMPLE FROM ROD A-2 AT 13-11/16 - 14-9/32 IN. FROM BOTTOM OF FUEL COLUMN.
that have occurred in the high power region of Rod A-2.

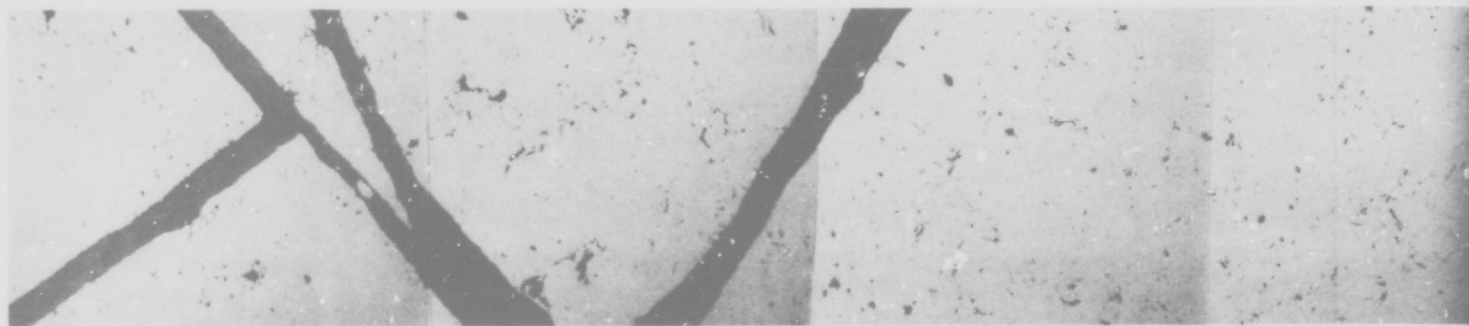
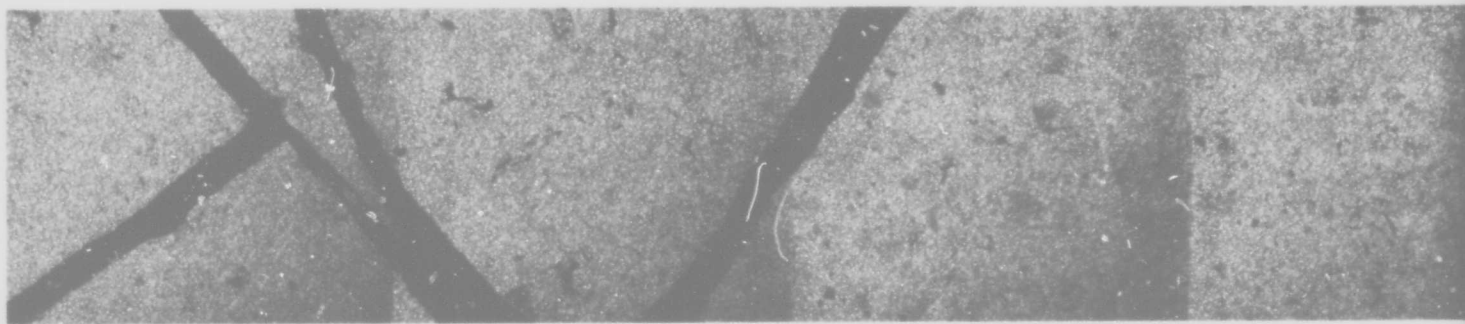
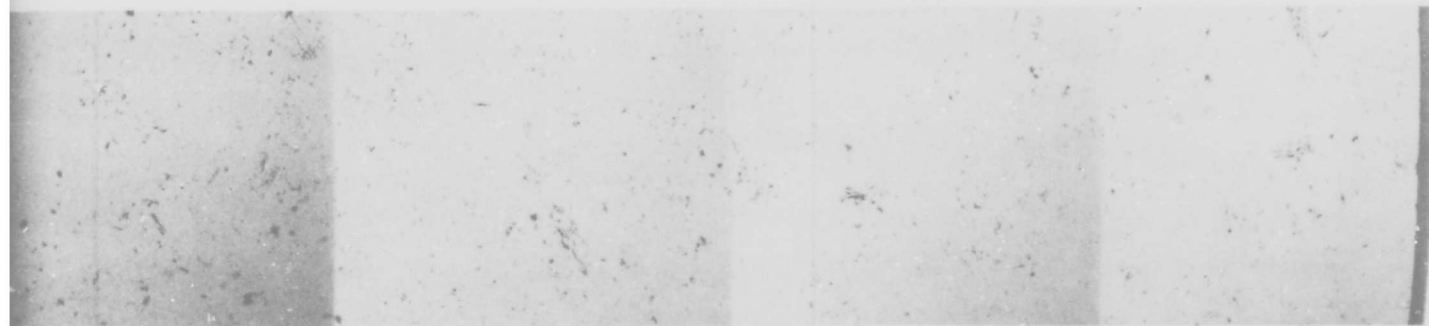
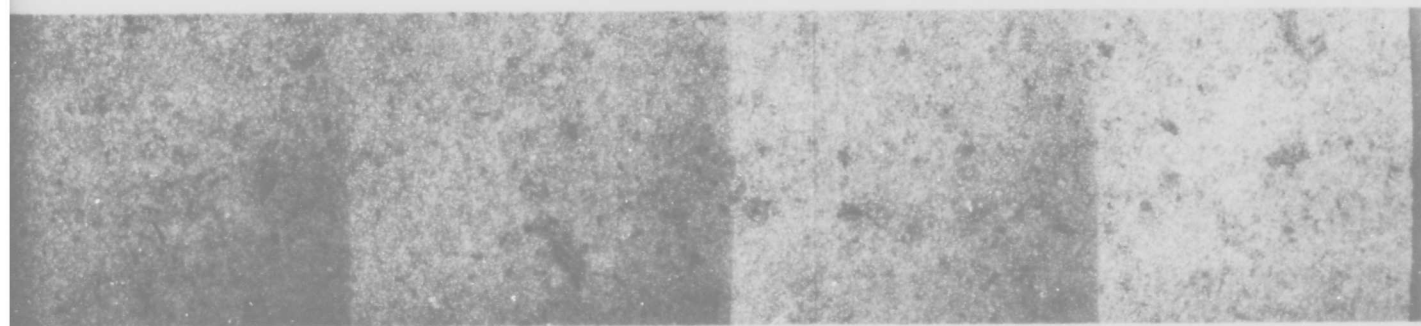
FIGURE 23. LOW MAGNIFICATION IN RADIAL TRAVERSES OF METALLOGRAPHIC SAMPLE FROM ROI
Note that the microstructure is uniform over the radius.

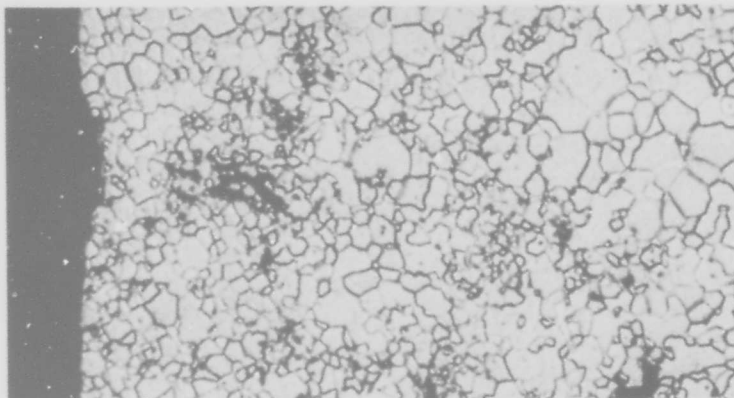
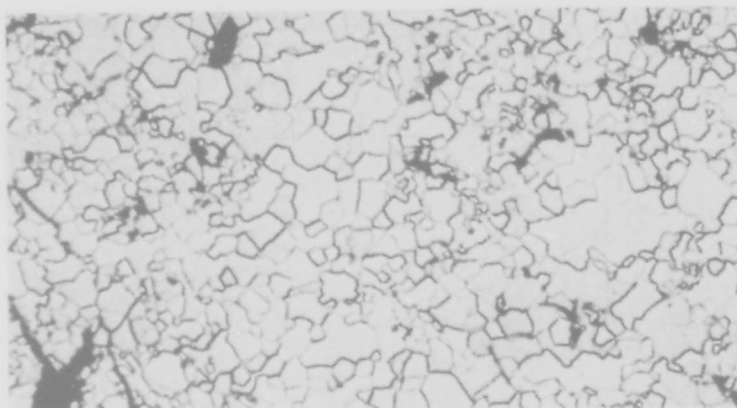
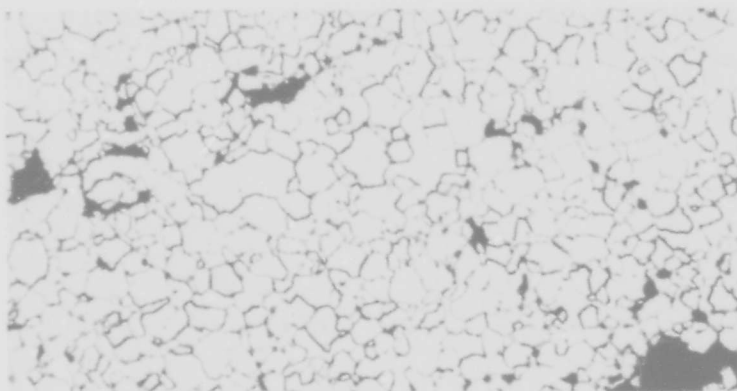
FIGURE 24. ETCHED MICROSTRUCTURE OF ROD F-8 AT 13-25/32 - 14-3/8 IN. Note that grain size is uniform in all radial positions. This is the second highest burnup metallographic specimen examined. Grain structure of lower burnup specimens were similar to this.
