ANALYSIS OF LIQUID ROCKET TANKAGE

Bell Aerospace Company

Air Force Rocket Propulsion Laboratory

April 1975

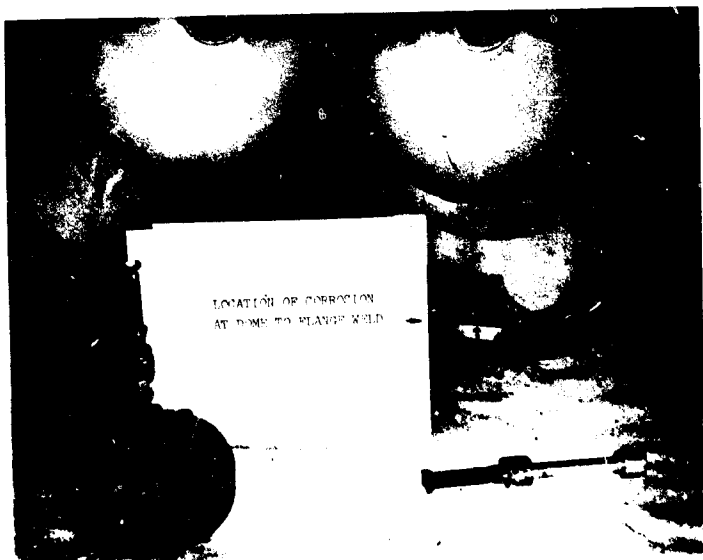
Local area of corrosion at arrow is exhibited in Detail Failure Analysis Section

Figure 44. Surface Appearance of A-286 Stainless Steel Tank (No. 17, Martin S/N 003) Loaded with  $21F_4$  For over One Year

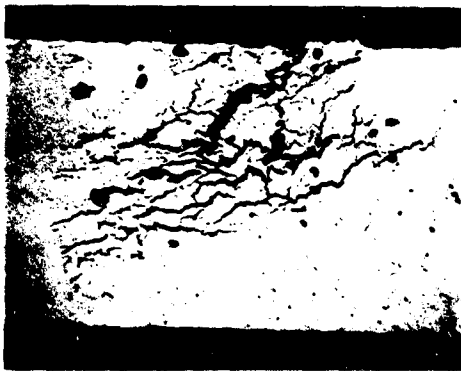
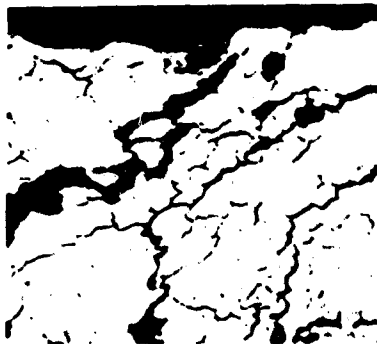
**Figure 46.** Cross Section of Manifold Tubing Weld Leak Shown in Figure 45 Martin 10-gallon Tank S/N 005. Note Inter-dendritic Corrosion Path

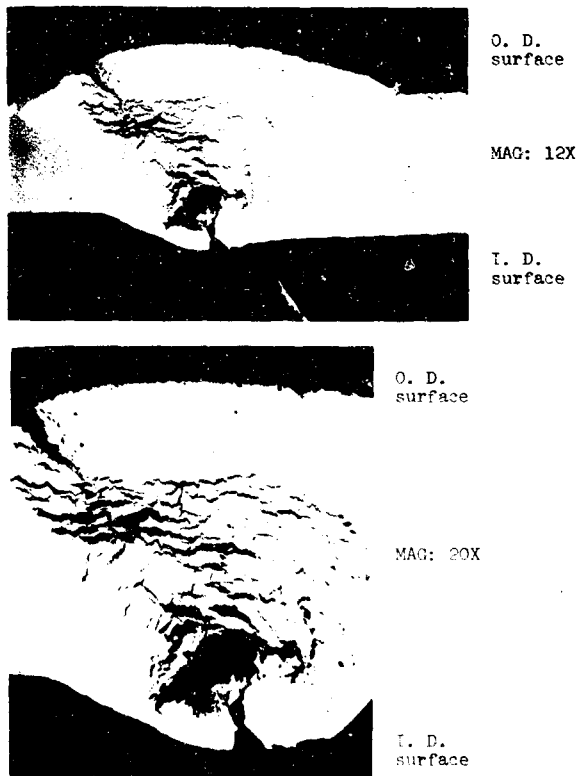
Figure 50. Cross Section of Tube Weld Adjacent to Perforated Area Shown in Figure 49. Probable Initial Vapor Leakage Path is Discernible Between External and Internal Openings

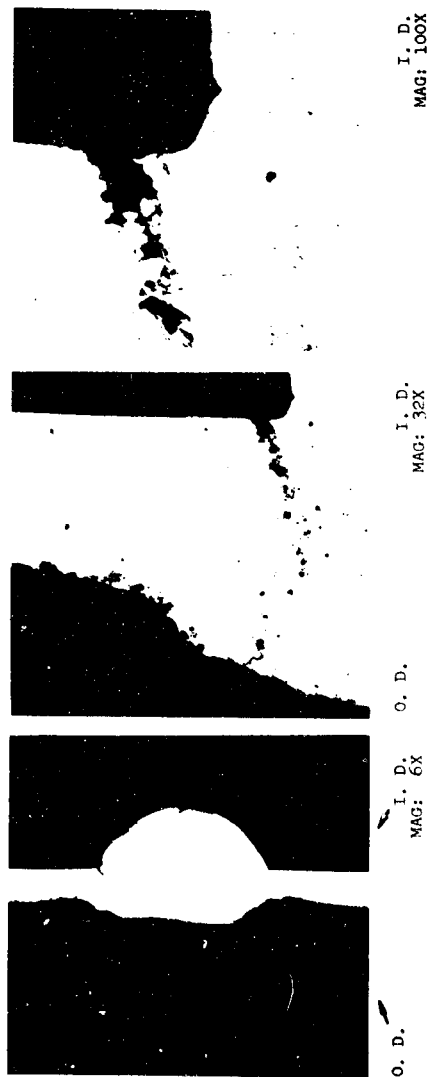
Figure 53. Cross Sections of Corrosion Leak Occurring at Edge-of-Weld in the 6061 Aluminum Inlet Tube of 2024 Aluminum Alloy Tank No. 1 (S/N9) used to Store  $\text{ClF}_3$  Propellant for Eight Months

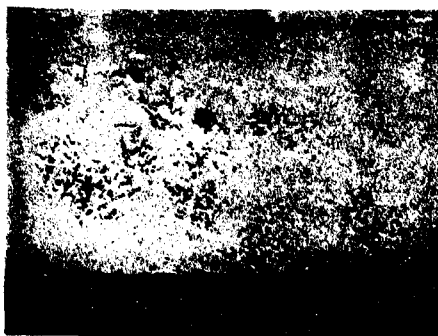
Figure 55. Porosity and Shrinkage Observed in Parent Metal Drop-thru of Tank No. 1 Inlet Tube. Parent Metal Alloy is 4043 Aluminum.

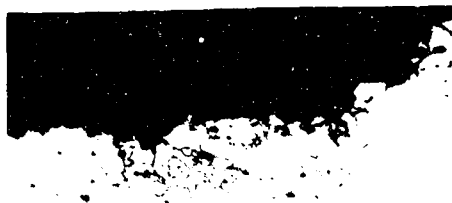
Figure 68. Cross Section of Typical Shallow Pit Seen on Internal Surface of 1-quart Aluminum Alloy Container S/N 19

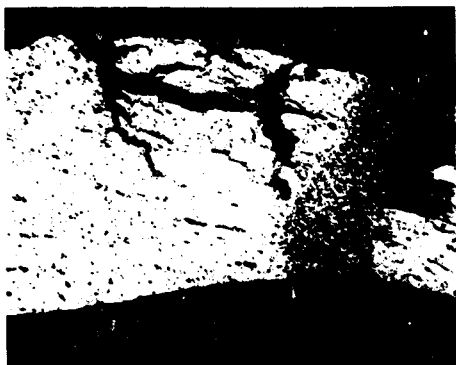
NOTE:  
Origin of  
attack is  
on external  
surface and is  
concentrated in  
weld metal near  
edge of weld.  
Crack at arrow  
is shown in  
Figure 76.

Figure 75. Cross Section of Corroded and Perforated Weld  
Now in Figure 76, at Other Edge of Weld from  
Perforation

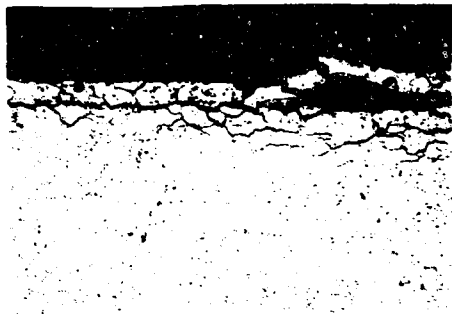
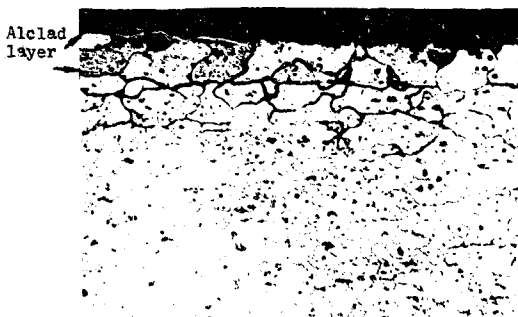
- a. Unetched view showing corrosion attack under Alclad layer causing lifting and loss of cladding in spots

Figure 81. Metallographic Sections Showing the Corrosion on the External Surface of the Solid State Bonded Tank

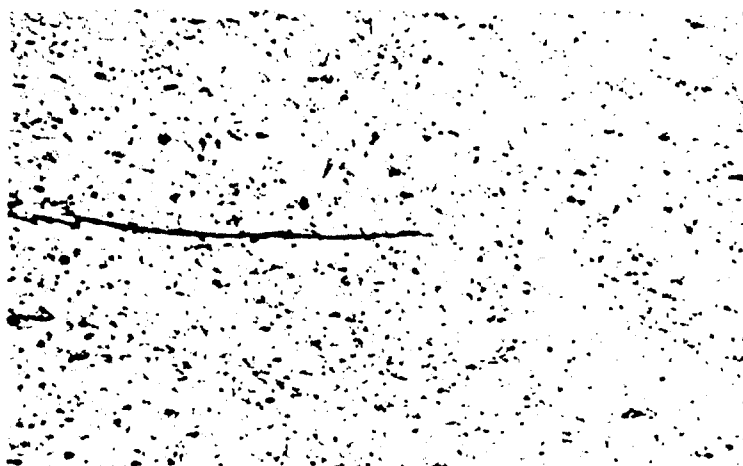
- a. Joint shape in region where corrosion occurred on external surface (arrow)

- b. Unetched view showing transition from unbonded to bonded region
