FAILURE ANALYSIS OF TAINTER GATE CABLE-ADJUSTING  
BOLTS5. TYPE OF REPORT & PERIOD COVERED  
FINAL

James Aleszka

CONSTRUCTION ENGINEERING RESEARCH LABORATORY  
P. O. Box 4005  
Champaign, IL 6182010. PROGRAM ELEMENT, PROJECT, TASK  
AREA & WORK UNIT NUMBERS

April 1975

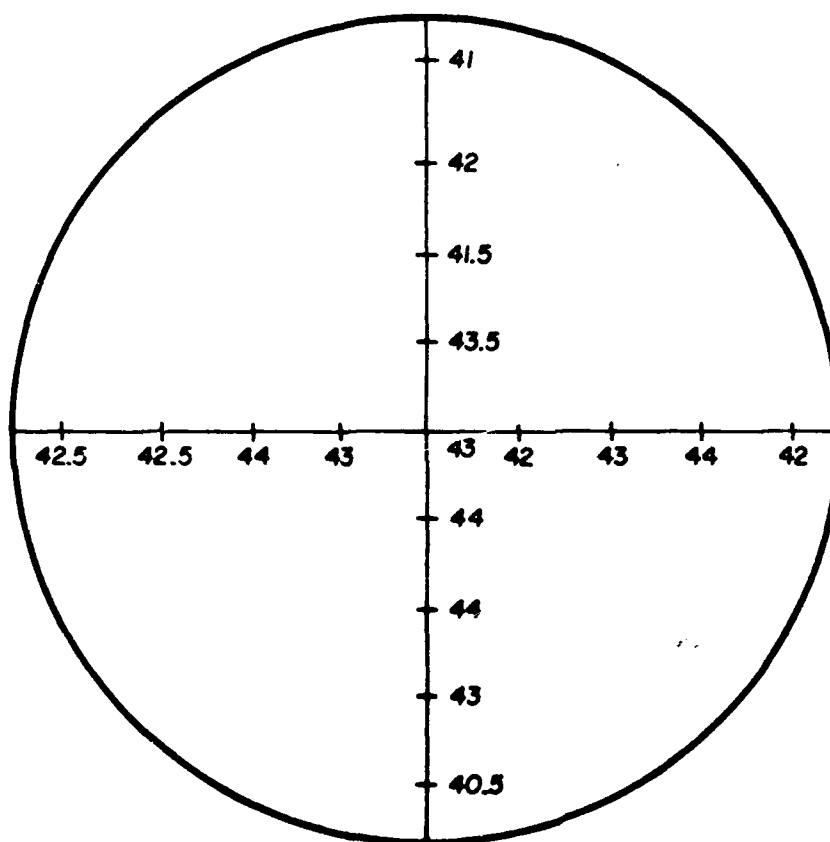
values were taken across cross sections of the broken bolts, and a tensile specimen was machined from one bolt. The results of one of the hardness tests are shown in Figure 12. The average hardness of the bolt was about Rockwell C43. The tensile specimen had a maximum tensile strength of 172 ksi and a 0.2 percent offset yield strength of about 140 ksi.

Rc 40 = BHN : 350

Avg = 43Rc

Figure 12. Results of Rockwell C hardness tests performed on a cross section of a broken bolt.

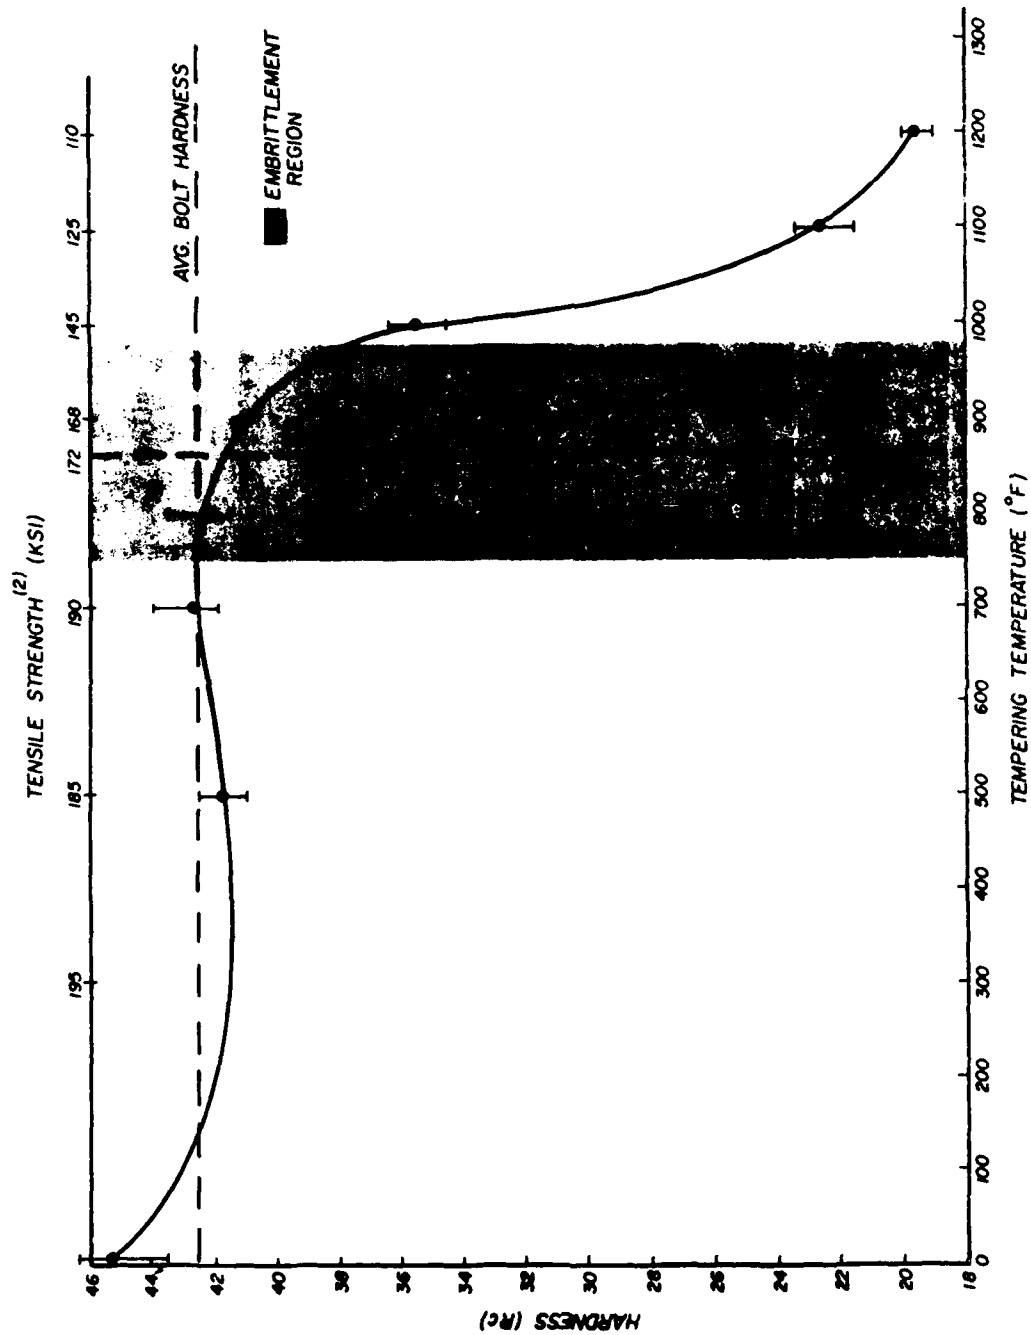
not as a ductility loss.<sup>6,7,8</sup> Using Figure 15 to correlate the hardness of the faulty bolt with its tensile strength, shows that this bolt was probably tempered at about 860°F. This temperature is in the center of the embrittlement range. The initial intergranular path indicates that these bolts were embrittled during heat treatment.

The bolts tested by the Dravo Corporation had an average tensile strength of 140 ksi and an average hardness of Rockwell C30.5. From Figure 15, the corresponding tempering temperature would be about 1015°F. This temperature is very close to the upper embrittlement region, so the corrosion resistance of the bolt is questionable. Similarly, the bolt tested by the Pittsburgh Testing Laboratory had a tensile strength of 191.7 ksi. The corresponding tempering temperature could have been either between 300-400°F or near 700°F, depending upon the hardness, which unfortunately was not given. If the latter estimate is more accurate, then the bolt could have been embrittled.

Figure 15. Hardness vs. tempering temperature for type 416 stainless steel.

The corrosion resistance of the bolts can be restored if the following heat treatment steps are performed:

- a. Preheating to 1200°F-1400°F for 1 hour
- b. Austenitizing at 1700°F-1850°F for 1 hour
- c. Oil quenching
- d. Tempering at 1100°F-1200°F for 1 hour
- e. Oil quenching.

d. It is recommended that the type 416 bolt material meet the following specifications:

Tensile Strength: 110 ksi - 140 ksi

Hardness:  $R_B 95 - R_C 26$

Tempering Temperature: 1100°F to 1200°F
