LOCARCH SHELTER

AFCEC-TR-75-7

Final Report For Period December 1973 to August 1974

| REPORT DOCUMENTATION PAGE | | READ INSTRUCTIONS BEFORE COMPLETING FORM | |
|---|---|--|--|
| 20. ABSTRACT (Continue on reverse side if necessary and identify by block number) The report describes the erection, field testing and disassembly of the LocArch air transportable aircraft shelter, manufactured by the Lockheed Georgia Co. Marietta, GA. The outcome of the shelter evaluation revealed the design concept to be basically sound but deficiencies existed in the arch panels and the end closures. An in depth analysis of the shelter components was conducted during the test program. The entire shelter system was subjected to simulated environmental tests to evaluate its performance for possible world wide use. | | | |

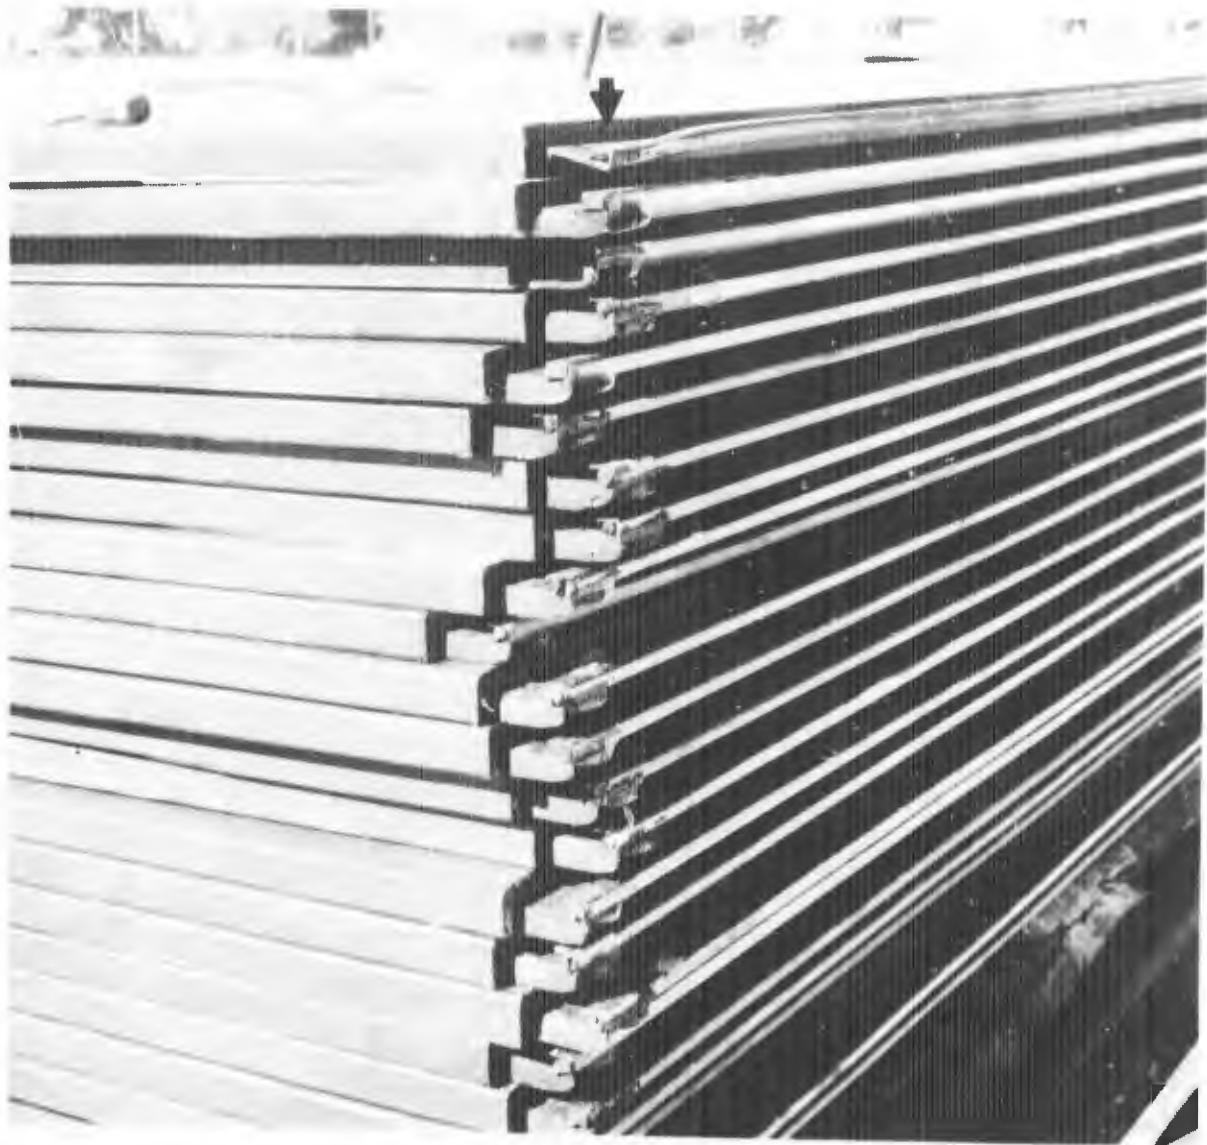
Figure 13 Arch Panels as Received From the Contractor

Figure 13 shows the arch panels as they were received from the contractor. Some minor damage was experienced during shipment as indicated on the top panel of the pallet. This was easily corrected by means of a screwdriver that was inserted in the aluminum extrusion and the aluminum extrusion bent back to shape.

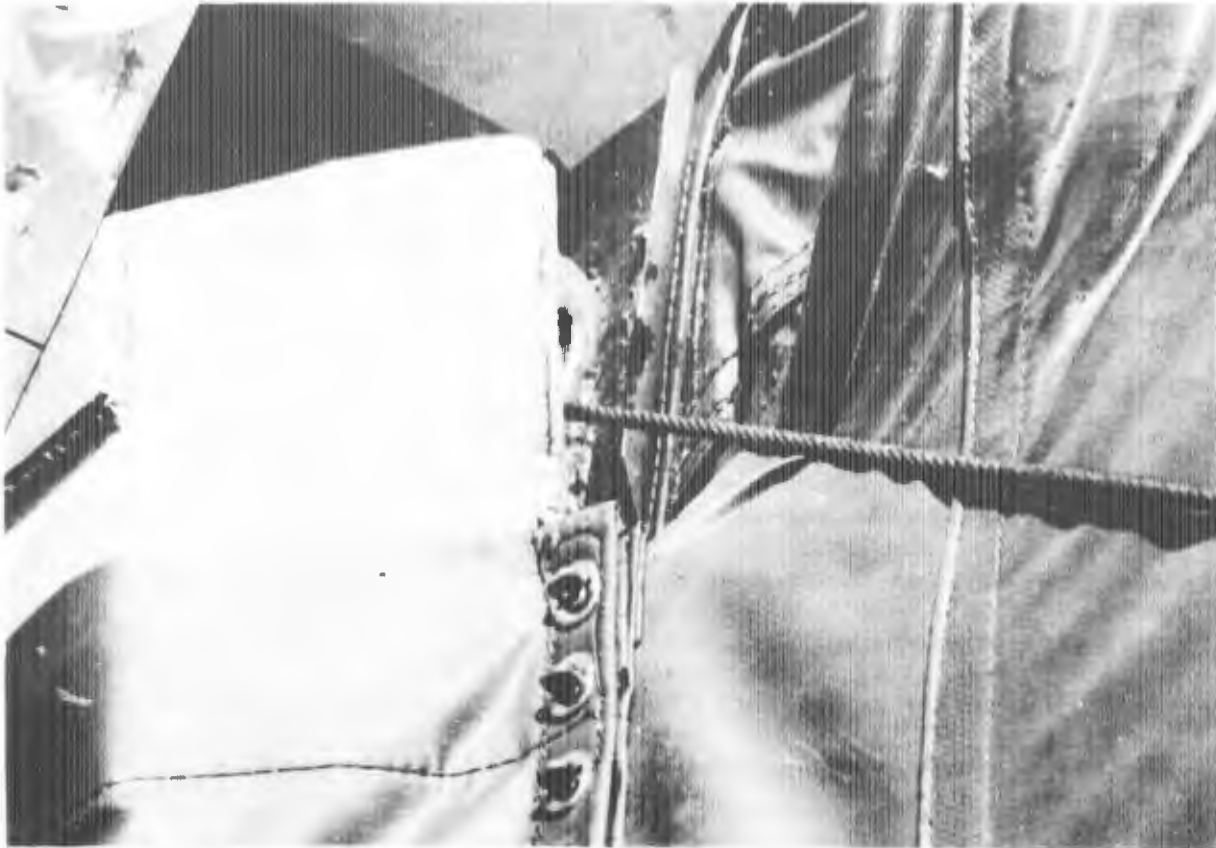
Figure 47 shows where the cable passes through the uppermost part of the nonpivoting vertical support posts and then down to the winch. Considerable wear was experienced at this point both on the aluminum and the fabric material.

(Figure 47 Cable Wear Experienced at Vertical Support Post entry into the shelter. As previously described for the purposes of this test program, only one container was provided in the contract to provide testing of the proposed system. The side closures for the end wall consisted basically of a fabric material between the arch beam and the vertical support beam that was hooked to the container. The attachment method was by use of a rail similar to that used on the panel to panel connection. This was bolted onto the exterior of the container and the arch beam and then a similar rail was attached to the edge of the fabric and locked the fabric transition from the shelter

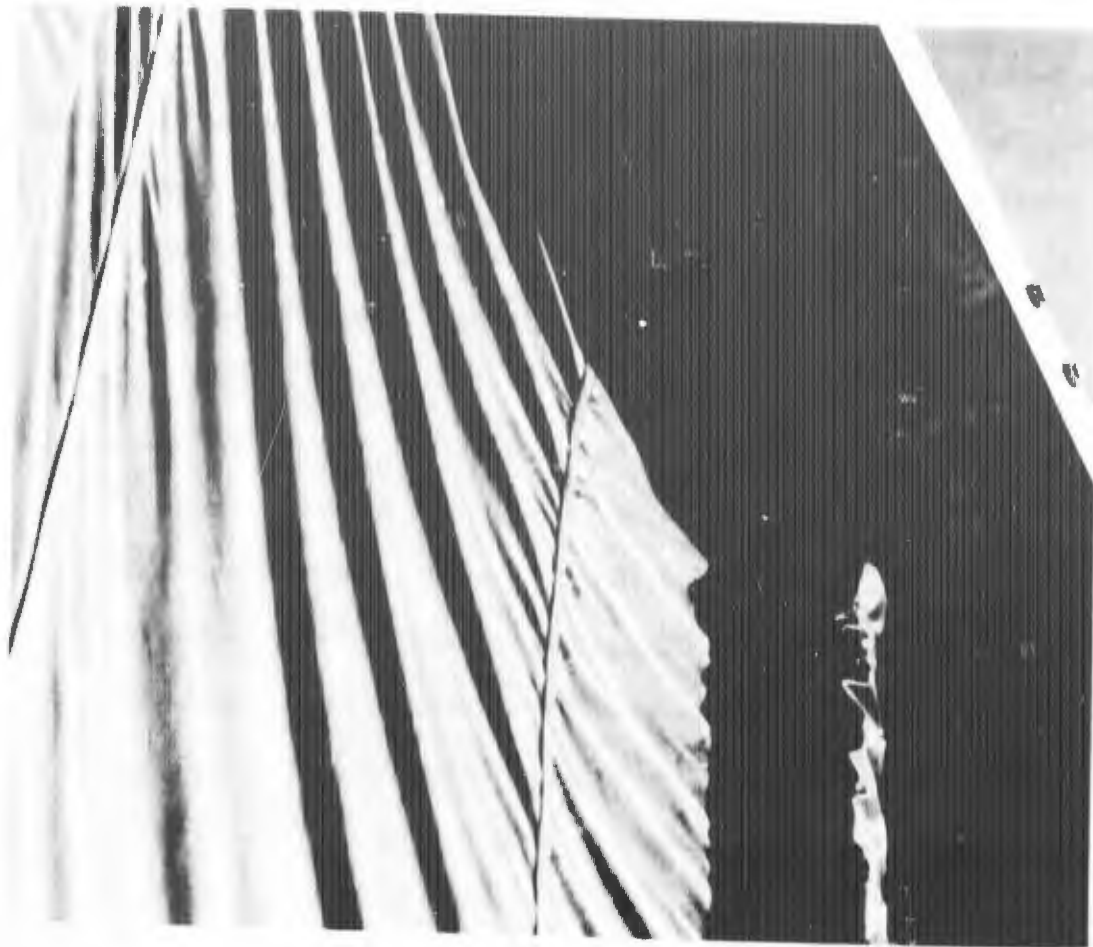
During the entire test program, the fabric door was left in the closed position, the truck entry position and full open position for extended periods of time to observe the environmental effects on the door. Figure 48 shows where one of the vertical support posts came loose from the arch beam. This particular post is the only one that did separate from the arch beam. The cause was constant vibration

Figure 48 Vertical Support Beam Separated From Arch Beam on the door from blowing wind. The vertical support post is held on the beam with a nut that is screwed onto the erection pin. This problem could easily be overcome with the insertion of a cotter-pin behind the nut to hold it securely in place.

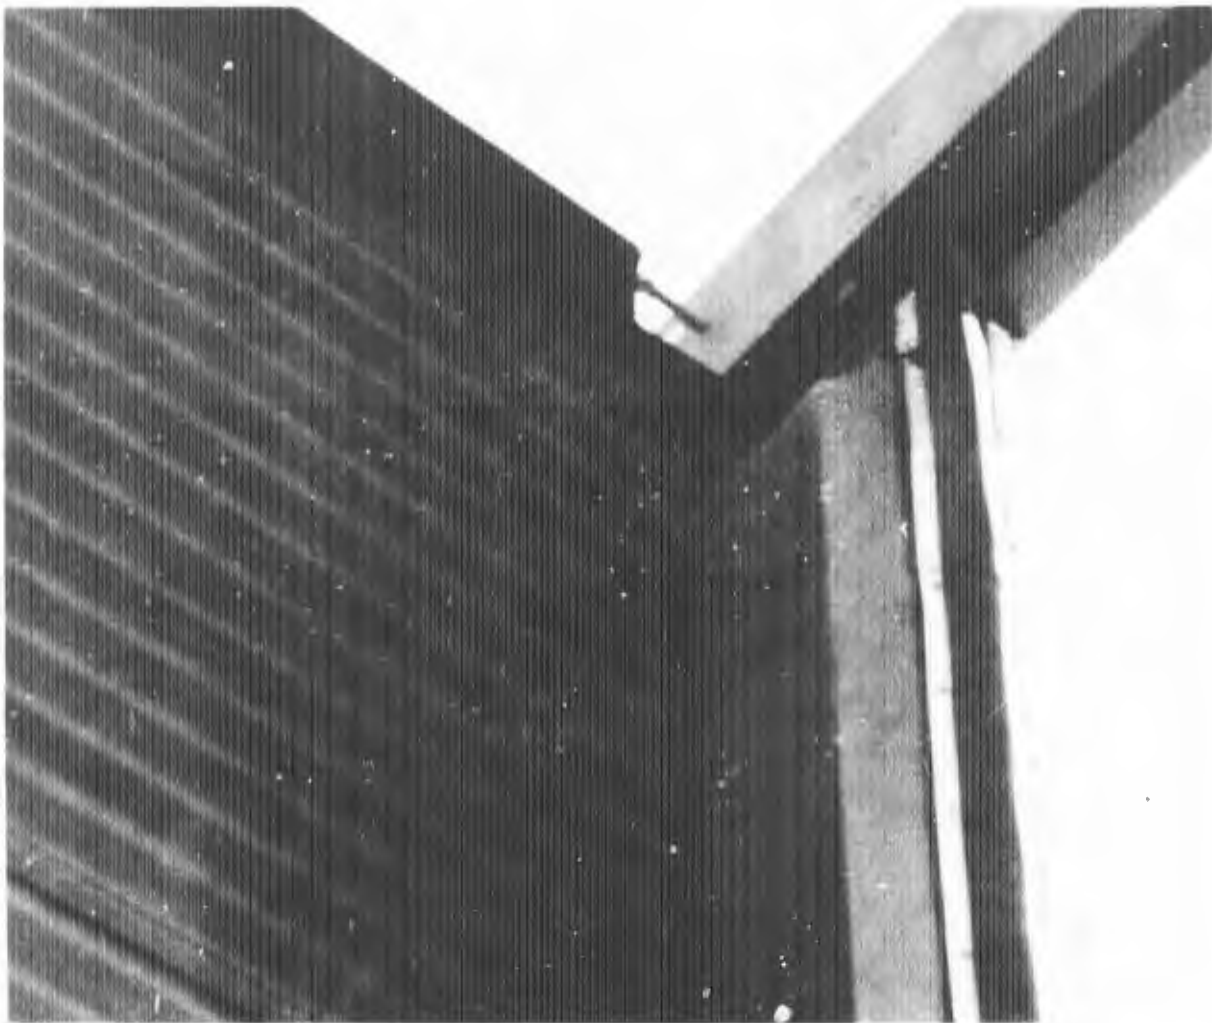
Figure 53 Vertical Beam Binding in Upper Trolley Rail,
Metal Door

due to the ground elevation. This caused the upper trolley rail to be unlevel. As the personnel tried to open the door, it bound in the upper trolley rail. The keeper release ropes were used to pull the upper portion of the door laterally as it rides in the rail and physical force is used at the bottom. Figure 53 shows the vertical beam inside the trolley rail. When the beams started to twist,

it bound inside the rail and had to be released by either pulling the door back toward the closed position or using a piece of equipment to get up high enough to force its release. Figures 54 and 55 show both sides of the metal door in full open position. When both sections are

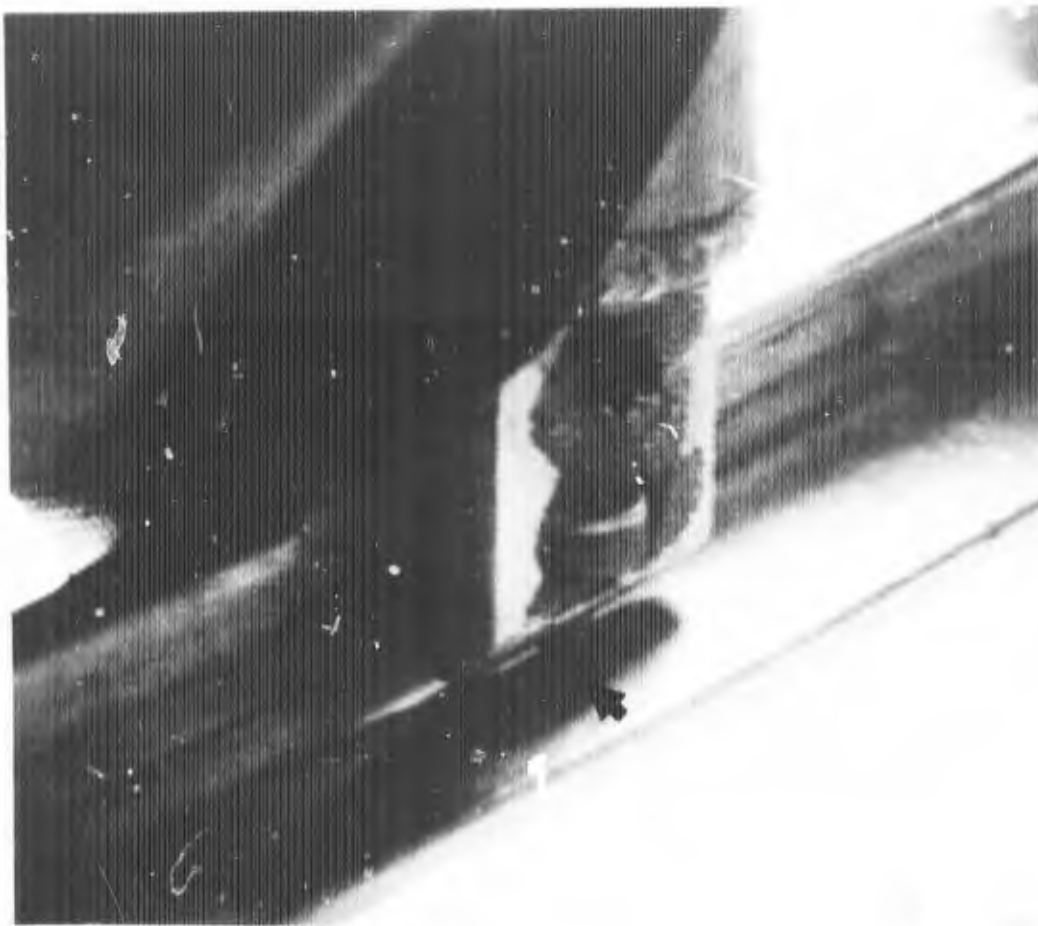
Figure 57 Screw Coming Out of Roller on Lower Guide Rail, Metal Door

was the roller in telescoping pipe that fit over the bottom guide rail came out several times because the screw that held the roller kept loosening. This problem was easily solved by putting an aluminum tack weld on the screw to hold the roller in place (Figure 57). Table IV shows the times required to open and close the door during the cycle period. It was opened and closed several times in addition to these but the door kept binding, particularly on the left side in the upper

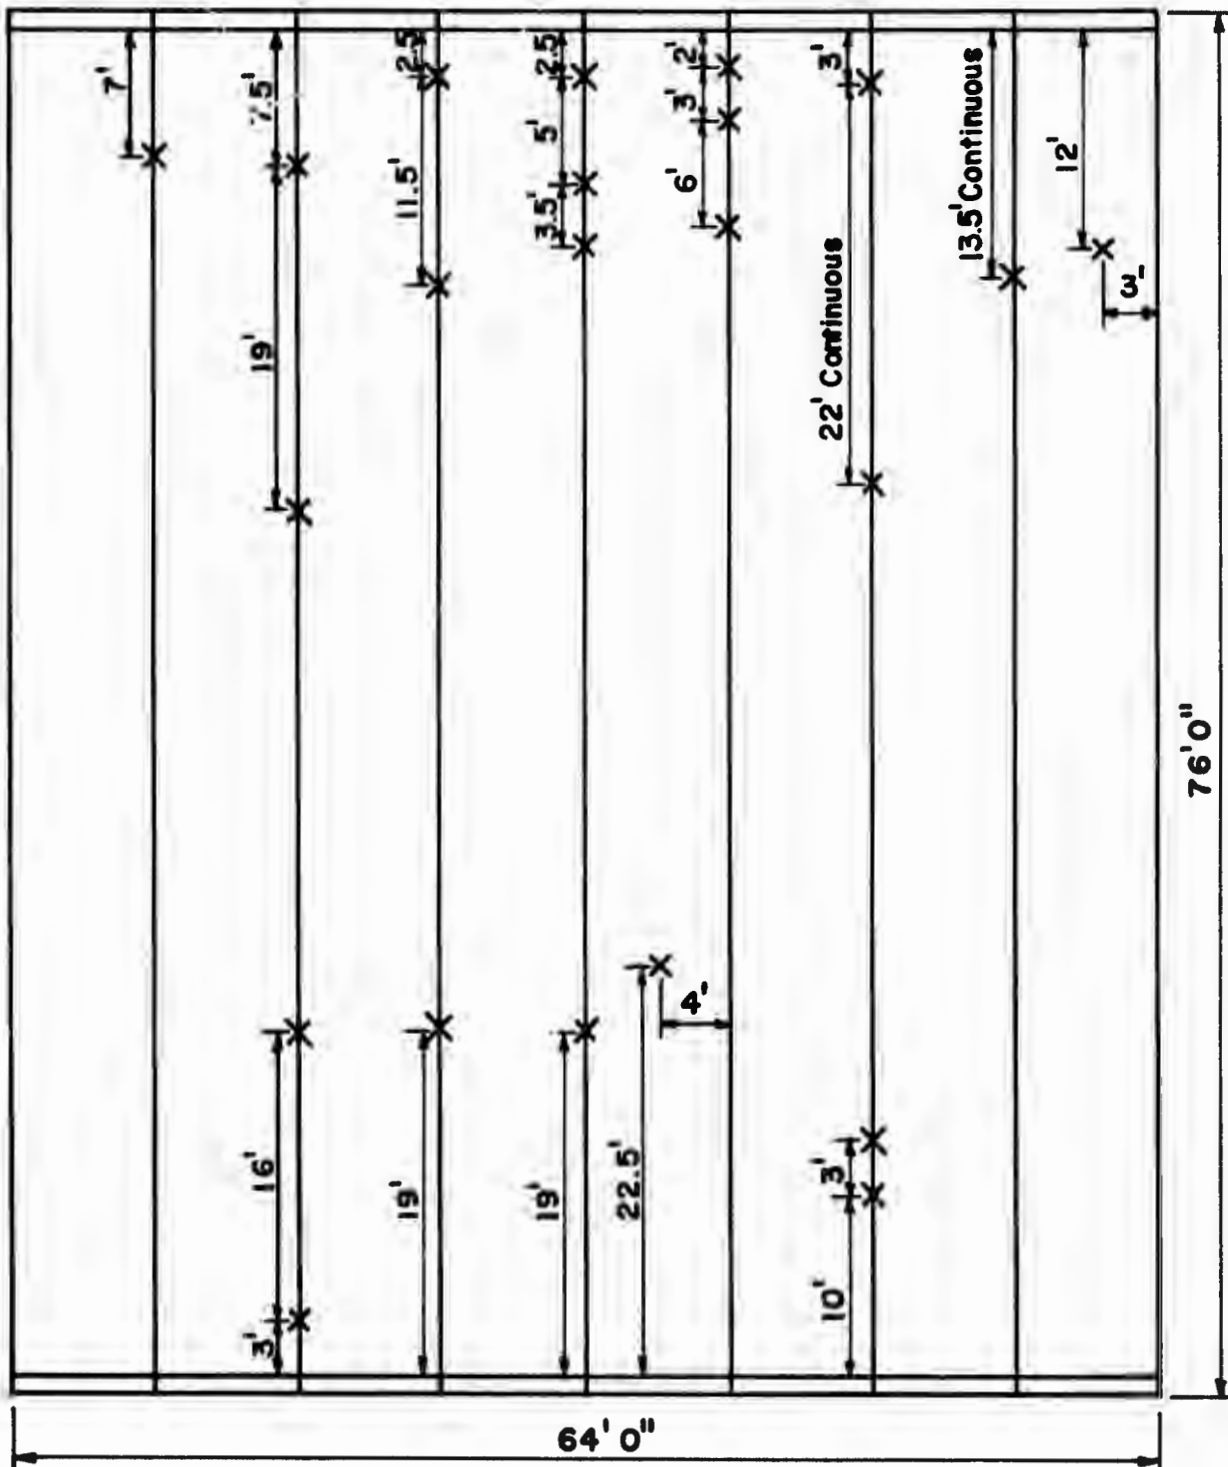
Figure 58 Water Leakage Points After Rainfall

4. Water and Wind Test. Approximately two weeks after the building was first erected and before any water tests were carried out, the building experienced a heavy rainfall. Many leaks were noted throughout the structure, particularly near the perimeters of the building. It was discovered that some slack had come into the panels; therefore, all the archs were retensioned. After they were tightened, some of the leaking did stop but not completely (Figure 58). Only one leak was noted in the panel to panel connection. Water testing on the shelter after the first erection was primarily carried out with the use of a fire hose. Personnel conducted the test on different areas around the building and by applying water to the various components to ascertain if any specific areas were vulnerable to the leakage. Water testing with the fire hose then proceeded to observe if the structure inherently leaked or erection deficiencies resulted in the leaking. Spraying water on the top of the building and letting it free fall on the top created a buildup of water running off and down the sides. As this water ran down over the panels, a great deal of water also entered the arch beam, which was, of course, the drain. As the water accumulated in the arch beams, water was noticed splashing out of the arch beams at the beam connections and also carrying over the arch beam and down the side of the beam. This problem was

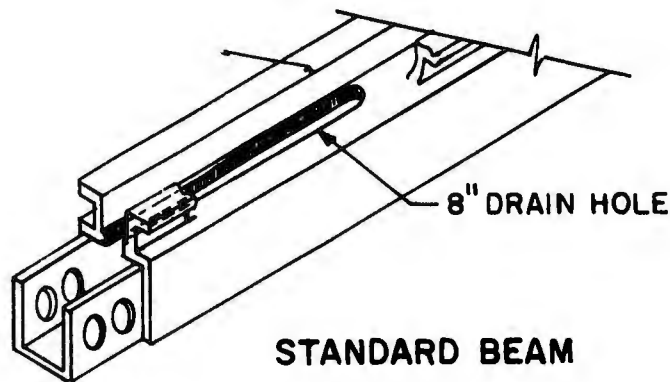
Figure 59 End of a Typical Arch Beam With Cutout For Water to Enter Beams

multiplied the further down the arch the water was allowed to travel. Figure 59 is a detail of the arch beam and the cutout that allowed the water to fall into the arch beam and subsequently be carried down the arch to the drain. The Lockheed Company was notified of this problem. Lockheed accomplished a field fix on two of the arch

beams at the two lower areas by cutting out an additional piece of aluminum to enlarge the hole and thereby allow more water to fall into the arch beam. This modification was made only on four beam sections and would be required throughout the whole building in order for all arch beam segments to be interchangeable. This modification did resolve some of the problem, but it was evident that water was still coming in the building at the track on the arch beam where the panel insert did not completely enclose it. Another problem that was noted was that it made a difference on which side of the shelter the water was allowed to run down at the panel to panel connection. The locking joint on the panel, if it were overlapping down, carried

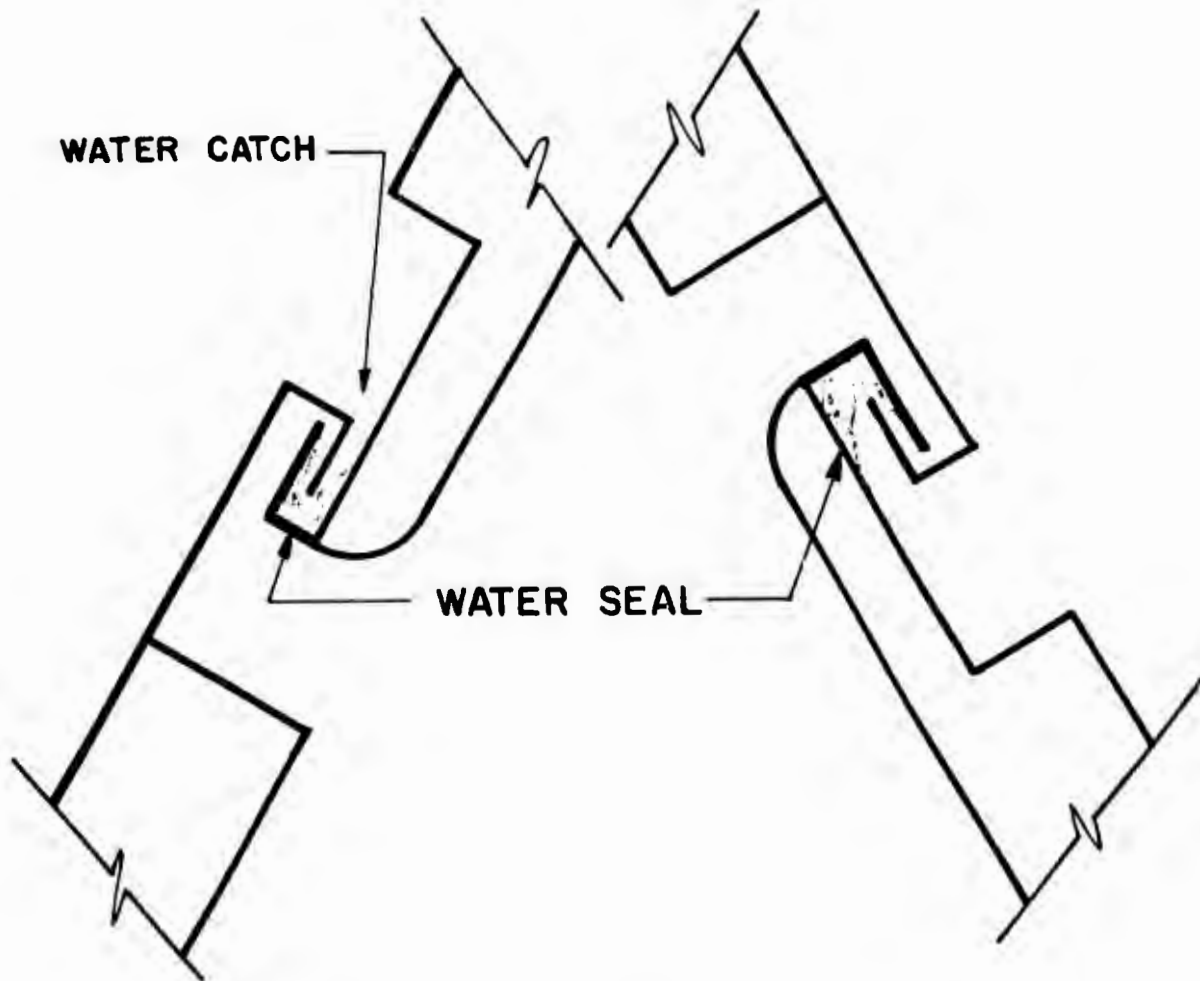
Figure 60 Detail of Panel to Panel Joints on Each Side of the Shelter

Expansion and contraction of the metal also played a part in the frequency of leaks in the panel to panel and panel to beam connections. During the morning, there were noticeably less areas that allowed water to pass through than in the heat of the afternoon. Further

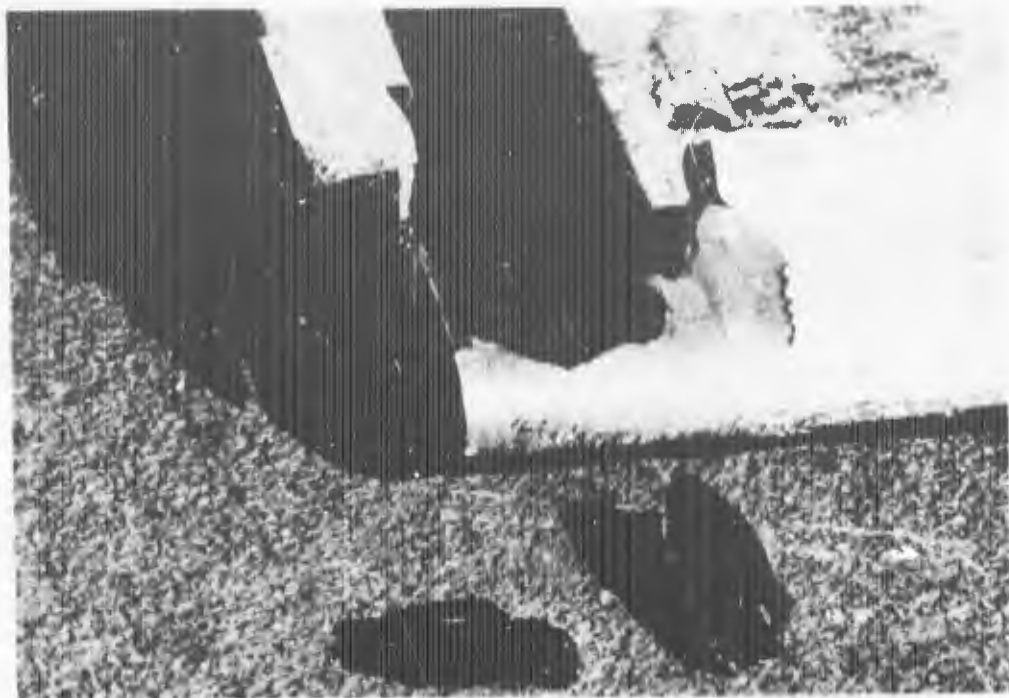
Figure 67 Damaged Panel Insert When Dropped From Six Foot Height

six-foot height. These particular panels had been used in the shelter. One can observe the sand and grit that accumulated in the insert and the buildup that subsequently developed. The condition of the inserts after being dropped from the six-foot height did not make them unusable; in fact, they were put back into the shelter without any noticeable difference, Figure 69 is a photograph of a puncture in the skin of the panel and the honeycomb core exposed. This puncture came as a result of one of the drop tests from the three-foot height. The panel was held

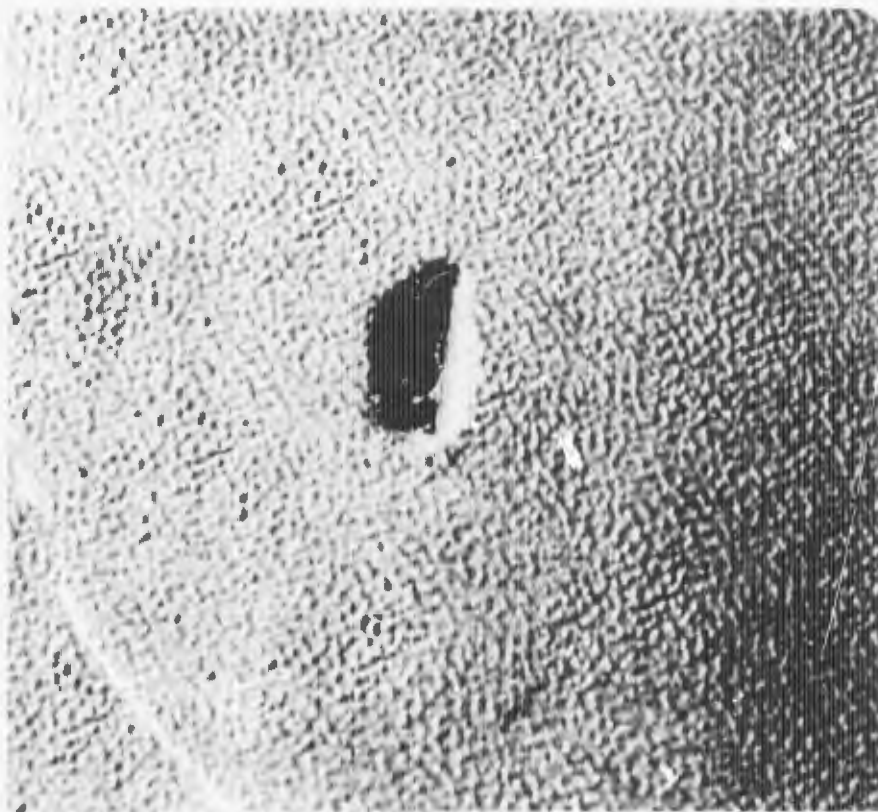
Figure 69 Puncture (approx $\frac{1}{2}$ in) in Panel Skin With Honeycomb Core Exposed

in the vertical position for the drop and when it impacted the ground on the edge it fell over on a small rock. The weight of the panel falling on the rock on the concrete surface penetrated the .017 inch thick aluminum skin without any difficulty. This was noticeable throughout the test phase of dropping panels on the concrete. A surface puncture such as this would allow the water to migrate inside the panel and render it useless in a short time. If the panels were handled carefully through the erection process, no damage resulted. Under field conditions, one can assume somewhat rougher handling than the panels experienced during the test. The thin aluminum skin, the edge members and panel inserts would most likely undergo a great deal of damage during the life of a shelter.

(b) Panel Repair Kit. Several repairs were effected on different panels, some while the panel was installed in the arch and others undertaken on a flat horizontal surface. Repairs were accomplished first by cleaning the puncture on the face sheet of the damaged panel. Then the epoxy filler was poured into the void and some epoxy binder painted onto the surrounding area. A rectangular patch was installed over the damaged area and kept under pressure until it was securely bonded to the panel. The repair technique worked well while the repair was accomplished on the ground, but it was difficult to apply the epoxy to a damaged area while the panel was installed in an arch except on the top of the shelter. The viscosity of the epoxy was such that it would run somewhat, causing voids under the face sheet after it was put in place. Tests were also conducted on panel repairs by using the epoxy filler without the aluminum face sheet. This method worked equally well as with the face sheet and took less time, Numerous

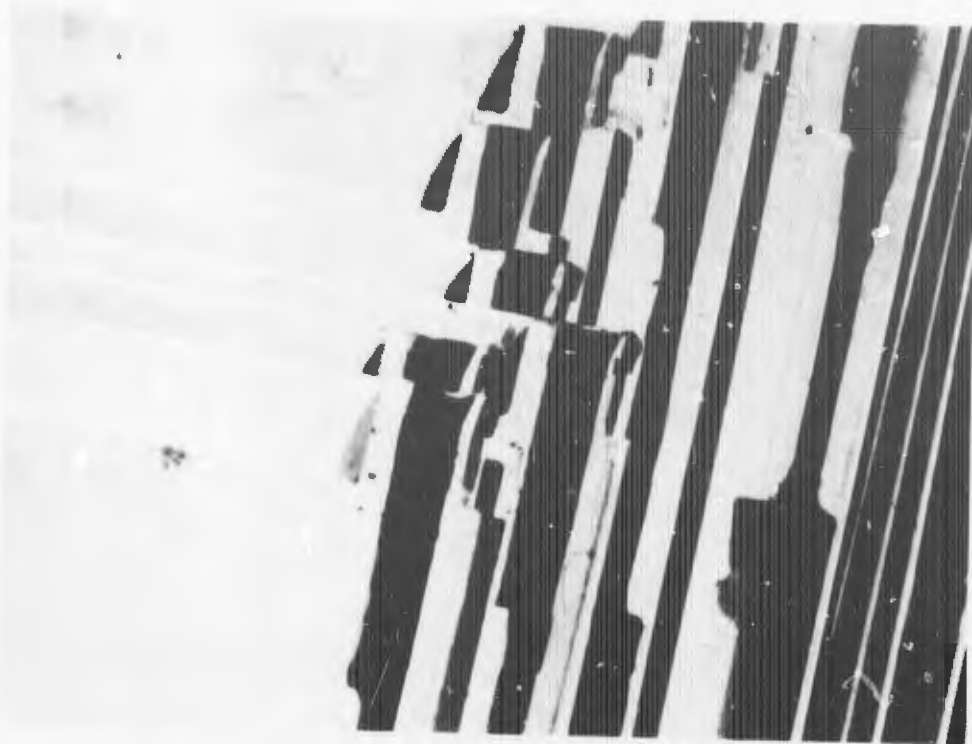
Figure 72 Panel Inserts After Removal From Arch Beam

hold the foot securely on the base channel (Figure 71). After all the panels were removed, it was observed that there was no appreciable damage but there was a build up of sand in the panel inserts that rode over the arch beam tracks. The sand was mixed with the silicone lubricant and had become almost a greasy paste-like substance. These deposits apparently built up over a 3 month period, since the time that the building was first erected (Figure 72).

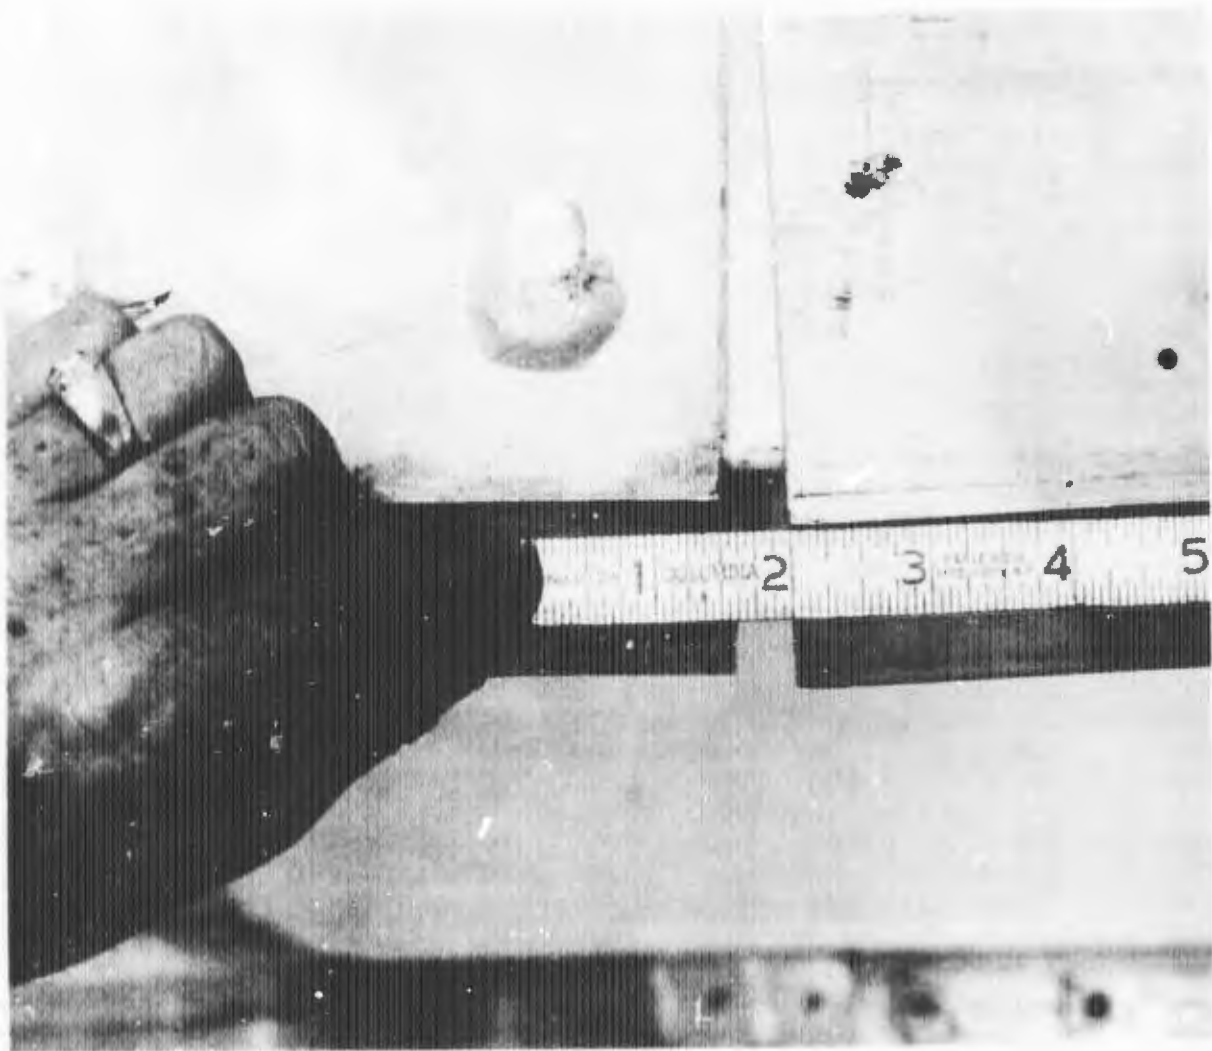
Figure 77 Joint at Center Arch Beam

shelter with the sandbags in place. It was somewhat surprising to see the shelter absorb as much deflection without any apparent failure. Figure 77 shows the center segment of the 5th arch beam, the area under the heaviest load. The weight of the sandbags had caused the beam to deflect to such a degree that $\frac{1}{2}$ inch space occurred where the bayonet slotted into the preceding beam. Before the loading of the sandbags, the joint had no separation in the area. It was also observed that the erection pins at this particular joint became oval, rather than their original round shape. Figure 78 is

After all the deflection measurements were recorded, the sandbags were unloaded from the shelter and measurements were again taken to observe if any permanent deformation had occurred. The center segment of the fifth arch beam showed a deflection of $4\frac{1}{2}$ " from the original position. The outer edge, 8 ft from the center line had retained a deflection of 1". The center of the 4th and 6th arch beam showed a deflection of approximately 2 inches. No apparent structural damage occurred, but the panels between the 4th and 5th beams and the 5th and 6th beams were observed to have somewhat of a bow after the sandbags were unloaded. One of the L-shaped locking bolts for the panel tensioning bars broke in the base channel as a result of the load test. The loaded panels retained a deflection after the disassembly of the shelter. The panels were turned on the reverse side of the deflection and supported at each end with 4 x 4's. Sandbags were placed on the panel to load it in the opposite direction and within one day the panels had regained their original shape.
