**DYNAMIC TESTING OF A COMPOSITE MATERIAL  
HELICOPTER TRANSMISSION HOUSING**

**Bell Helicopter Company**

**Army Air Mobility Research and Development  
Laboratory**

USAAMRDL-TR -75-47

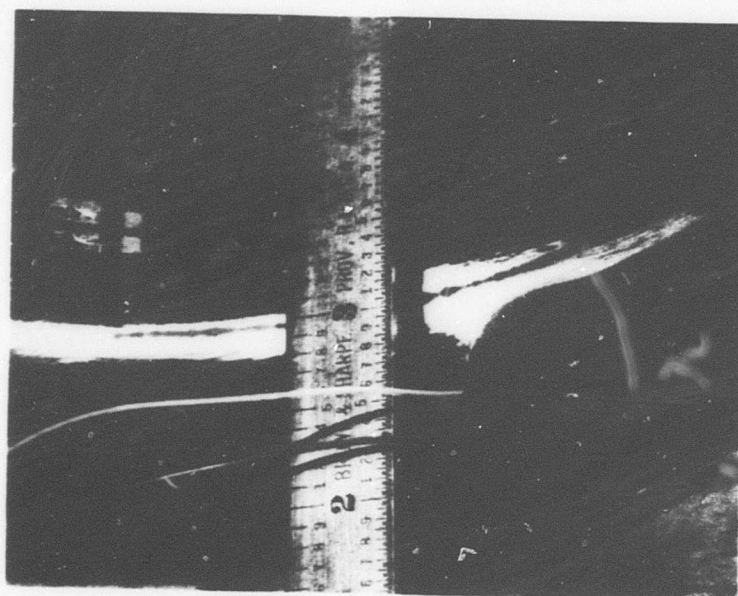
After completion of the gage evaluation test, all of the bores in the S/N 1 and S/N 2 housings were dye-penetrant inspected. As shown in Figures 8 through 11, all of the bores in the S/N 1 housing had hairline cracks except the one for the input pinion roller bearing. All of the bores in the S/N 2 housing, including the input pinion roller bearing bore, were similarly

Figure 9. Close-up of Crack in the Input  
Quill Bore of S/N 1 Housing.

cracked. The cracks in the input and accessory quill bores were located approximately in the same plane as the intersection of the housing cylindrical wall and the quill bores. It is possible that a thermal expansion differential between the housing wall and the quill bores could have caused the graphite liners to crack. As shown in Figures 12 and 13, the graphite liner in the bore for the input gear roller bearing was severely cracked. These cracks could possibly have been caused by a thermal expansion differential between the graphite liner and the surrounding nine webs.

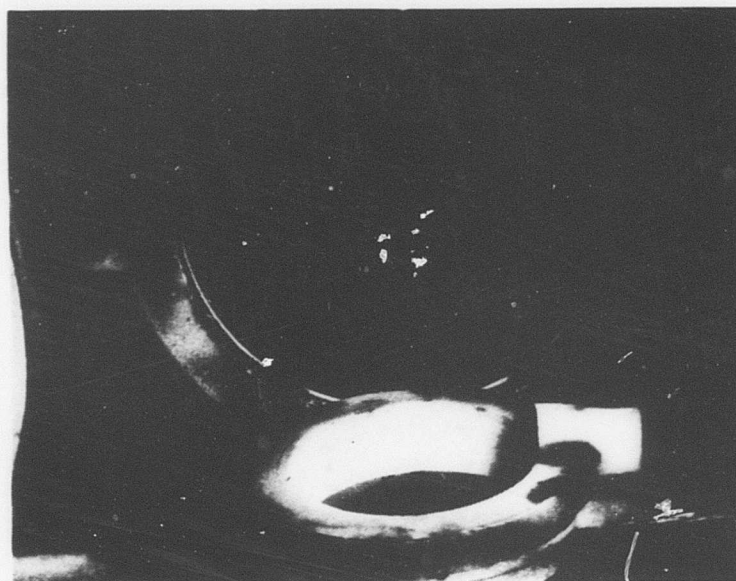
Figure 11. No Cracks in the Input Pinion Roller Bearing Bore of S/N 1 Housing.

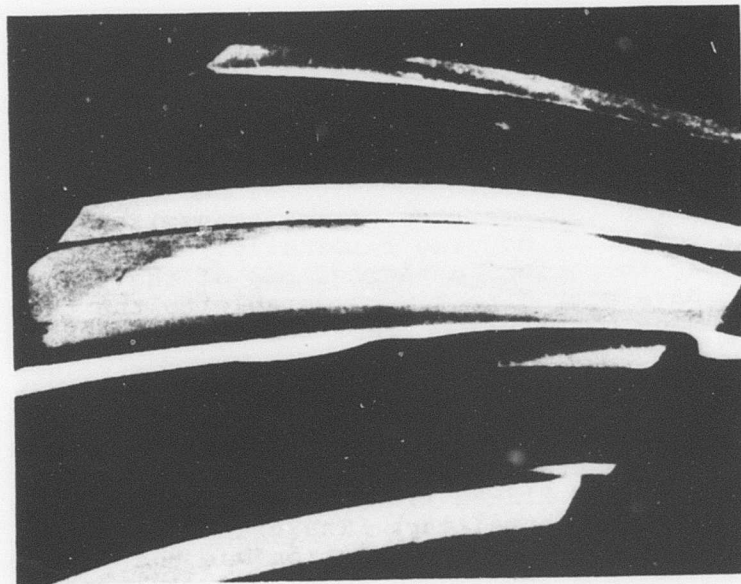
Figure 35. Acceptance Test Wear Pattern for Drive Side of Pinion (1144 Input HP).

stiffer than the magnesium housing since the pattern did not move as close to the heel as usual. The pattern's being slightly low on the tooth could be corrected by changing shim thickness. Since the composite housing was shown to be only slightly stiffer than the magnesium housing, redevelopment of the input spiral bevel pinion and gear was not necessary.

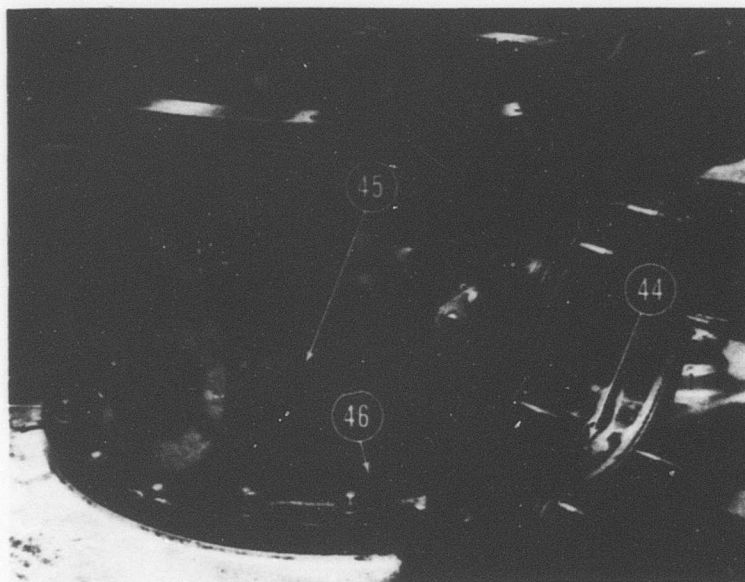
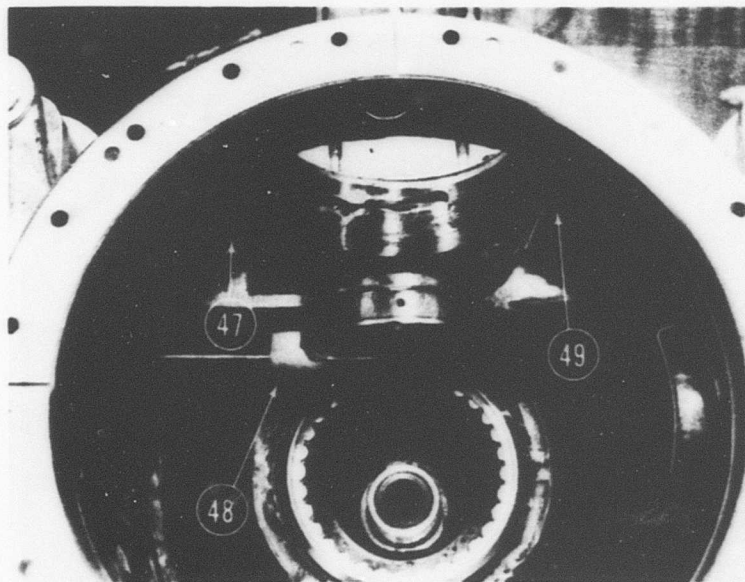
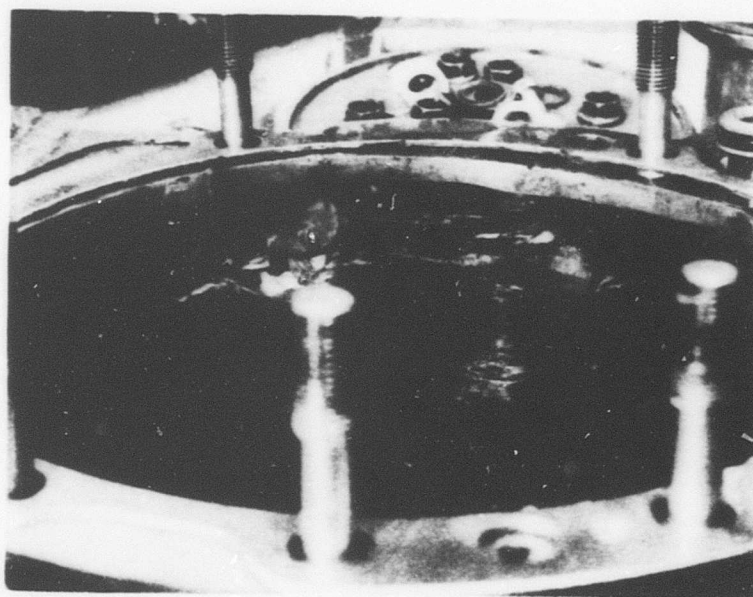
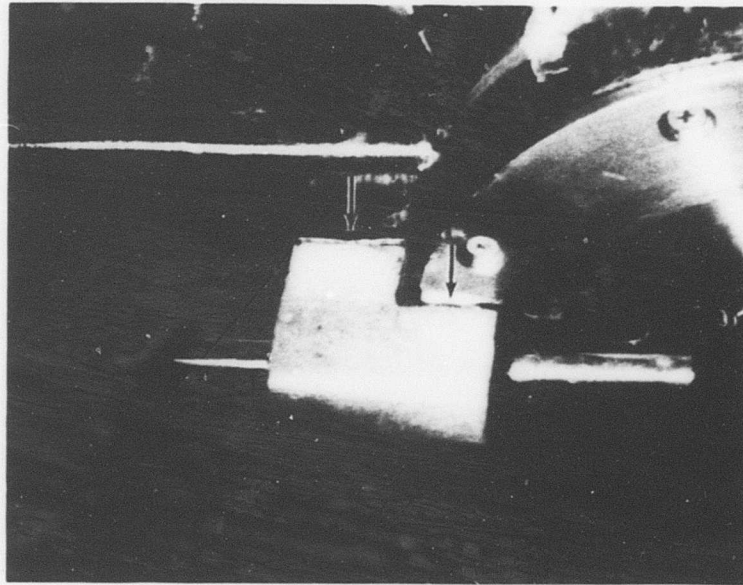
After completion of a 10-minute warm-up the following morning, the load was gradually being increased to the torque specified for Step 14. At a load of approximately 1002 mast horsepower and 75 tail rotor horsepower, the input quill area of the composite housing structurally failed. The axial load acting on the input quill at failure was approximately 3600 pounds. As shown in Figures 38 through 41, the input quill was pushed approximately .8 inch out of the housing, allowing the input pinion and gear teeth to disengage. As shown in Figures 42 through 49, the composite housing was damaged beyond repair. Figures 42 and 43 provide orientation for Figures 44 through 49.

Figure 38. Left-Side View of Transmission  
After Failure of Composite Housing.

Figure 39. Right-Side View of Transmission After Failure of Composite Housing.

Figure 40. Left-Side View of Composite Housing After Failure.

Figure 41. Right-Side View of Composite Housing After Failure.

Figure 42. Exterior of Composite Housing After Failure.

Figure 43. Interior of Composite Housing After Failure.

Figure 44. Input Bore of Composite Housing After Failure.

Figure 45. Tear Located on Left Side of Input Bore of Composite Housing After Failure.

Figure 46. Crack Near Bottom Flange of Composite Housing After Failure.

Figure 47. Crack in the Input Pinion Roller Bearing Web-Housing Bond After Failure, Right Side.

Figure 48. Interior Boss That Houses Oil Jet for Input Pinion Roller Bearing After Failure.

Figure 49. Crack in the Input Pinion Roller Bearing Web-Housing Bond After Failure, Left Side.
