TYNDALL AFB BOMB DAMAGE REPAIR FIELD TEST, DOCUMENTATION AND ANALYSIS

Lawrence D. Hokanson, Capt, USAF
Air Force Weapons Laboratory

October 1975

Final Report

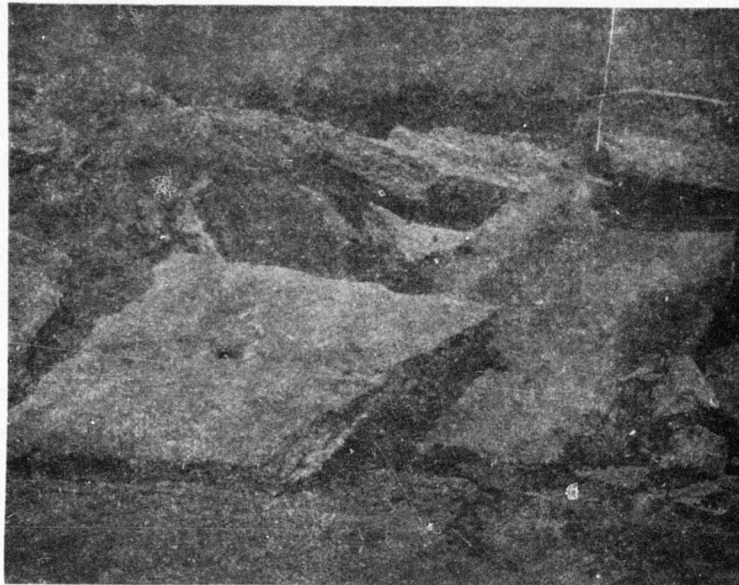
In Test 1-1 a large amount of time was expended in removing broken concrete slabs from the crater area (figure 9) even though a shortage of backfill material existed. This material would have made excellent backfill; however, AFM 93-2 provides no guidance for determining suitability. The solution to this lies both in training of potential BDR OICs and NCOICs and in providing more guidance in AFM 93.2.

Figure 9. Test 1-1, Broken Slabs Removed from AM-2 Air Field Patch Assembly Area

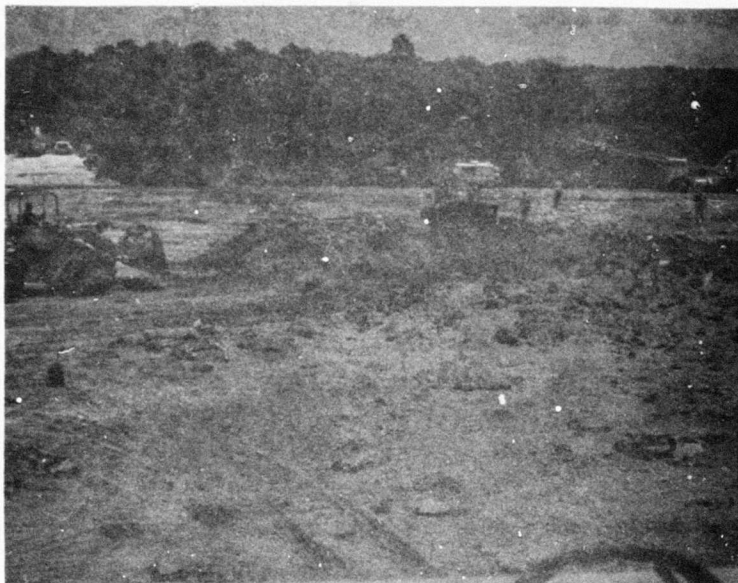
Figure 11. Test 1-1, AC 645 Loader Attempting to Push Debris Directly into Crater

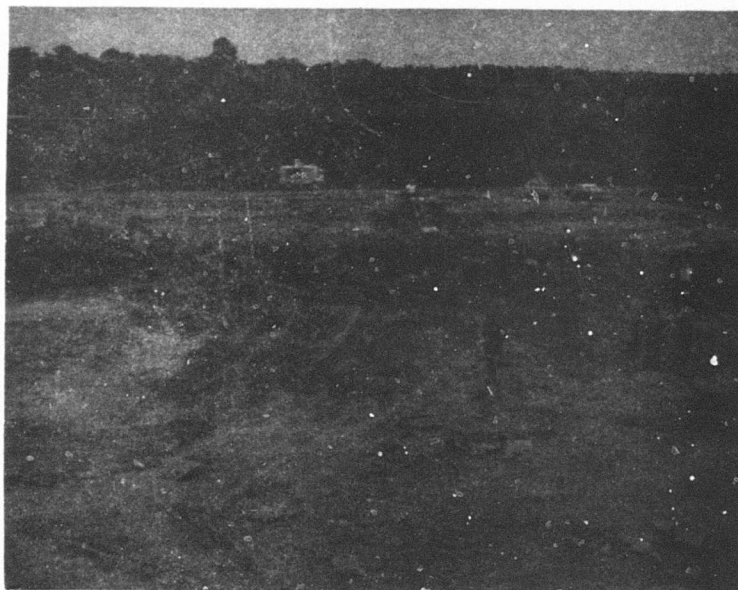
Figure 14. Test 1-1, Comparative Work Done by TD 20, Right Side, and Three AC 645's, Left Side, in Equal Period. Note Minimum work accomplished by 645's since repair progress shown in figure 11.

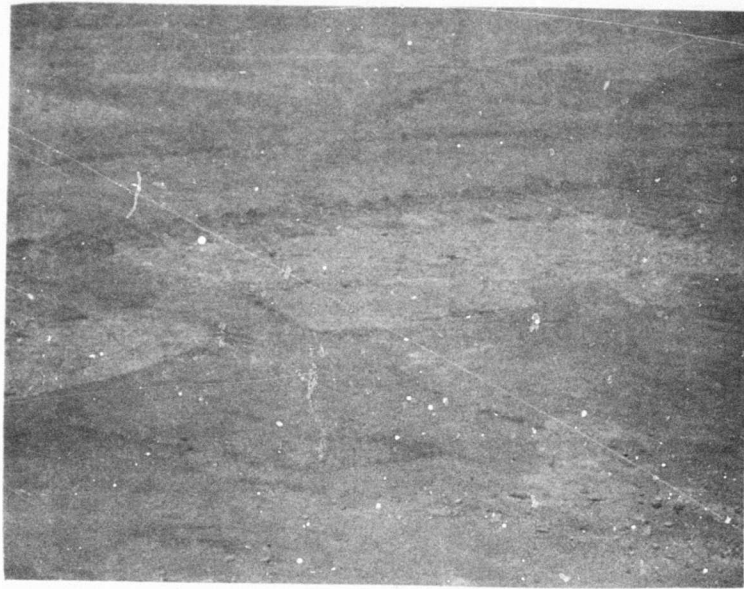
Figure 15. Test 1-1, Pavement Gouges Made by AC 645 Loaders with Four in One Buckets

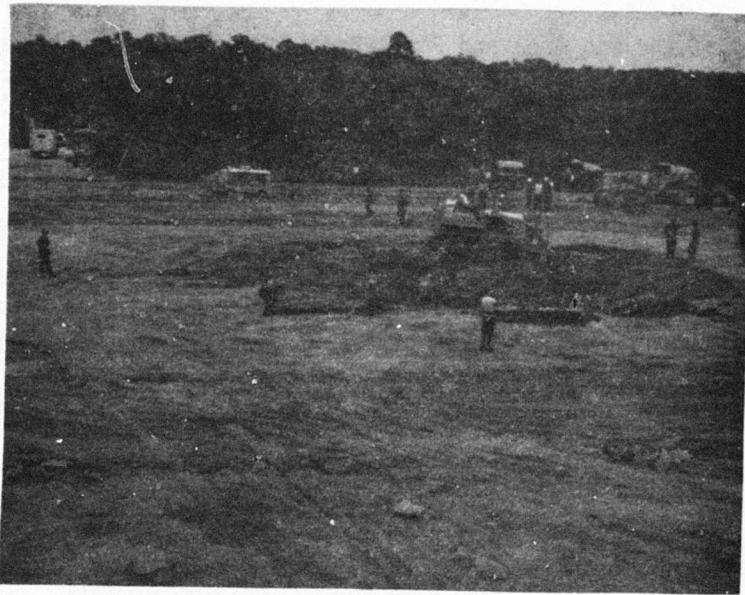
Once the pavement to be removed was identified, a time-consuming process of lifting the pavement out with a dozer or loader blade (figure 17) and then loading the debris into a loader bucket began (figure 18). The equipment in the package is not suitable for this use. Since the overlay of asphaltic concrete physically hides the joints in the pavement, it is extremely difficult to find a point at which the concrete can be broken for removal.

Figure 17. Test 1-1, TD 20 Lifting and Breaking Free Large Upheaved Pavement Sections

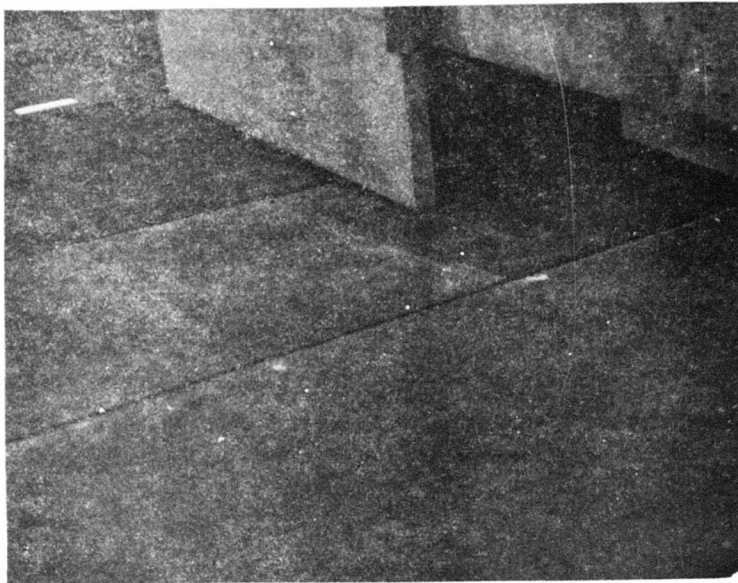
The deflection recorded does not represent the maximum in the case of line C, where each point was loaded as the deflection was measured. Rotation of the sections of mat relative to each other caused an extreme concentrated load along the dedge of the mat panels abutting the joint. This deflection was extreme enough that a part of the load cart had to be removed to complete the testing (figure 30). The poor compaction of the base course, described above, is believed to be the cause of this problem.

Figure 30. Test 1-1, F-4 Load Cart Hung Up on Excessive Deflection in AM-2 Airfield Patch

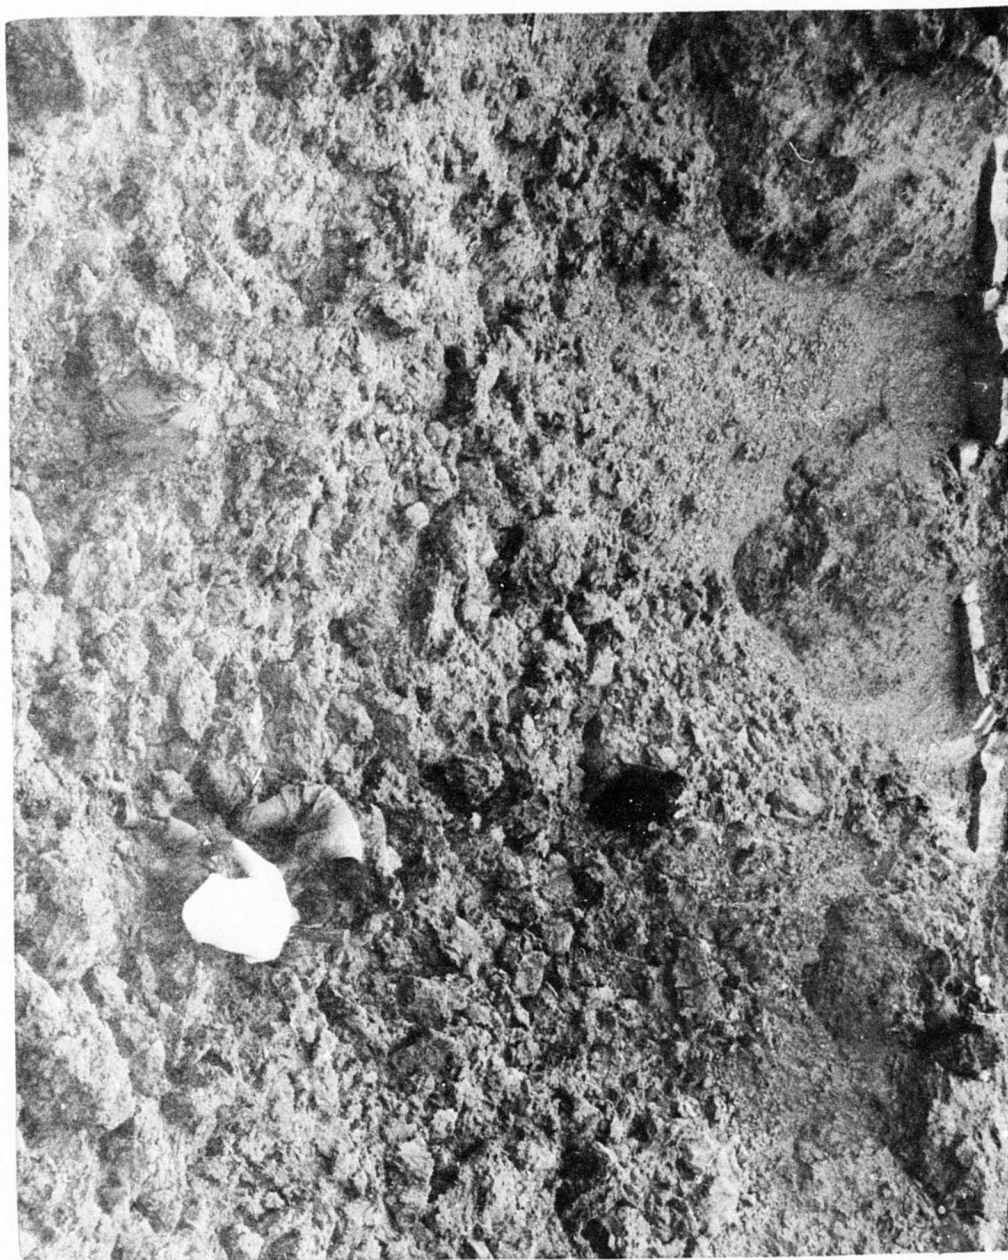
Figure 44. Test 1-2, Distorted and Sheared Crater Wall and Floor Material

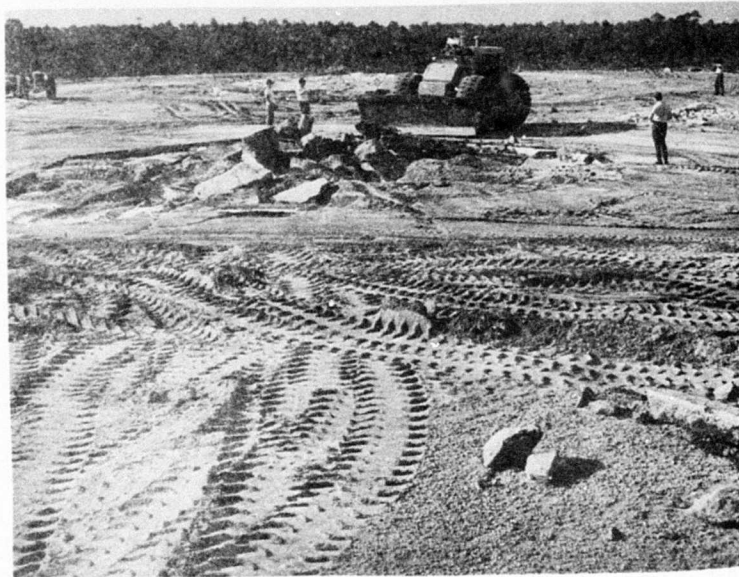
Because of the problem encountered with the use of the 280 RT noted below, the procedure took longer than had been expected. One factor causing excessive time was the over filling of the crater (figure 61) with debris and the tardy switch from working outside the crater to working inside. It was originally felt that the 380 RT could handle the entire job from outside the crater. In addition, if a machine capable of uplifting the pavement had been moved inside at an earlier time, (figure 62) the elapsed time would have been further reduced. In general, the procedure worked well as witnesses by table 12, a schedule of events during the actual test. Had the crater not been overfilled with debris the use of the TD 20 tractor would have been avoided. This equipment package and procedure was far superior to that exercised in Test 1-1, and is the basis of the proposed repair procedure and equipment package suggested later.

Figure 61. Test 1-3, Overfilling of Crater with Debris

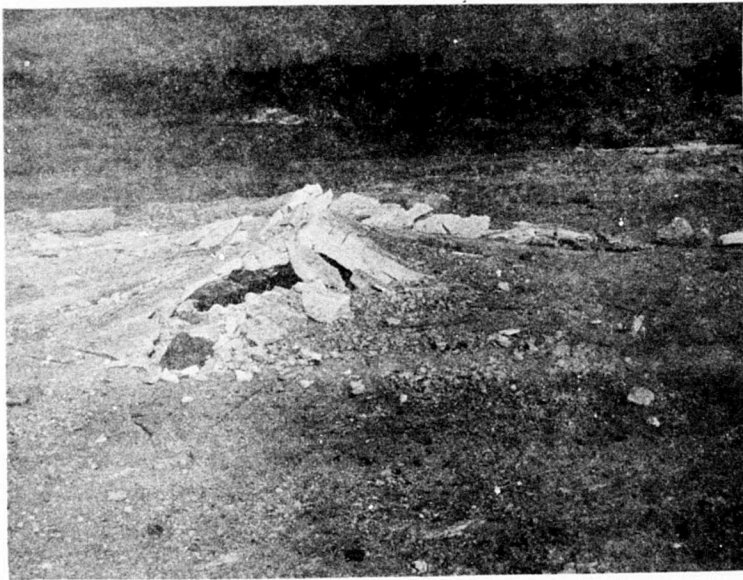
Expansion and contraction phenomena in the mass of regulated-set led to failure within weeks (figure 70). This is discussed in section VIII.

Figure 70. Test 1-4 NW, Failure of Regulated-set Cement Cap

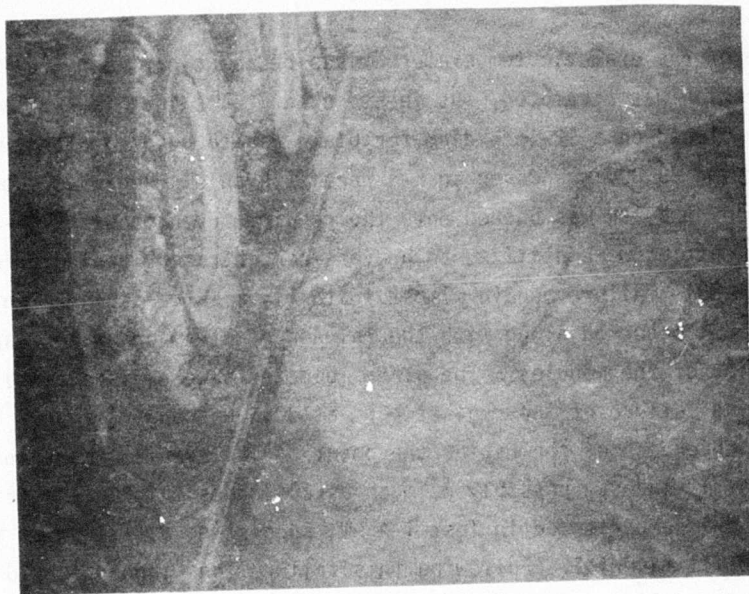
Figure 88. Test 2-1, AM-2 Matting Used to Support Load Trailer,
Also Shown are Concentric Cracks

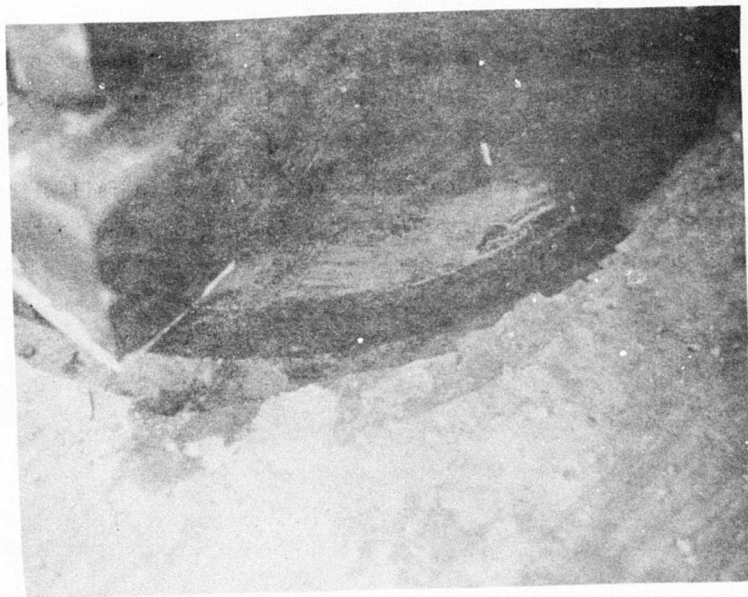
Figure 89. Test 2-1, Punching Failure of Reg-set Cap under Load Plate

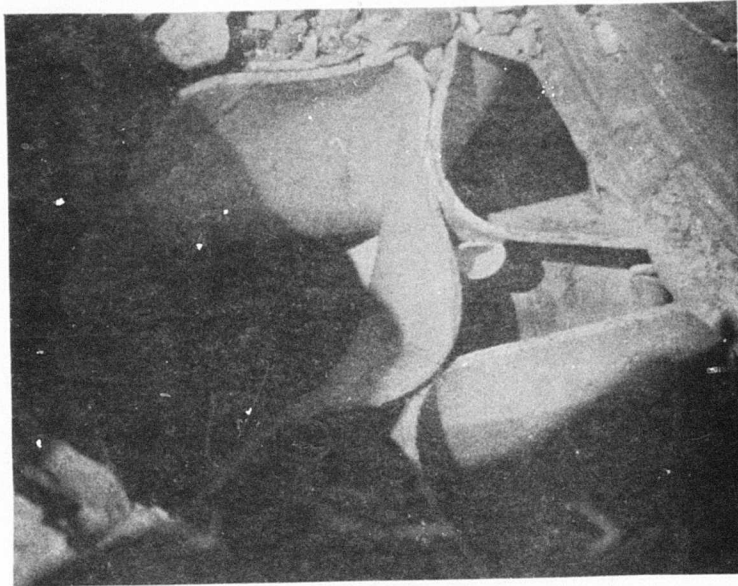
Figure 92. Test 2-1, Buckled PVC Module Elements
Beneath Failure in Figure 91

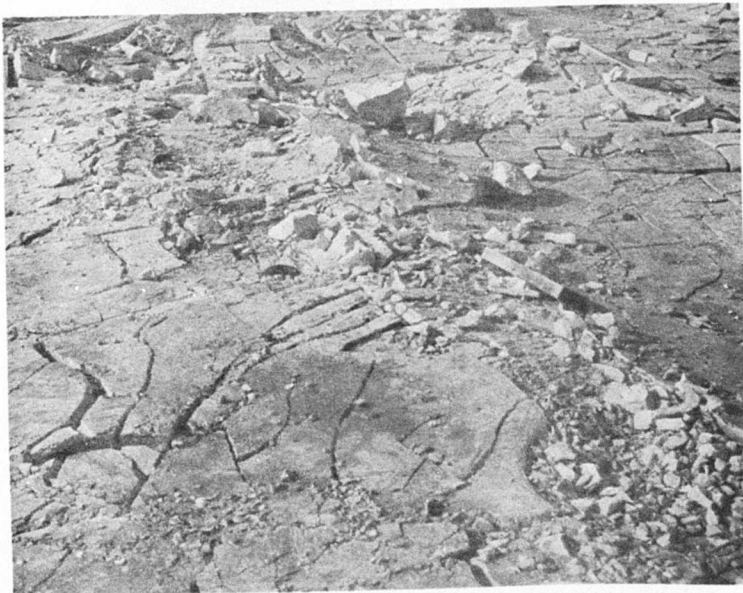
Figure 93. Test 2-1, No Load Deterioration of Reg-set Surface

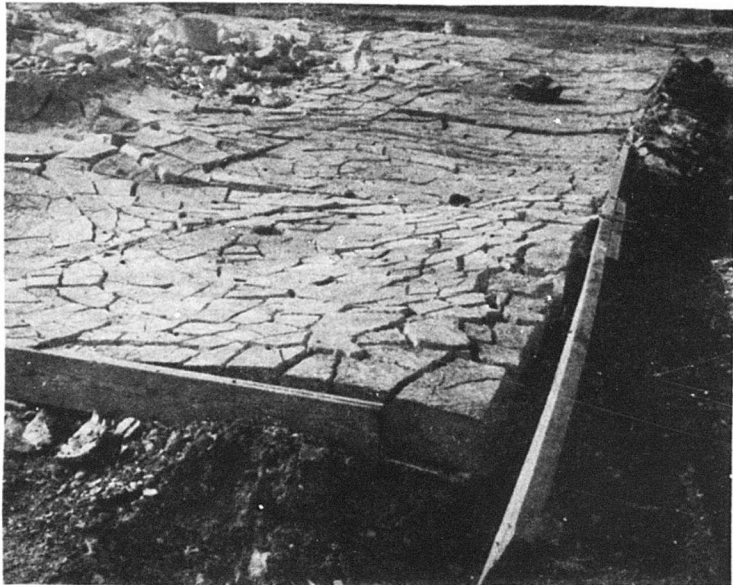
Figure 94. Test 2-1, Evidence of Expansion in Reg-set Surface

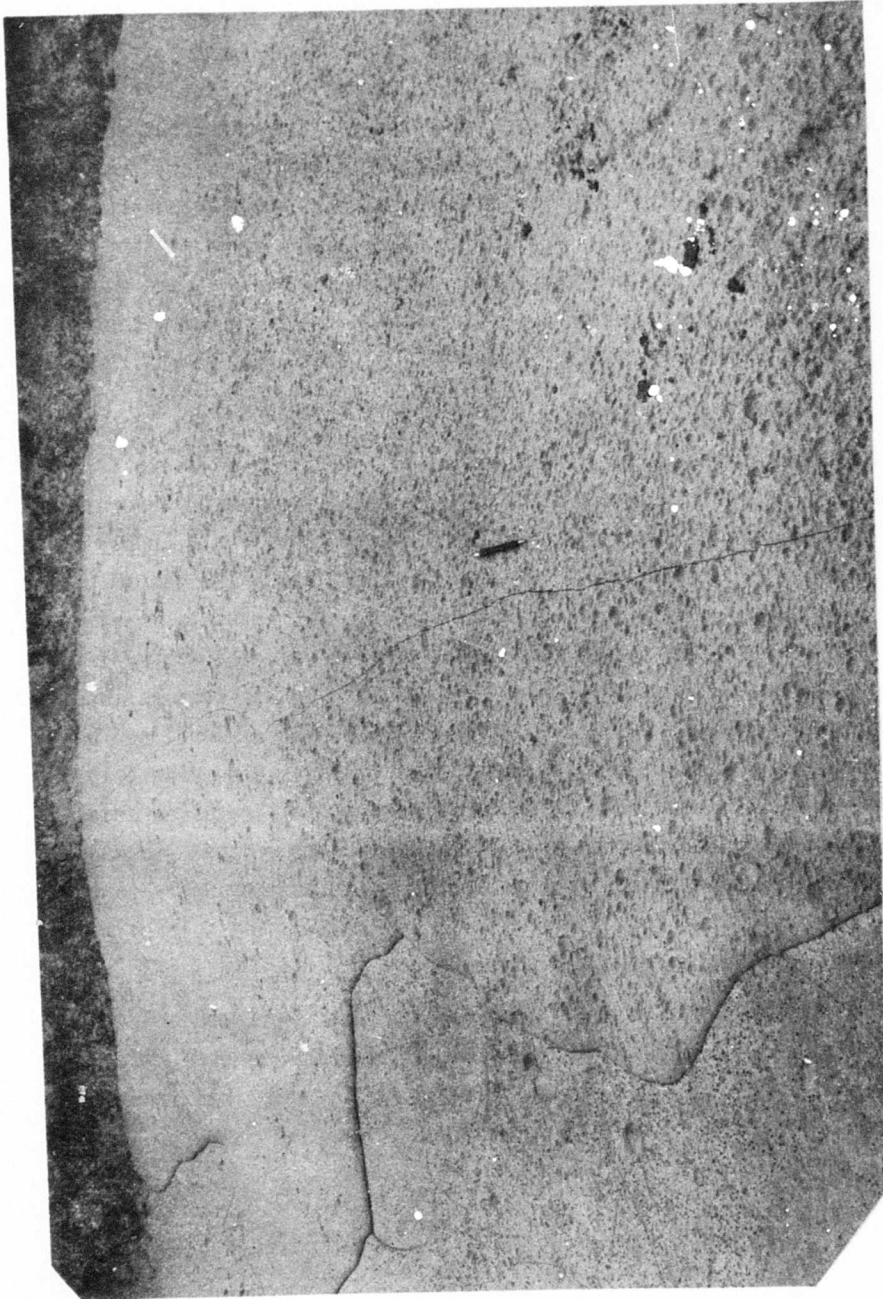
Figure 97. Cold Joints Resulting from Flat Sheet, like Curing of Reg-set

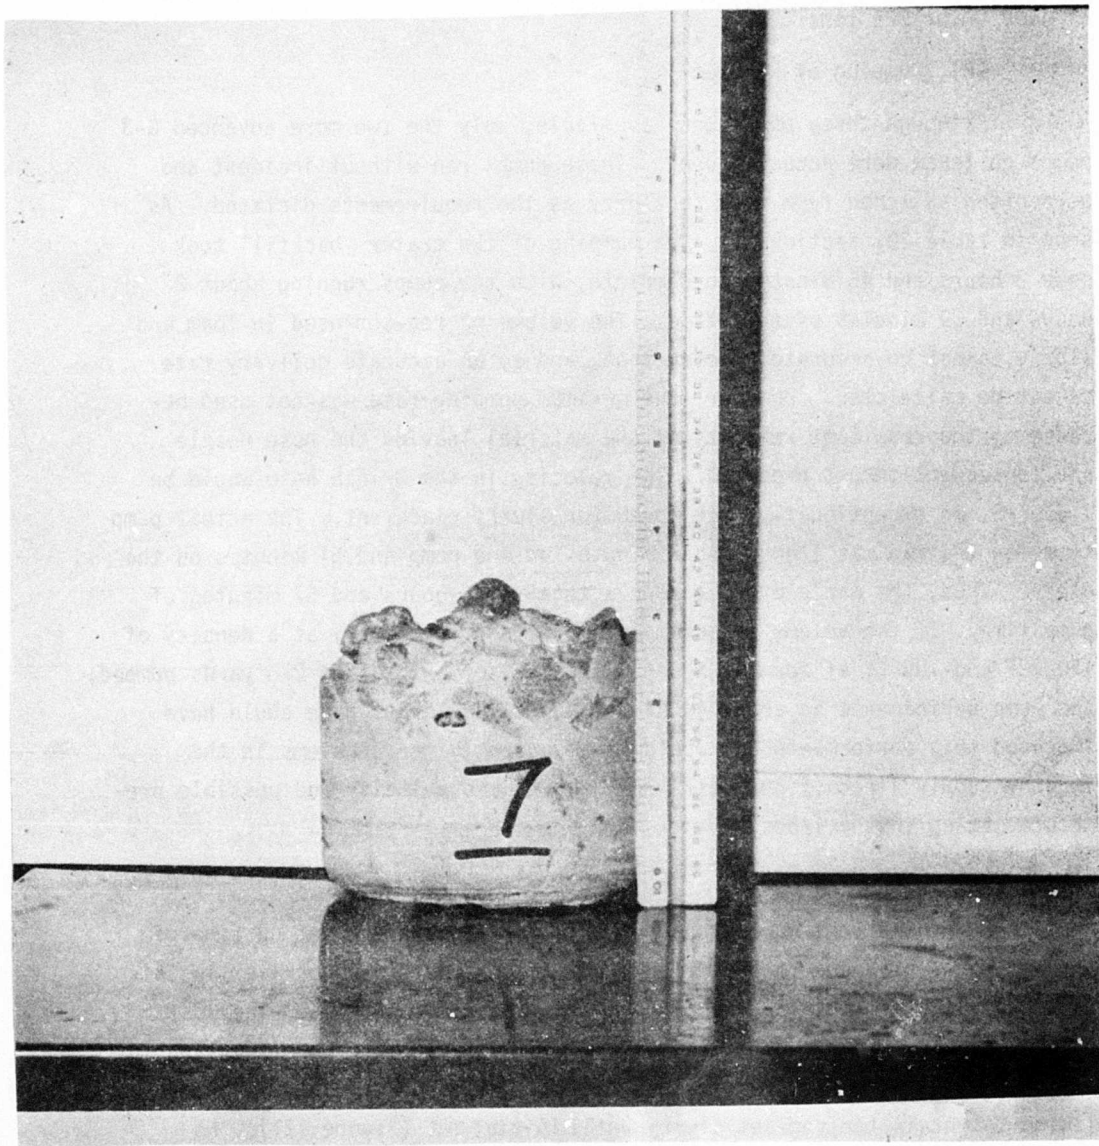
Figure 116. Core Sample Illustrating Slurry Cut Off by Fines

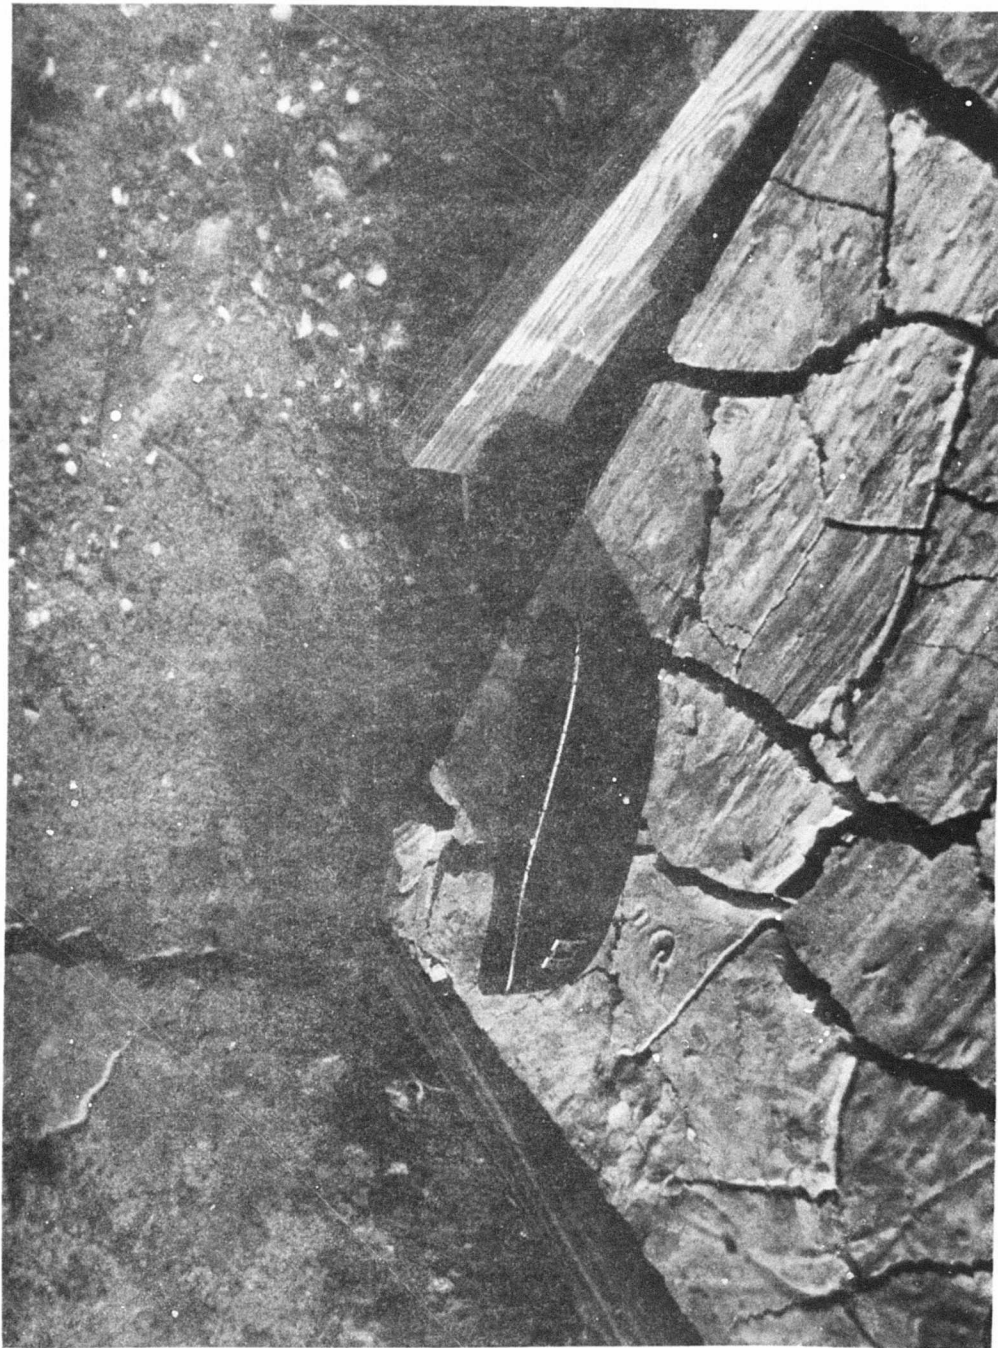
Figure 122. Evidence of Extreme Expansion, Deteriorated Cap, Test 2-1

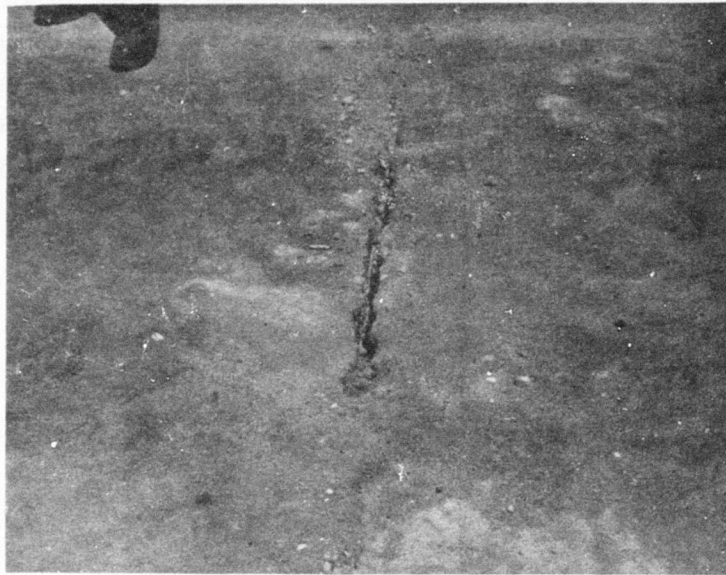
Figure 126. Pavement Cracking Outside Zone
of Upheaval, Test 1-1
