SEAWATER CORROSION OF FASTENERS IN  
VARIOUS STRUCTURAL MATERIALS

by  
Harvey P. Hack

April 1976

Report 76-0034

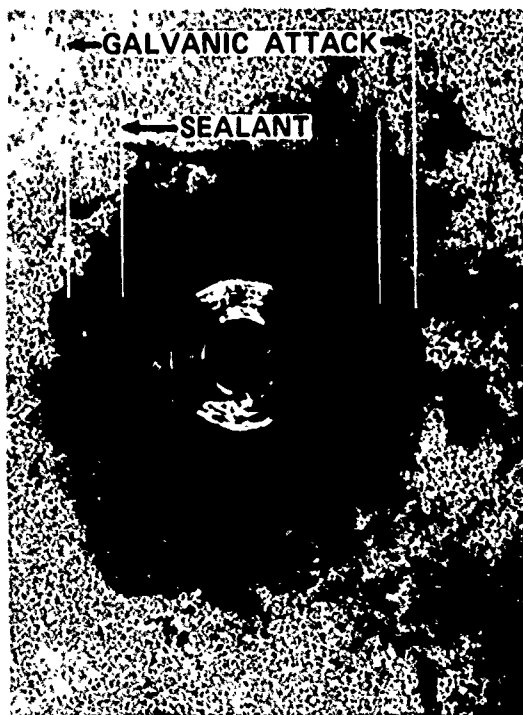
Figure 2  
Corrosion Attack on HY-130 Steel Panels

No attack occurred on any of the fiber glass or titanium panels. Corrosion of the HY-130 steel panels consisted primarily of a general, uniform attack, as shown in item (2) of figure 2. In some instances, especially on panels which had housed the more noble bolt materials, a very mild form of galvanic attack was present, as shown in items (b) and (c) of figure 2. This electrochemical attack was, in most cases, barely visible and fairly broad, with a maximum depth of 2-5 mils (50-125  $\mu$ m). On the panels where sealant was used, it occurred outside of the area covered by sealant (which oozed out from the threads as the bolt was tightened). On the panels where sealant was not used, it occurred outside of the area of bolt-head contact. Unexpectedly, this corrosion was present on one panel containing an aluminum bolt.

Bolt sealant is also recommended for HY-130 steel structures as it appears to prevent localized attack under the bolt heads. Aluminum and steel fasteners are not recommended due to their high rate of galvanic corrosion. All other materials in this study appear to be satisfactory, from a corrosion standpoint, for this application.

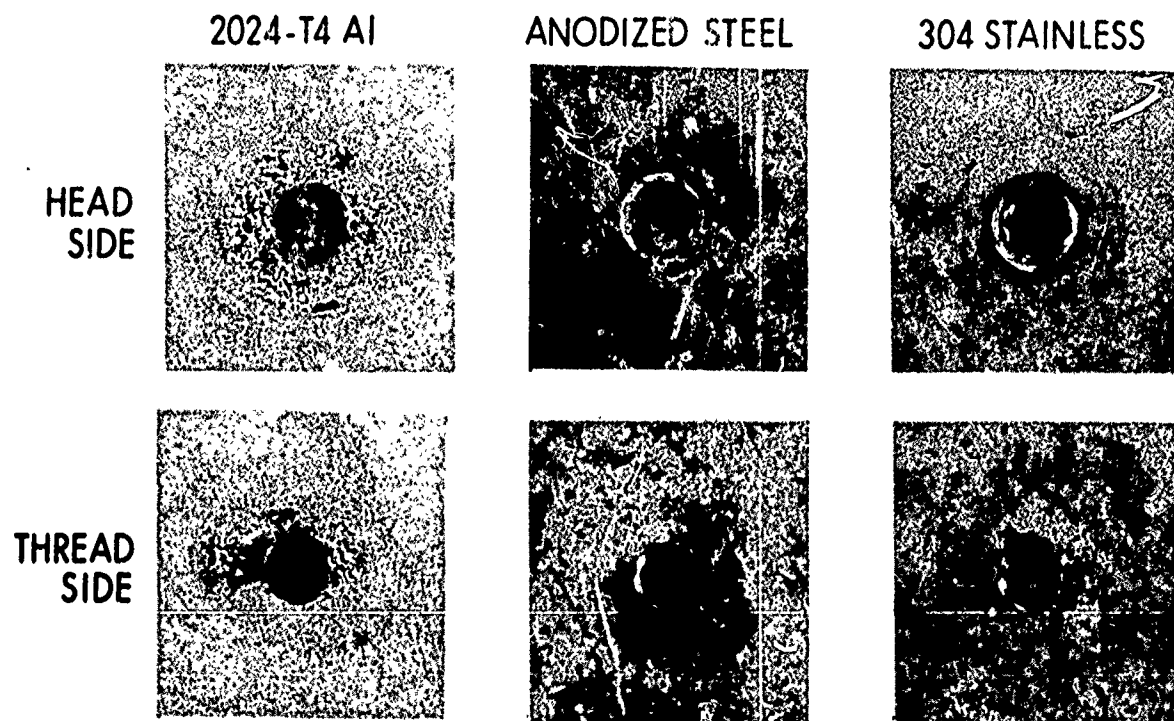
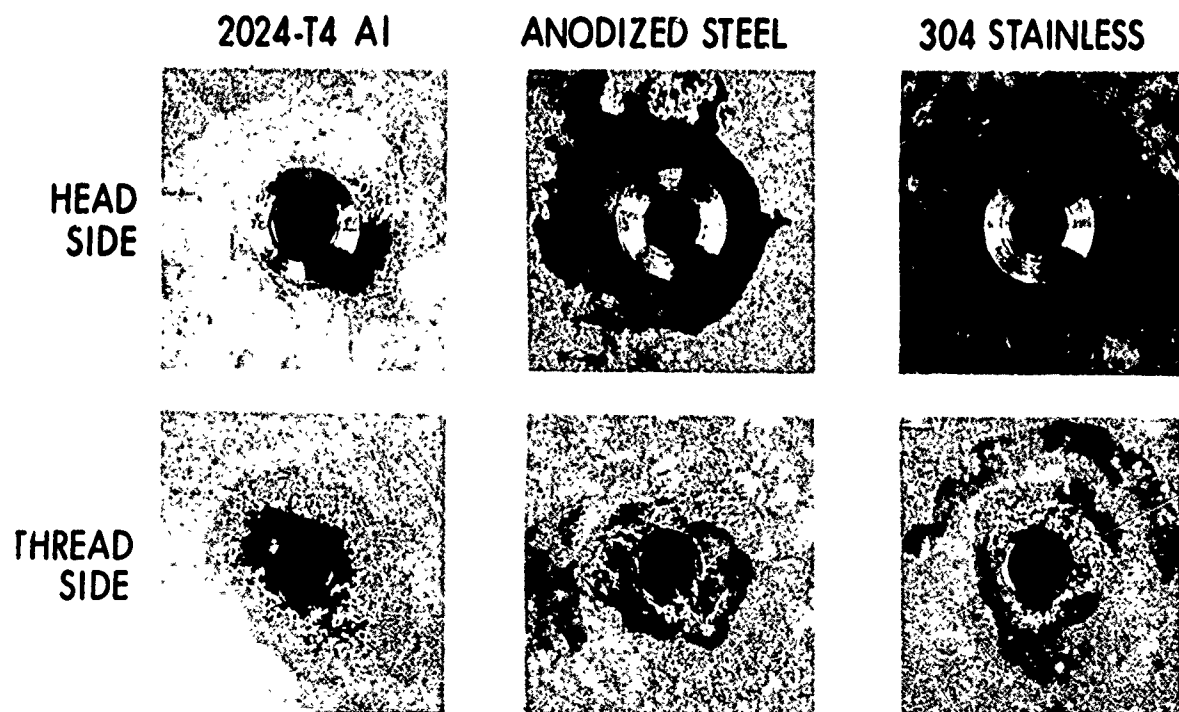
rosion Attack on Aluminum panels (Bolt Materials as Indicated)

The corrosion attack on the aluminum panels was usually in the form of mild pitting and local attack at the plate edges. Also present was a mild-to-intense form of localized inter-granular attack, up to 3/16 inches (5 mm) deep at the bolt hole. This attack is shown for both front and back of each panel in figure 3.

It is not surprising that most of the aluminum panels which had bolts of the materials more noble than aluminum (steel, the stainless steels, A286, MP35N and titanium) experienced galvanic attack. However, the panel with aluminum bolts also experienced very intense galvanic attack at the bolt holes. It should be noted that 2024 aluminum is slightly more noble than 5456 aluminum. The intensity of the attack on the panels did not appear to be related to the relative position of the bolt material in the electromotive series, as the most intense attack took place on the panels with aluminum bolts and the least attack took place on the panels with A286 bolts. Use of the sealant tended to reduce galvanic attack near the bolt head but had no systematic effect on the attack on the opposite side of the panels near the threaded shank, where sealant had not accumulated.

Use of a sealant material is highly recommended for aluminum alloy 5456 structures as this material appears to reduce the localized galvanic attack on the structure. Bolts of 2024 aluminum are not recommended as they will pit significantly. All of the other bolt materials in this study, although not suffering degradation themselves, could cause localized galvanic attack of the structure. They should be considered only if a form of corrosion protection, such as painting, liberal use of sealant to cover the entire bolt, or cathodic protection, is employed.

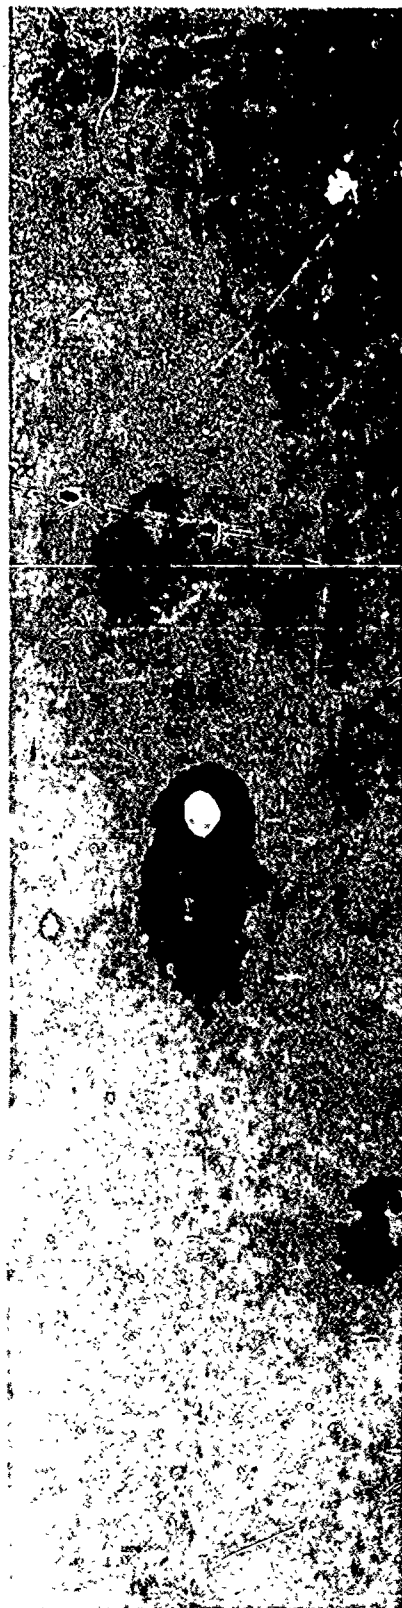
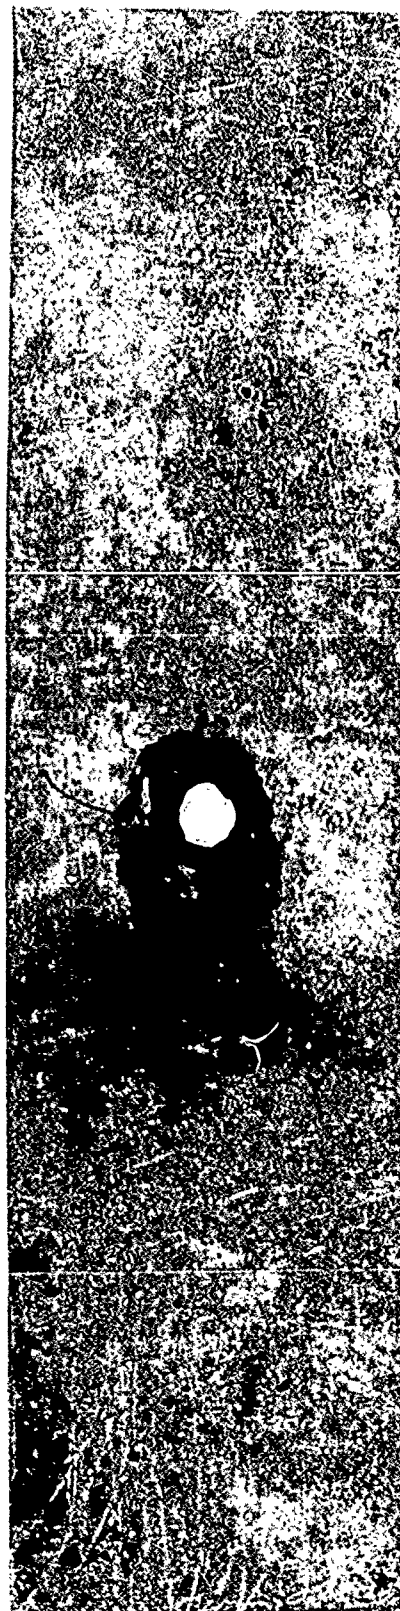
Figure 6  
Corrosion Attack on 17-4PH Panels with 304 Stainless Bolts

The relative position of the bolt material in the electro-motive series did not appear to have any significant effect on the intensity, location, or probability of attack. In one instance the corrosion appeared to initiate at the crevice formed by an aluminum bolt. The use of the sealant seemed to have the effect of establishing a better crevice, thereby increasing the extent of the attack under the sealant.

Use of a sealant material on 17-4PH stainless steel structures is definitely contraindicated. The sealant tends to establish a tighter crevice, increasing the likelihood of crevice corrosion on the structure. Unless the entire structure is well painted, use of aluminum or steel bolts is not recommended due to their high rate of galvanic attack, and use of 304 stainless steel is undesirable due to extensive crevice corrosion of the fasteners. Use of A286, 316 stainless steel, MP35N, and titanium is favored from the viewpoint of fastener corrosion; however, some means of corrosion protection is necessary to prevent crevice attack of the structure.

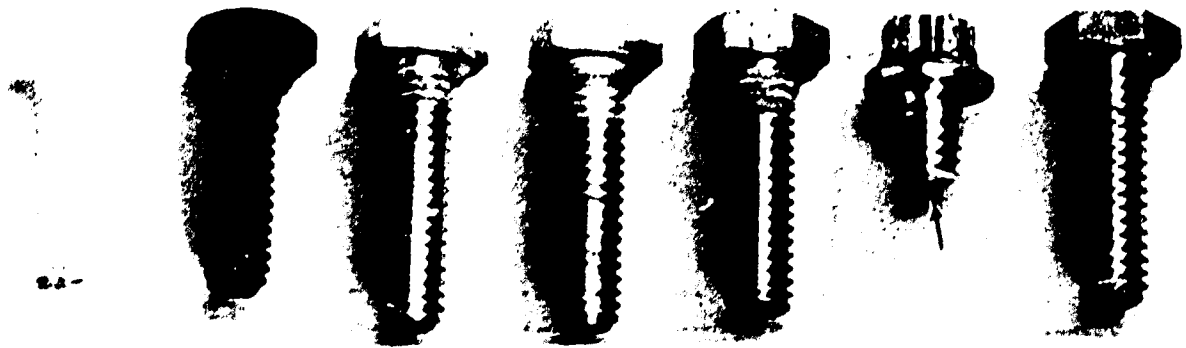
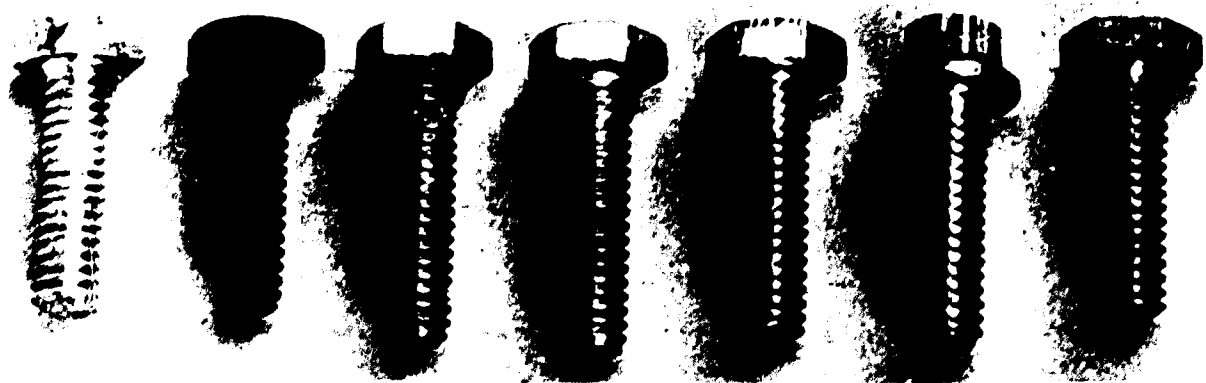
Figure 12  
Corrosion Attack on Bolts in Fiber Glass Panels  
(Arrow Indicates Mechanical Damage)

Figure 12 shows the corrosion attack on the bolts from the fiber glass panels. The aluminum bolts experienced pitting in the threads, especially at the cut end of the bolt, and intense pitting of the head of the bolt applied with sealant. Both steel bolts experienced a mild general attack, with some protection afforded under the sealant. The 304 stainless steel bolts suffered mild crevice attack which was somewhat reduced near the bolt head where sealant had been used. The 316 and A286 bolts suffered a mild crevice attack which amounted to only a slight etching. Use of the sealant completely eliminated this attack, however MP35N and titanium bolts were unaffected by the exposure.

Generally, use of a good sealant is recommended for bolting of fiber glass structures as it reduces the extent of crevice corrosion on the bolts subject to this type of attack. Both titanium and MP35N are highly recommended fastener materials for this application. The A286 and 316 stainless steels are subject to mild crevice corrosion but would probably perform satisfactorily. Crevice corrosion on 304 stainless steel is of sufficient magnitude to make this material unsuitable for this application. Steel bolts are generally easy to obtain and may be suitable for short exposures; however, the general corrosion rate for steel makes it unsuitable for long exposures. Aluminum alloy 2024 is subject to considerable pitting and is not recommended for use in fiber glass structures.

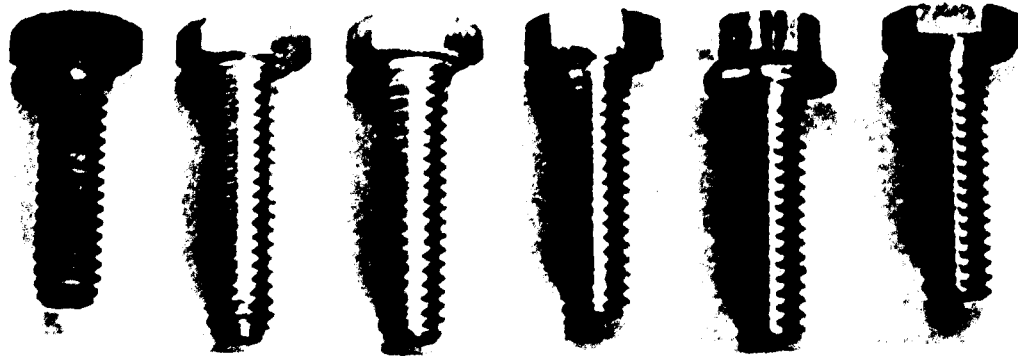
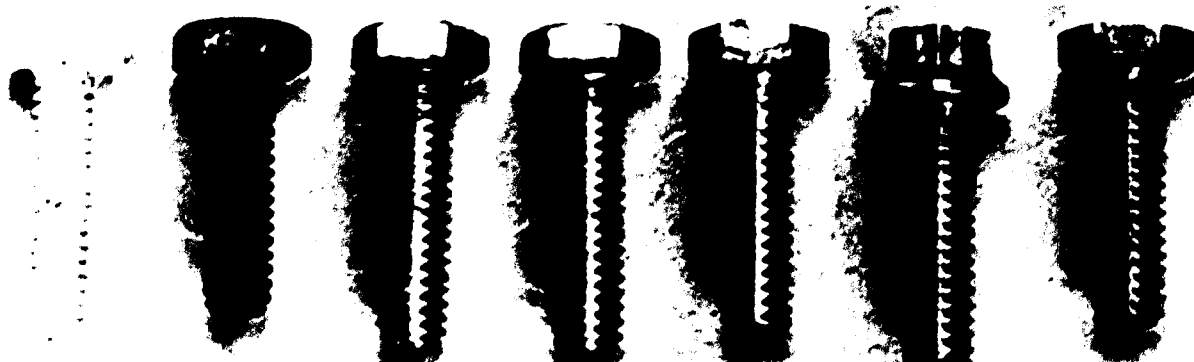
Figure 13  
Corrosion Attack on Bolts in Aluminum Panels

Bolts in the aluminum panels, illustrated in figure 13, all received adequate galvanic protection to eliminate all corrosion attack with one exception. The aluminum bolt applied with sealant experienced intense pitting on the exposed threads. This was not expected, as 2024 aluminum is slightly cathodic to 5456 aluminum in seawater.

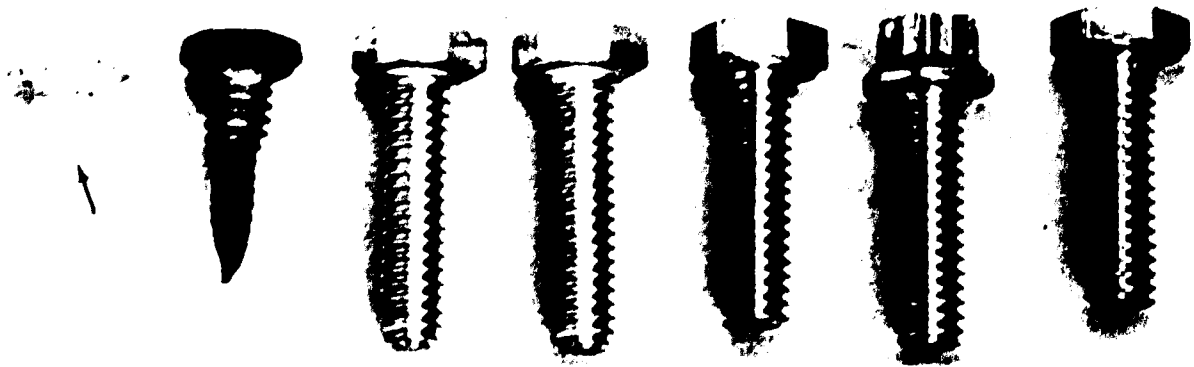
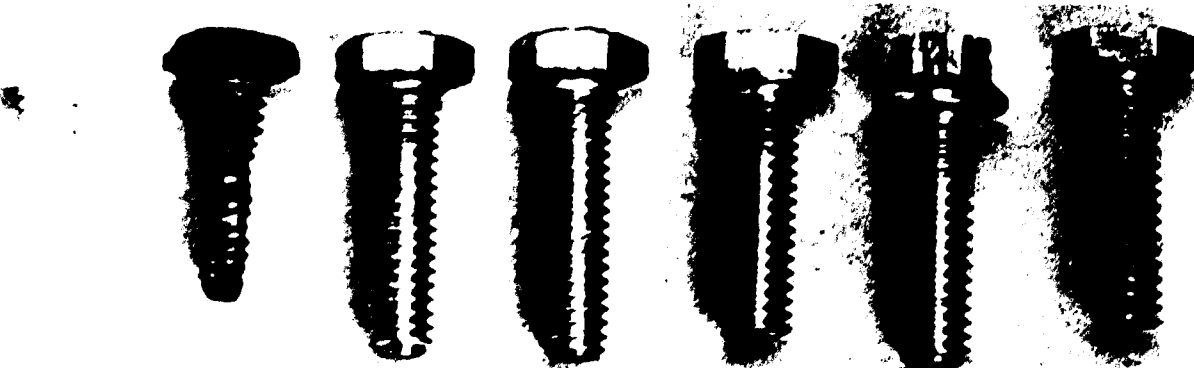
Figure 14  
Corrosion Attack on Bolts in HY-130 Panels  
(Arrow Indicates Mechanical Damage)

As can be seen in figure 14, all bolts, except those of aluminum and steel, received adequate galvanic protection from HY-130 panels to reduce their corrosion attack. The entire surface of the aluminum bolts, except that under the sealant, was uniformly pitted. The end of one of these bolts was broken off during the test. Although some galvanic corrosion of the steel bolts was expected, as they should have been slightly anodic to the 5Ni steel in seawater, the actual attack was much more intense than would be predicted. Although almost complete protection was afforded in the crevices, extensive corrosion attack occurred on the exposed surfaces.

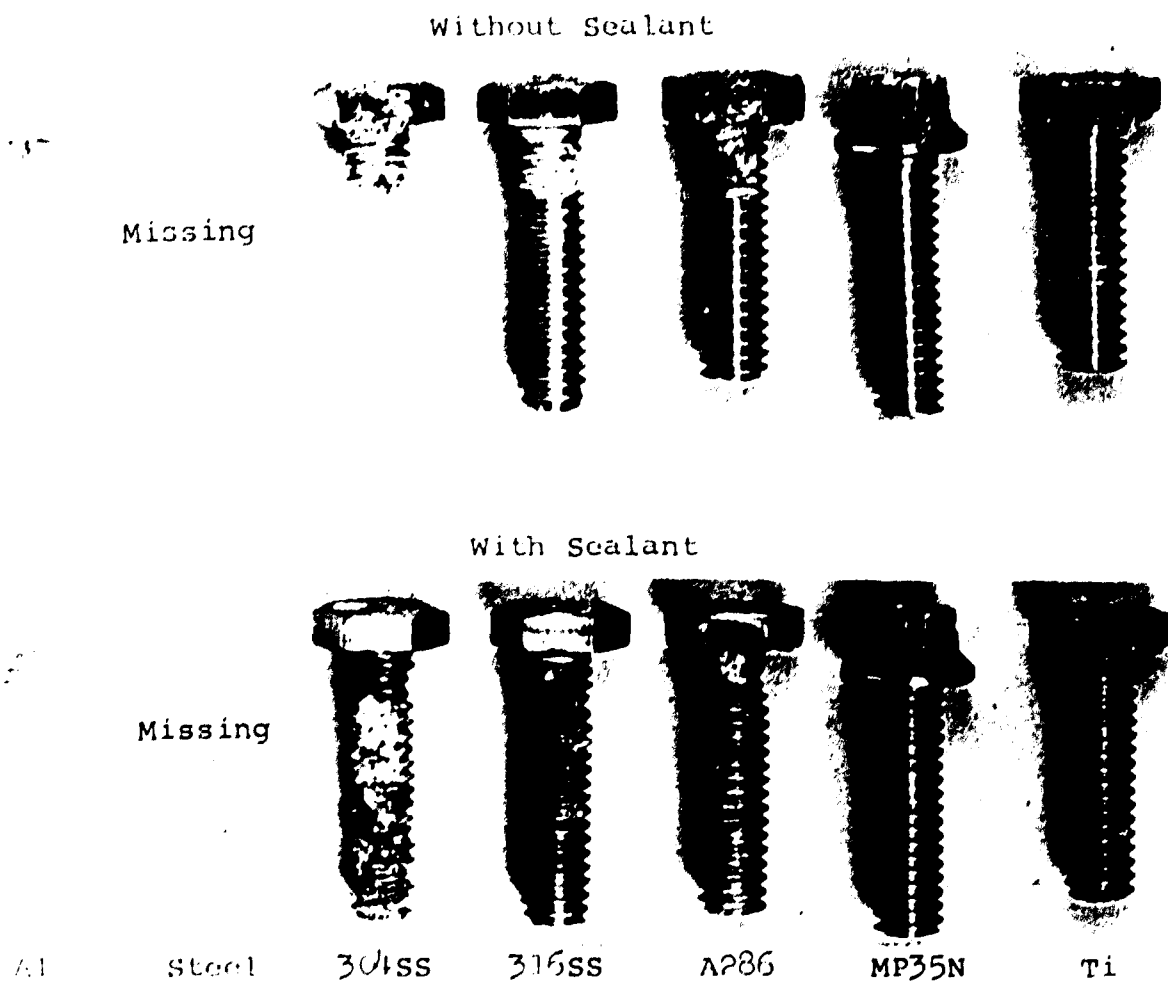
Figure 15  
Corrosion Attack on Bolts in Titanium Panels

The titanium panels generally caused very extensive galvanic attack on the bolts, as seen in figure 15. The entire aluminum bolts, except for the areas in the crevices, were completely corroded away. The steel bolts were missing, and it can be deduced, since the threads in the panels were intact, that these bolts either corroded away completely or suffered sufficiently extensive attack to allow them to fall out of the panels. The 316 stainless steel bolts were riddled with holes, and the attack on the 304 stainless steel bolts, although limited to the threads in or near the crevice, was still quite intense. The only time in the entire test series where A286 experienced major attack was in these panels. This attack was most intense in the crevice area but was also very significant in the head of the bolt without sealant and under the sealant in the head and threads of the bolt with sealant. Generally, the sealant afforded no protection against the galvanic attack on any of the bolts. In contrast to the others, the MP35N and titanium bolts experienced no corrosive attack whatsoever.

Bolt sealant is not necessary to mitigate corrosion in bolted titanium structures. Its use appears to have no significant effect on the corrosion behavior of the fasteners. Titanium and MP35N are the only fasteners tested that are recommended for this application. The A286 and stainless steel fasteners would suffer serious pitting and crevice corrosion in this application, whereas the steel and aluminum fasteners would suffer serious galvanic attack.

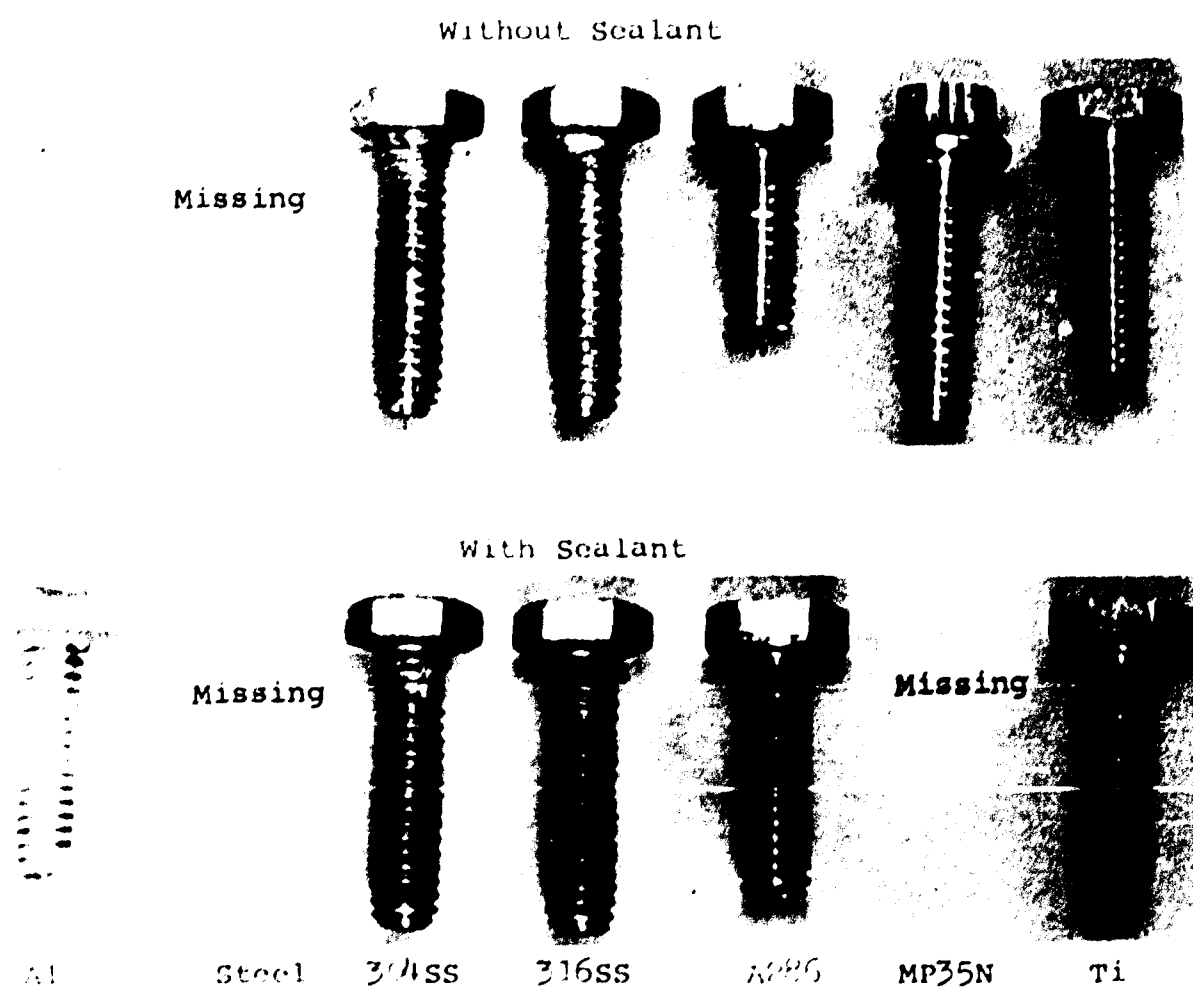
Figure 16  
Corrosion Attack on Bolts in 17-4PH Panels

The attack on the standard-sized bolts in the 17-4PH stainless steel panels, as pictured in figure 16, appeared to be considerably less than the bolts in the titanium panels. Galvanic corrosion of the aluminum bolts was quite variable. One bolt was almost completely corroded away, except for the portion inside the crevice, while the other bolt experienced some pitting on the head and the cut end of its threads which was minor by comparison (although still considered significant). The steel bolts were both missing. Since the threads in both panels were still intact and since the areas around these bolts holes were stained with rust, these bolts probably either corroded completely or fell out after extensive attack had occurred. Extensive crevice attack was apparent on the 304 stainless steel bolt with sealant, while some attack was present but not as obvious in the threads and under the head of the bolt applied without sealant. None of the other bolts in this panel experienced

significant attack. The A286 bolt applied without sealant was broken during the test, however. In addition, one of the MP35N bolts was missing. Examination of the panel housing this bolt shows extensive corrosion, with complete destruction of the threaded hole. This evidence, along with the appearance of the other bolt, leads to the conclusion that the MP35N bolt fell out of the plate as the plate corroded away.

There is some inconsistency in the behavior of the 304 stainless steel fasteners in the 17-4PH stainless steel panels. The nominal 1/4-inch bolts suffered crevice attack, as previously mentioned and illustrated in figure 16, whereas the smaller flat head and pan head fasteners suffered essentially no attack under almost identical circumstances, as described above and illustrated in figure 17. The reason for this anomalous behavior is not known.

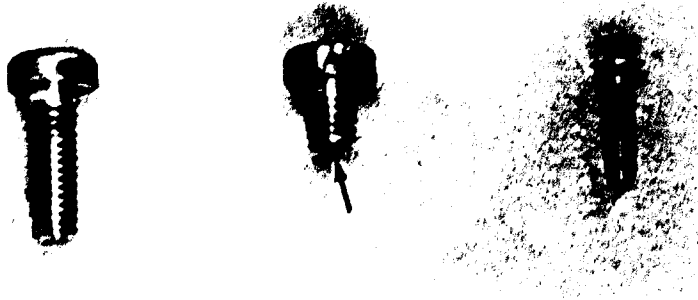
Figure 17  
Corrosion Attack on Small 304 Stainless  
Bolts in 17-4PH Panel  
(Arrow Indicates Mechanical Damage)

The appearance of the small 304 stainless steel fasteners that were exposed in a 17-4PH panel is shown in figure 17. All of the small flat head fasteners, except the one shown, were destroyed for analysis. All were free of attack and similar in appearance to the one shown in figure 17. Likewise, the pan head fasteners were free of corrosion, except for slight etching of the threads in one fastener which is shown at the upper left in figure 17. One fastener had been put in a hole in the panel which subsequently had the threads completely corroded away. This fastener was missing after exposure and probably dropped out of the panel intact.
