TECHNICAL REPORT NO. 6-570 -

# DURABILITY AND BEHAVIOR OF PRESTRESSED CONCRETE BEAMS

## LABORATORY TESTS OF WEATHERED PRETENSIONED BEAMS

June 1976

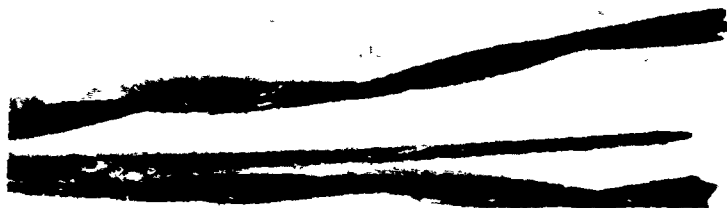
a. Strand 3 at seaward end

16. The intensities of rusting on the center wires of the beam 13 strands matched those on the external wires in all cases except the one for the landward end of strand 4. Here the center wire was heavily corroded for 2 in. farther into the beam than were the outer wires. Photos 8a-8c show the relation between the outer wires and the inner wire of strands 3, 7, and 8 in beam 13. Although the rusting is

difficult to see because of the lack of contrast, these photographs show how the rusting of the inner wire matches that of the outer wires. In each photograph, the wires are more heavily corroded in the right half of the picture.

Photo 8. Relation between outer wires and inner  
wire of some strands in beam 13

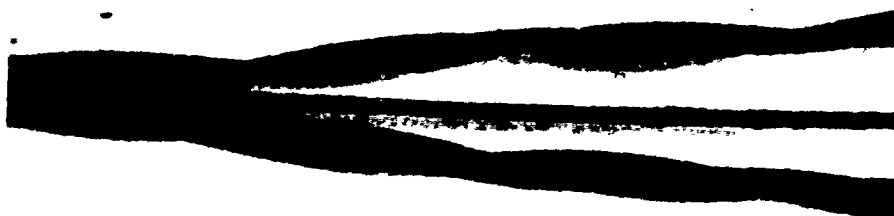
c. Central section of strand 8 at 17 in. from  
landward end

| Strand | Extent of Corrosion | | |
|---|---|---|---|
| 8 | 4-H<br>5-M | 7-H<br>1-M | In 26-in.-long section, 10 in. of heavy, 10 in. of moderate, and 6 in. of light rust; two broken wires due to heavy corrosion |

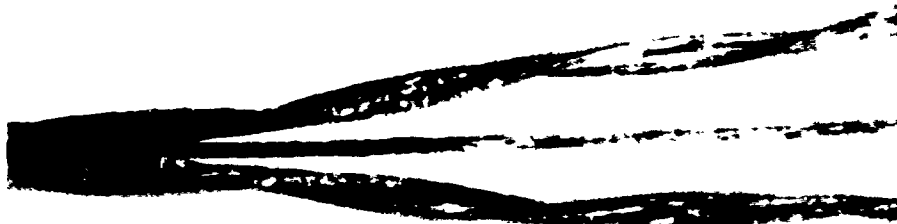
b. Strand 6 at 15 in. from landward end

21. The interior wire of this beam showed the same results as did the interior wire of beam 13. The corrosion of the center wire matched that of the outer wires. Photos 9a-9d show the center wire in relation to the outer wires of strands 4, 6, 8, and 9. In all cases where the outer wires were heavily rusted, the inner wires were also, and where the outer wires were lightly rusted, the center wires were also.

Photo 9. Relation between outer wires and inner wire  
of some strands in beam 21
