DEPARTMENT OF THE ARMY  
UNITED STATES ARMY AVIATION TEST BOARD  
Fort Rucker, Alabama 36360

SUBJECT: ~~Letter Report~~ "Product Improvement Test, T53-L-11  
Metal Spray Repaired Engine," ~~ADT&E~~ Project No.  
5-0151-13, USATECOM Project No. 4-

## ENGINEERING ANALYSIS

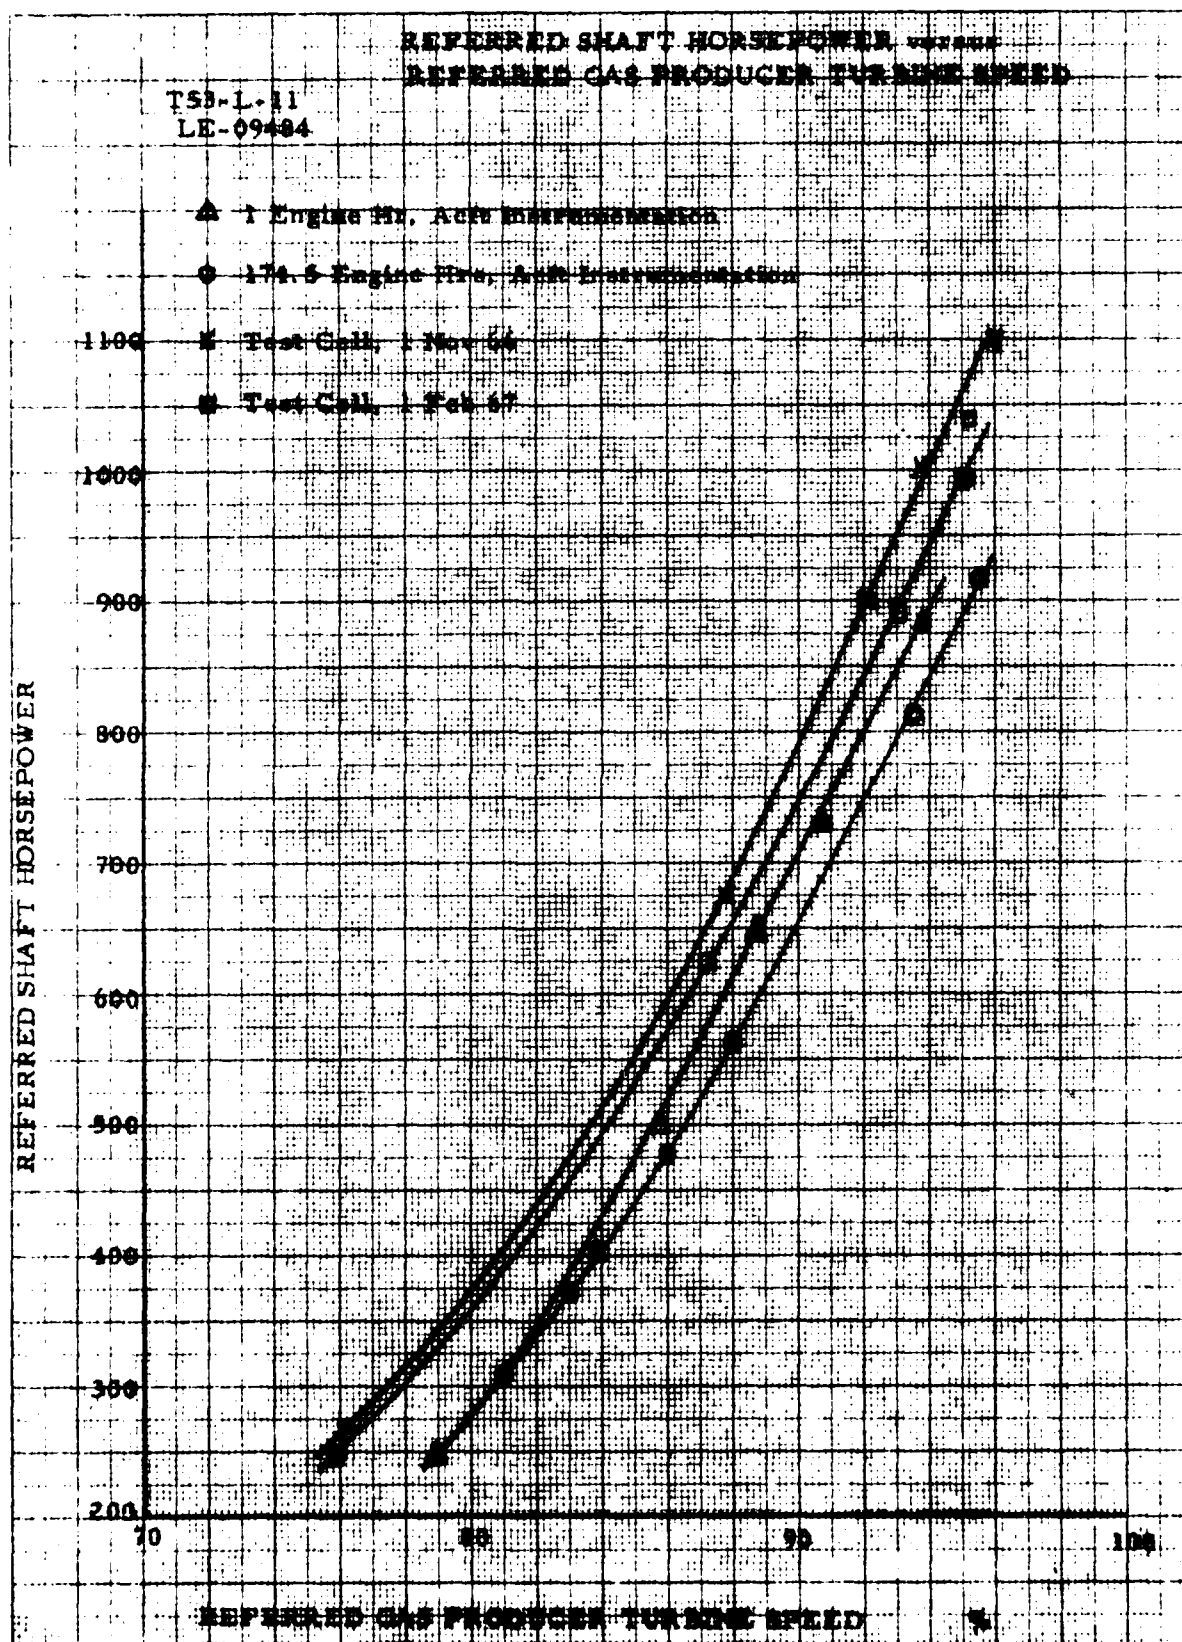
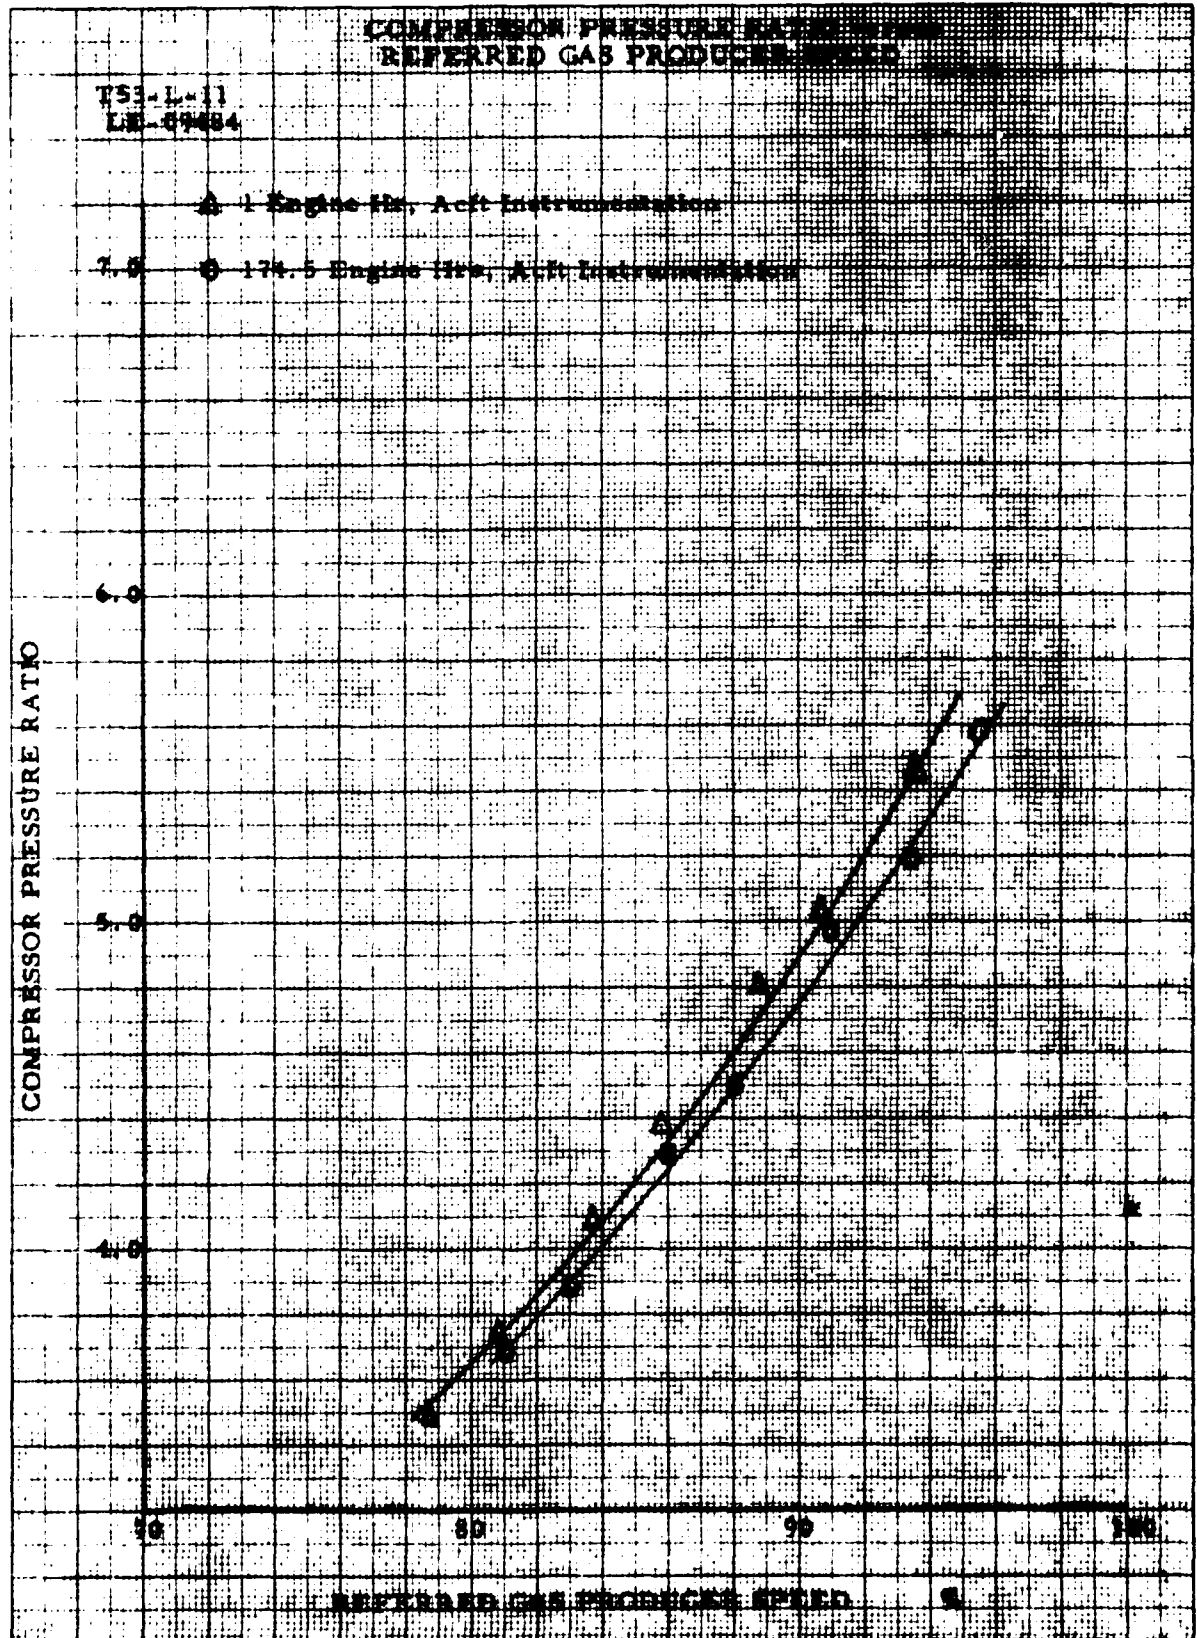
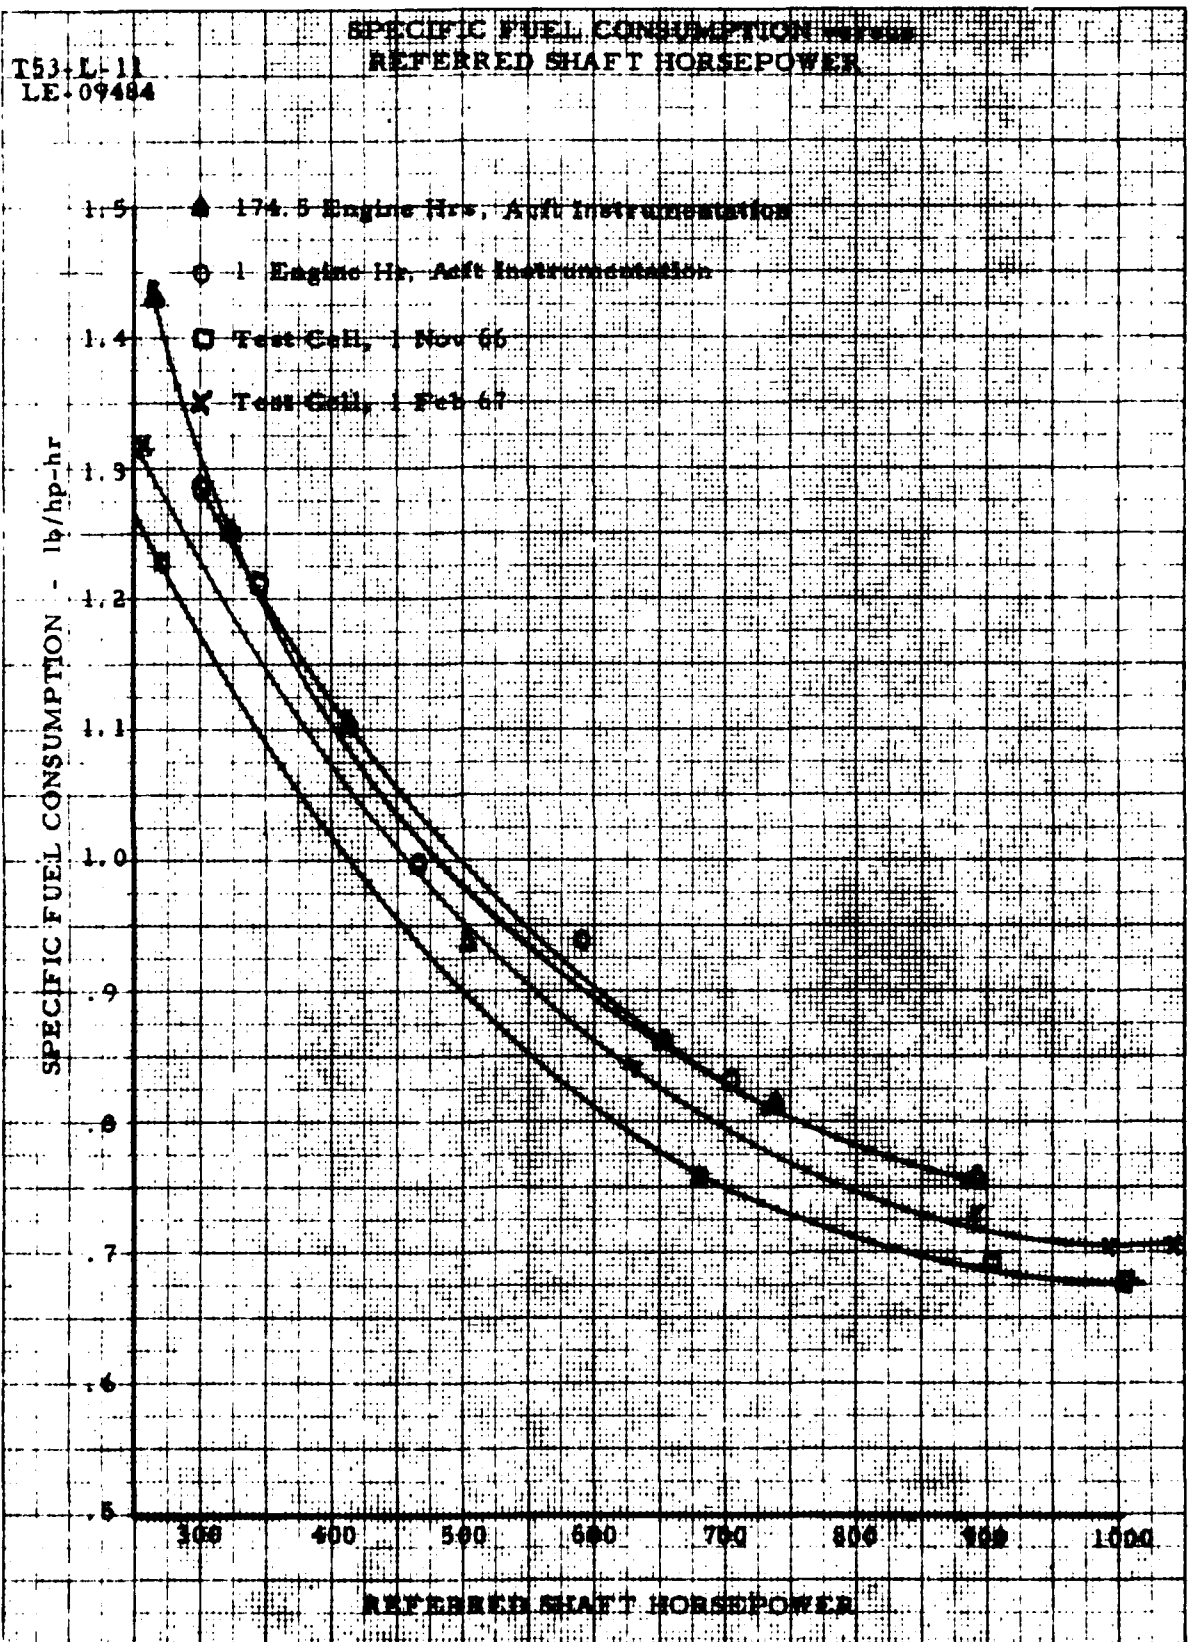
A graphic indication of the change of engine performance after 174.5 engine hours (3.6 sand hours) can be seen in figures 1, 2, 3, 4, and 5.

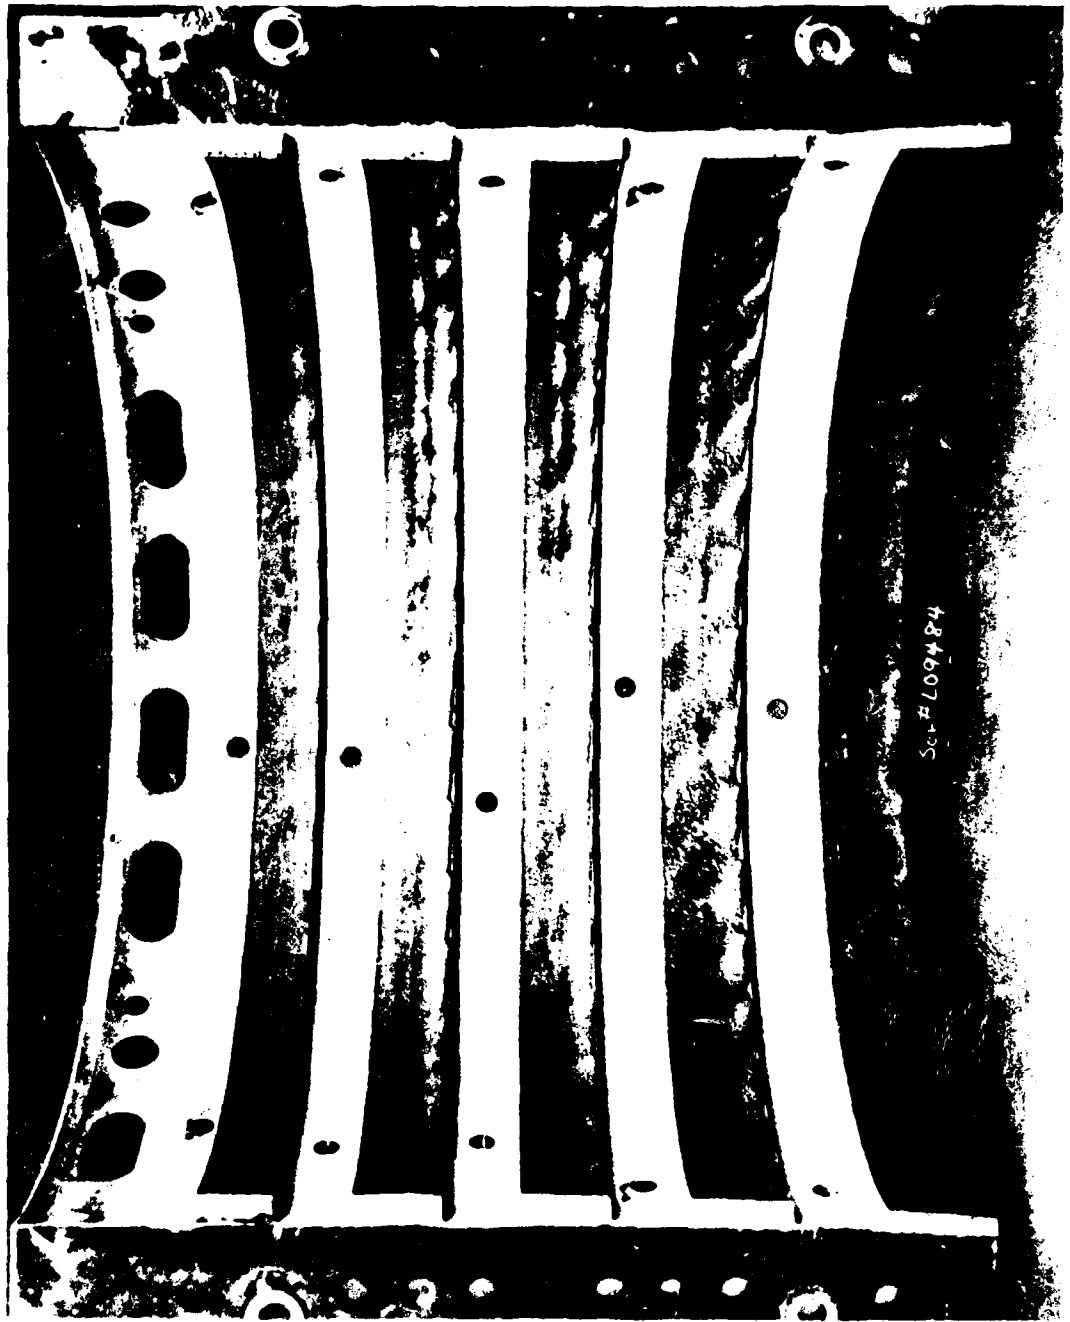
Figure 27.

4. The engine was disassembled for inspection at USAADMAC after the test was terminated at 174.5 engine hours (3.6 sand hours). Figure 27 shows the general condition of the top case of the compressor. Inspection of the lower half of the compressor case revealed that it sustained far greater erosion damage than did the top half of the case. The condition of the lower half of the compressor case is shown in figure 28 (left side, forward section), figure 29 (right side, forward section), figure 30 (left side, rear section), and figure 31 (right side, rear section). The condition of the centrifugal impeller housing is shown in figures 32 and 33. The general condition of the rotor assembly is shown in figure

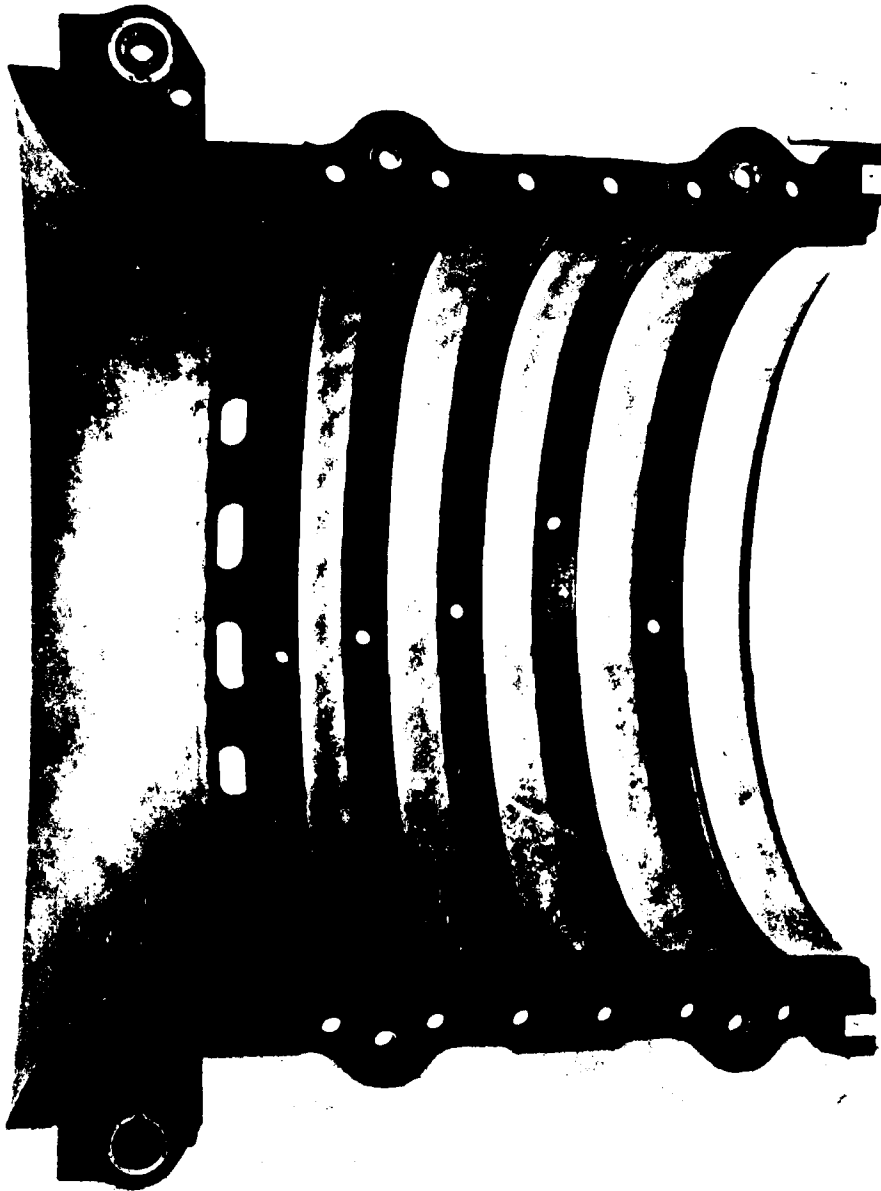
1. The general condition of the axial and centrifugal compressor housing of the baseline engine (S/N LE-10420) after 3.8 hours of sand exposure is shown in Figures 35 and 36. It would appear that the erosion of the axial compressor land areas of the metal-spray repaired engine (S/N LE-09484) after 3.6 hours of sand exposure is more severe than the erosion of the land areas of the baseline engine. Comparison of the trailing edge outboard blade tips of the axial compressor blades, however, indicated the blade tips on the baseline engine (S/N LE-10420) had eroded to a rounded-off condition (Figure 37). The trailing-edge outboard blade tips of the metal-spray repaired engine were thinning and rolling up toward the convex side (Figure 34), but had not eroded away like those in the baseline engine.

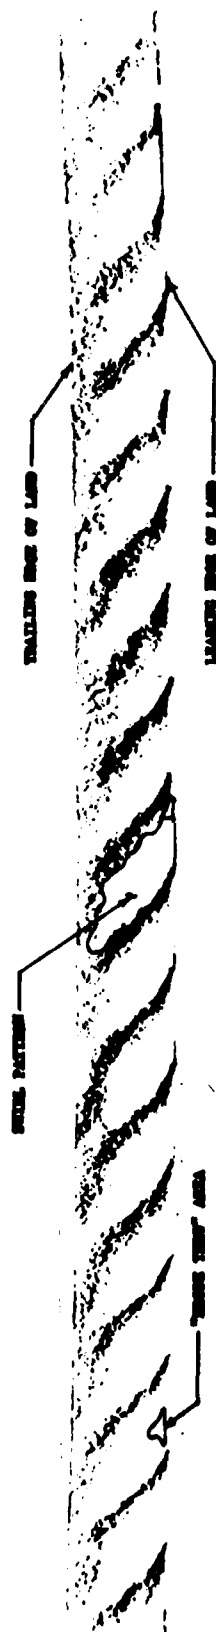
FIGURE 1

The down impression of the second stage land shows typical "wrist" patterns caused by sand and dust erosion. The dark areas are the peaks (high spots) and the light areas are the valleys (low spots). One "wrist" area was drawn in to show the shape and location, and also the point of deepest erosion.
