# EXAMINATION OF CORES FROM FOUR HIGHWAY BRIDGES IN GEORGIA

Sponsored by The Georgia Department of Transportation

Conducted by U. S. Army Engineer Waterways Experiment Station  
Concrete Laboratory  
Vicksburg, Mississippi

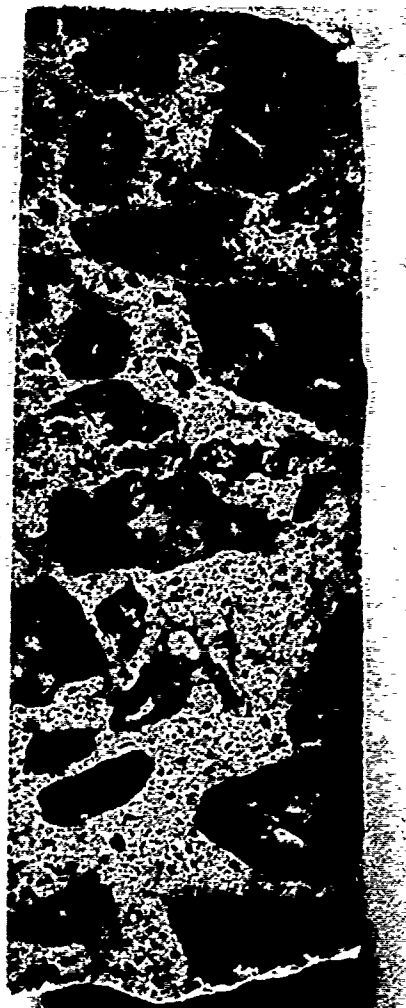
Photograph 1

GDOT-2(3) sawed and ground surface X 1.1. Top of the core at top. Coarse aggregate particles below arrow and above arrow are internally fractured (see photographs 2,3). Particle near right middle has an associated gel pocket (photograph 4). Many of the pieces of coarse aggregate contain internal cracks.

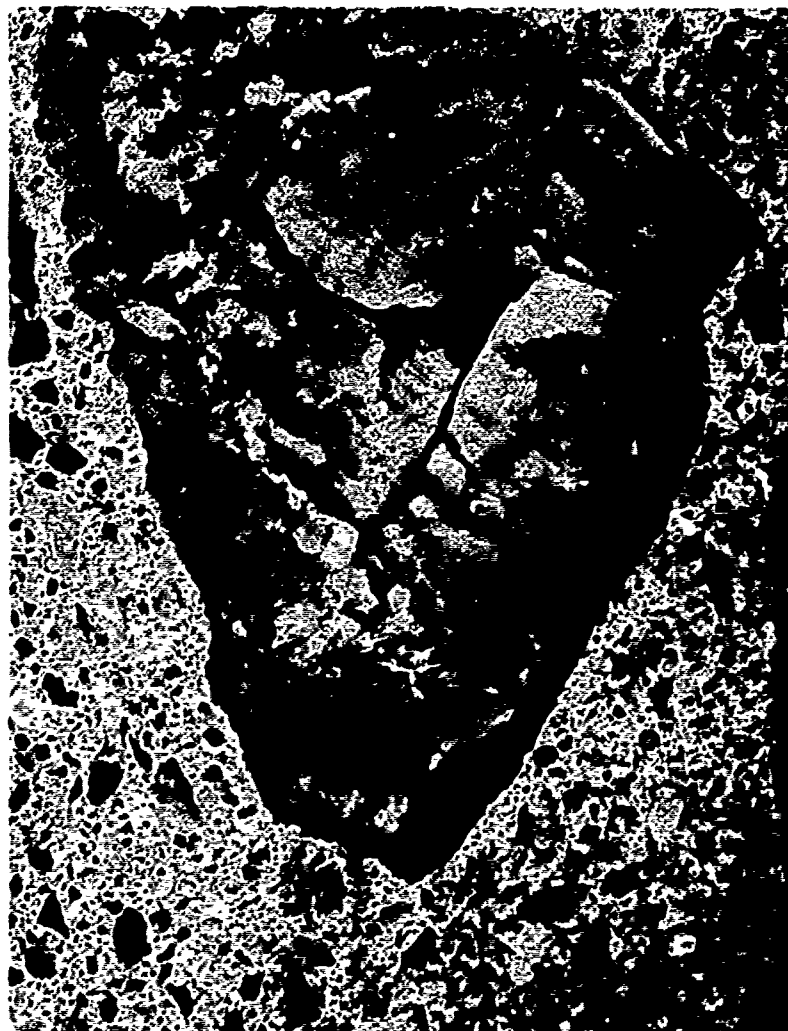
GDOT-2(3) Part of sawed and ground surface X 5.5. Extensive internal cracking of coarse aggregate particle and rim at upper left and lower left.

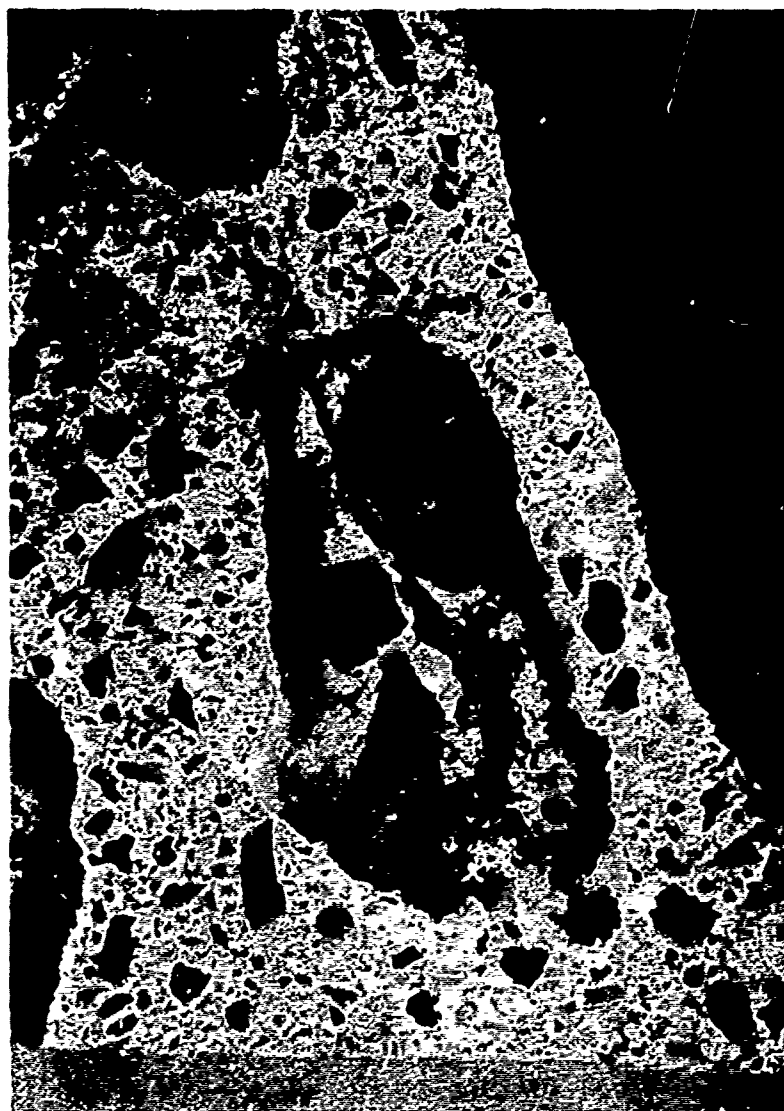
Photograph 3

GDOT-2(3) Part of sawed ground surface X 9 showing internal crack in coarse aggregate and apparent rim at top and lower right of particle. Particle in upper left of photograph is shown in photograph 4.

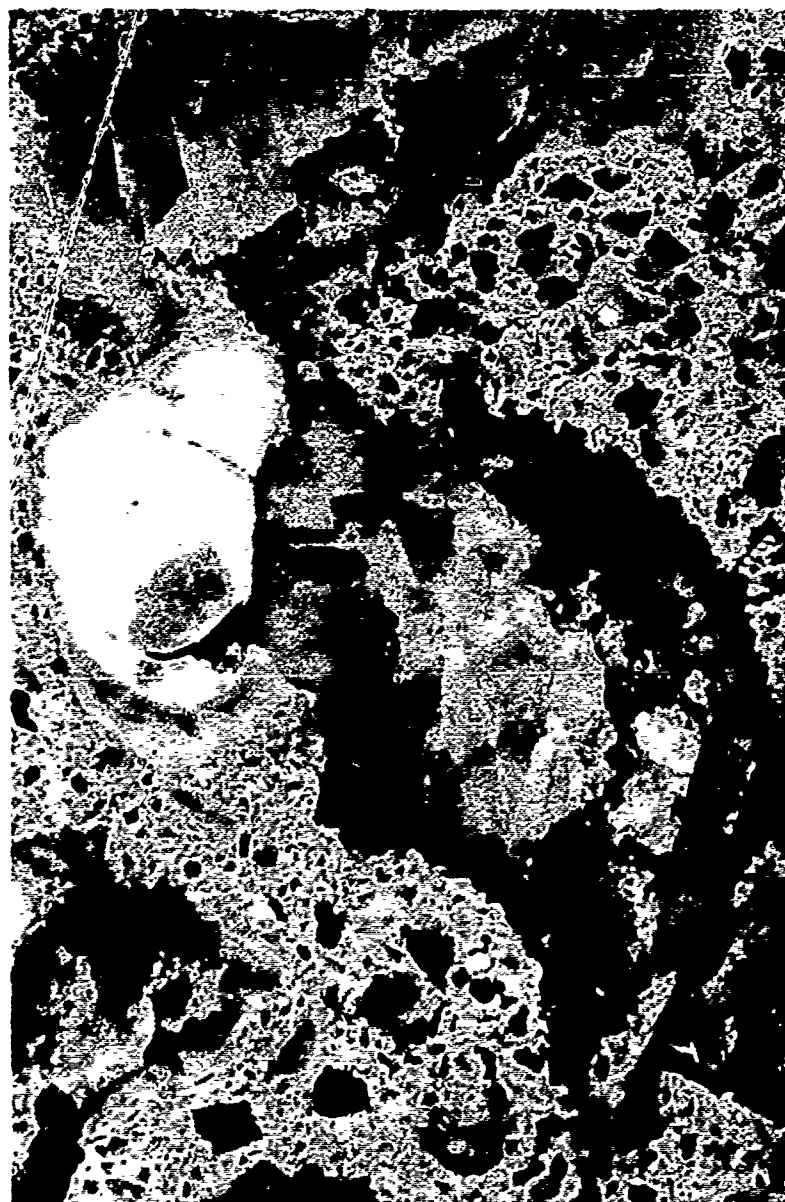
GDOT-2(3) sawed and ground surface X 9 showing a gel-filled pocket adjoining a coarse aggregate particle with internal cracks.

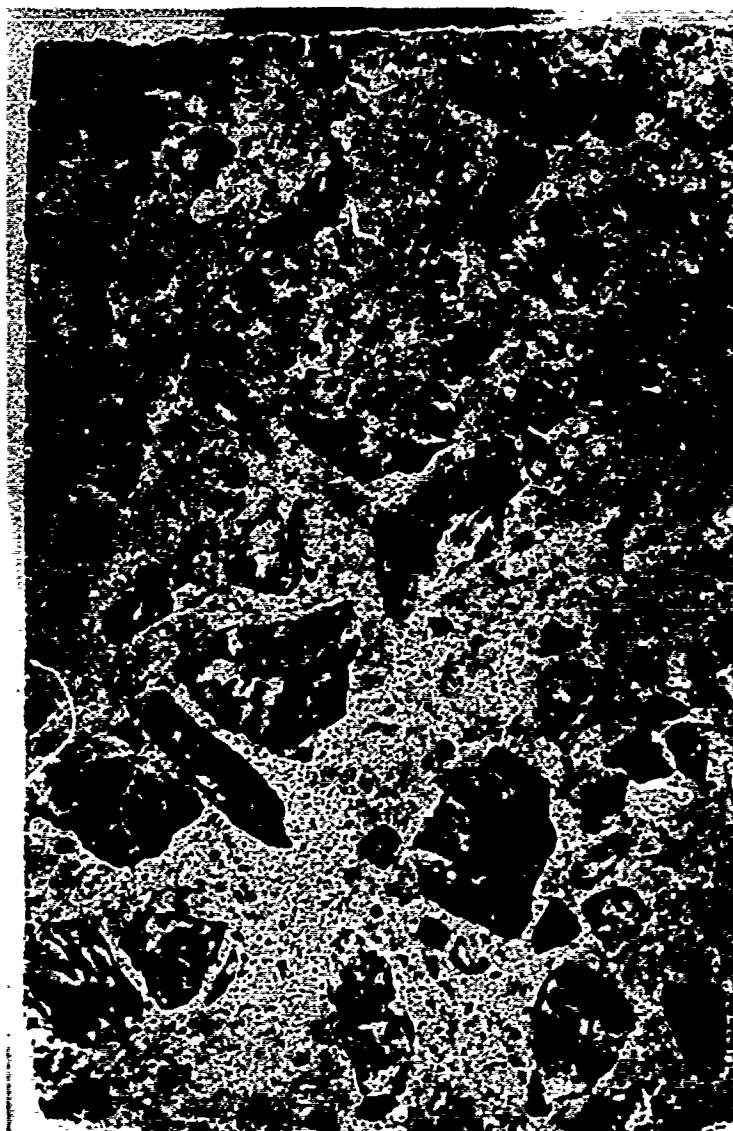
15. Photograph 5 shows a sawed and ground longitudinal section through the upper part of the core. Two open wide cracks run from the finished surface at the top of the photograph for relatively short distances into the core. In the relatively large mortar area about 4 in. below the top surface three vertically trending filled cracks can be seen. They are part of an extensive crack system that is traced in photograph 6. The crack near the middle of the top surface ran all the way across the top of the core, while the crack at the upper right was

GDOT-3 Longitudinal sawed and finely ground surface of the upper section of core X 1, showing rimmed coarse aggregate, internally cracked coarse aggregate, and narrow filled cracks in the mortar. The large irregular air void on the right in the lower half is lined with clear gel.

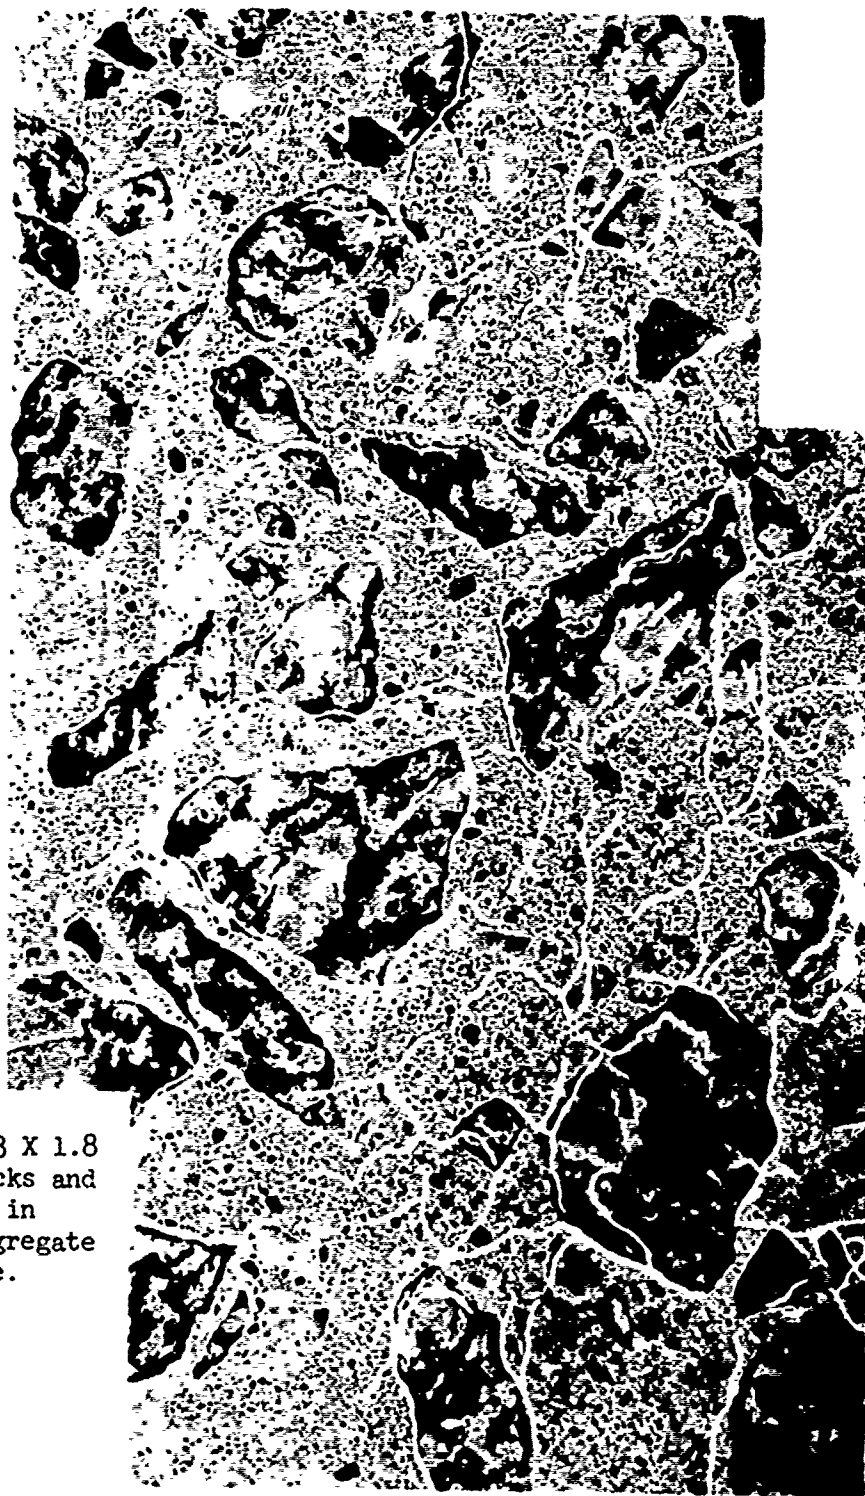
present but inconspicuous on the top surface. If one considers the crack system in photographs 5 and 6, on the surface, and in the thin sections it appears that elongation parallel to the long axis of the core and widening normal to the long axis of the core have both taken place. Some of the crack fillings in the paste and in a few cracked aggregate particles consist in part of alkali-silica reaction gel but a far greater part of the preserved fillings in the thin sections consist of ettringite. Presumably the ettringite filled the cracks that it occupies when the cracks were open and relatively empty, thus when the concrete as a whole was in an expanded condition. However, the concrete cannot be assumed to have been in the most expanded condition that it ever achieved, if it is assumed that ettringite crack-fillings bordering coarse aggregate, except those along undersides as cast, formed in space made vacant by shrinkage of the aggregate after it had been in the most expanded condition. It is not believed that there was an external source of sulfate to react with tricalcium aluminate but rather that the ettringite is that characteristic of fairly advanced concrete deterioration, and represents the original sulfate and tricalcium aluminate contents of the cement redeposited outside of the mortar in open space produced in part by early subsidence below coarse aggregate and in part by cracking caused by alkali-silica reaction.

Part of GDOT-3 X 1.8  
with open cracks and  
filled cracks in  
mortar and aggregate  
shown in white.

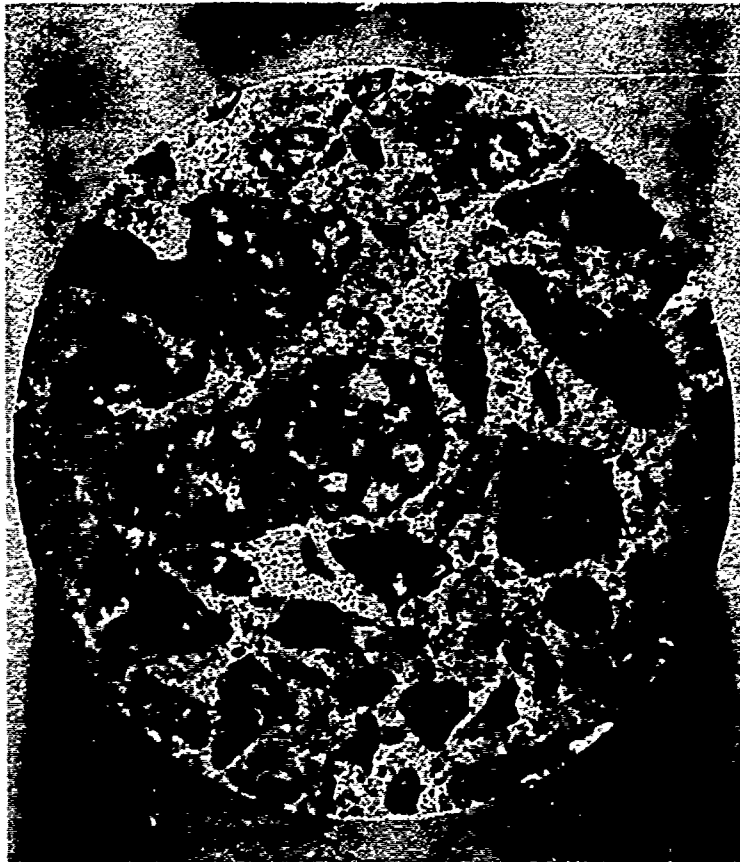
GDOT-4 Springfield transverse slice, finely ground, X 1. Some partial rims are seen, and open internal cracks in the large piece of coarse aggregate near the center at the upper right and the left end of the particle and just to the left of center on the lower margin.

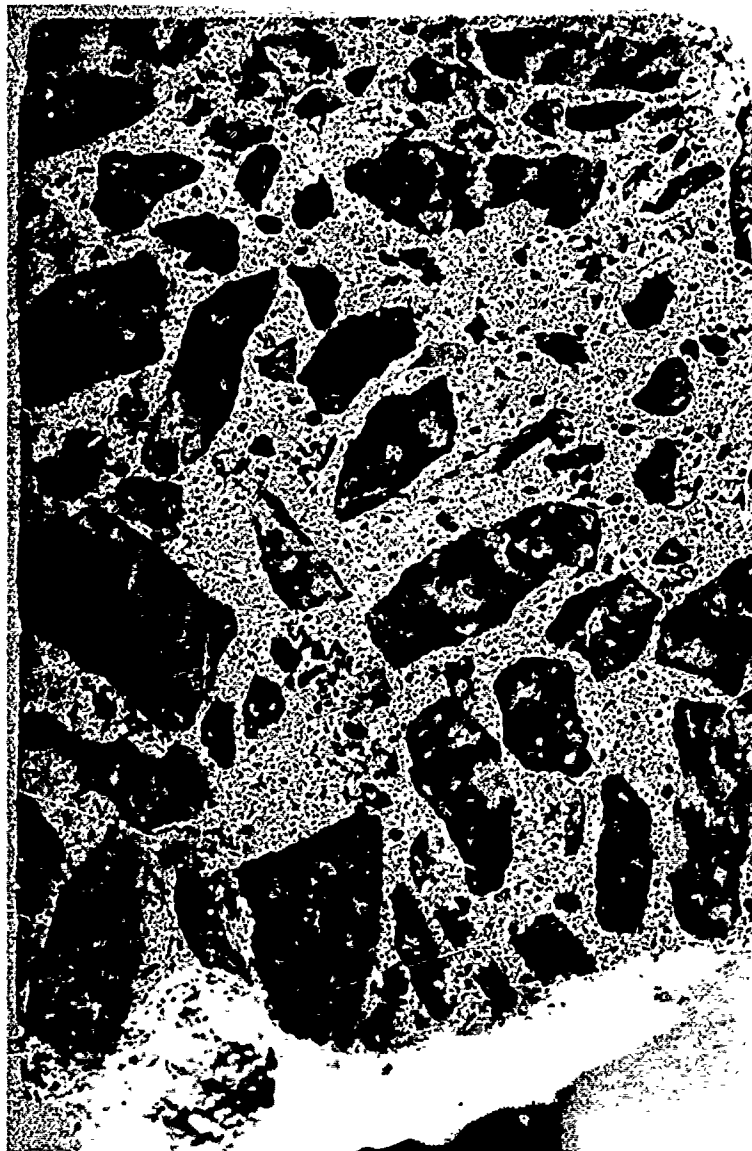
GDOT-5 (Springfield) finely ground longitudinal slice X 1 showing a crack visible on the outer surface, some rims on coarse aggregate, some internal cracks, and regions of very wet mortar toward lower left.
