DEPARTMENT OF THE ARMY
UNITED STATES ARMY AVIATION TEST BOARD
Fort Rucker, Alabama 36360

24 MAR 1966

SUBJECT: Letter Report, Armed and Armored Chinook Safety-Release
and Weapon-Verification Testing, USATECOM Project No.
4-5-2010-07

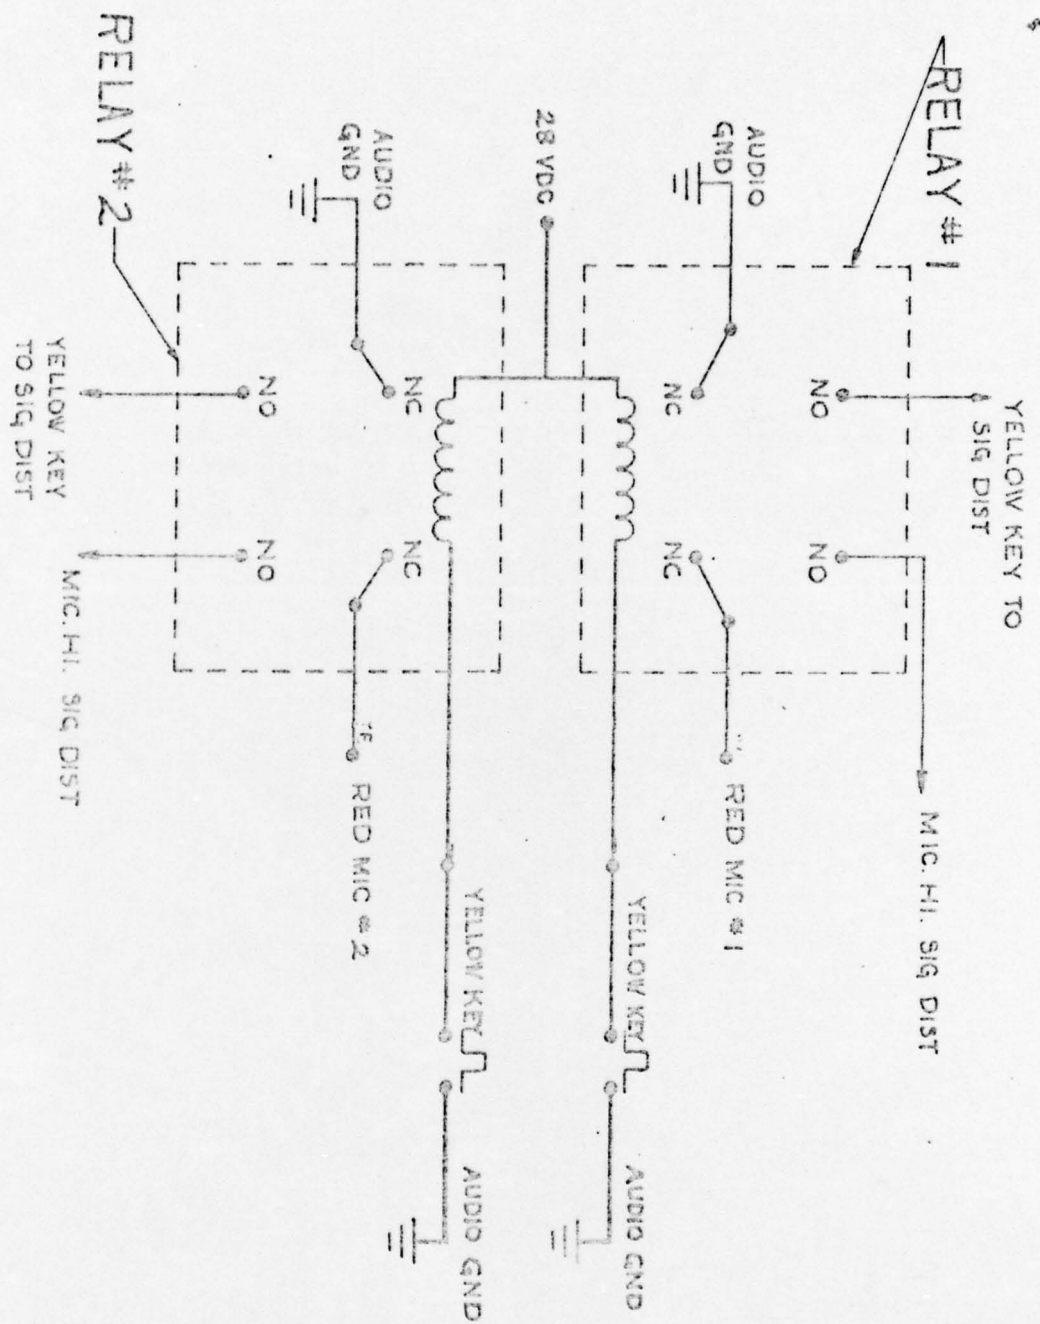
INDIVIDUAL KEYING CIRCUIT
 FOR GUNNER'S INTERCOM
 IN UH-1B, D HELICOPTERS

the helicopter, could not be achieved using the standard Army APH-5 helmet. An APH-5 helmet was modified with ear protector muffs, Model ASP-184, manufactured by David Clark Co., Inc. and with a directional microphone, FSN 5965-680-9798. The loss of communication between the gunners and other crewmembers is caused partially from both gunners using a common signal distribution amplifier. As a result, when one gunner "keyed" to talk, the other gunner's microphone was also energized, thus picking up twice the ambient noise (wind, rotor, transmission, engine, etc.) and causing an impedance mismatch to the amplifier. To eliminate keying of both microphones by one gunner and to make communication possible, a miniature 28 v. d. c. relay, FSN 5945-837-5318 (Incl 1) was installed in series with each gunner's microphone and key line to permit individual keying by each gunner.

c. The installation of the relays in series with each gunner's microphone line makes communication possible from the gunners to other crewmembers.

6. Conclusions. It is concluded that communication problems can be significantly reduced by the construction of a sound attenuating helmet with a highly directional microphone and installation of the miniature 28 v. d. c. relay.
