ARMY AVIATION TEST BOARD FORT RUCKER ALA  
TEST OF T53-L-13 ENGINE (S/N LE-14083).(U)  
NOV 68

DEPARTMENT OF THE ARMY  
UNITED STATES ARMY AVIATION TEST BOARD  
Fort Rucker, Alabama 36360

SUBJECT: Letter Report of Test of T53-L-13 Engine (S/N LE-14083).  
USATECOM Project No. 4-6-0150-05

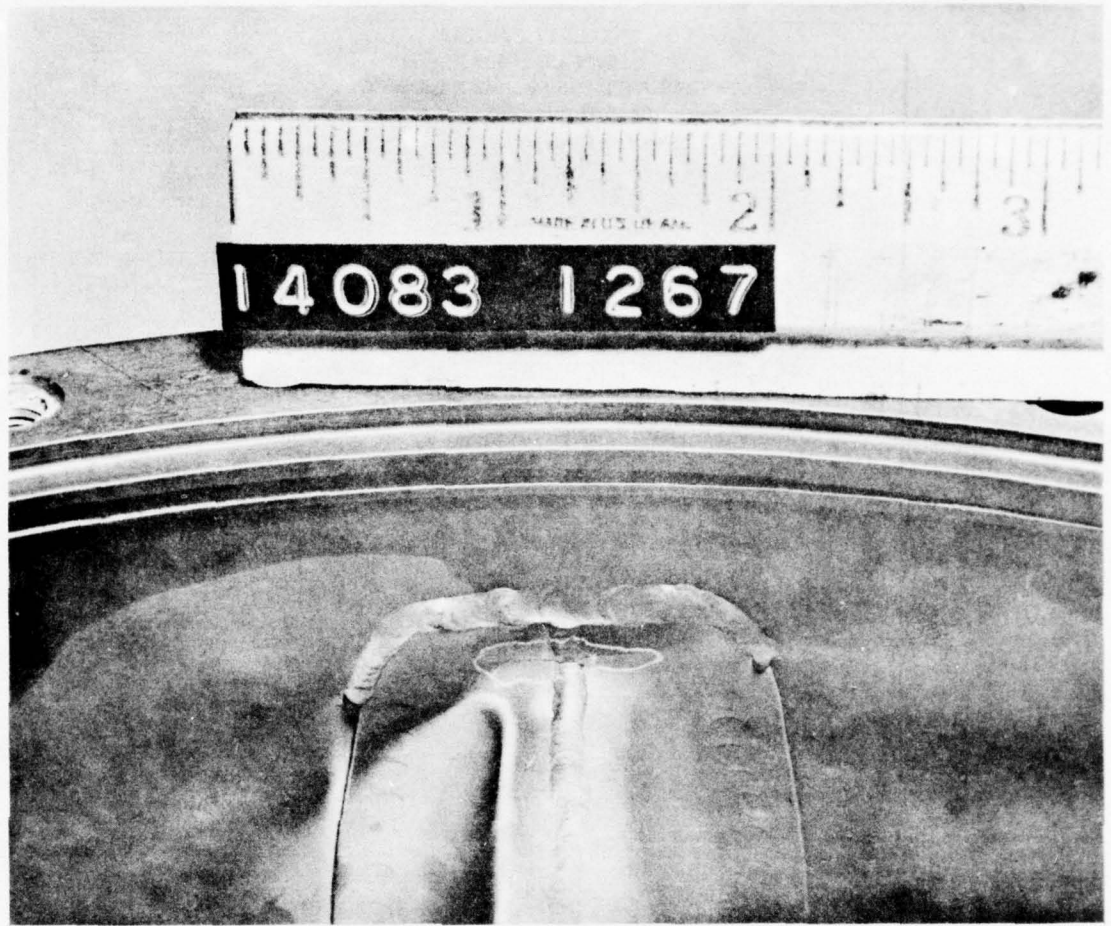
Figure 5.

| <u>Nomenclature</u> | <u>FSN and P/N</u> | <u>Component<br/>Hours</u> | <u>Damage Exceeding TB</u> |
|---|---|---|---|
| Exhaust<br>Diffuser | 2840-925-5467<br>1-150-240-01E | 300.0 | 5/8-inch crack extending circumferentially across weld in outer strut at outboard leading edge (figure 5). |

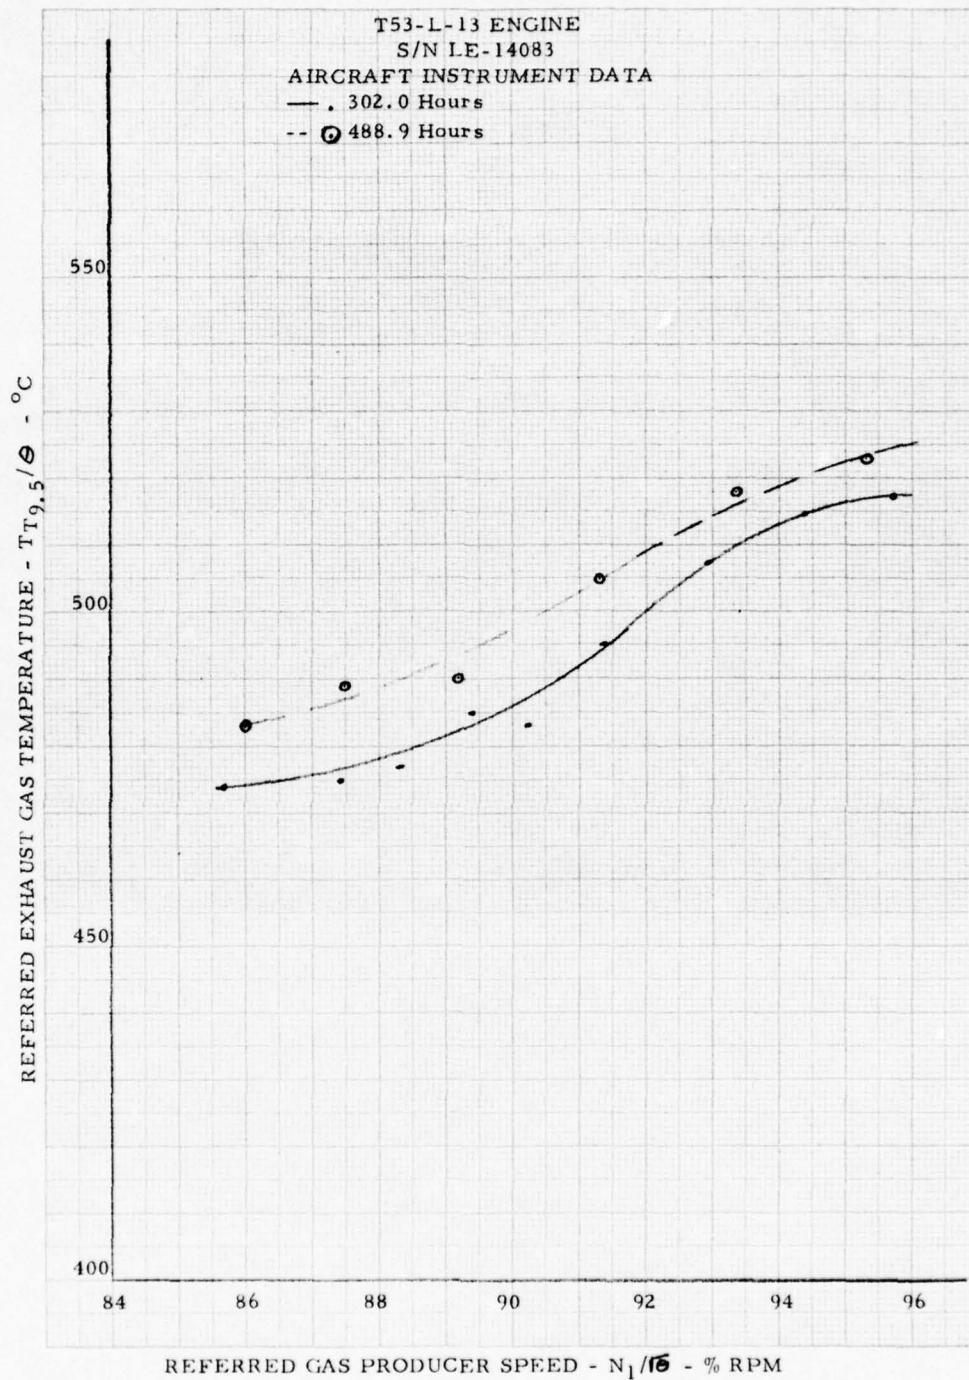
Figure 6.

| <u>Engine<br/>Hours</u> | <u>Fault and/or Remarks</u> | <u>Action Taken</u> |
|---|---|---|
| 488.9 | Engine exhaust gas temperature (EGT) increased approximately 15 <sup>o</sup> C. (figure 6). | Replaced flow divider (troubleshooting). |

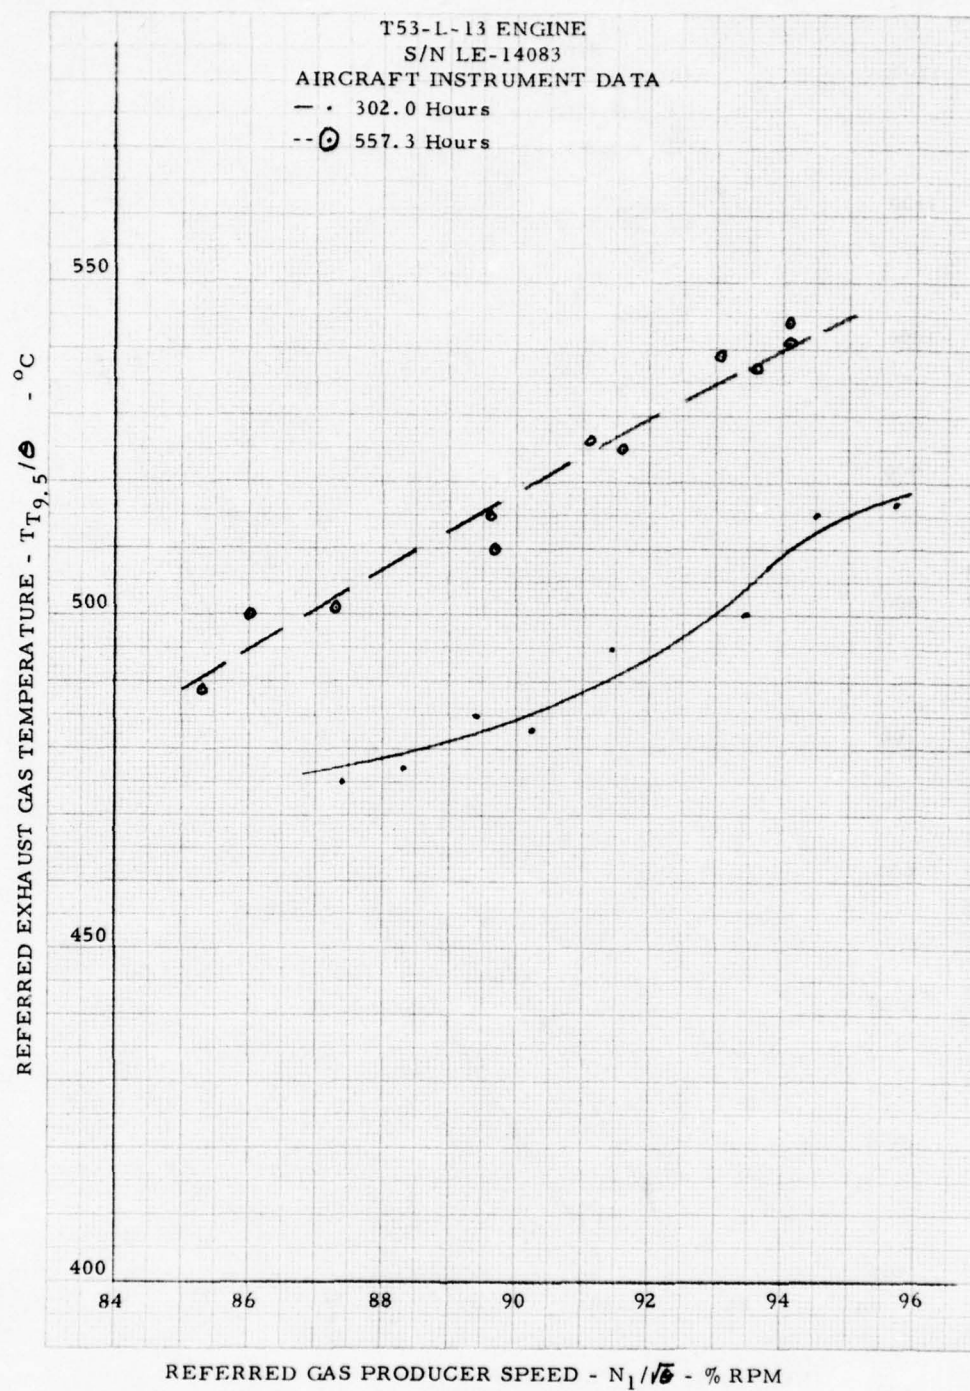
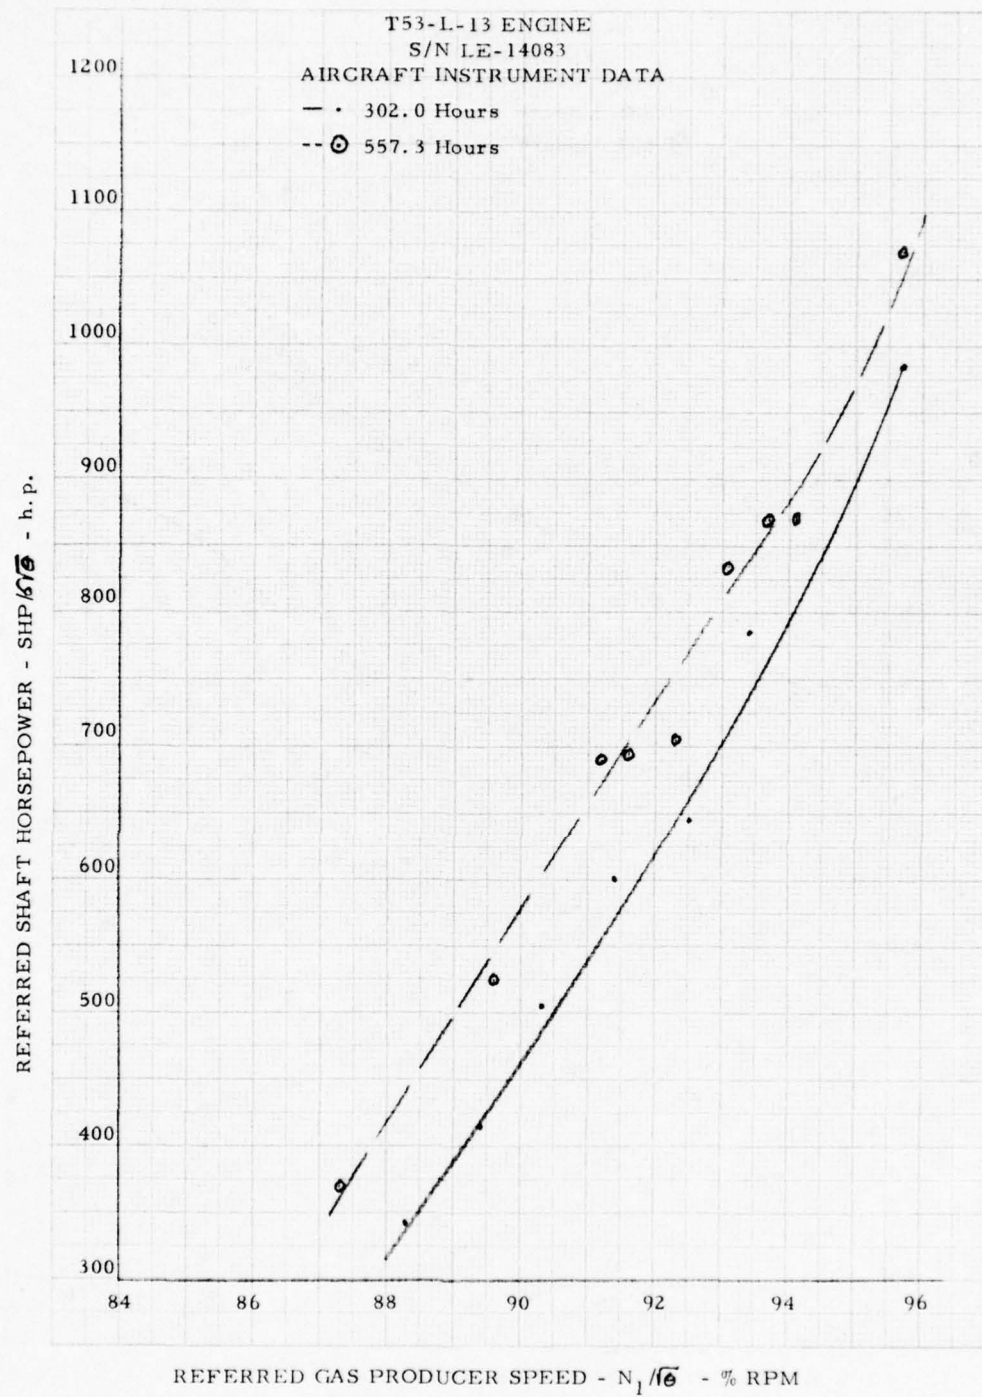
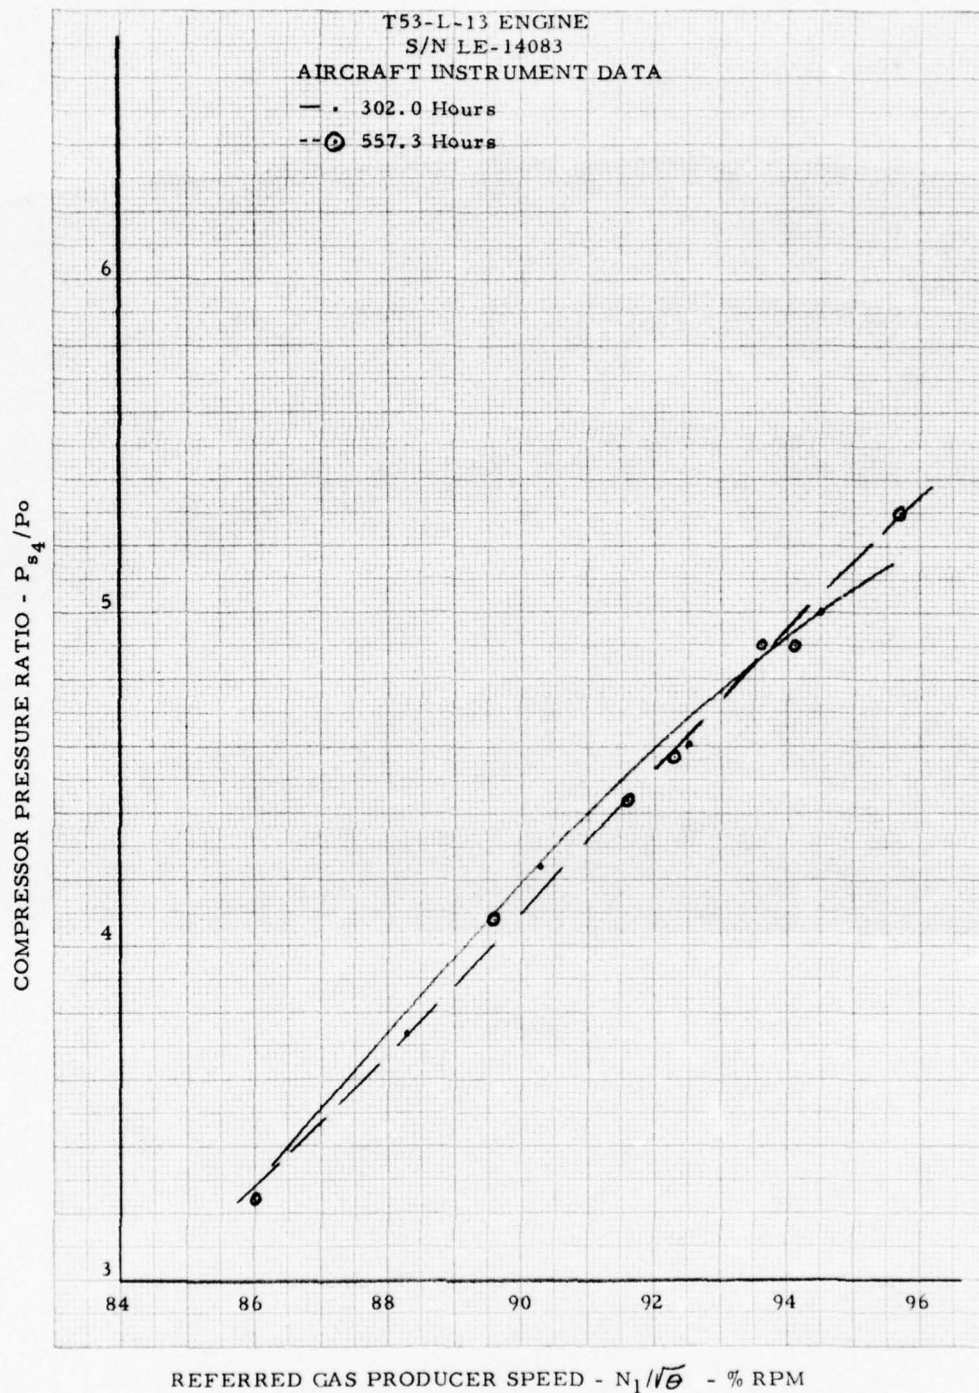
b. Figures 9, 10, and 11 show engine performance prior to removal at 557.3 hours compared to performance subsequent to reassembly after the 300-hour analytical hot-end inspection. It should be noted that the increases in EGT were evident only when EGT was referred and compared to the referred EGT immediately after reassembly of the engine at 300.0 engine hours. The indicated EGT observed by the pilots in no way alerted them to an increase in EGT.

e. The increase in referred EGT was symptomatic of the severe circumferential cracking in the first-stage GP nozzle and the associated tip rubbing of the first-stage GP rotor. It should be emphasized again that the rise in EGT was not evident to the pilot. Only by referring the EGT and comparing it to a baseline EGT did the increase become apparent.

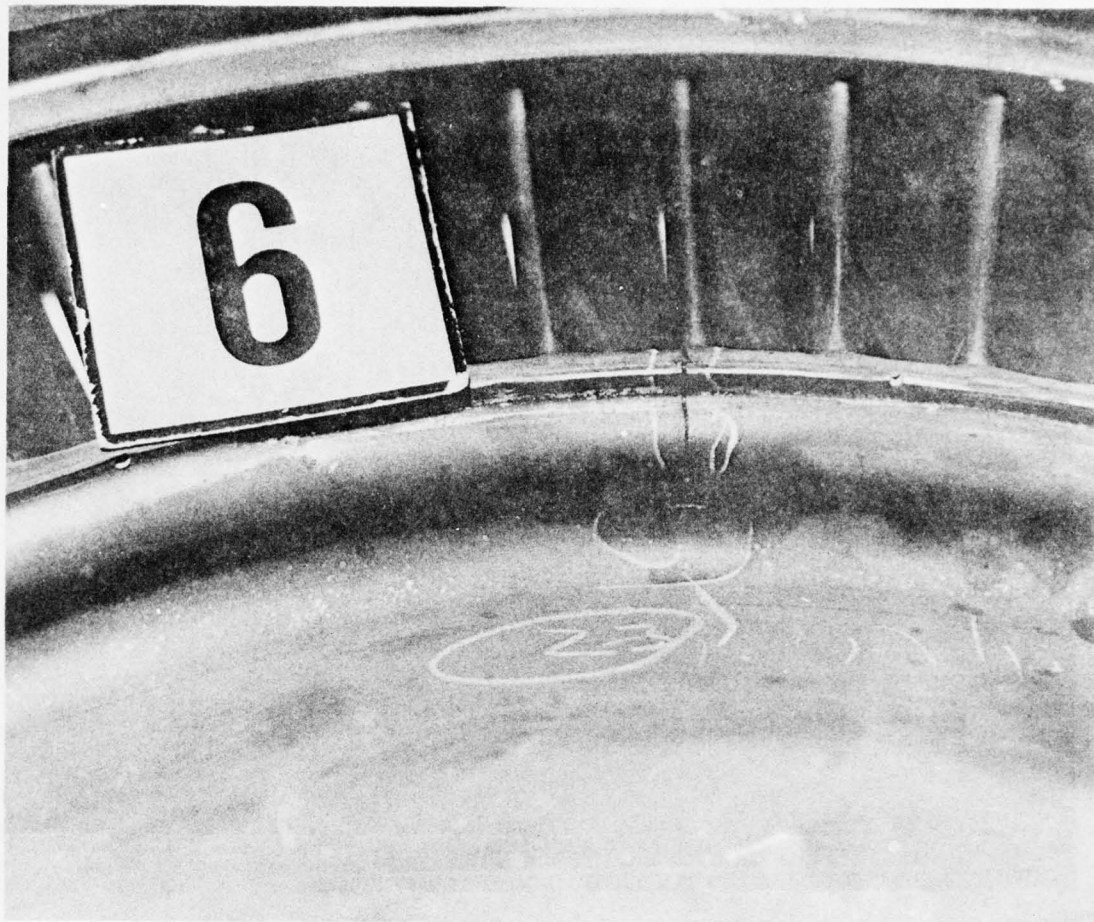
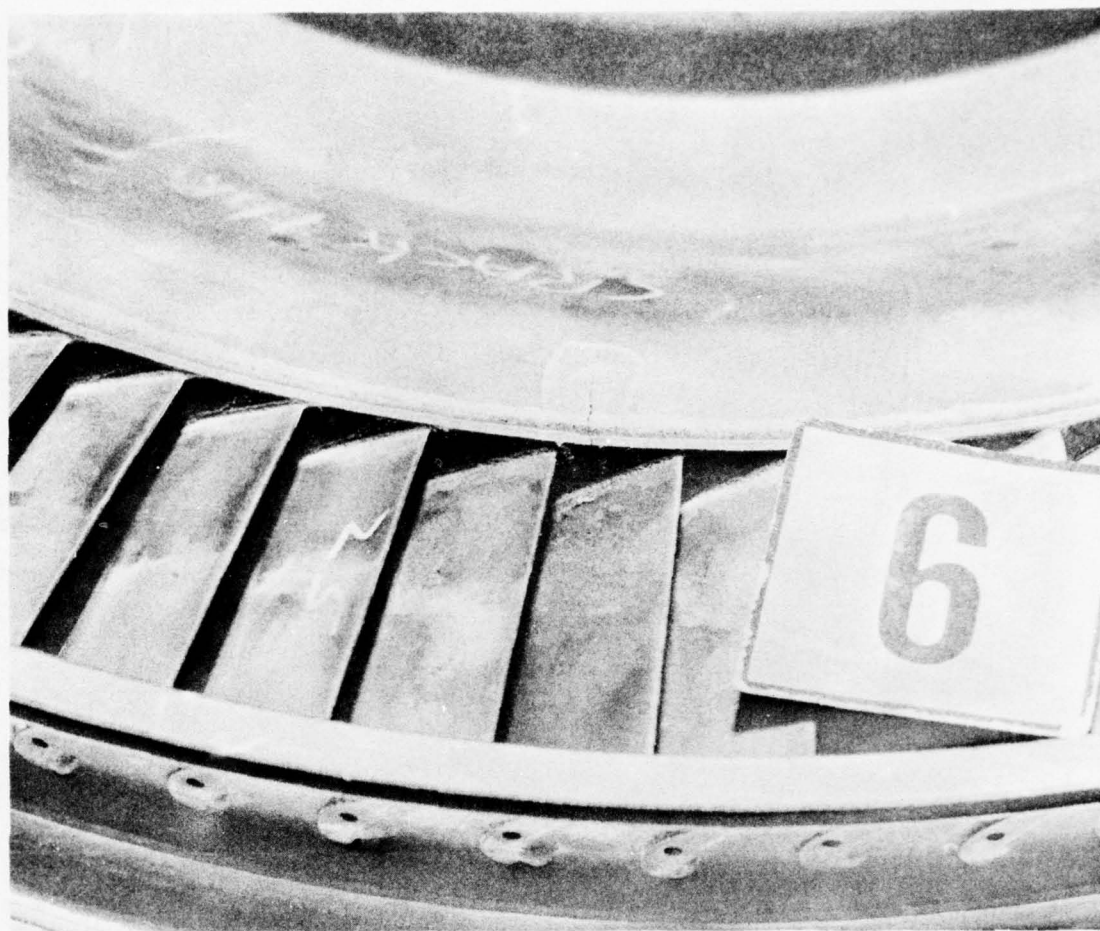
| <u>Nomenclature</u> | <u>FSN and P/N</u> | <u>Component Hours</u> | <u>Damage Exceeding TB</u> |
|---|---|---|---|
| Second-Stage<br>GP Nozzle | 2840-925-9665<br>1-120-000-06D | 557.3 | Two cracks extending completely across inner shroud with up to 1/2 inch of cracking in vane brazement. Both inner shroud cracks extended into the front support 7/32 to 3/8 inch and into the aft support 5/32 to 13/32 inch (figures 14 and 15). |

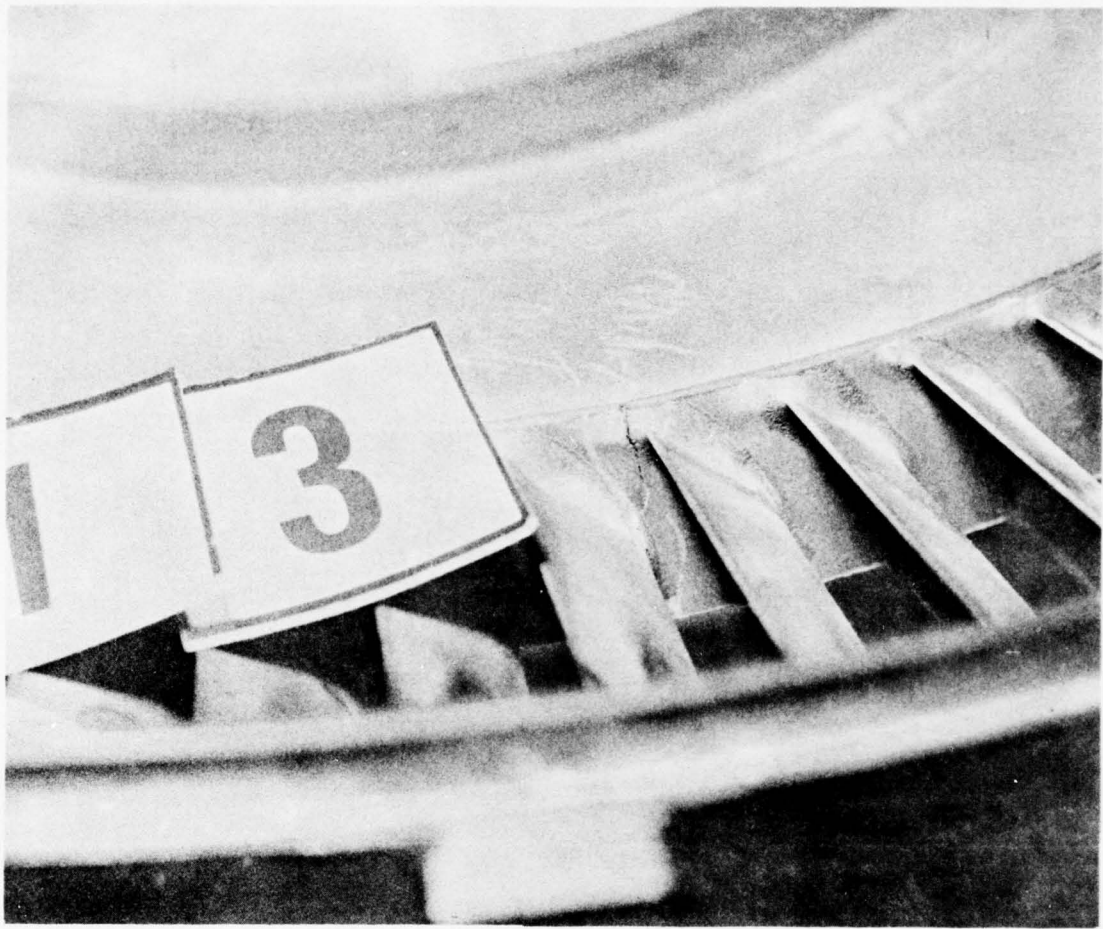
Figure 16.

| <u>Nomenclature</u> | <u>FSN and P/N</u> | <u>Component Hours</u> | <u>Damage Exceeding TB</u> |
|---|---|---|---|
| Second-Stage<br>Power-Turbine<br>(PT) Nozzle | 2840-943-2382<br>1-140-470-05E | 557.3 | Two 5/8-inch cracks in inner shroud and vane brazements (figure 16). |

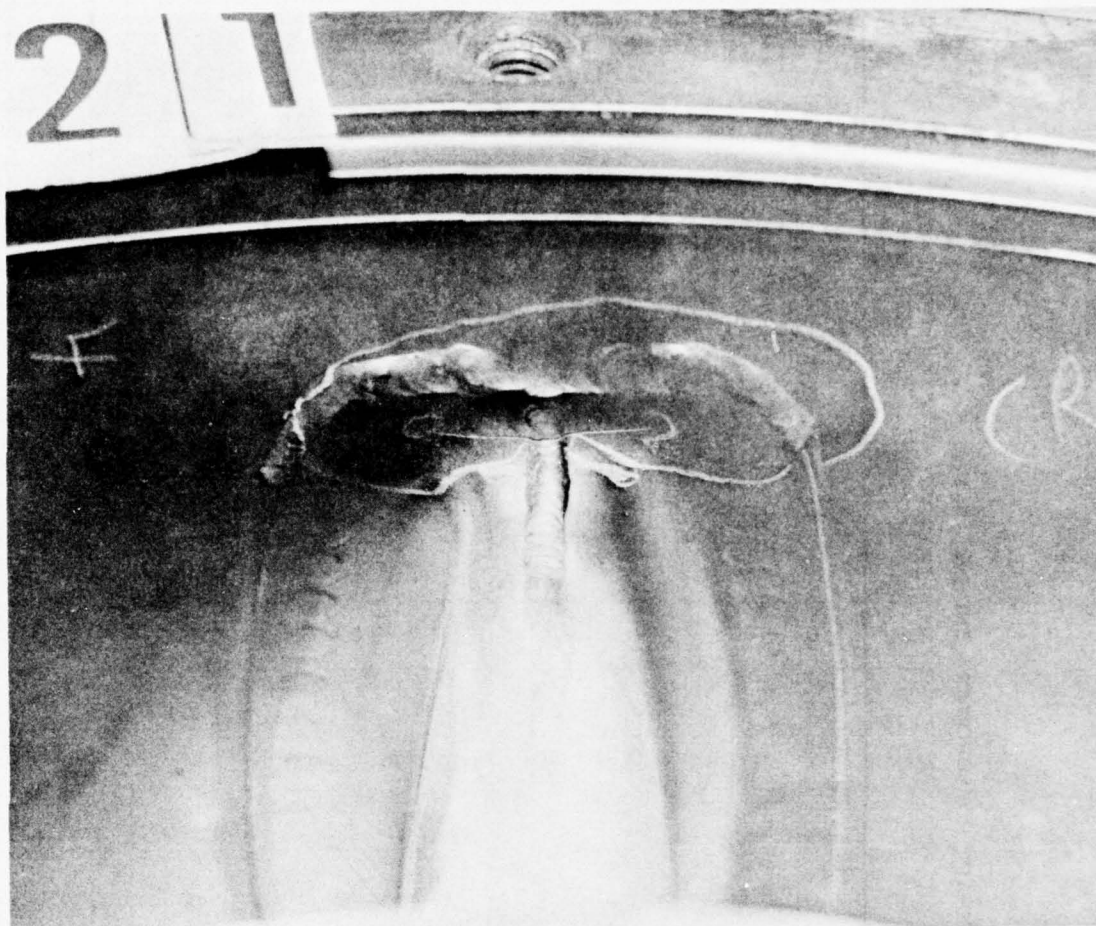
Figure 17.

| <u>Nomenclature</u> | <u>FSN and P/N</u> | <u>Component Hours</u> | <u>Damage Exceeding TB</u> |
|---|---|---|---|
| Exhaust<br>Diffuser | 2840-925-5467<br>1-150-240-01E | 557.3 | Two cracks extending across two struts at out-board leading edge. Both extended across weld and measured 1/2 and 3/4 inch (figure 17). |

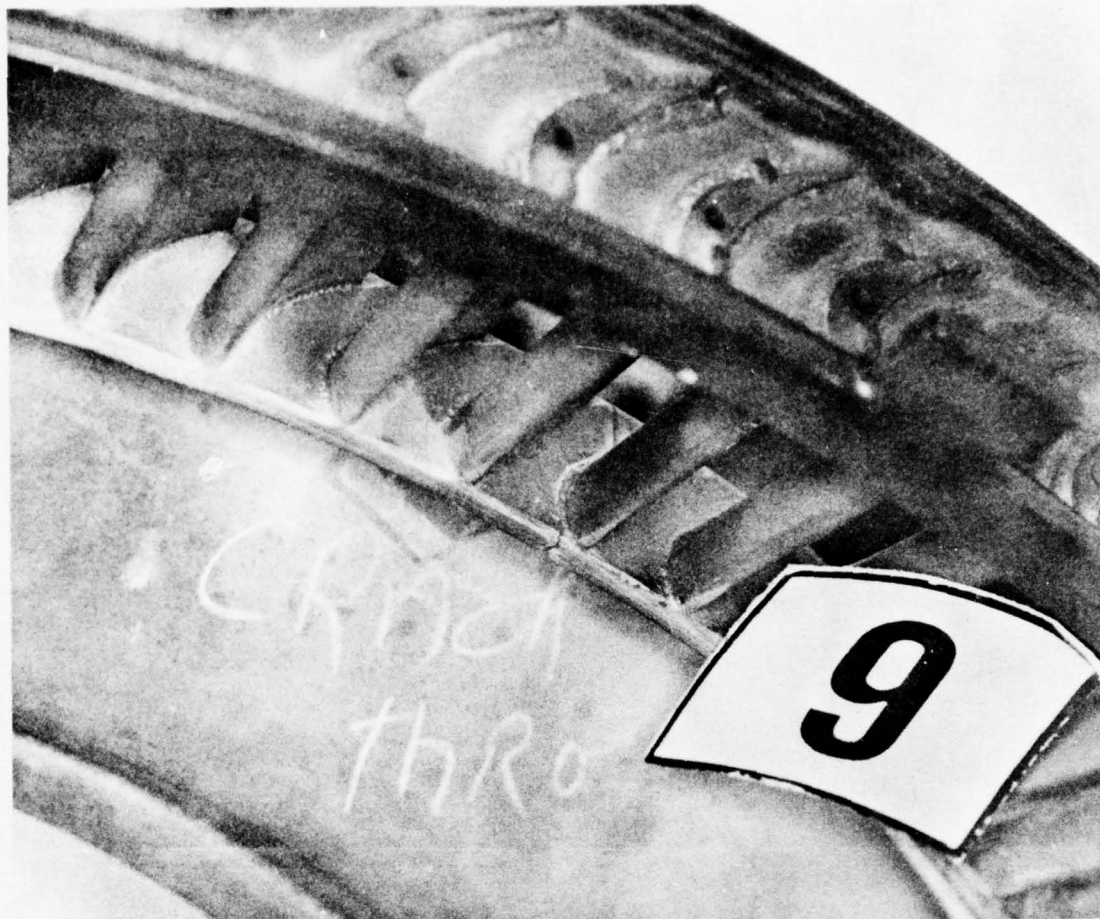
Figure 23.

| <u>Nomenclature</u> | <u>FSN and P/N</u> | <u>Component</u> | |
|---|---|---|---|
| Second-Stage<br>GP Nozzle | 2840-925-9665<br>1-120-000-06D | 897.3 | Three cracks extending across inner shroud with up to 1/2 inch of cracking in vane brazement (figure 23). Two of these cracks extended into both the front and aft supports. One extended only into the front support. The cracks extended between 7/32 and 25/32 inch into the forward inner support and between 3/8 and 1/2 inch into the aft inner support (figures 24 and 25). Thirty-nine vanes had brazement cracks extending 5/16 inch in the outer shroud at the leading edge. At 17 vanes, these brazement cracks extended axially up to 5/32 inch into the outer shroud (figure 26). |

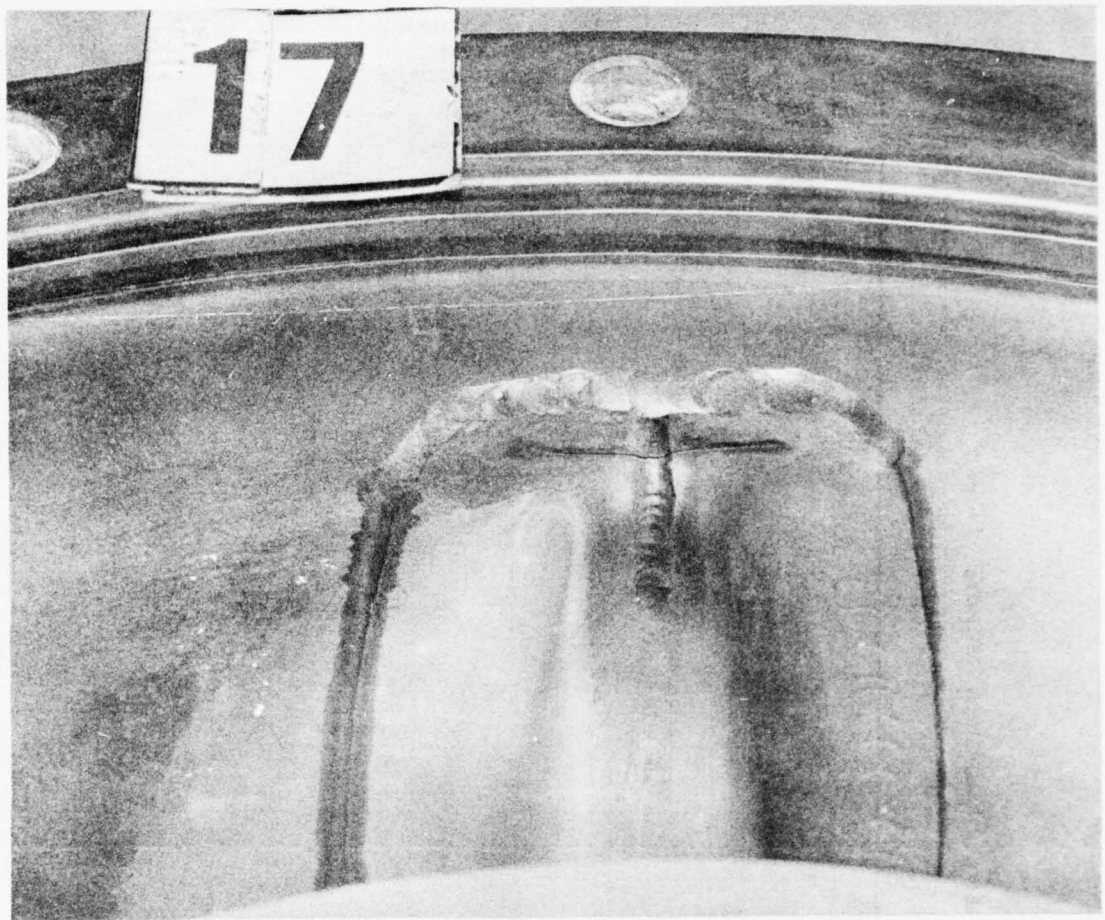
Figure 29.

| <u>Nomenclature</u> | <u>FSN and P/N</u> | <u>Component<br/>Hours</u> | <u>Damage Exceeding TB</u> |
|---|---|---|---|
| Exhaust<br>Diffuser | 2840-925-5467<br>1-150-240-01E | 897.3 | Two cracks extended across two struts at the outboard leading edge. Both extended across the weld and measured 27/32 and 3/4 inch (figure 29). |

| <u>Nomenclature</u> | <u>FSN and P/N</u> | <u>Component<br/>Hours</u> | <u>Damage Exceeding TB</u> |
|---|---|---|---|
| Exhaust<br>Diffuser | 2840-925-5467<br>1-150-240-01E | 1,500.7 | Two struts had cracks of 13/16 and 1 inch in the leading edge at the outer shroud (figure 29). |

| <u>Nomenclature</u> | <u>FSN and P/N</u> | <u>Component Hours</u> | <u>Damage Exceeding TB</u> |
|---|---|---|---|
| Exhaust<br>Diffuser | 2840-925-5467<br>1-150-240-01E | 1,808.3 | Two struts had cracks in the leading edge at the outer shroud. One extended 1 inch circumferentially. The other crack extended 1 1/8 inch circumferentially (figure 29). Another crack, forward of the previous crack and located in the mid cone, extended 1 11/16 inch circumferentially. At the midpoint of this crack, a crack branched 1/4 inch axially to the strut weld and then extended out 1 inch along the strut weld into the mid cone at a 45-degree angle to the strut (figure 45). |

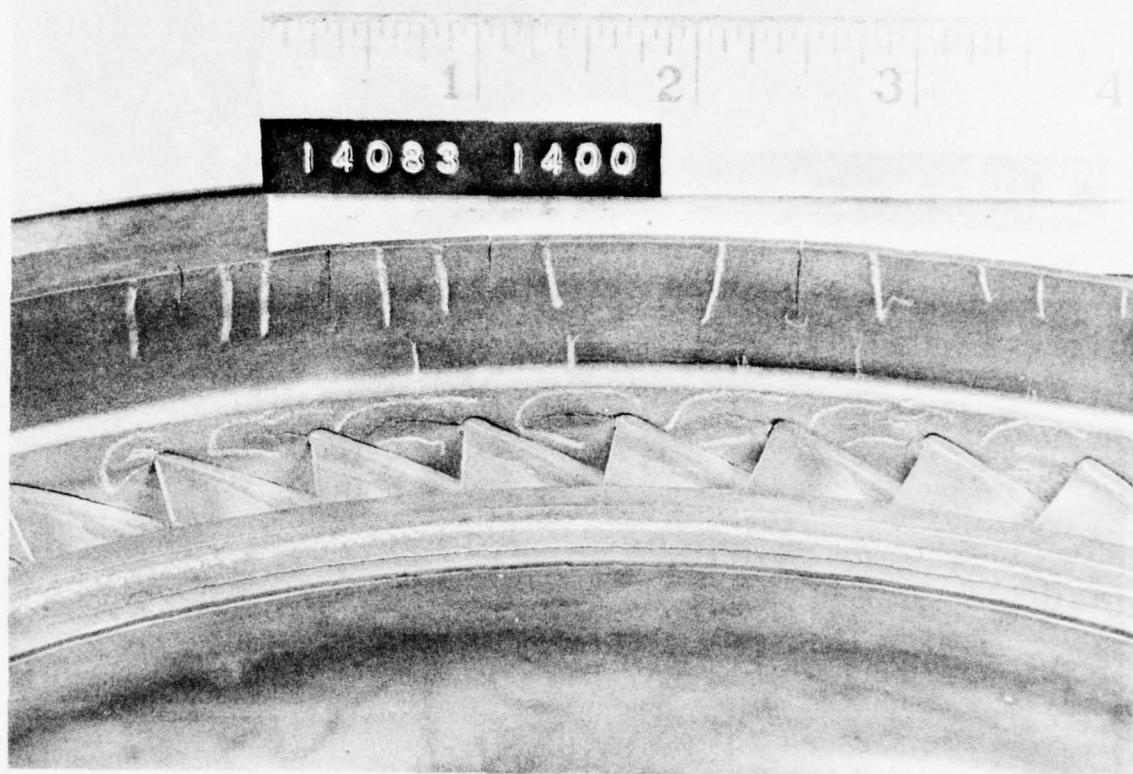
Figure 33.

| <u>Nomenclature</u> | <u>FSN and P/N</u> | <u>Component<br/>Hours</u> | <u>Reason for Replacement</u> |
|---|---|---|---|
| First-Stage<br>GP Nozzle | 2840-975-0258<br>1-110-520-14 | 642.0 | Cracks in channel at rear of nozzle extended circumferentially through areas of 6 1/2, 8 1/4, and 10 inches (figure 33). Circumferential crack in outer shroud connecting trailing edge of three vanes (figure 34). New cast nozzle, P/N 1-110-520-19, installed (ECP LY-GT-155). |

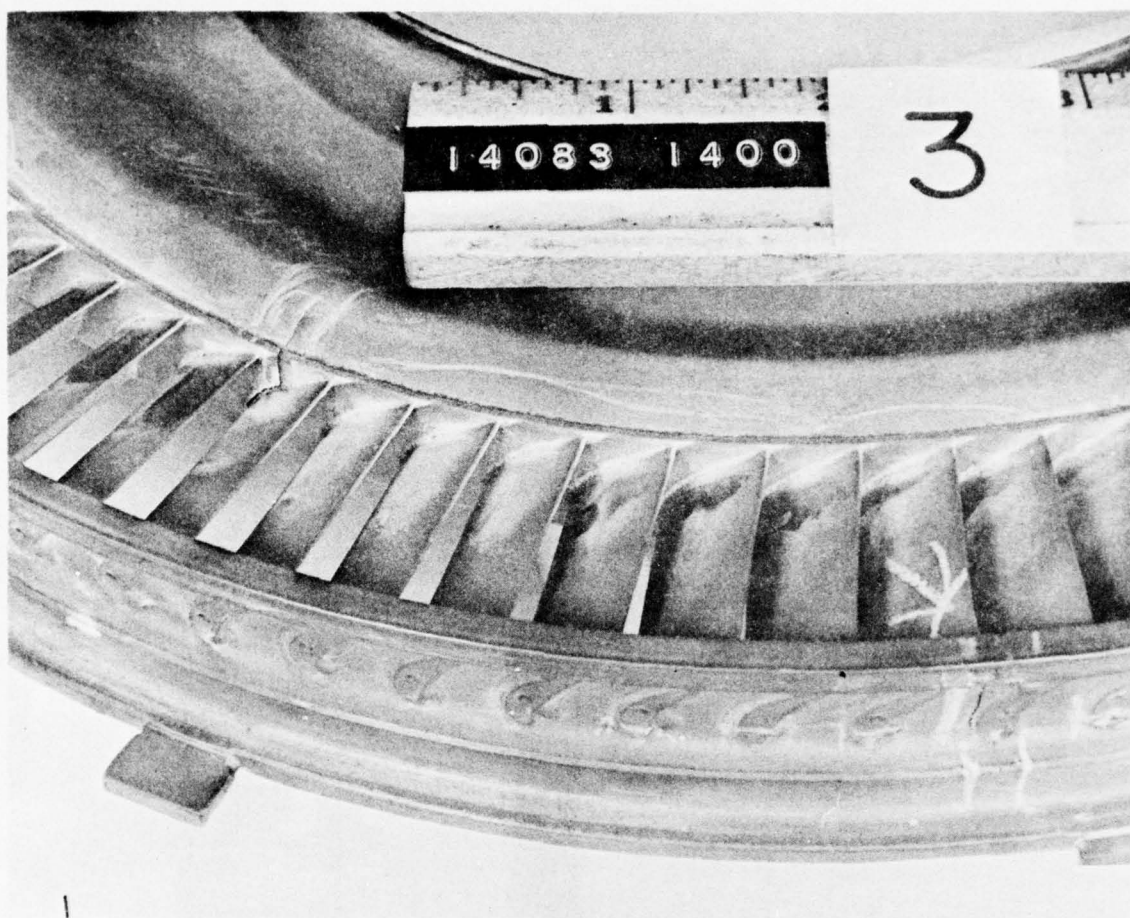
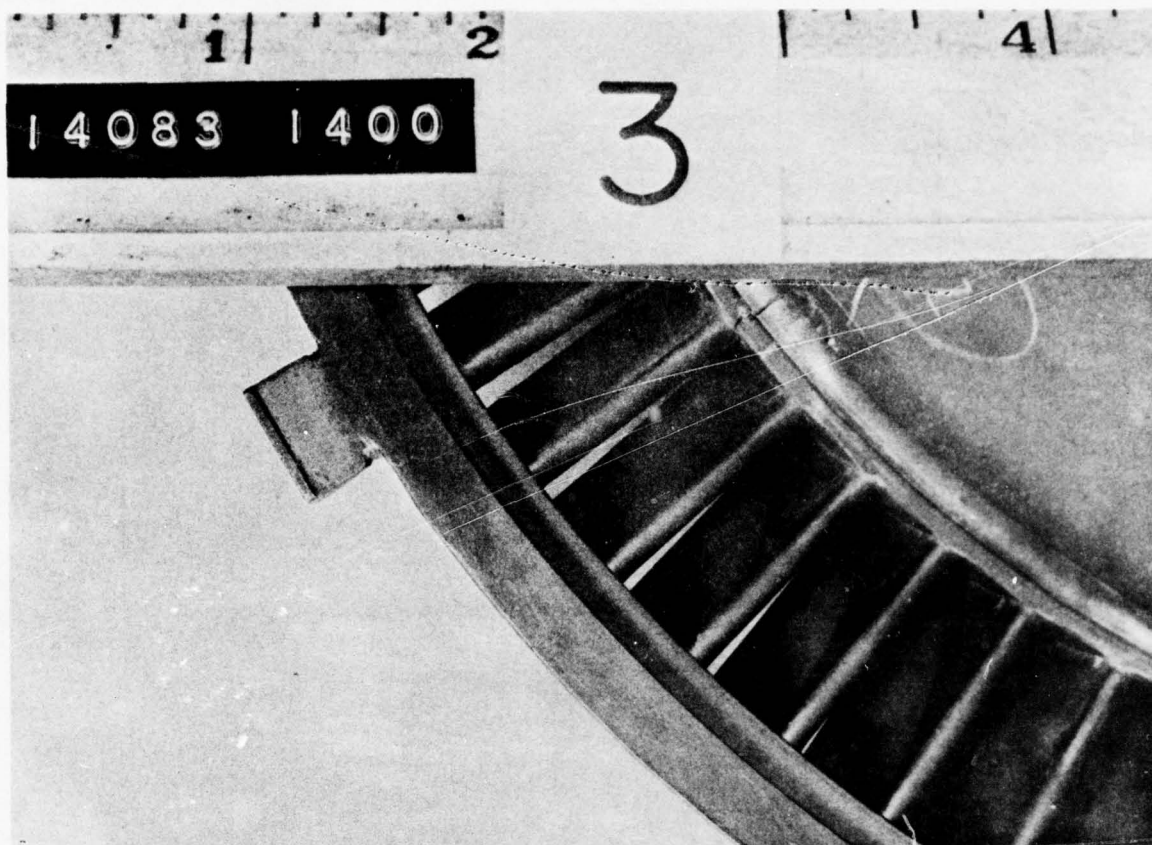
| <u>Nomenclature</u> | <u>FSN and P/N</u> | <u>Component<br/>Hours</u> | <u>Damage Exceeding TB</u> |
|---|---|---|---|
| | | | into the outer shroud axially at the leading edge of the vanes; however, they did not extend over the step. Ten cracks extended over the edge of the step up to 3/8 inch from the vane leading edge. Two vanes had brazement cracks of 5/16 and 15/16 inch at the inner shroud. Two other vane brazement cracks extended into the outer shroud to both the leading and trailing edges, completely across the outer shroud. (These type cracks are shown in figures 36 and 37.) |

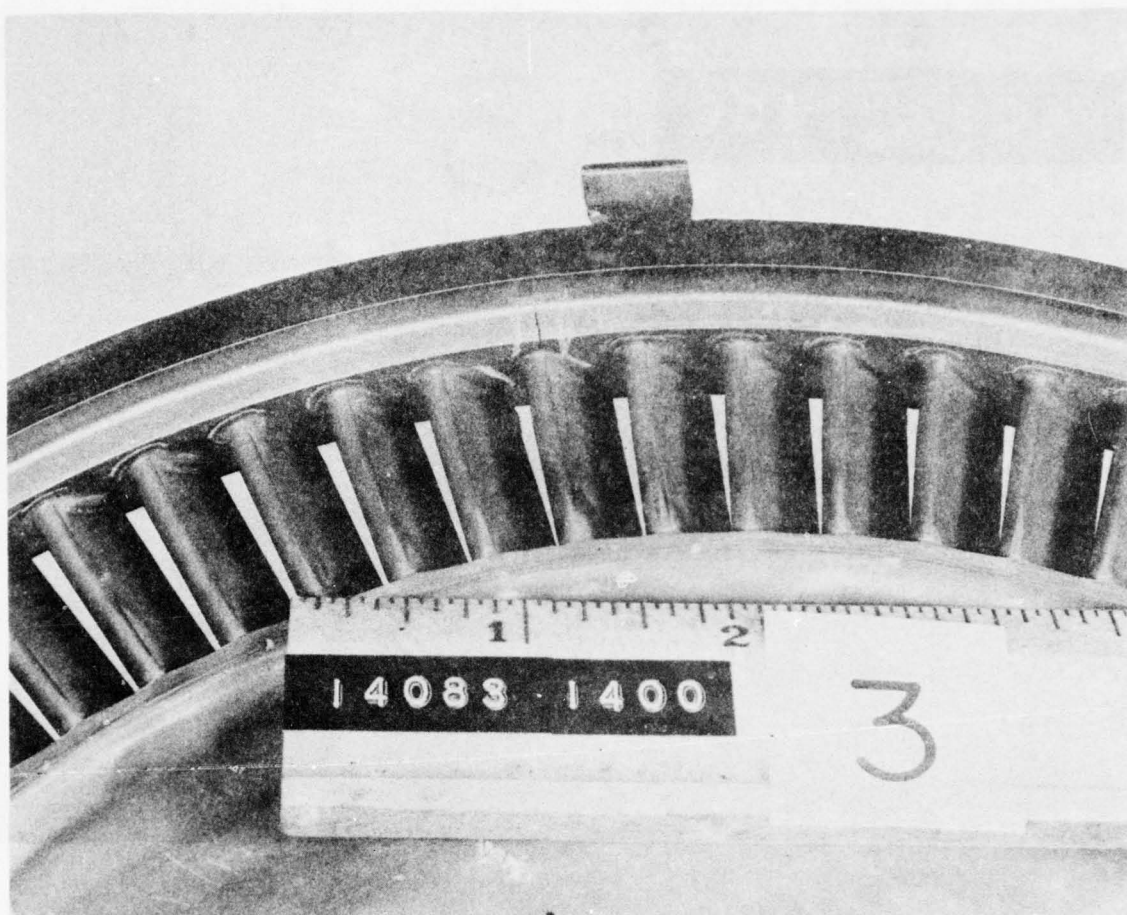
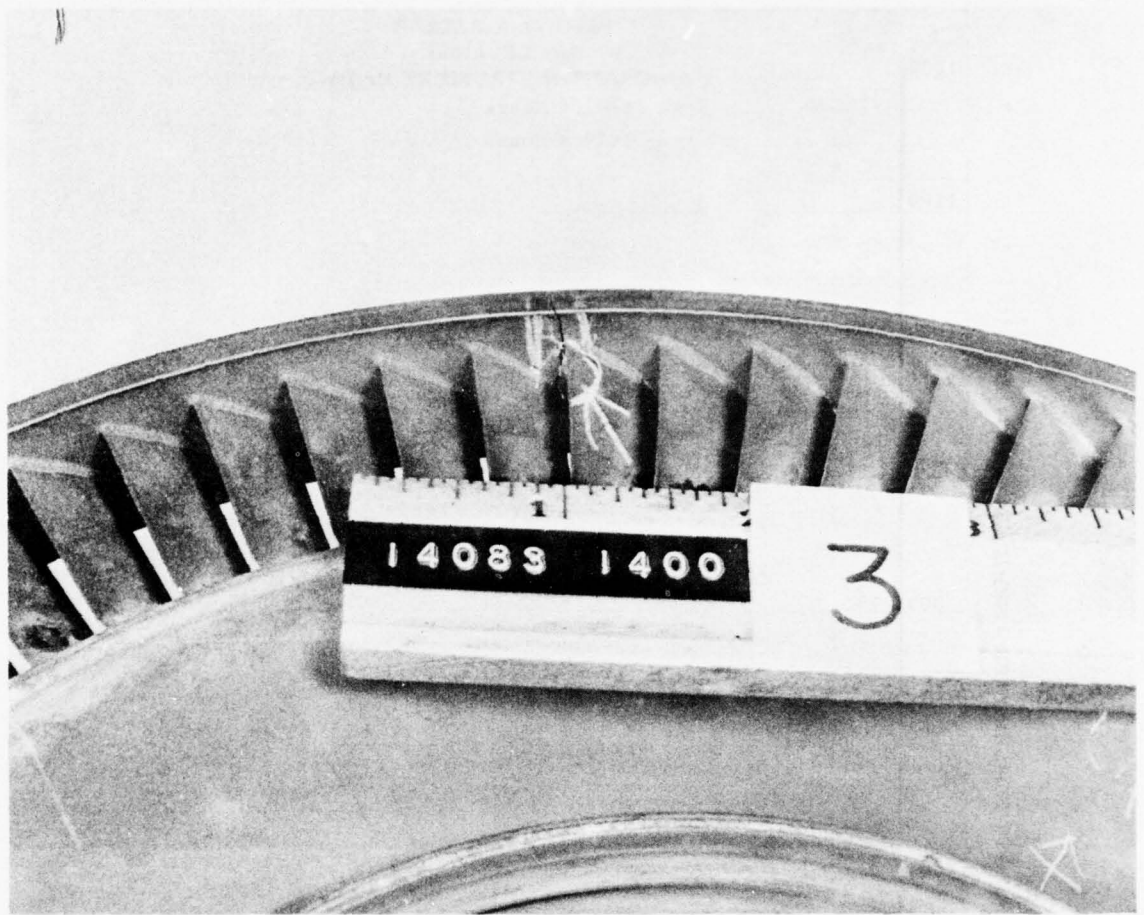
| <u>Nomenclature</u> | <u>FSN and P/N</u> | <u>Component<br/>Hours</u> | <u>Damage Exceeding TB</u> |
|---|---|---|---|
| | | | of the outer shroud. Five of these type cracks extended over the edge of the step at the leading edge of the nozzle up to 11/32 inch from the vane leading edge (figure 38). Three vane brazement cracks extended axially up to 1/2 inch toward the trailing edge of the nozzle (figure 39). |

| <u>Nomenclature</u> | <u>FSN and P/N</u> | <u>Component<br/>Hours</u> | <u>Damage Exceeding TB</u> |
|---|---|---|---|
| | | | <p>vanes in the outer shroud extending axially from the vane leading edge toward the nozzle leading edge; however, they did not extend over the step. Seven brazement cracks which extended into the outer shroud extended over the step onto the vertical face of the outer shroud up to 3/8 inch axially from the leading edge of the vane. Two vanes had cracks in the outer shroud and vane brazement of 9/16 and 1 3/16 inch total length. The cracks did not extend completely to the leading or trailing edge. These cracks are shown in figures 38 and 39.</p> |

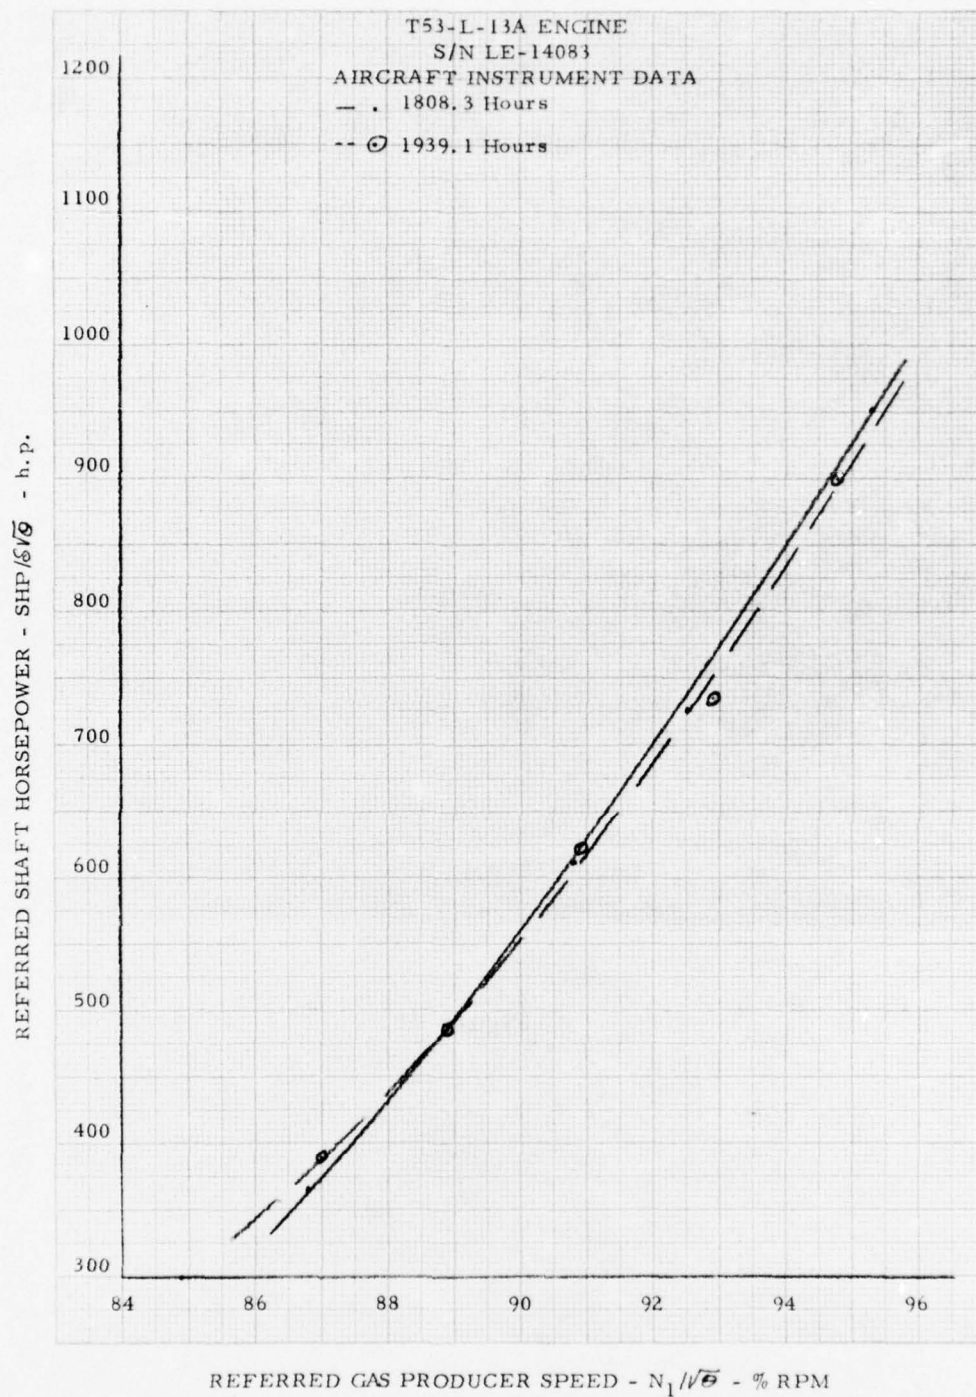
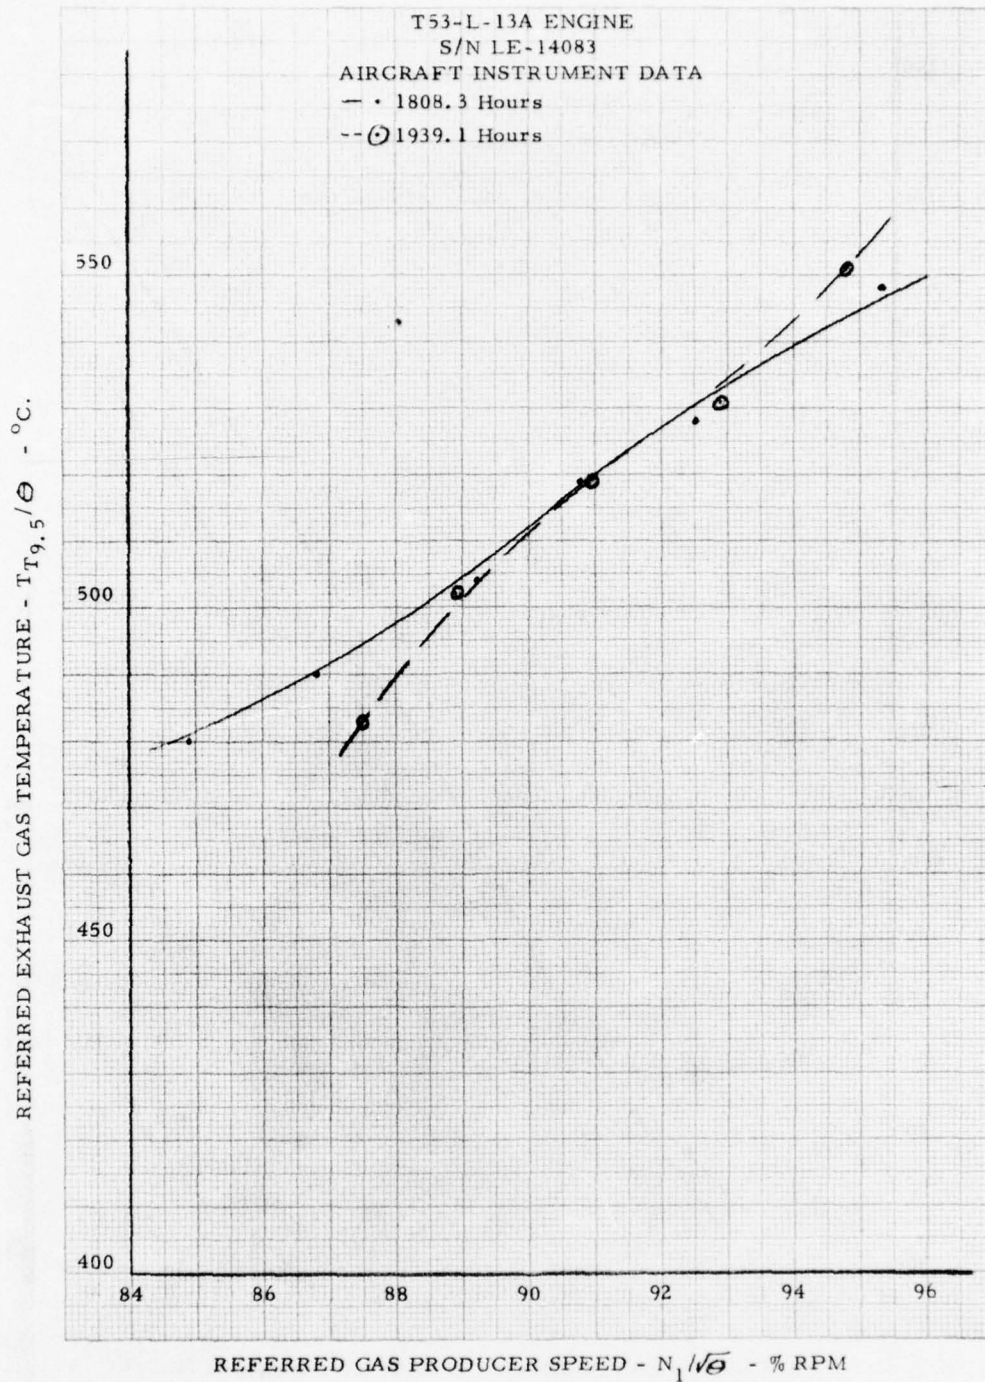
b. Figures 46 and 47 show the engine performance just prior to the compressor disc failure as compared to the performance after the 1,808.3-hour inspection. Figures 48 and 49 show the change in engine performance due to use and nozzle change during the 1,839.1 hours of operation at the USAAVNTBD.
