DEPARTMENT OF THE ARMY  
UNITED STATES ARMY AVIATION TEST BOARD  
Fort Rucker, Alabama 36360

SUBJECT: Final Report of Product-Improvement Test of OH-6A  
Rotor Blades with Increased Twist and Contour Tolerances.

SUBJECT: Final Report of Product-Improvement Test of OH-6A Rotor  
Blades with Increased Twist and Contour Tolerances,  
USATECOM Project No. 4-6-0251-18

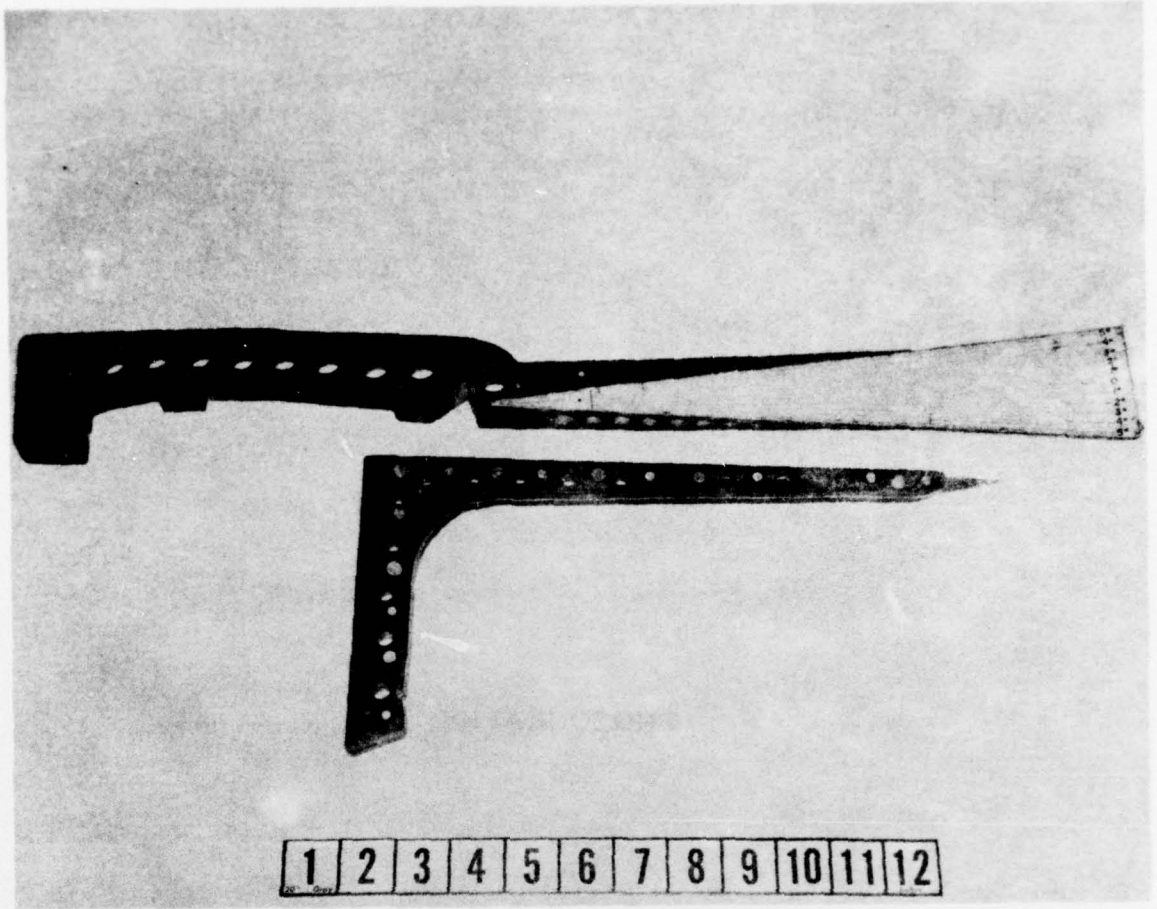
Figure 1.

- d. Accurate trim tab or pitch change link adjustments were not possible with existing tools. Locally manufactured tools (figures 1 and 2, inclosure 4) were used during the test.

c. Tools suitable for accurate adjustment of trim tabs and pitch-change links be provided to units equipped with the OH-6A.
