14 PTPD REPORT NO. 76-34  
16 AFPEA-REPORT NO. 76-P7-40  
12

6 GNU-179 A/E CONTAINER  
ROUGH HANDLING AND VIBRATION TEST.

HQ AFALD/PTP  
AIR FORCE PACKAGING EVALUATION AGENCY  
Wright-Patterson AFB OH 45433

11 October 1976

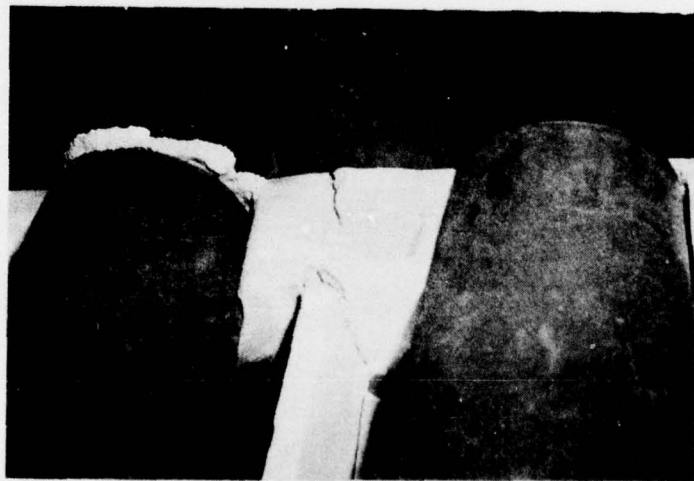
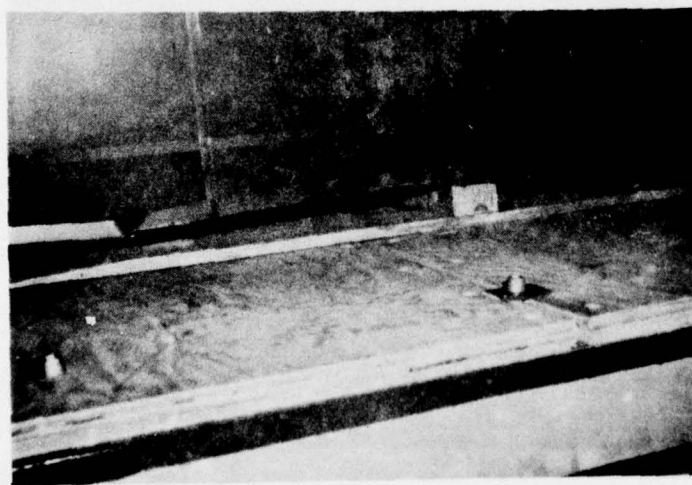
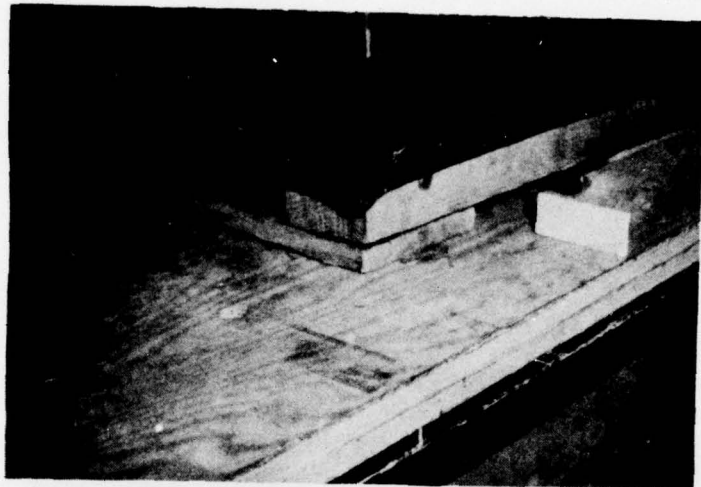
This test resulted in additional internal and external damage to the container. The damage is shown in Figures 10-13, pages 16 thru 18. The bottom of the external container was further distorted and three cracks developed at various stress points on the container. The interior blocking and bracing was chipped in many places with cracks developing at the ends. One end was broken out but was still providing protection. There was no damage inside or outside that disqualified this container, however, as in the first vibration test, one dispenser rotated. The degree of rotation was approximately 25°.

3. Test A1-2. The cracks that developed at the stress points could be an indication that the bottom panel should be strengthened either by the addition of stiffeners or increasing the gauge of the panel.

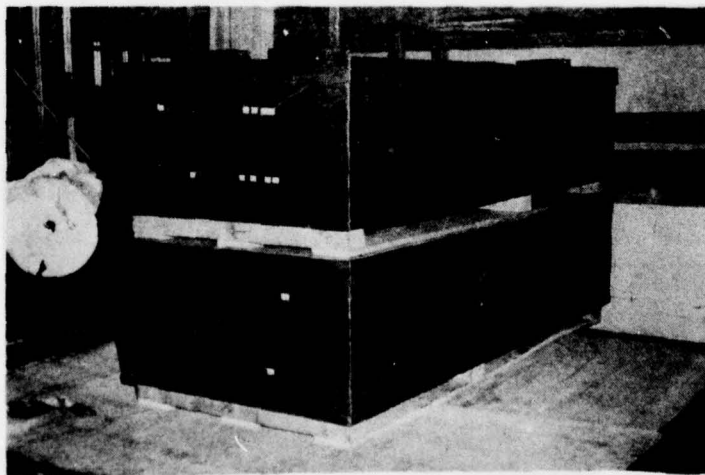
Figure 14. Two-High Pendulum Impact Test

6. Pendulum Impact (Test # B3). The procedure for this test was identical to that used for the test in 4 above, except that only the ends were tested. On this series of tests, two containers, one atop the other, as shown in Figure 14, page 18, were impacted to provide insight as to the quality of the three various stacking lugs. Each type of container (I, II, and III as defined on page 2 ) was evaluated.

4. Test B3-5 and 6. This test indicated the structural integrity of all lug designs. Also, the increase in impact force did not appreciably damage the container. (Since these containers will probably be shipped in a stacked configuration, this test was a good indication of what could be expected as far as load stability.)

3. The design of the stacking lugs is part of this evaluation. From all indications in the two-high pendulum impact test, the lug style I, Figure 2, page 2, appears the optimum to use. The other two styles proved difficult to stack from the standpoint of forklift operations.

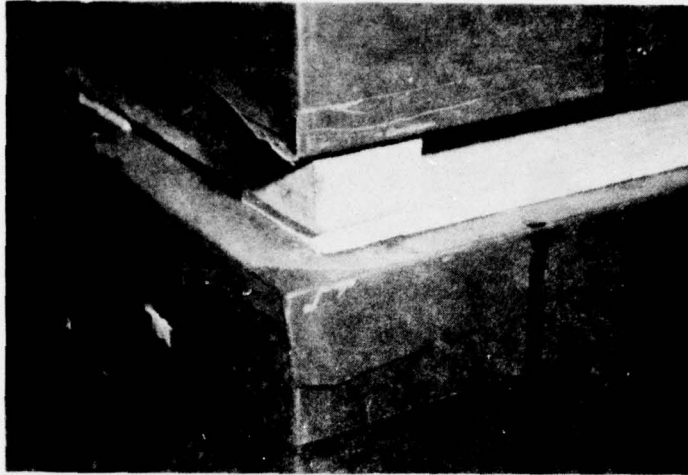
Figure 15. Pendulum Corner Damage

The first set of impacts was made on container III-1 with II-1 container stacked on top. There was no appreciable damage connected with this impact as shown in Figure 15, page 19. There was a slight rotation of the top container around the forward lug.

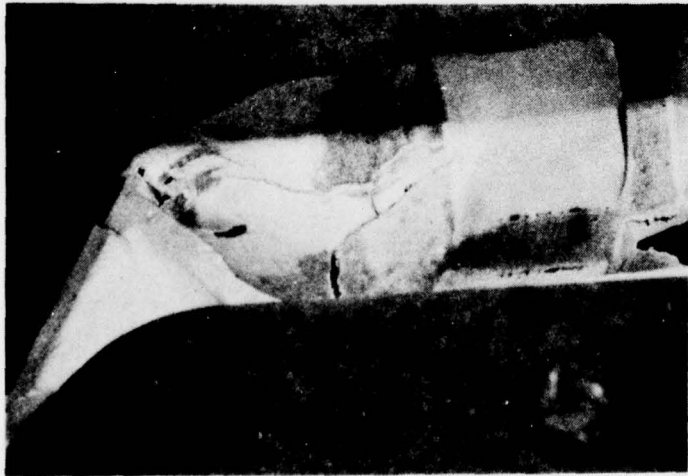
Figure 16. Additional Polystyrene Damage

Exterior damage from this test did not differ significantly from the damage received from any previous tests. Upon the final inspection, at the end of test B3, there was no unusual damage to the interior blocking and bracing. An example is shown in Figure 16, page 19. All straps held up with no signs of fatigue.
