Special Report 76-8

A SURVEY OF ROAD CONSTRUCTION AND MAINTENANCE PROBLEMS IN CENTRAL ALASKA

E.F. Clark and O.W. Simoni

October 1976

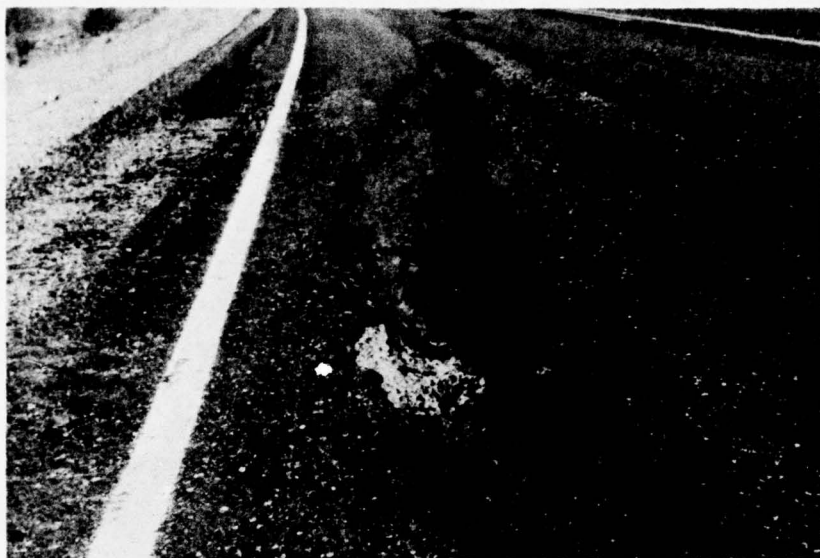
Figure 15 shows pavement failure on the Chena Hot Springs Road which was probably caused by degradation of underlying permafrost. This is one of many such failures noted along a five-mile section of this road. Figure 16 shows a section of the Richardson Highway where substantial subsidence of the pavement has occurred. Both the problems on the Chena

Figure 15. Pavement failure on Chena Hot Springs Road.

Hot Springs Road and the Richardson Highway may have been caused by disturbing the thermal regime in the subgrade. Staged construction would have allowed the degradation of the subgrade to stabilize before paving.

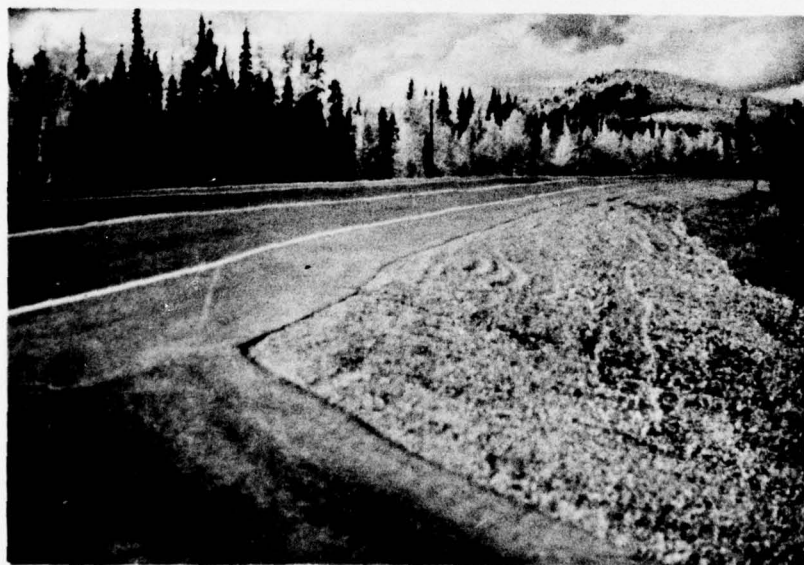
Figure 16. Undulation of pavement on Richardson Highway.

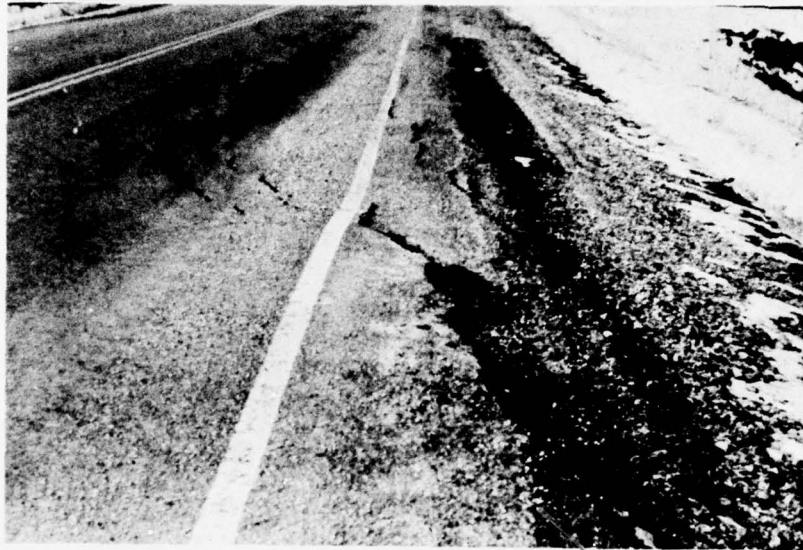
Figure 17, taken on the Elliott Highway, shows an embankment failure of a deep fill (approximately 15 ft) over a saddle. Severe road shoulder settlements and pavement cracking occurred on both sides of the road. Figure 18 shows a section of the Elliott Highway with a longitudinal crack that follows the center line. Tension cracks of this nature are

Figure 17. Embankment failure at road shoulder.

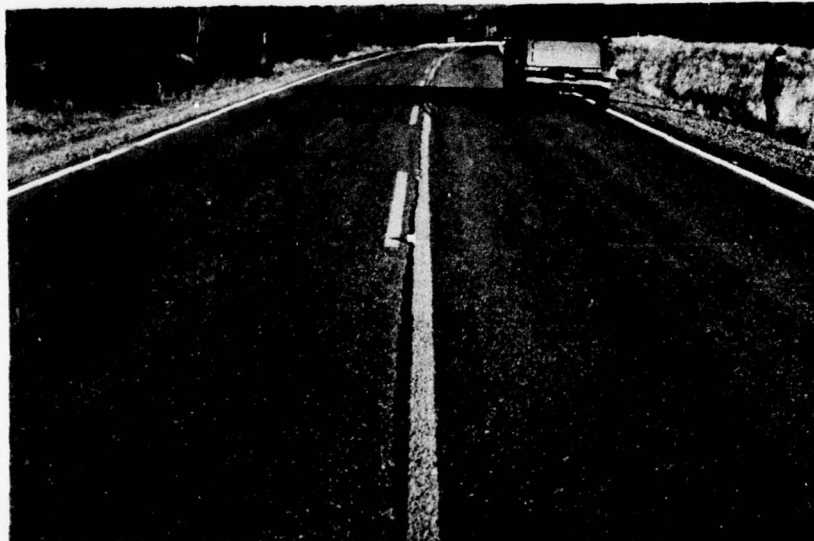
Figure 18. Longitudinal crack along center line.

prevalent in many places along Alaskan highways (as well as in more temperate regions). They permit intrusion of surface water into the embankment and result in subsequent failure. Some highway engineers have attributed these cracks to planes of weakness, resulting from paving one lane at a time with poor bonding between the two lanes.

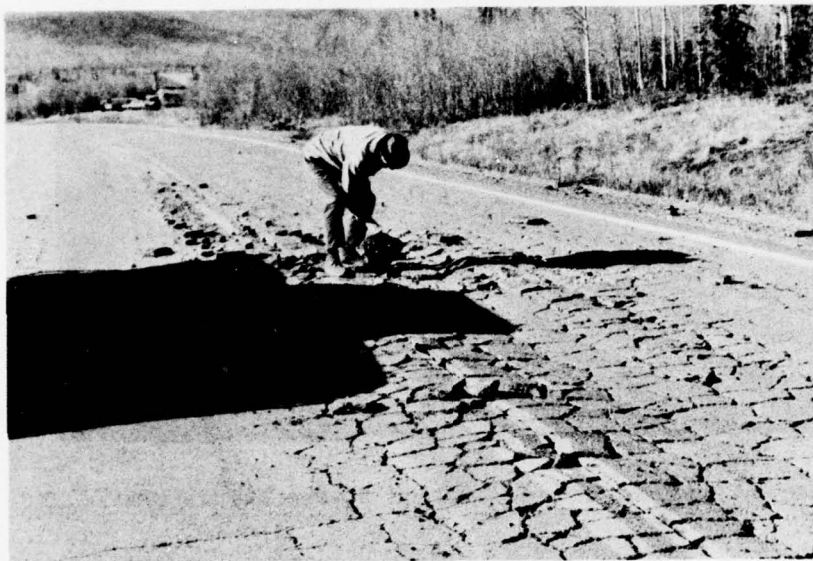
Figure 19 shows pavement failure along the Elliott Highway. This embankment is apparently weak, as evidenced by the rutting. A high water table may be a contributing factor, as there is a stream nearby.

Figure 19. Pavement failure on the Elliott Highway.

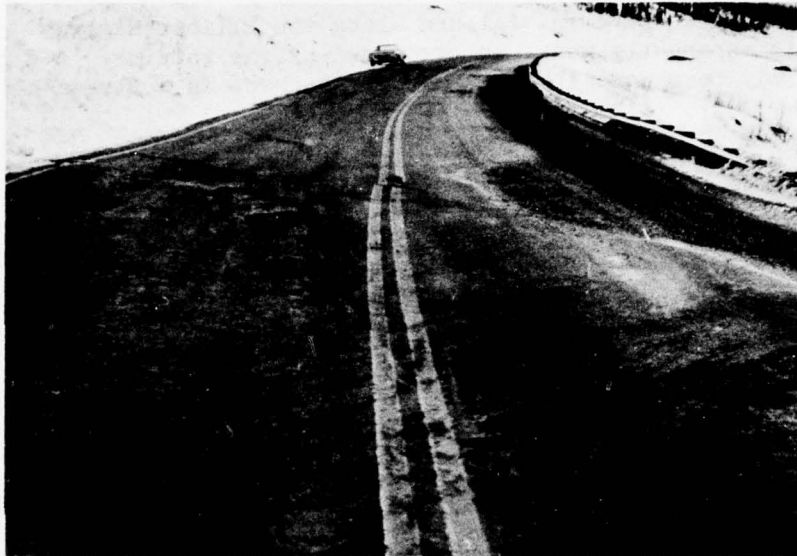
Figure 20. Creep on side hill on Steese Highway, mile 21.

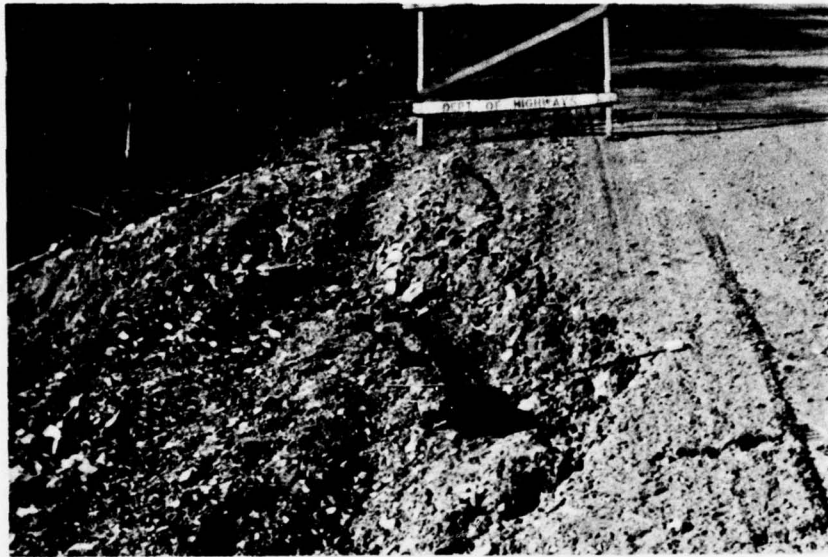
Many instances of shoulder failure were observed during April and May of 1973. Figure 21 shows a typical slope failure along the Elliott Highway. In this case, high water and washout of the toe of the embankment caused cracking and subsequent sliding of the shoulder. Figures 22 and 23 show shoulder failure along the Trans-Alaska Pipeline Service (TAPS) road, and Figure 24 shows a similar failure on the Chena Hot Springs Road.

Figure 21. Slope failure along the Elliott Highway

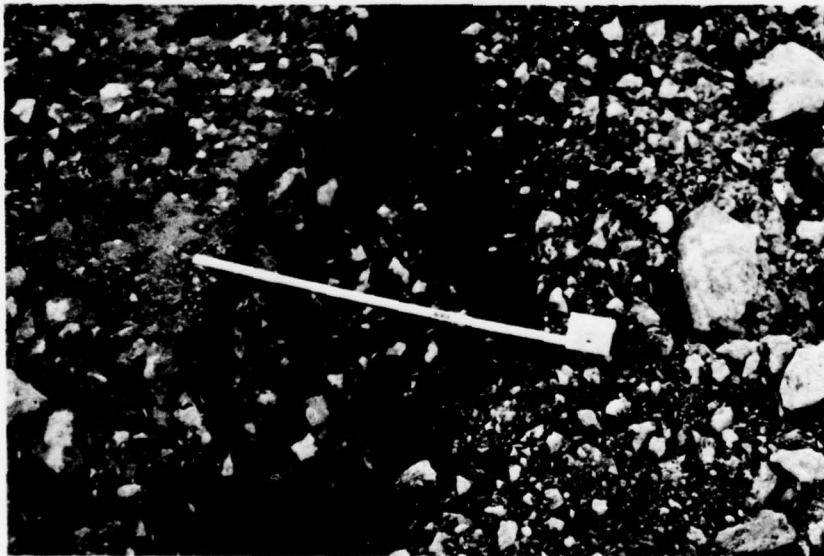
Figure 22. Shoulder failure along TAPS road

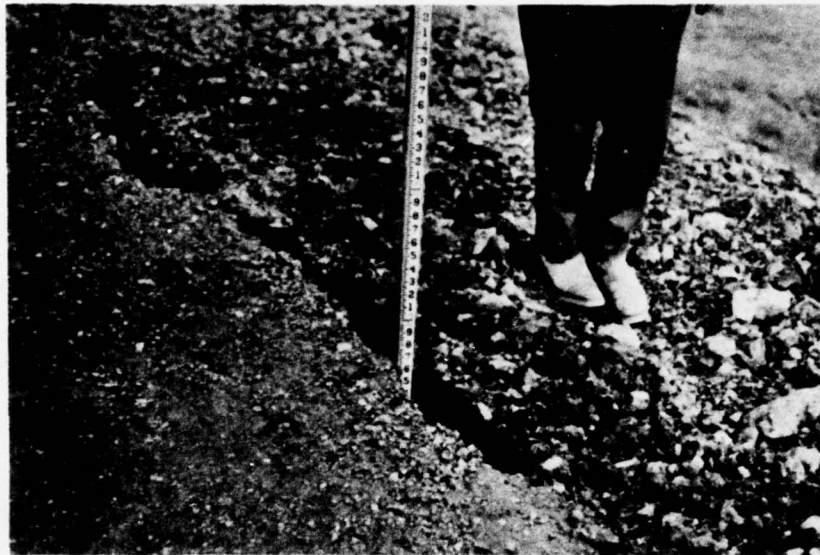
Figure 23. Longitudinal crack caused by settlement of embankment toe (TAPS road, mile 54.9).

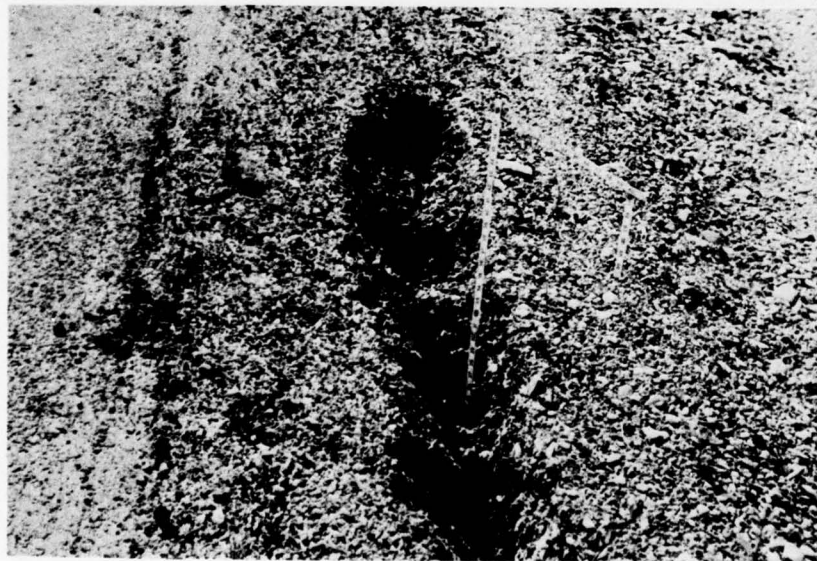
Figure 24. Shoulder failure caused by permafrost degradation under embankment toe (Chena Hot Springs Road, mile 12).

The above photographs illustrate but a few of many such failures observed. In cases in which failures are caused by permafrost degradation at or under the toe of the embankment, use of insulation such as polyurethane or polystyrene in and extending out from the shoulder might provide a solution (Fig. 25). Earth berms extending several yards from the embankment might also serve a useful purpose in preventing this type of failure.

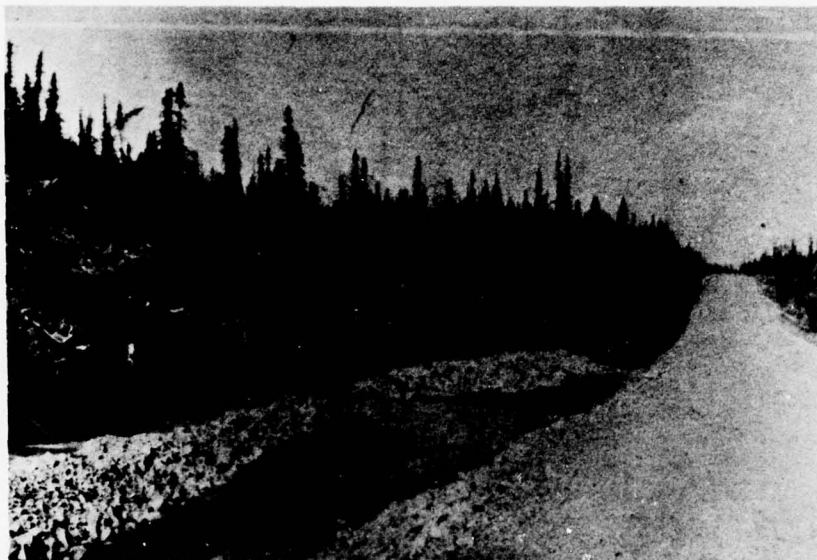
Another problem of great concern to Alaska highway engineers is that of slope stability where sidehill cuts have been made, particularly through ice-rich permafrost. Under these conditions, the uphill slope degrades with an ensuing flow of water and mud, which if not corrected may continue for years. Figure 26 shows such a condition along the TAPS road. In this case it is interesting to note that, three years after initial construction, water and mud are still filling the uphill ditch with silt. The rock berm at the toe of the slope, placed there for the retention of the mud and for assistance in stabilizing the toe of the slope, is only partially successful. The mud is continuing to flow over or through the rock berm.

Figure 26. Slope instability on TAPS road (from Smith and Berg 1973).

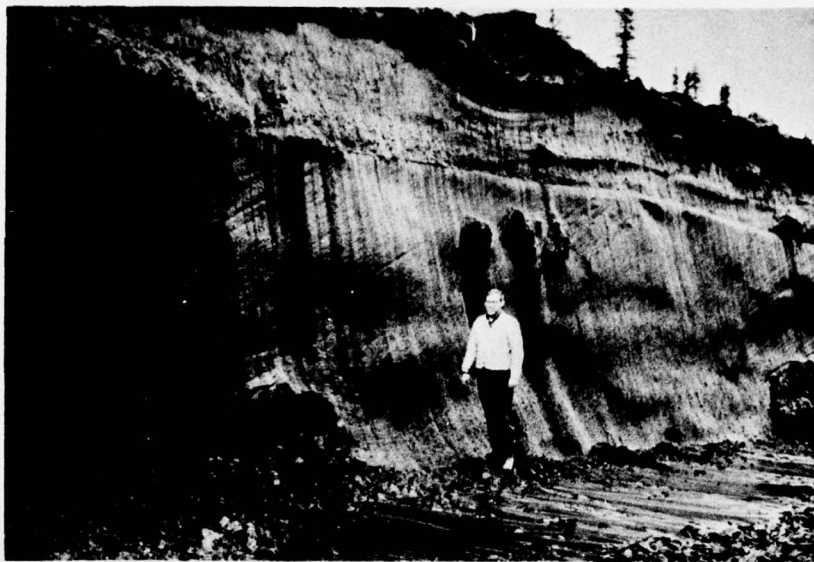
In a few instances sidehill cuts must be made through virtually pure ice, such as shown in Figure 27, which was taken along the TAPS road shortly after construction. In this case a vertical cut was made. Figure 28 shows another sidehill cut on the TAPS roads. Subsequent observations revealed that in less than two years the ice had receded about 4 ft, the grasses and other vegetation had sloughed down over the ice, and the cut had stabilized, as shown in Figure 29 which was taken in the same general location approximately two years after construction.

Figure 27. Vertical sidehill cut through ice at milepost 23.9 on TAPS road (from Smith and Berg 1973).

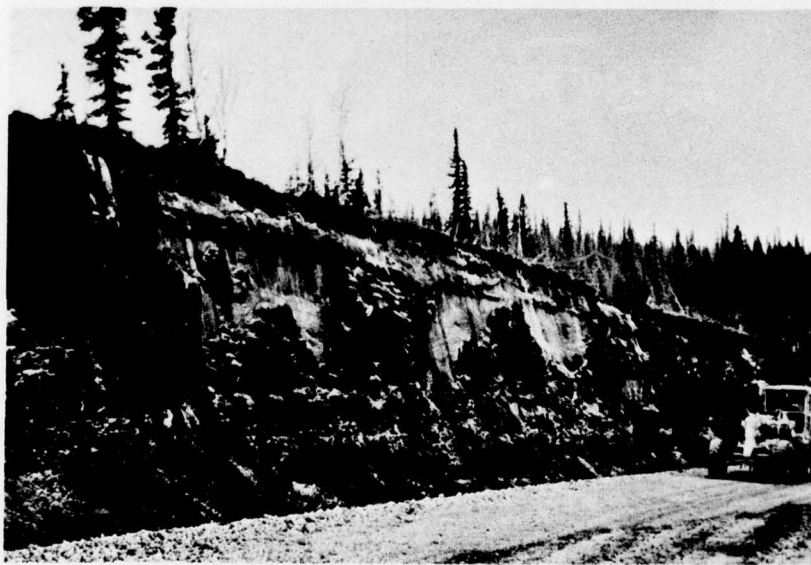
Figure 28. Vertical sidehill cut on TAPS road, 23 April 1970 (Smith and Berg 1973).

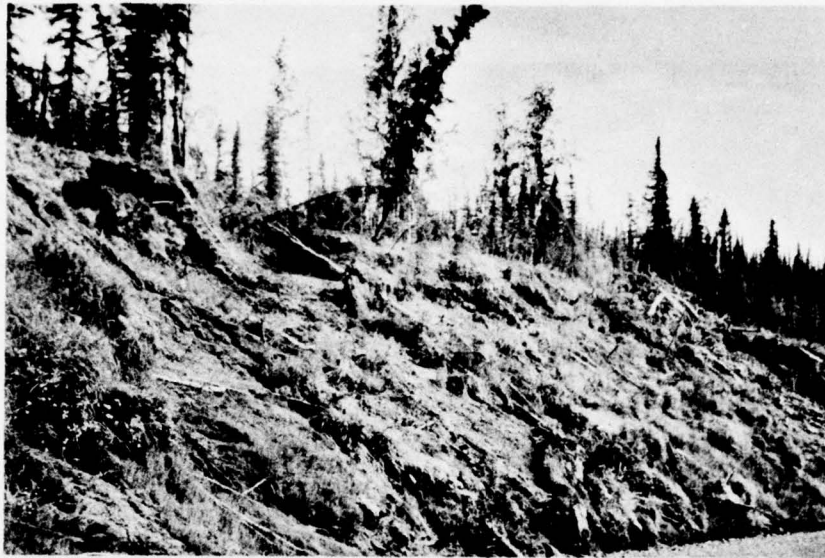
Figure 29. Same general location as shown in Figure 28 after approximately two years (photo. by N. Smith).

is considered to be justified. Research approaches might include identification and testing of fast growing plant species, use of organic mats to provide nutrients and conserve moisture, and use of gabions (wire baskets filled with rock) as shown in Figure 30.

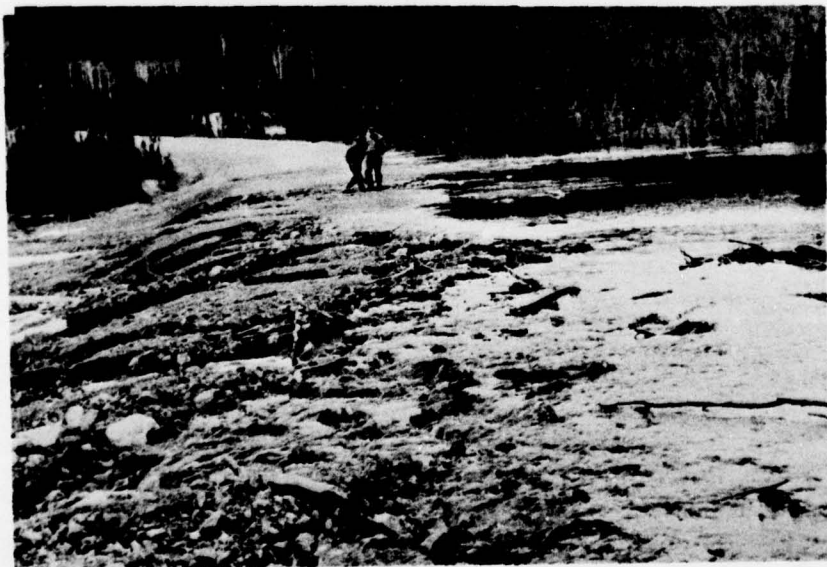
Figure 33. Washout along TAPS road (mile 5.6).

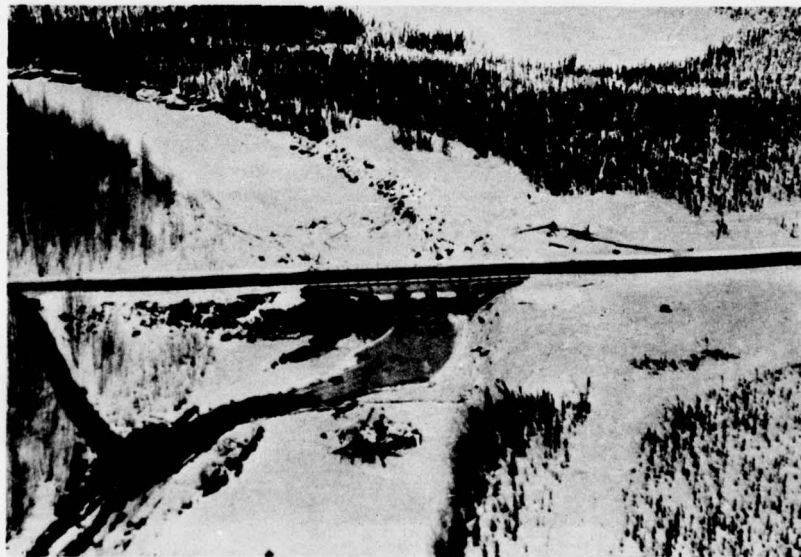
Figure 35 shows the Hess Creek bridge on the TAPS road. This is a pile bent bridge, constructed with "H" piles. The bents are probably

Figure 35. Hess Creek Bridge on TAPS road.

too close together, thus causing debris and ice buildup. Figures 36 and 37 show serious damage that this bridge sustained from log jams and repeated impacts from ice floes. Although unsuccessful at this location,

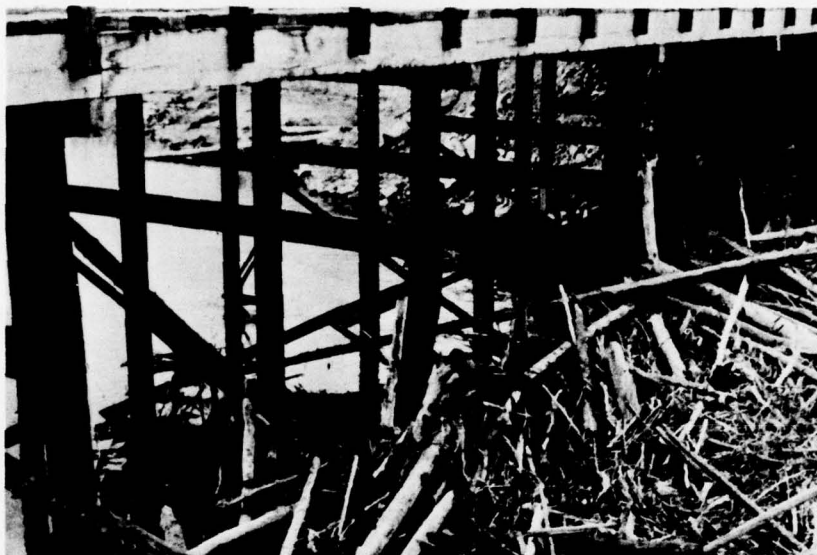
Figure 36. Damage to Hess Creek bridge from ice and debris during high water and ice breakup.

deflection devices such as those used for a pile bent bridge across the Chena River on Fort Wainwright (Fig. 38) have been found useful for some bridges. These deflectors are constructed of "H" beams and placed approximately 15 ft upstream from the bents. A crane is used to clear debris from the deflectors.

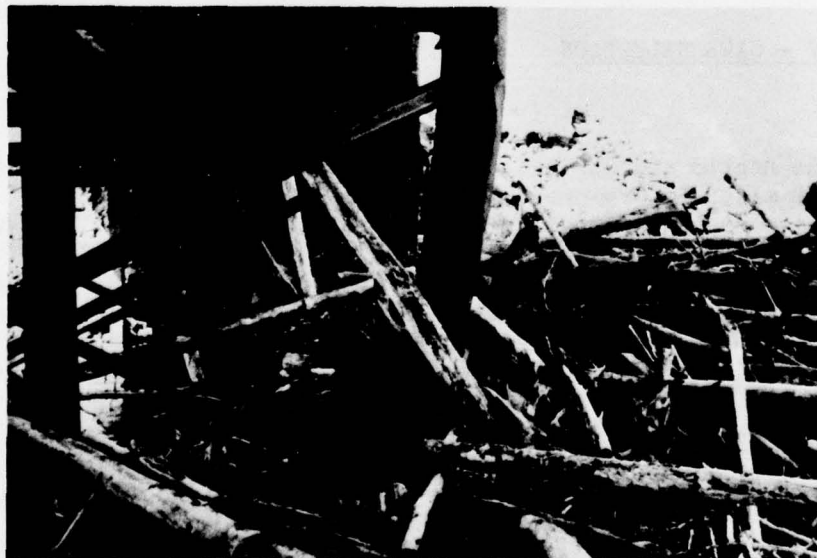
Figure 37. Closeup of damage to Hess Creek bridge.
