AEROSPACE CORP EL SEGUNDO CALIF ENGINEERING SCIENCE --ETC F/G 9/5
ALUMINA SUBSTRATE ASSEMBLY STUDY.(U)

Alumina Substrate Assembly Study

1 October 1976

Final Report

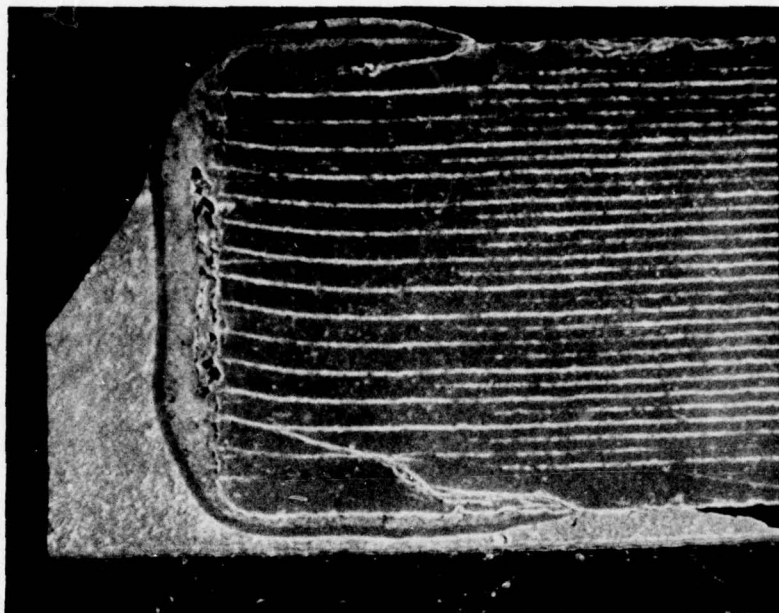
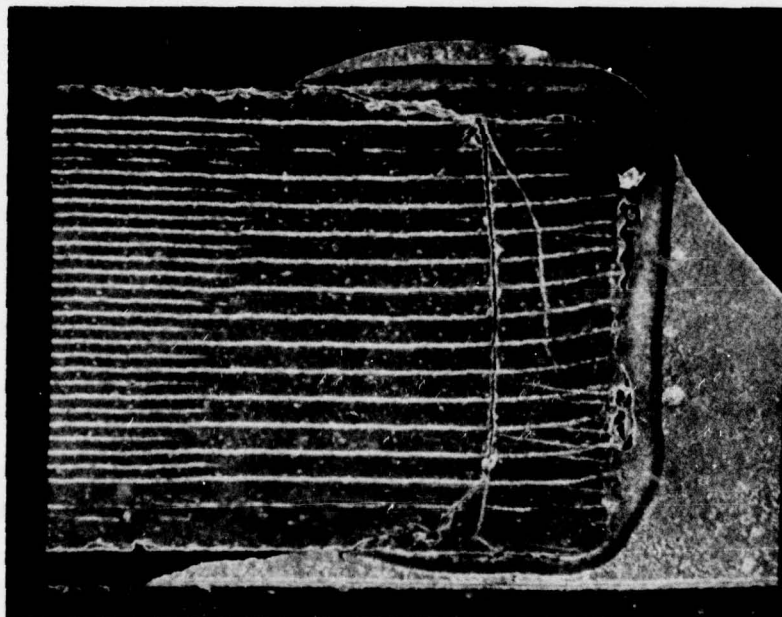
cycles ranging from -50°C to $+100^{\circ}\text{C}$. Capacitor C23 (10,000 pF, ceramic) was intermittent and finally failed open. Capacitor C24 (10,000 pF, ceramic) was observed in post-test measurement to have changed values. Since module 003 underwent no Phase II testing, the examination of capacitors C23 and C24 was accomplished in the final cross sectioning of the module at The Aerospace Corporation. Figures 26(a) and (b) are scanning electron microscope (SEM) photos of the end cap areas of C23. Cracks originate at about the edge of the metallization, both top and bottom. These cracks extend under the end cap for some distance and are then joined by a crack that is roughly parallel to the end of the capacitor. It is evident that the open was caused by the crack which completely traverses the ceramic body. Other minor cracks are also evident in the end cap area, and voids are present in the end cap metallization. Figures 27(a) and (b) are SEM photomicrographs of the end cap regions of C24. Voids can be seen in the end cap metallization and could easily explain the observed intermittency.

Figure 26. Scanning Electron Micrograph of the End Cap Areas of Capacitor C23 in Cross Section. (It should be emphasized that the major portion of the capacitor exhibited no cracking. Extensive cracking may be seen to originate at the ends of the end caps and radiate through the ceramic toward the end of this BX-type capacitor. The crack that is parallel to the end cap may be seen clearly in b.)

The crack that caused failure of capacitor C23 is located under the end cap. One cause for this type of failure has been suggested in preliminary work at TRW (Ref. 4). This study indicated that there is a definite correlation between this type of crack and the thickness of the copper barrier plating on the end cap for Union Carbide type BX capacitors. This failure can be observed to a greater or less degree in capacitors C23, C24, and C25 (Figures 26, 27, and 28 respectively). However, this failure mode was not observed with Union Carbide's NPO-type capacitors. This was confirmed in the present study in the cross section of unit C22 (Figure 29) which is of the NPO type. The intermittency in C24 could easily have resulted from cracking in the ceramic under the end cap or from the poor contacts in the end cap metallization.

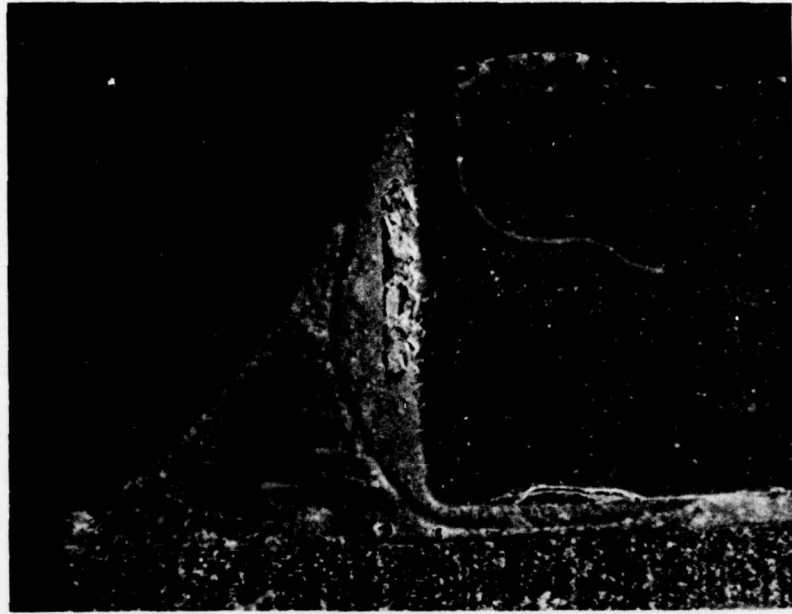
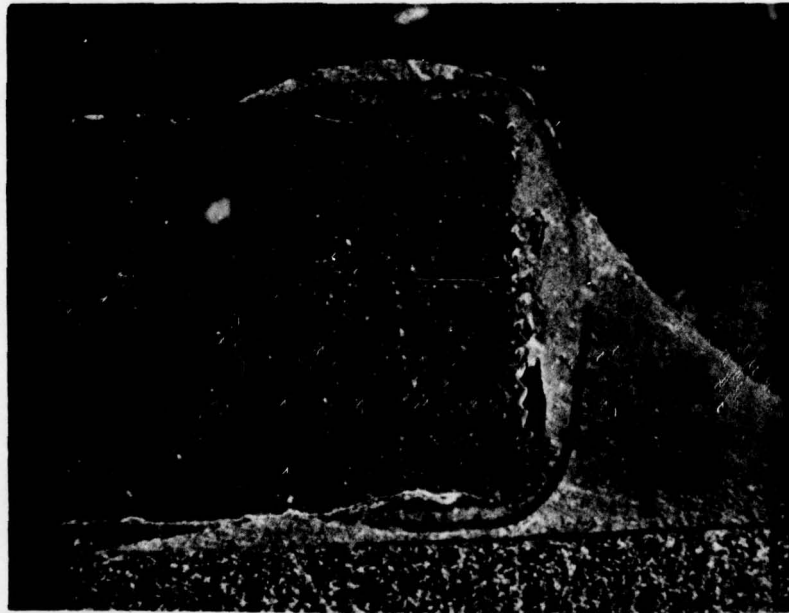
Figure 27. Scanning Electron Micrograph of the End Cap Areas of Capacitor C24. (In this BX-type capacitor no damage was observed except in the end cap areas where there was minor cracking of the ceramic and voids in the end cap metallization.)

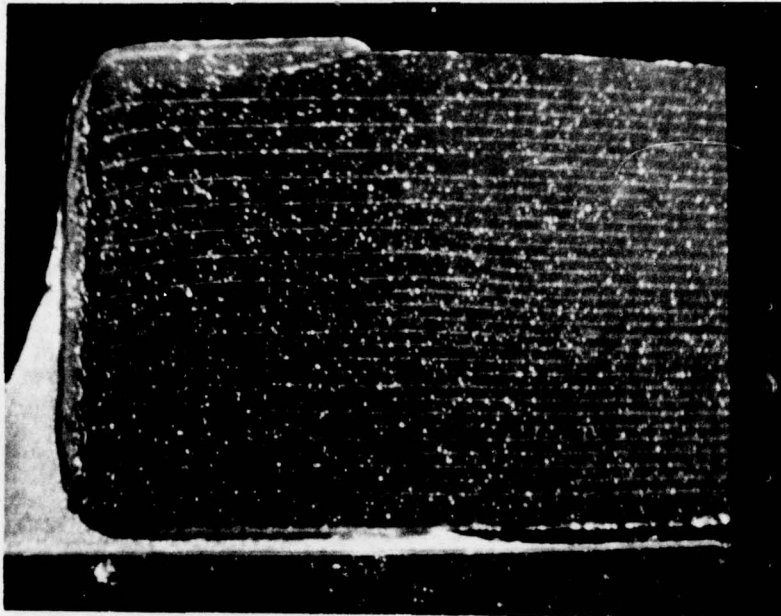
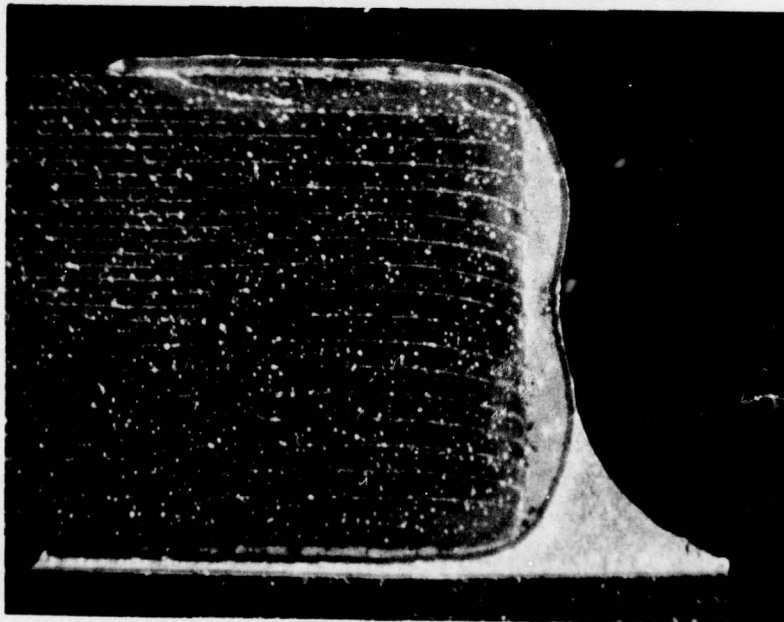
Capacitors C25 (100,000 pF, ceramic) and C22 (1800 pF, ceramic) were also examined in cross section. These are shown in Figures 28(a) and (b) and Figures 29(a) and (b) respectively. These capacitors exhibit few voids in the end cap metallization and only inconsequential cracking of the ceramic.

Figure 28. Scanning Electron Micrograph of the End Cap Areas of Capacitor C25 in Cross Section. (Little damage was observed in this BX-type capacitor except for very minor cracking of the ceramic in the end cap area.)

By comparison, the cross sections of two capacitors that did not fail showed structures that were quite good. This would indicate that good capacitors will survive the conditions imposed on them during this test, but those units with any defects can be expected to fail.

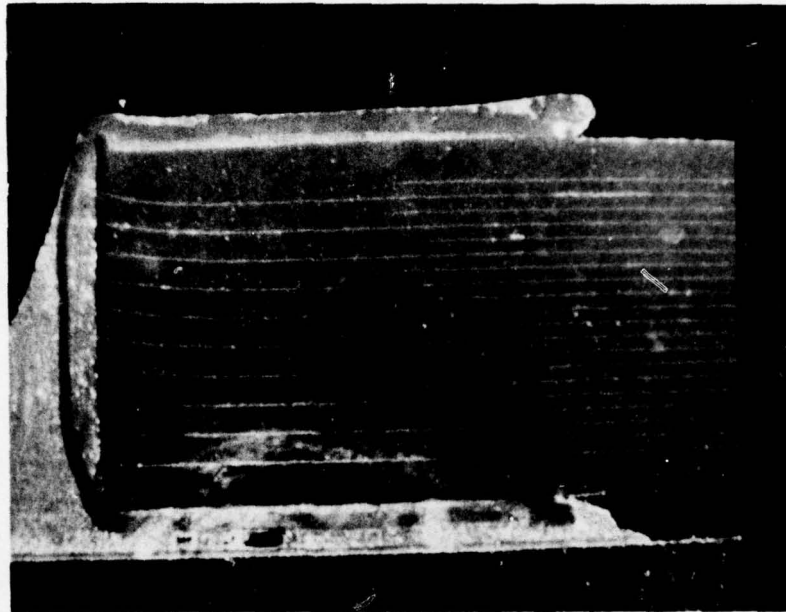
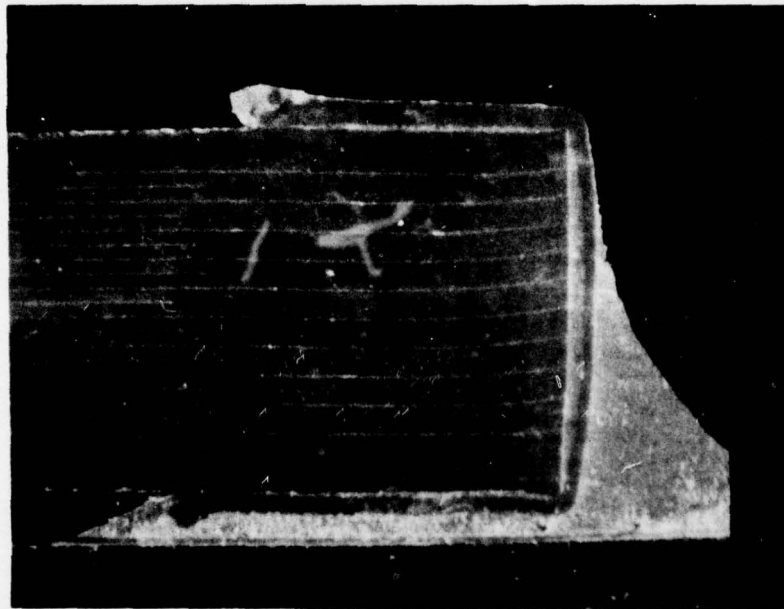
Figure 29. Scanning Electron Micrograph of the End Cap Areas of Capacitor C22 in Cross Section. (No damage was evident in the cross section of this NPO-type capacitor.)
