# Softbody Impact Resistance of Beryllium/Titanium Composite Blades

Detroit Diesel Allison  
Division of General Motors Corporation  
Indianapolis, Ind. 46241

May 1976

TECHNICAL REPORT AFAPL-TR-76-69  
Final Report for Period July 1975 - March 1976

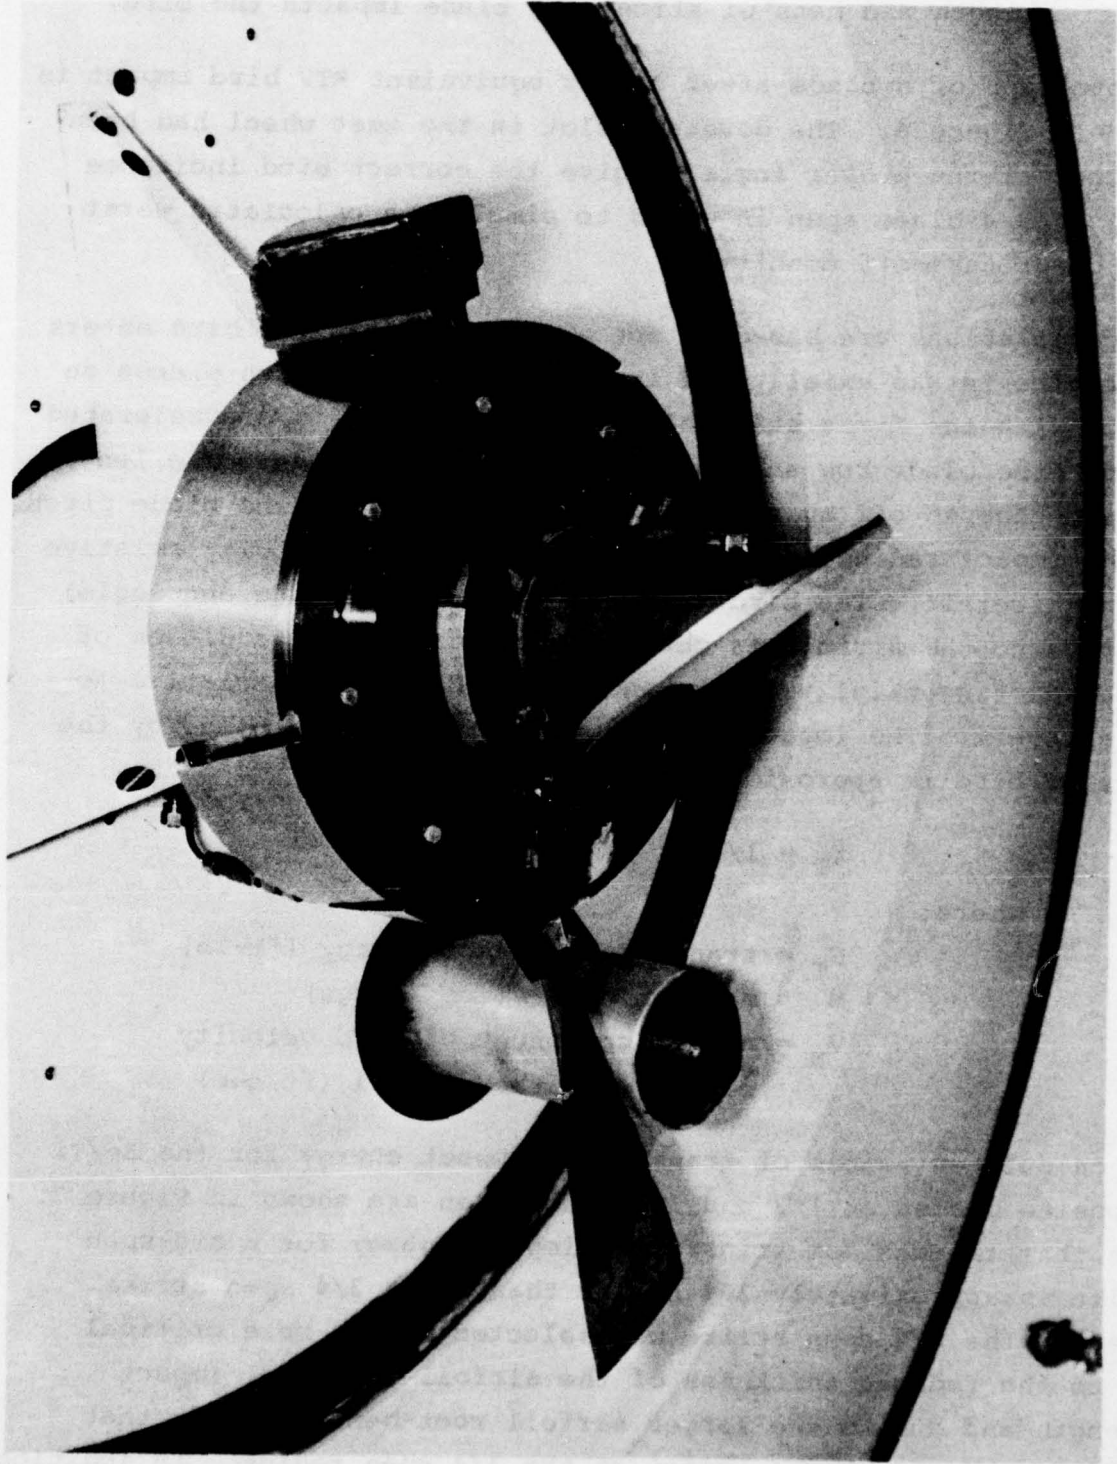
A photograph of a blade after a 3 oz equivalent RTV bird impact is shown in Figure 6. The dovetail slot in the test wheel had been machined at the proper angle to give the correct bird incidence angle at 3/4 blade span in order to simulate a calculated worst full-power take-off condition.

Figure 6. All Titanium Baseline Blade After 3 Oz. Impact.

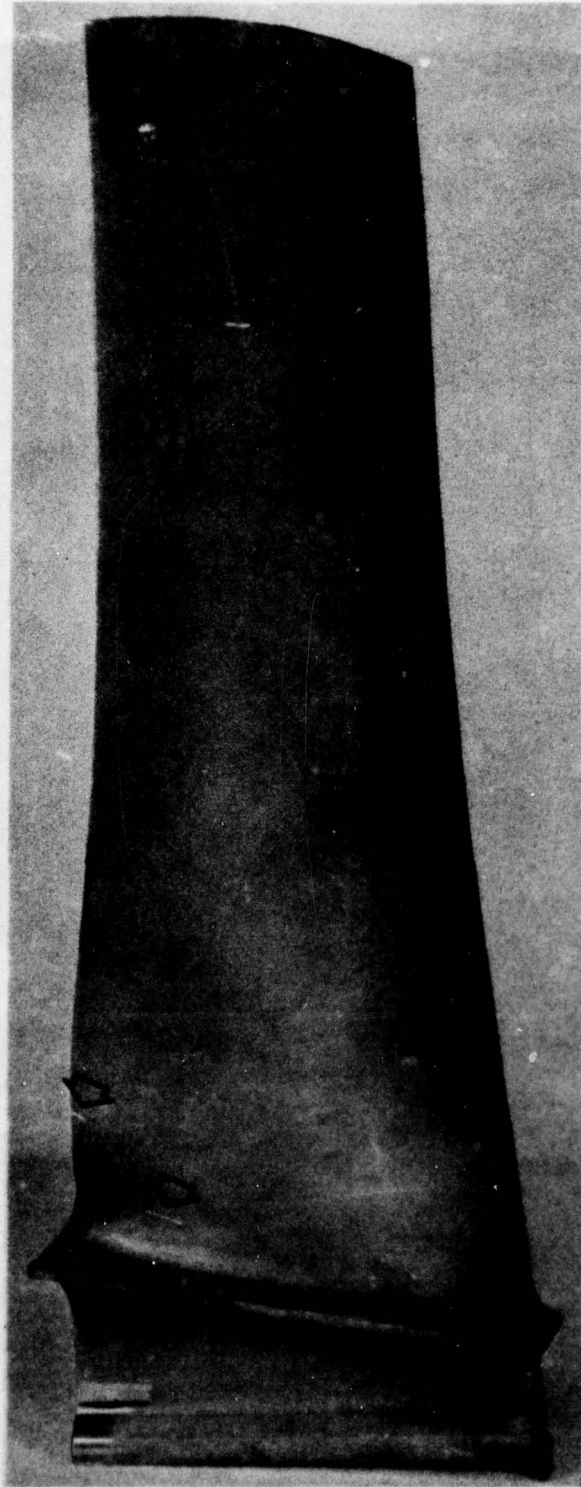
Fluorescent penetrant inspection indicated localized disbonding of the root blocks at the composite airfoil interface (see Figure 8). In fact, the overall quality of the diffusion bonding in this region was unknown and had been judged questionable. In order to partially demonstrate the structural soundness of the root block attachment, the decision was made to dovetail-pull test the two selected Be/Ti rod blades. A load equal to 120% of maximum airfoil design load was selected as the upper limit to be applied to the airfoil and this was found to equal 100% dovetail design load or 51,000 lbs. The dovetail-pull testing was accomplished with a test setup similar to that shown in Figure 9, but without the dial indicators. The upper part of the airfoil was held in the close-fitting steel clamping fixture by epoxy glue. The dovetail was positioned in a dovetail slot that was machined to the proper attachment geometry.

Figure 8. Fluorescent penetrant indications of localized root  
block-airfoil disbonds (Magn: 2/3X)

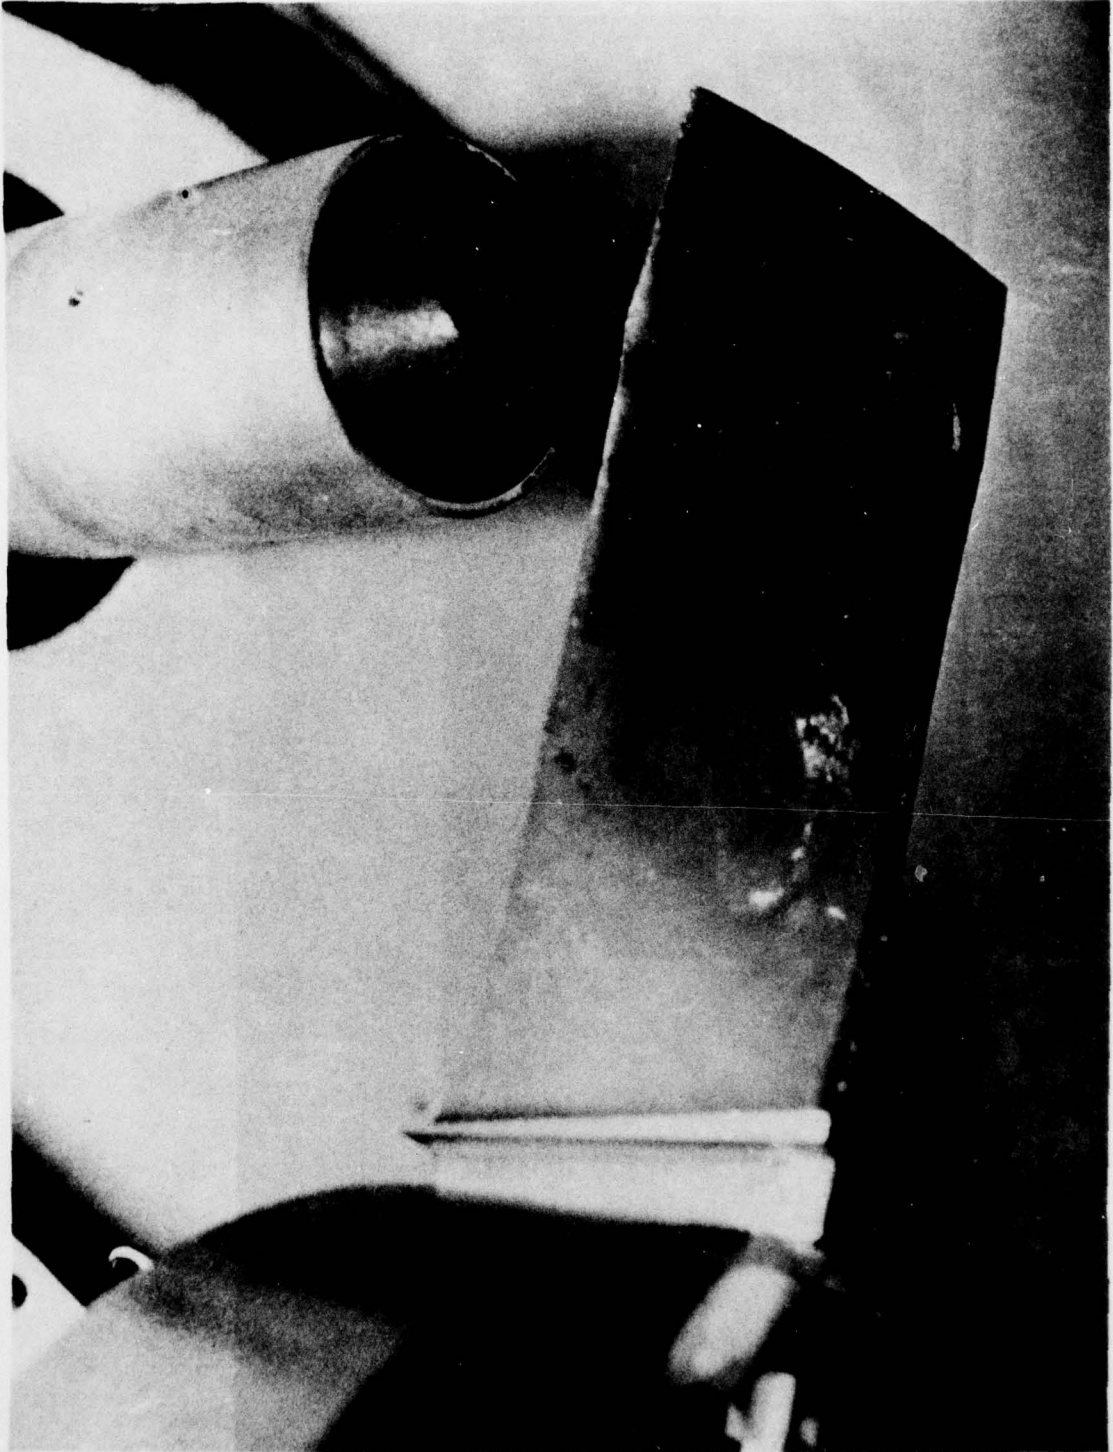
The blade damage due to the 3 oz and 2 lb equivalent baseline impacts are shown in Figures 11 and 12. Impact damage due to the 4 lb duck shot into the running engine is shown in Figure 13. Blade local damage due to the single-blade 2 lb equivalent RTV bird impact is more severe than that obtained from the 4 lb duck impact in the engine. The maximum blade tip deflection that occurred during the engine test is estimated from the high speed photos to be 3.50 inches. Detailed study of the single-blade 2 lb RTV bird impact high speed movies gave a maximum tip deflection of approximately 2.0 inches. Based on these observed deflections, the DDA 4 lb duck full rotor engine test should be about 1.8 times more severe than the 2 lb equivalent RTV bird impact test. The difference in local damage between the engine test and single blade test is thought not to be due to a poor simulation of bird material but rather due to the very positive way in which the RTV 560 bird is held in position by the piston bird holder in the single blade test.

Figure 11. All Titanium baseline blade after 3 oz. impact

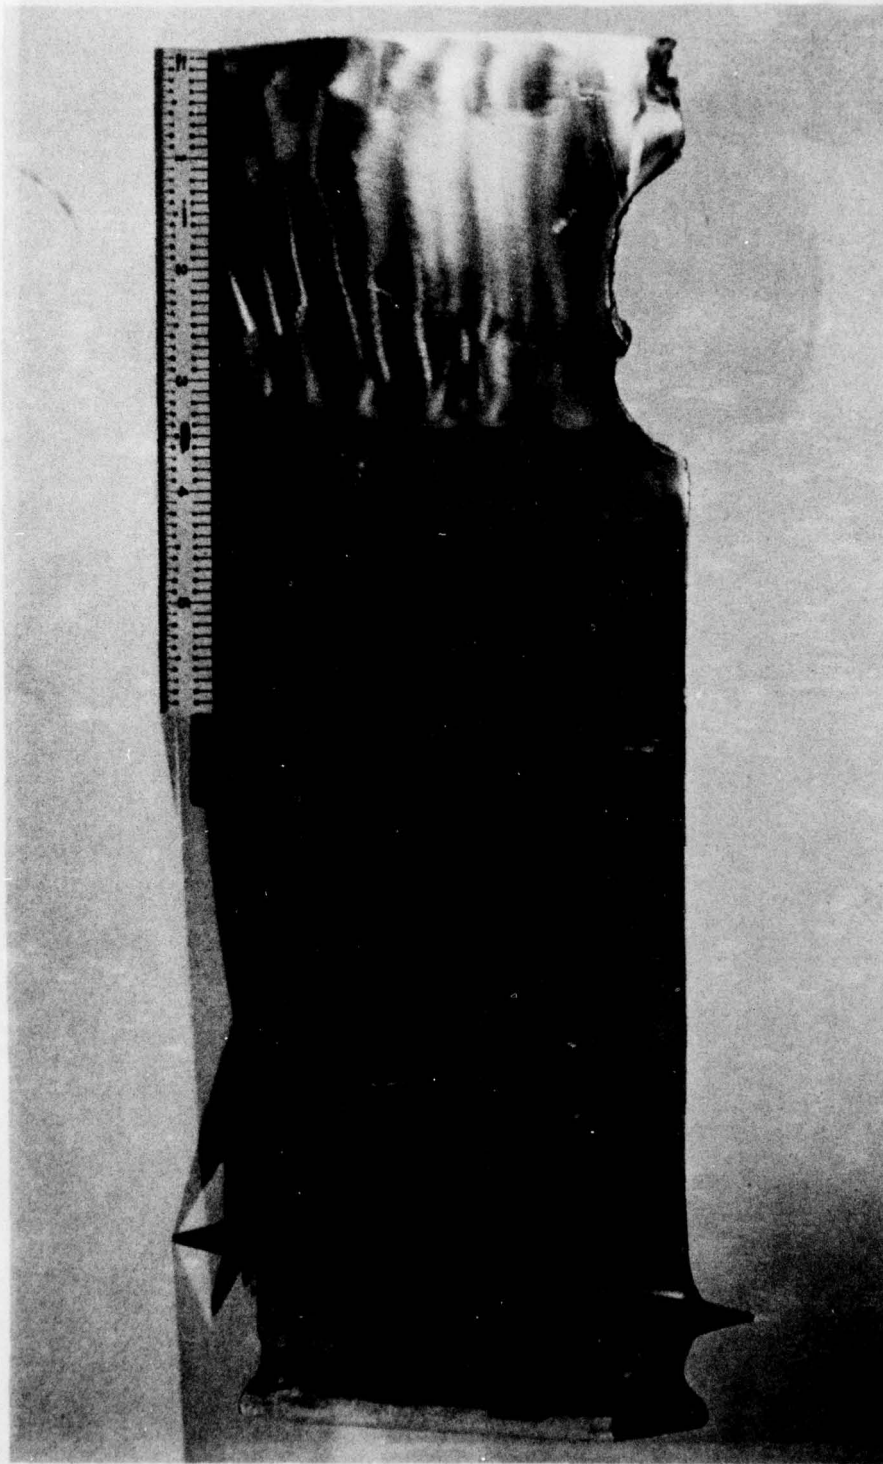
Figure 12. All Titanium baseline blade after 2 lb. impact

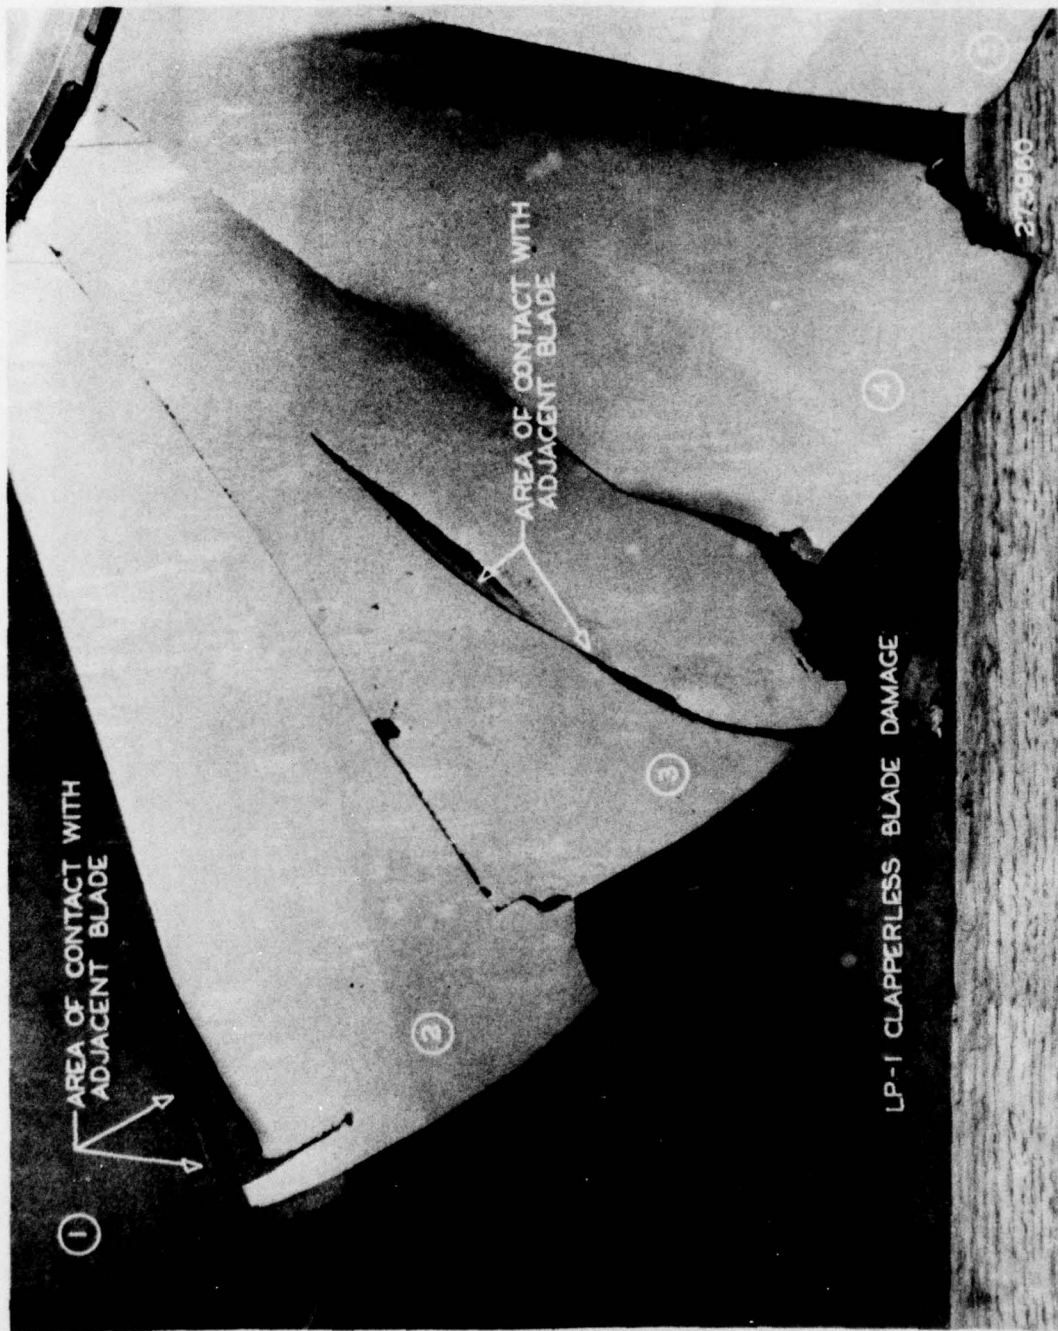
Figure 13. Blade Damage After 4 lb. Bird Impact In An Engine

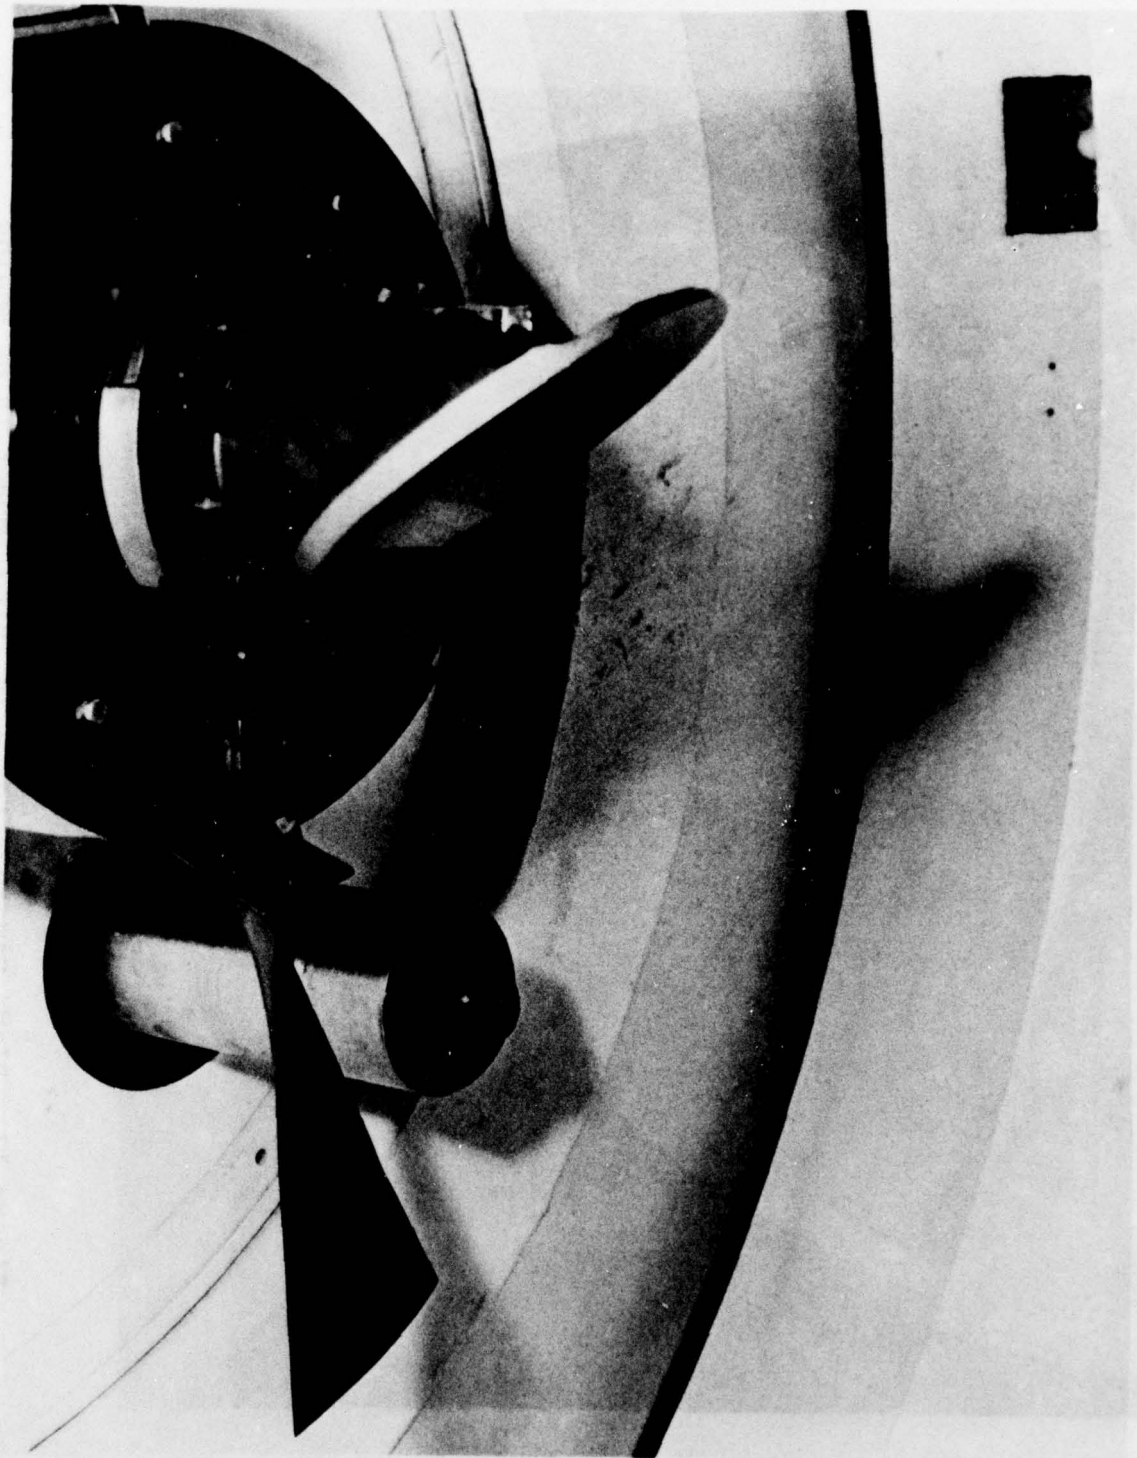
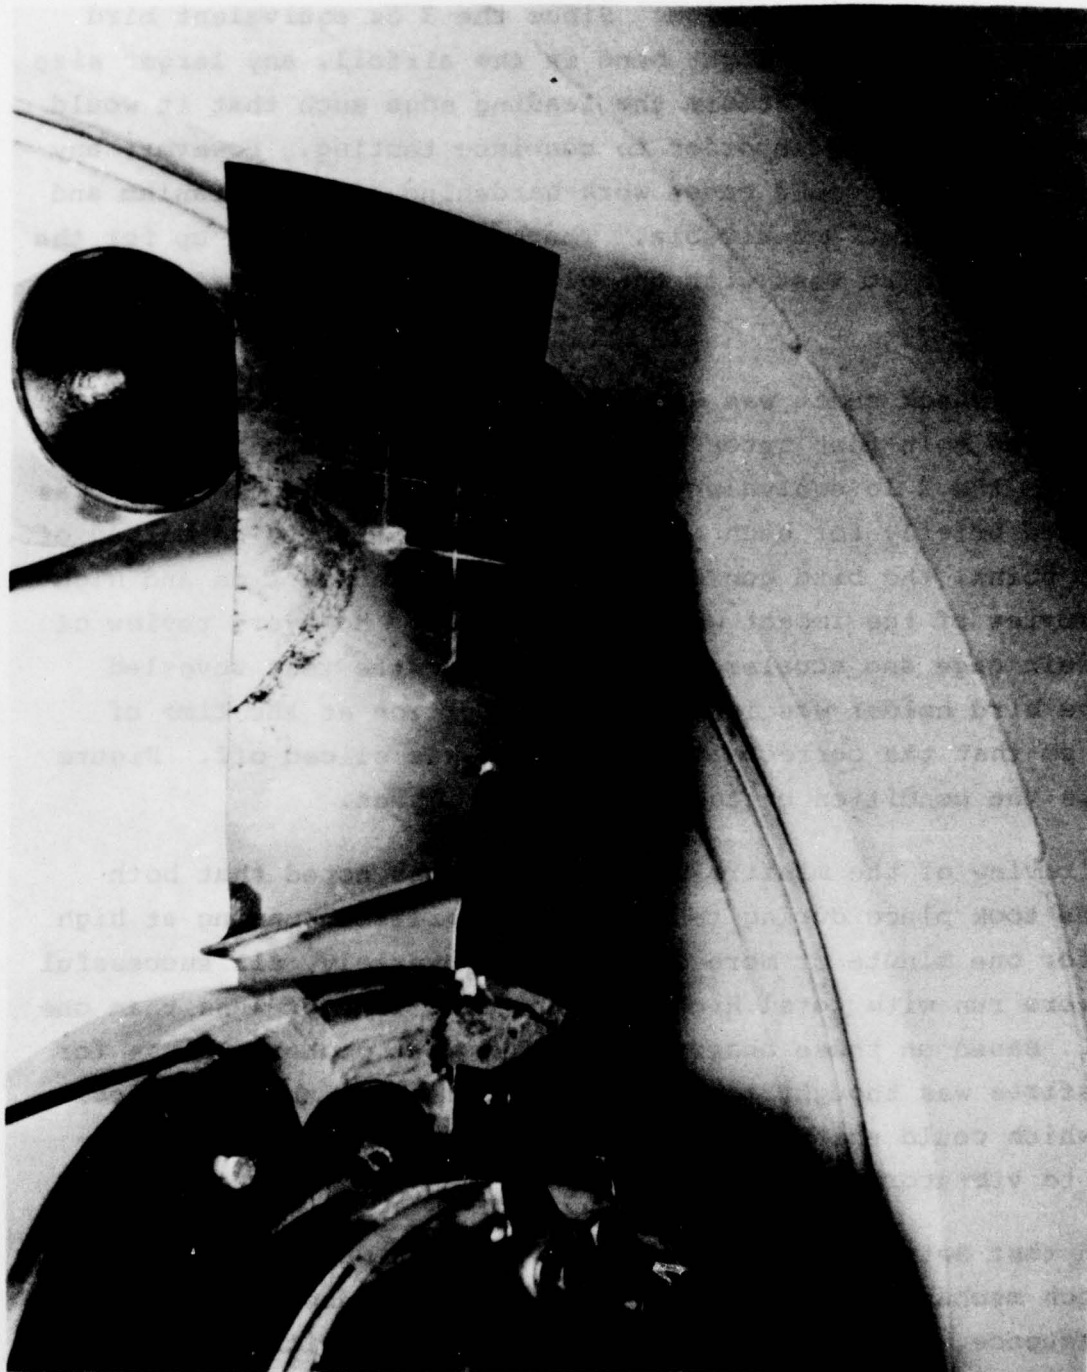
A simple check sheet was reviewed as the rotor was brought up to 100% speed followed by triggering the release for the 3 oz bird impact. All components performed well and the condition of the blade after the 3 oz equivalent shot is shown in Figures 14 and 15. Note the slight bend in the airfoil leading edge. The high speed

Figure 14. S/N E24-1 Be/Ti blade after 3 oz. impact, View 1

Figure 15. S/N E24-1 Be/Ti Blade After 3 Oz. Impact, View 2

- o The structural integrity of blades S/N E24-1 and S/N E23C-3 was demonstrated by overspeed testing to 110% design speed.
- o Blade S/N E24-1 withstood a calculated 3 oz equivalent size bird impact with only slight leading edge damage. This was followed by a calculated 2 lbs equivalent size bird impact where the blade essentially remained in one piece with the leading edge portion bending away from the main airfoil along a radial split or fracture. The bird injection gun misfired and prevented the high-speed movies from being taken, however the bird holder was down in the correct position at impact to give the correct amount of bird slice. The radial splitting type failure of the blade leading edge should have been expected due to the lower strength of the composite in the direction normal to the radially-configured Be rods. The use of an orientation other than uniaxial could increase the

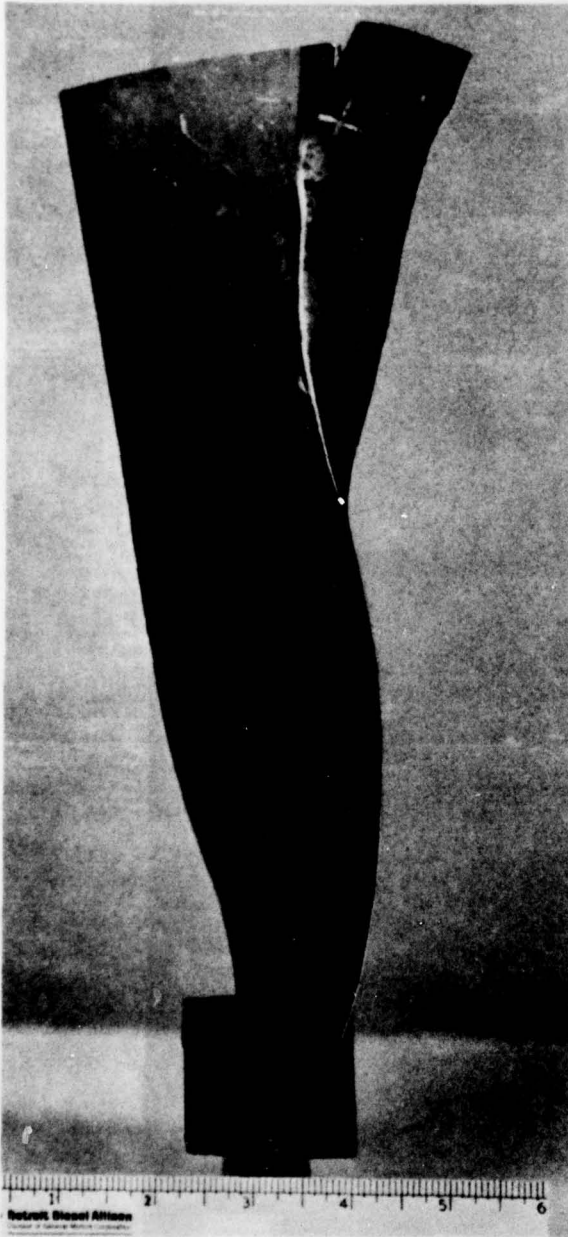
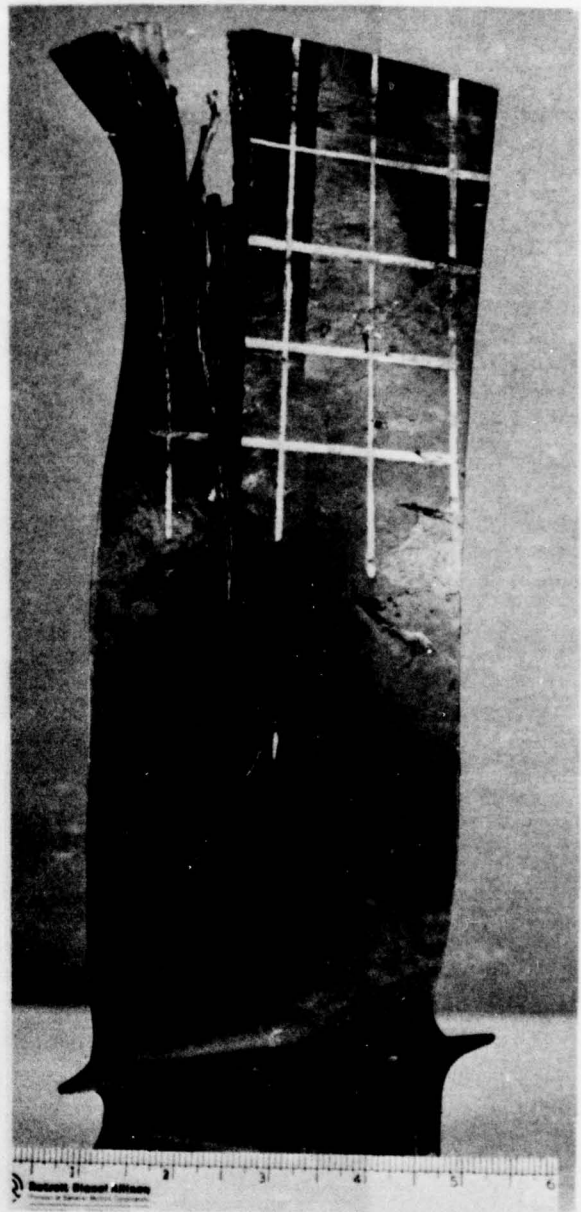
The written check sheet was expanded to cover all functions in more detail. The spin-test rotor was brought up to just below 100% speed with the 2 lb equivalent RTV bird loaded and the speed was stabilized briefly for each item on the check list to be marked off. At this point, the bird gun misfired for the second time and high speed movies of the impact were not obtained. However, review of the strain gage and accelerometer data after the test revealed that the bird holder was in the proper position at the time of impact so that the correct amount of bird was sliced off. Figure 16 shows the condition of the blade after impact.

Figure 16. S/N E24-1 Be/Ti blade after impact with 2 lb bird

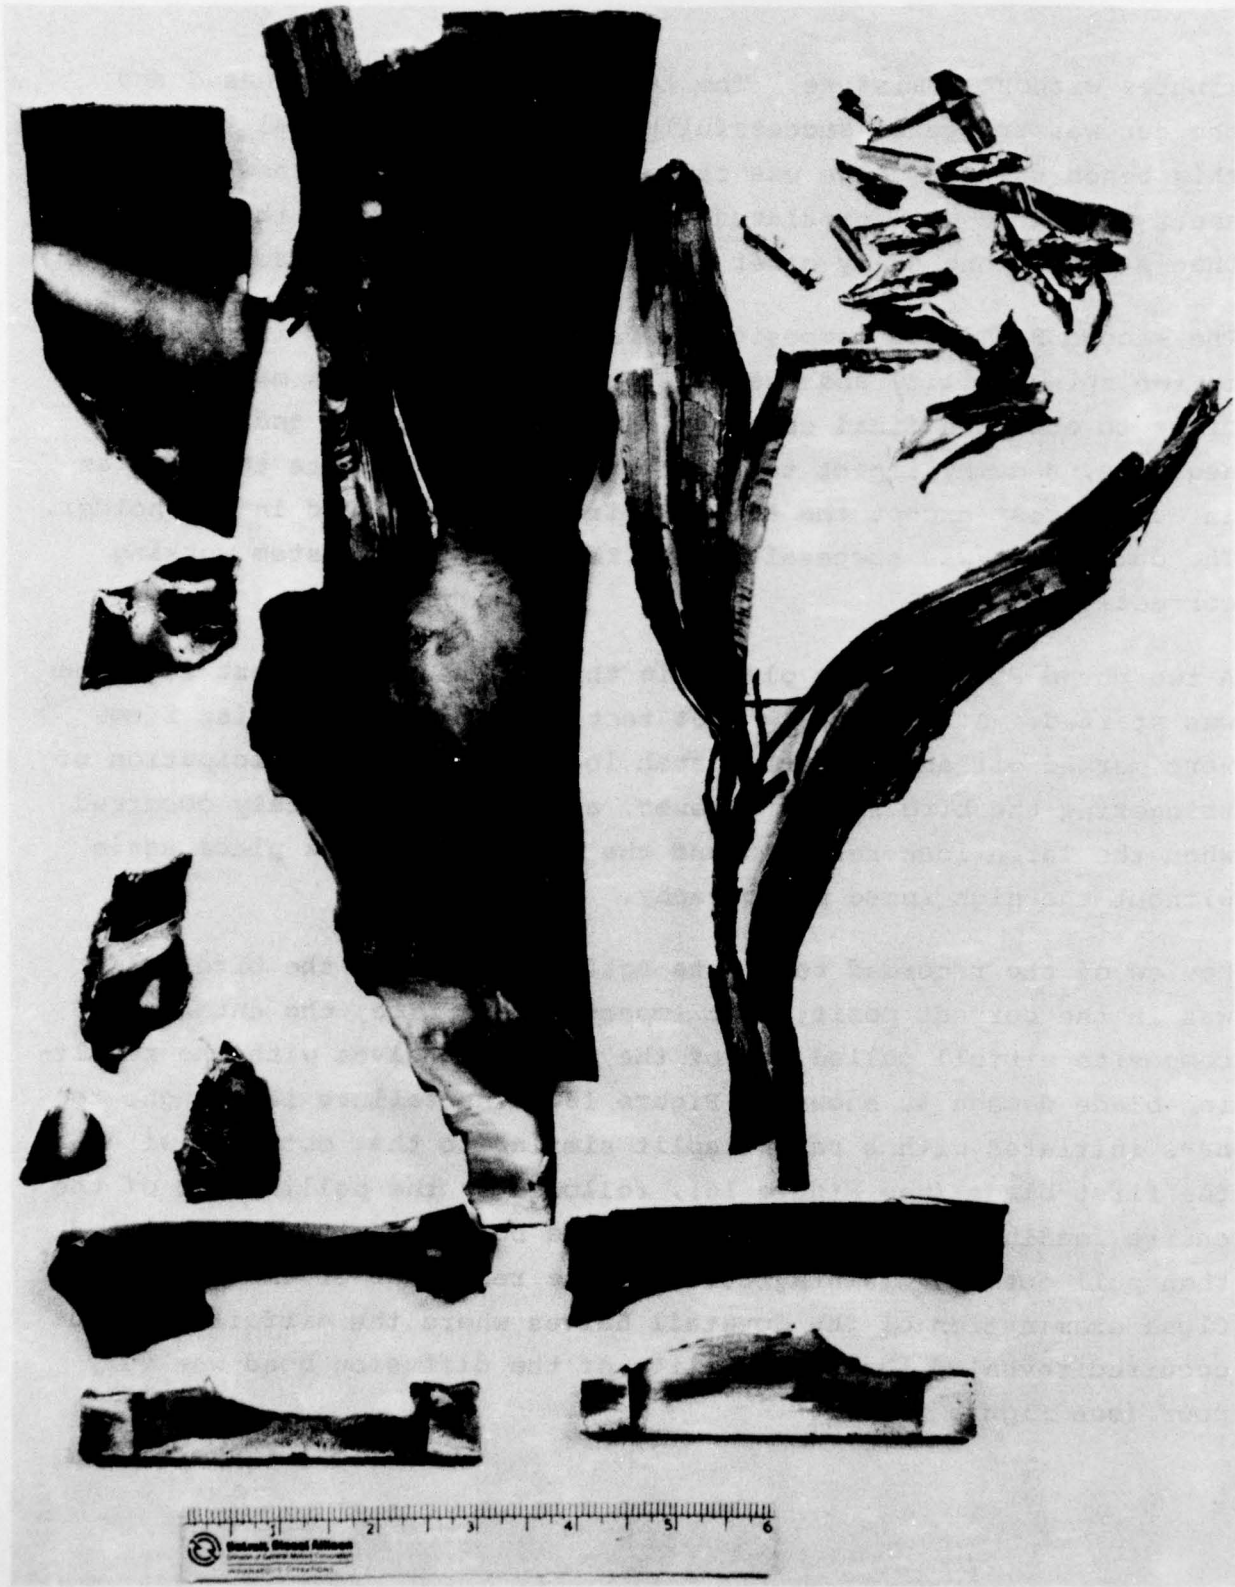
Review of the recorded test data again showed that the bird holder was in the correct position at impact. This time, the entire composite airfoil pulled out of the dovetail halves with the resulting blade damage as shown in Figure 18. The failure is thought to have initiated with a radial split similar to that obtained with the first blade (see Figure 16), followed by the pulling out of the entire leading edge portion down to the bottom of the dovetail and then pull out and disintegration of the remainder of the airfoil. Close examination of the dovetail halves where the airfoil pull-out occurred revealed that the quality of the diffusion bond was very poor (see Figure 18).

Figure 18. S/N E23C-3 Be/Ti Blade after 2 lb. impact

- o The blade S/N E23C-3 airfoil completely pulled out of the blade attachment during the 2 lbs equivalent size impact. A gun latch-locking mechanism had been incorporated to prevent misfire, but misfire accidentally occurred again and as a result high-speed photography was not obtained. The bird holder again injected into proper position for impact. Examination of the attachment halves after failure revealed a very poor quality of root bonding and this is considered to be the significant factor contributing to the total failure of S/N E23C-3. Good attachment bonding is essential to the satisfactory performance of the Be/Ti rod blades.

- o Further development of the DDA softbody single-blade impact procedure is required, particularly for the bird injector triggering mechanism and the bird holding system. An alternate bird material should be considered.
- o Blade fabrication processes could be developed that provide for

a positive attachment of the root to the airfoil.
