RDT&E PROJECT NO. 1X1-79191-D168

**SERVICE TEST
of
SELECTED LIGHTWEIGHT AVIONIC
EQUIPMENT (SLAE)**

Partial Report
by
MAJ Paul F. Bolam
Mr. Edward J. Dutton
May 1969

**DEPARTMENT OF THE ARMY
UNITED STATES ARMY AVIATION TEST BOARD ✓
Fort Rucker, Alabama 36360**

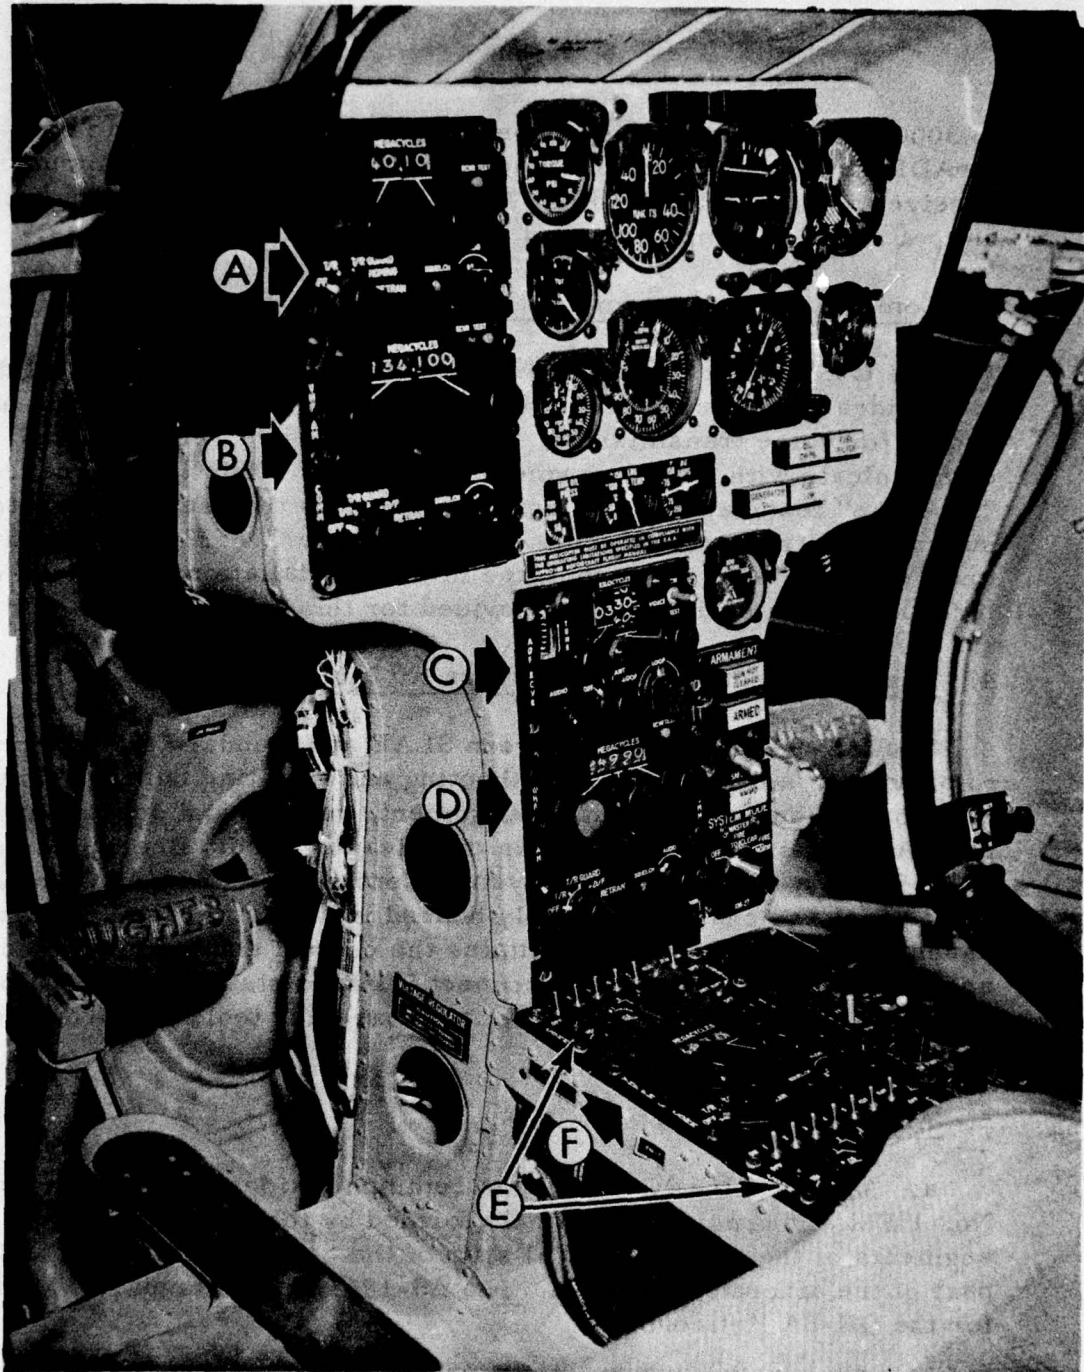
Figure 2. SLAE Installation in OH-6A Helicopter.

element of the antenna and was attached to the element using an "Adel" cable clamp. One failure occurred when the lower antenna broke away from its support fin at the weld point. This non-standard installation presented an ideal handhold for personnel engaged in ground-handling and maintenance operations. The antenna could easily be broken by such use.
