MISCELLANEOUS PAPER S-74-6

# EVALUATION OF DOW CHEMICAL PRODUCTION EXTRUDED TRUSS-WEB LANDING MAT

March 1974

Conducted by U. S. Army Engineer Waterways Experiment Station  
Soils and Pavements Laboratory  
Vicksburg, Mississippi

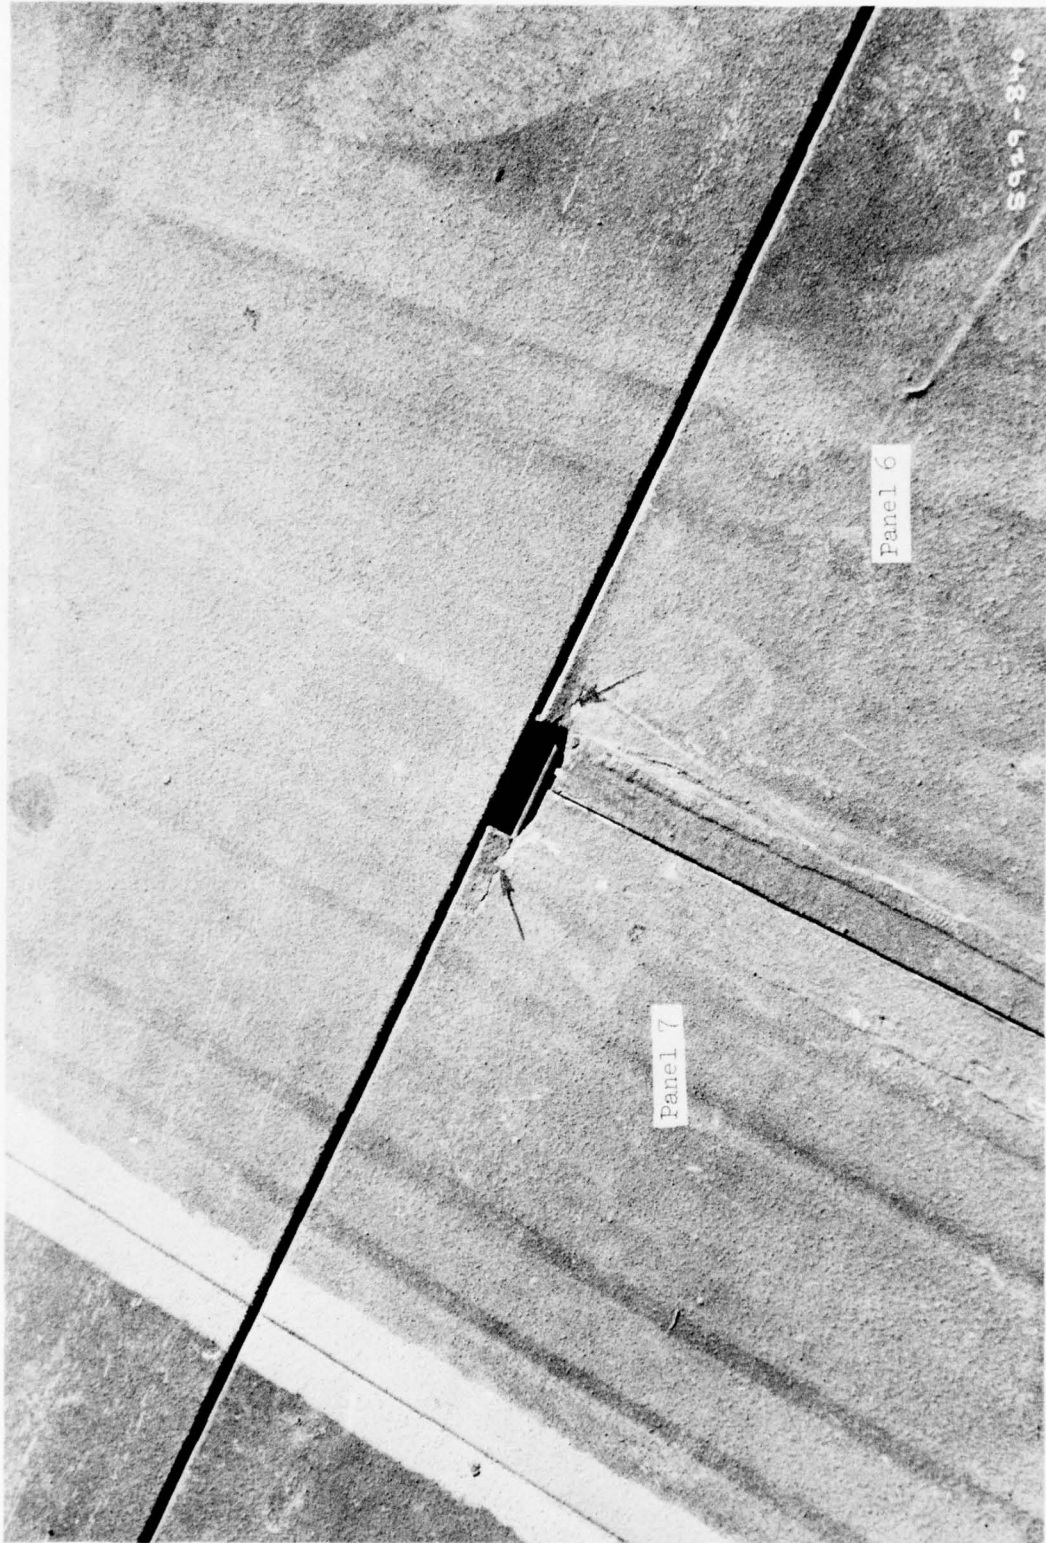
Curl on panels 6 and 7 (note antiskid flaking at corners)

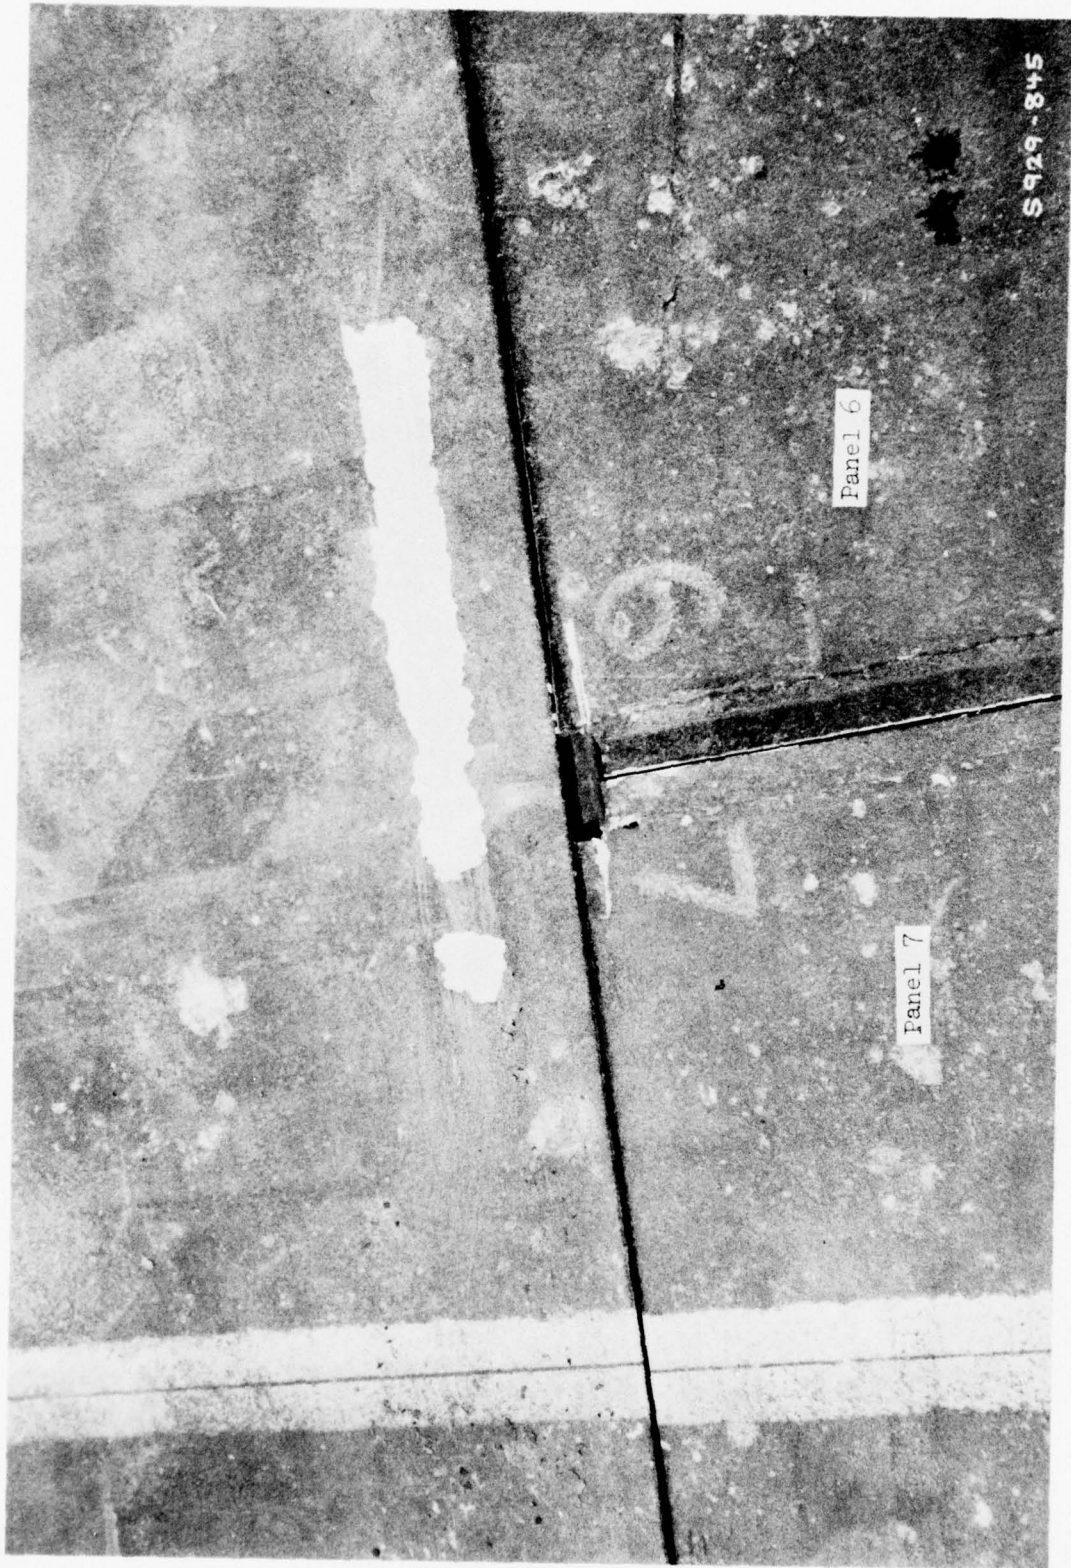
Panels 6 and 7 after 100 coverages

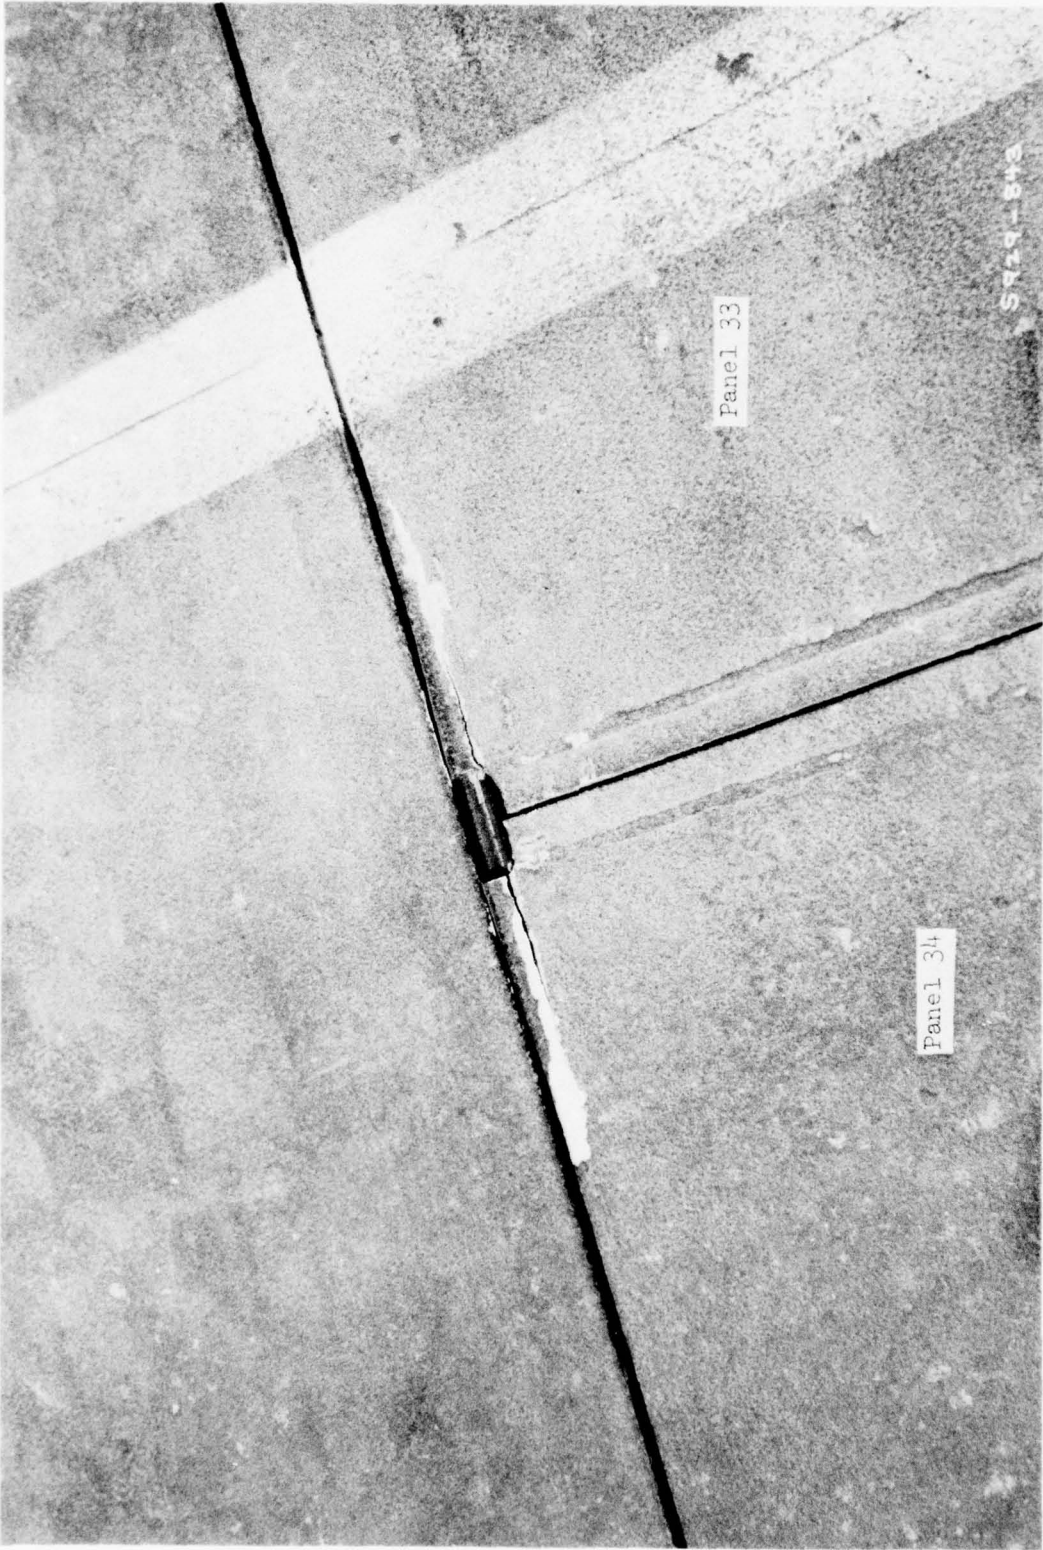
Panels 33 and 34 after 100 coverages

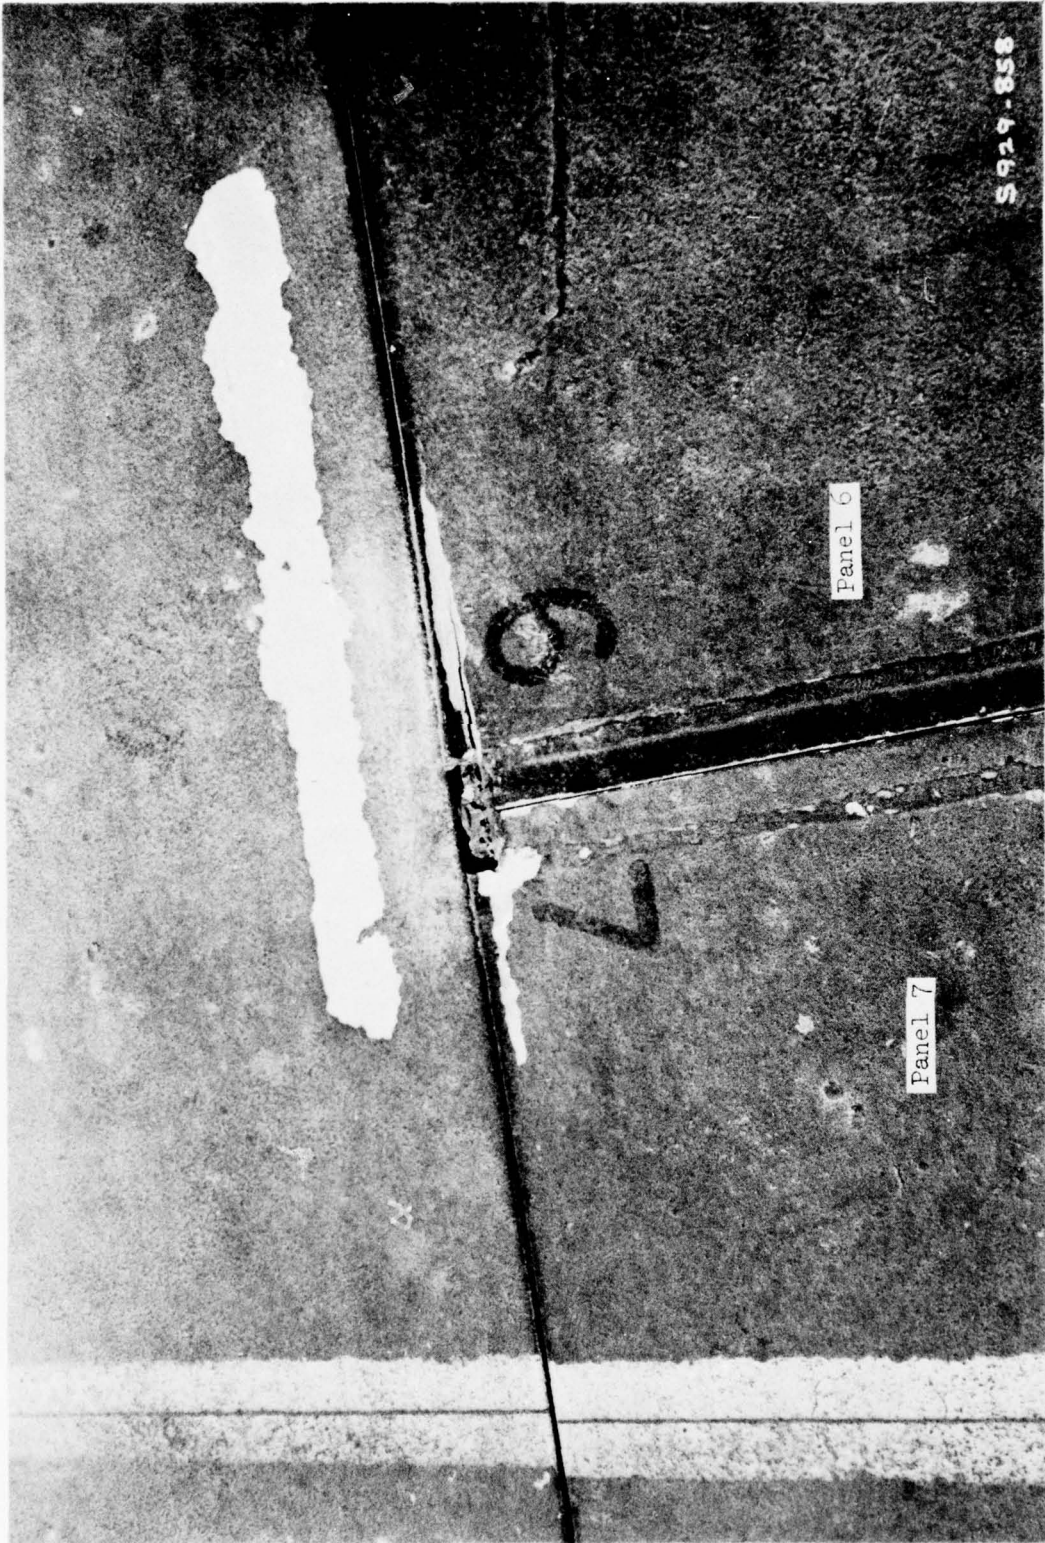
Panels 6 and 7 after 240 coverages

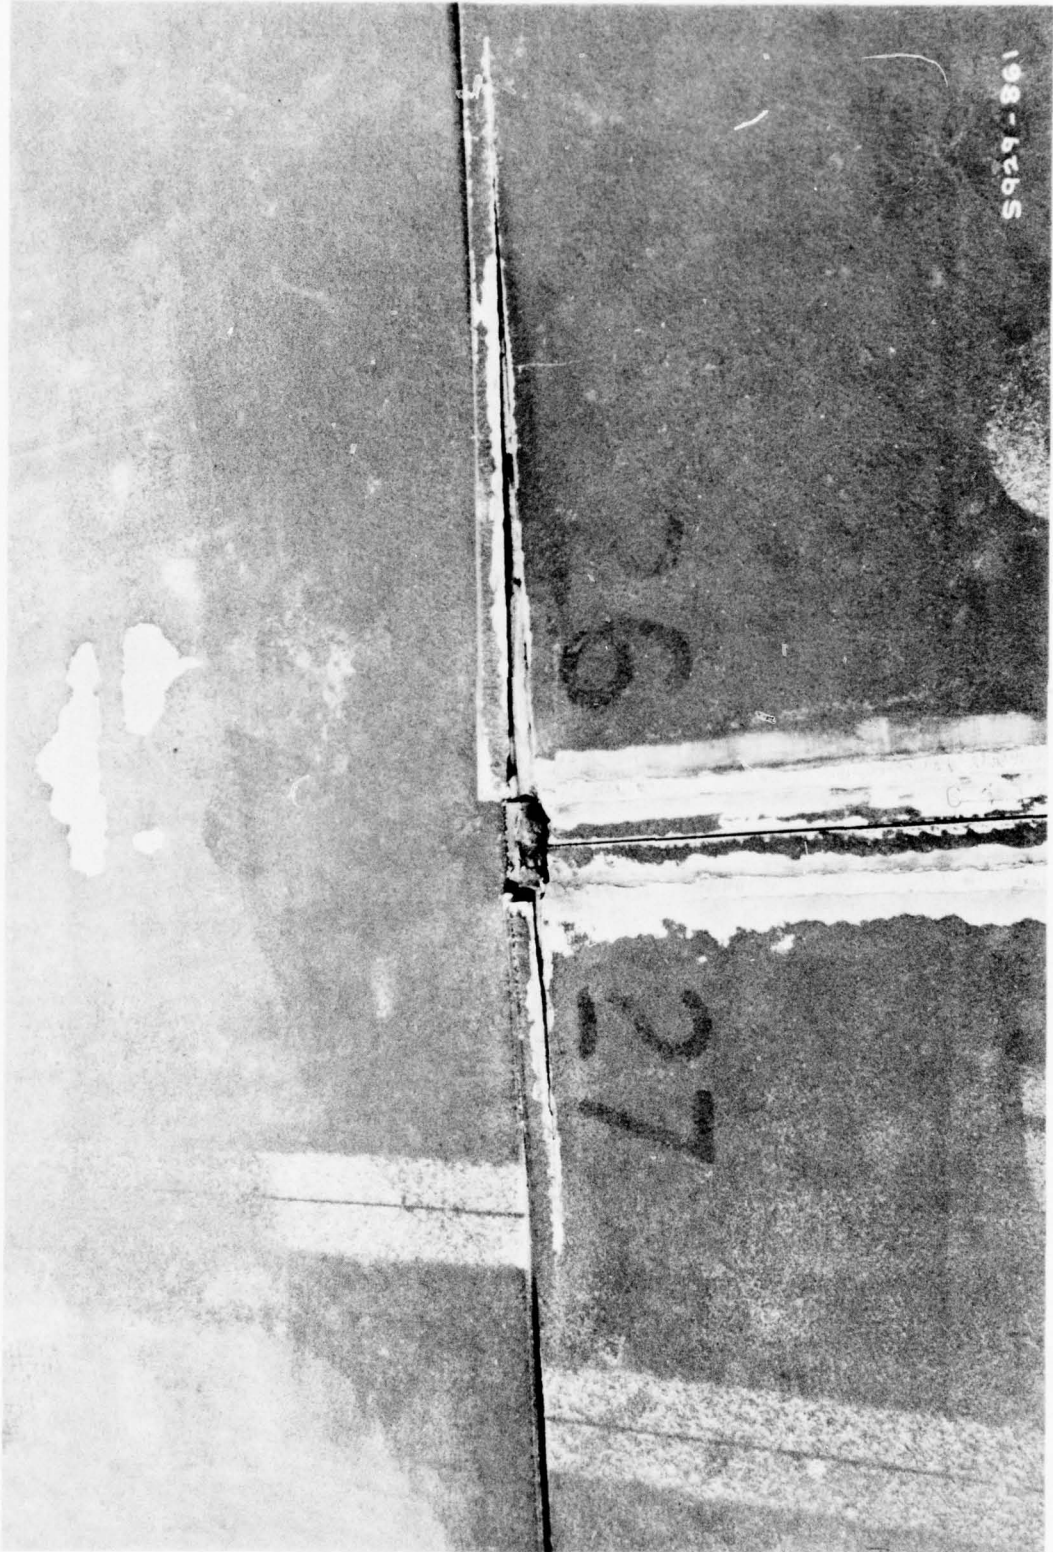
Panels 26 and 27 after 240 coverages

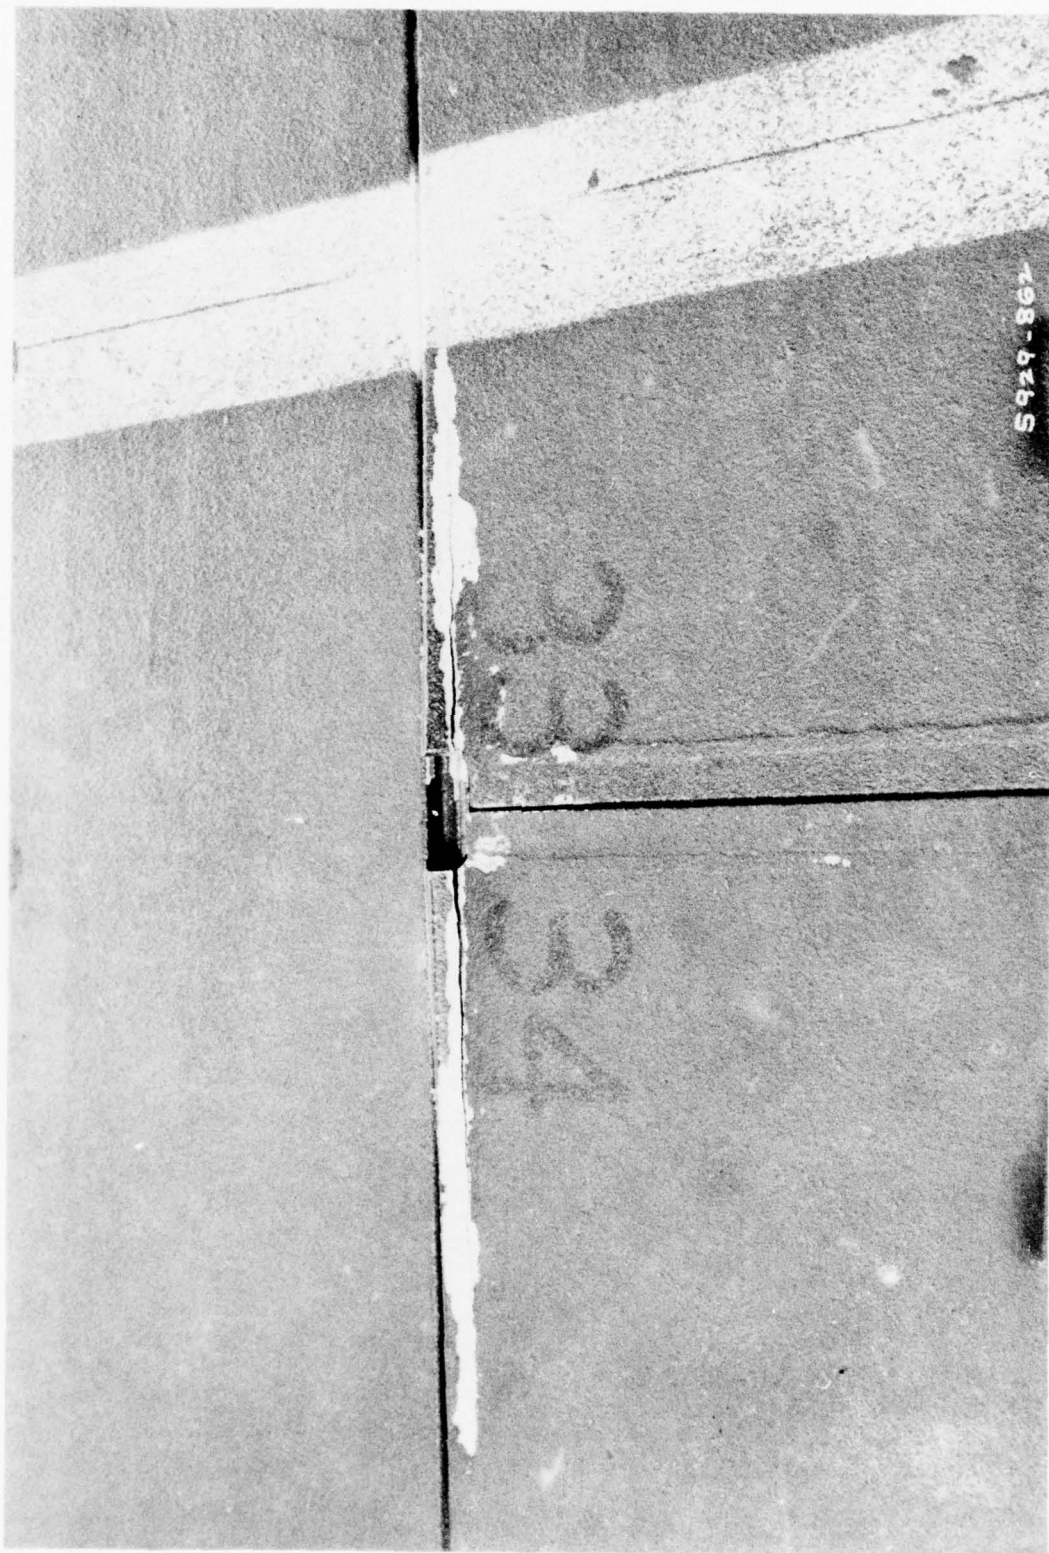
Panels 33 and 34 after 240 coverages

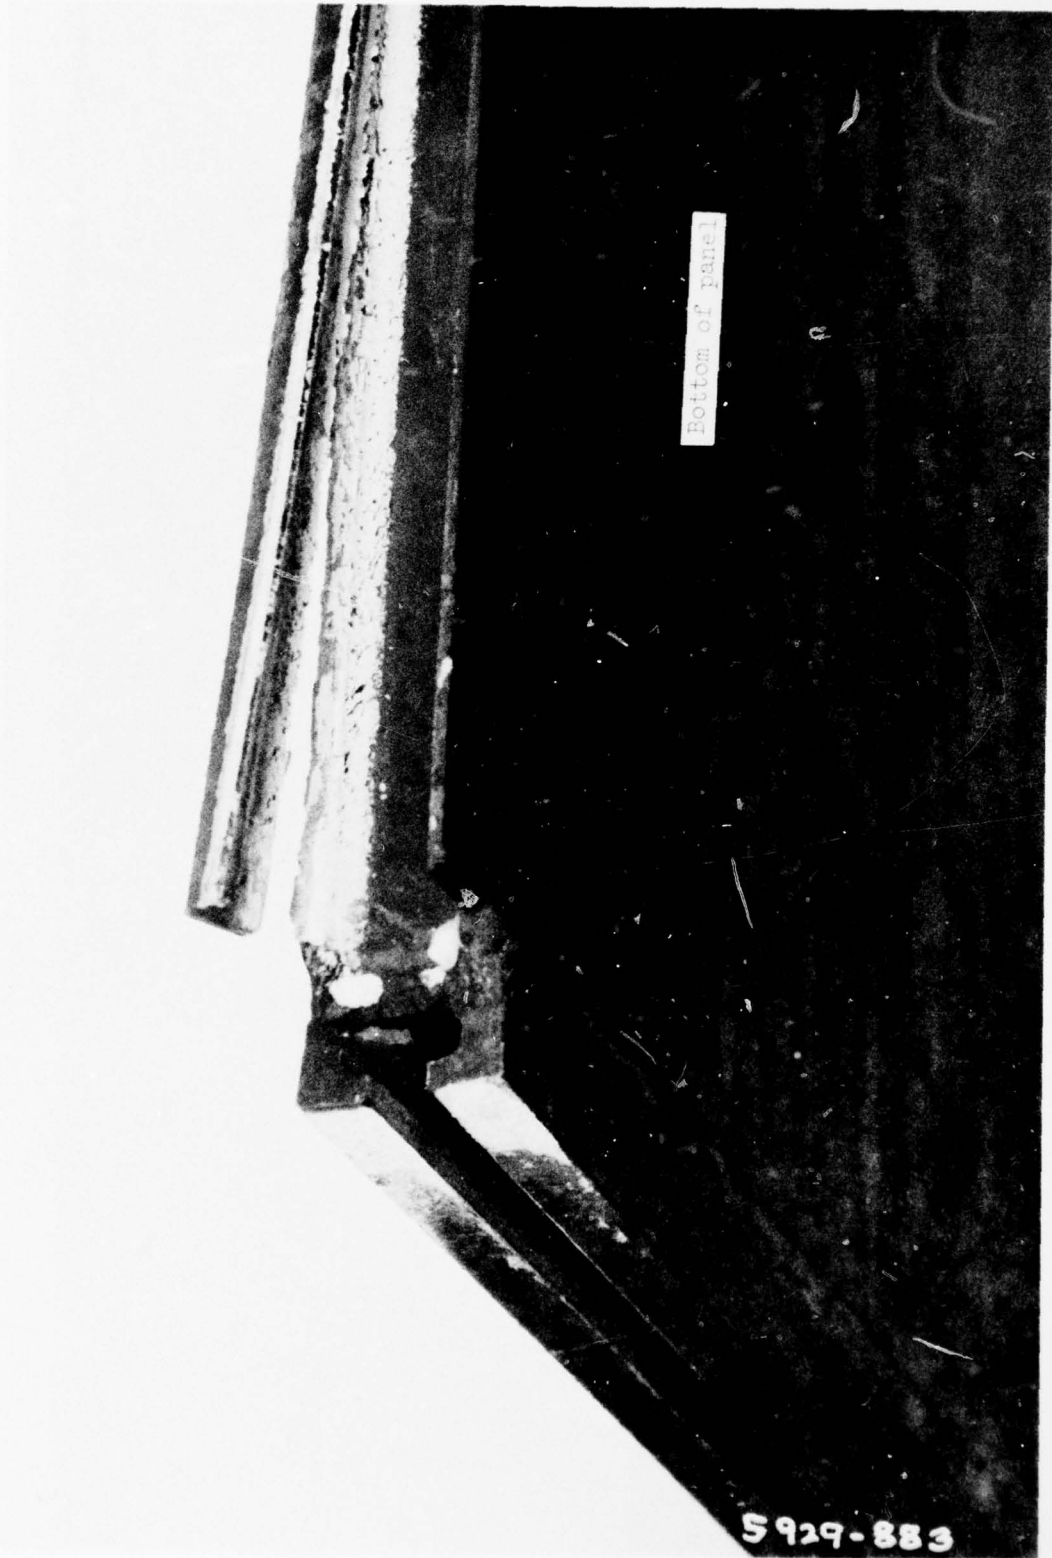
a. The mat sustained only 240 of the required 1000 coverages of the 50,000-lb SWL with a 250-psi tire-inflation pressure on a 4-CBR subgrade prior to failure of the mat due to splits along the female connectors at the panel corners.

Split in female connector after 240 coverages

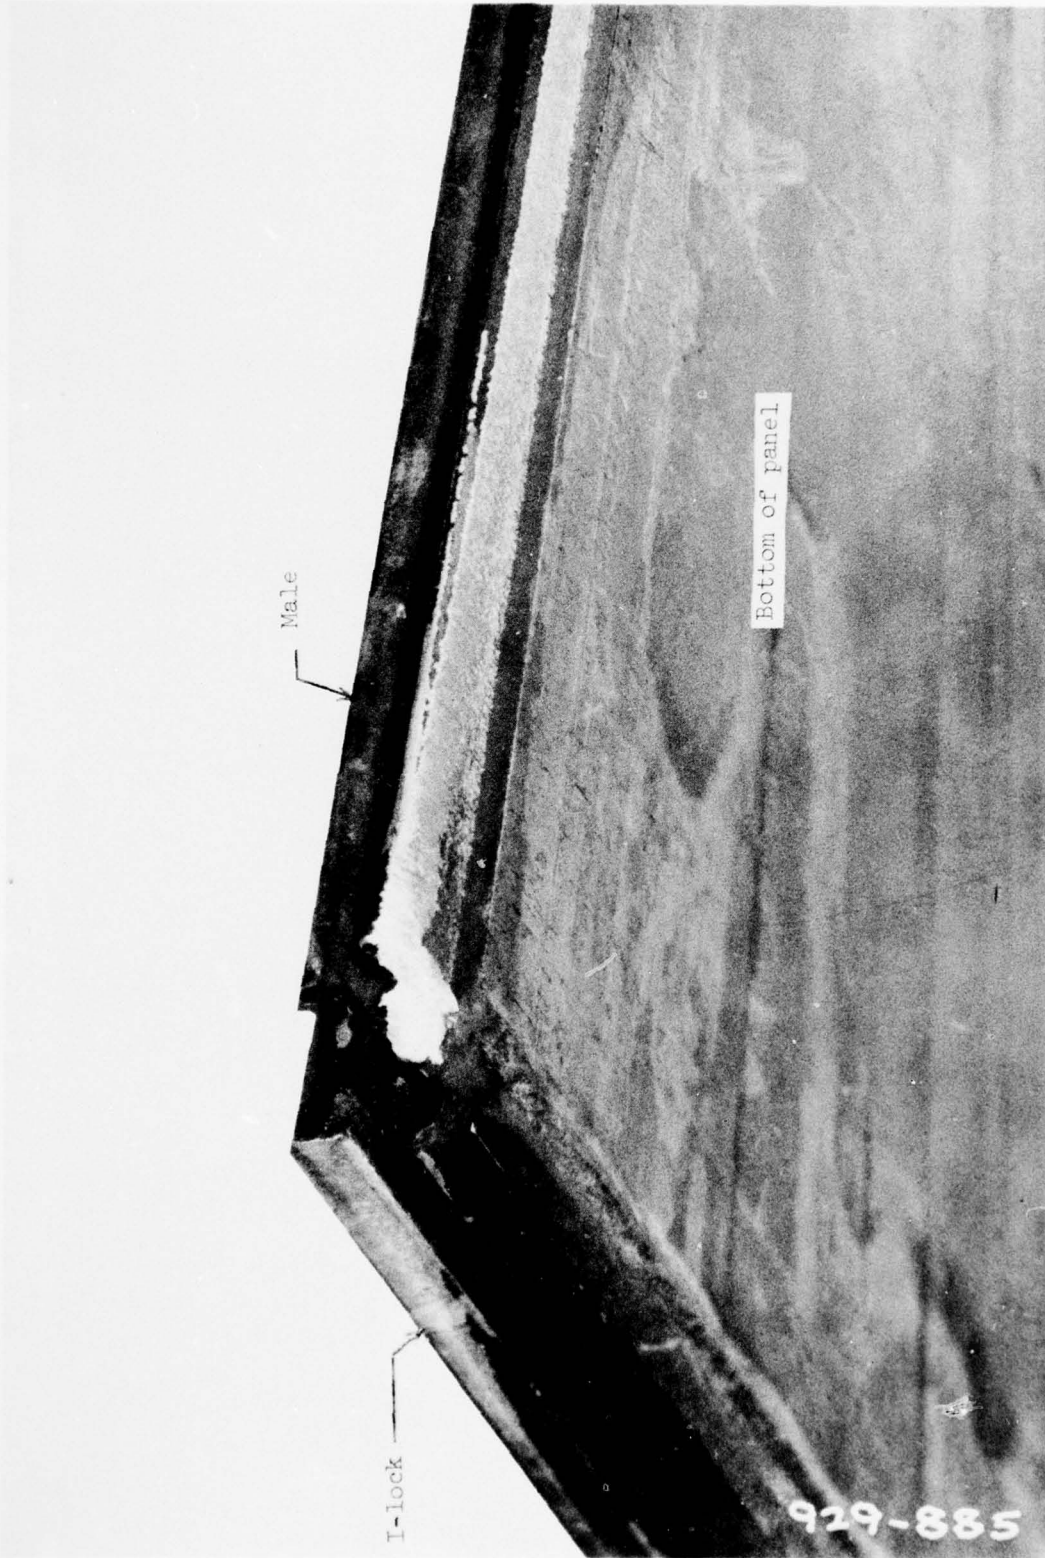
Wear and abrasion of male and I-lock connectors after 240 coverages

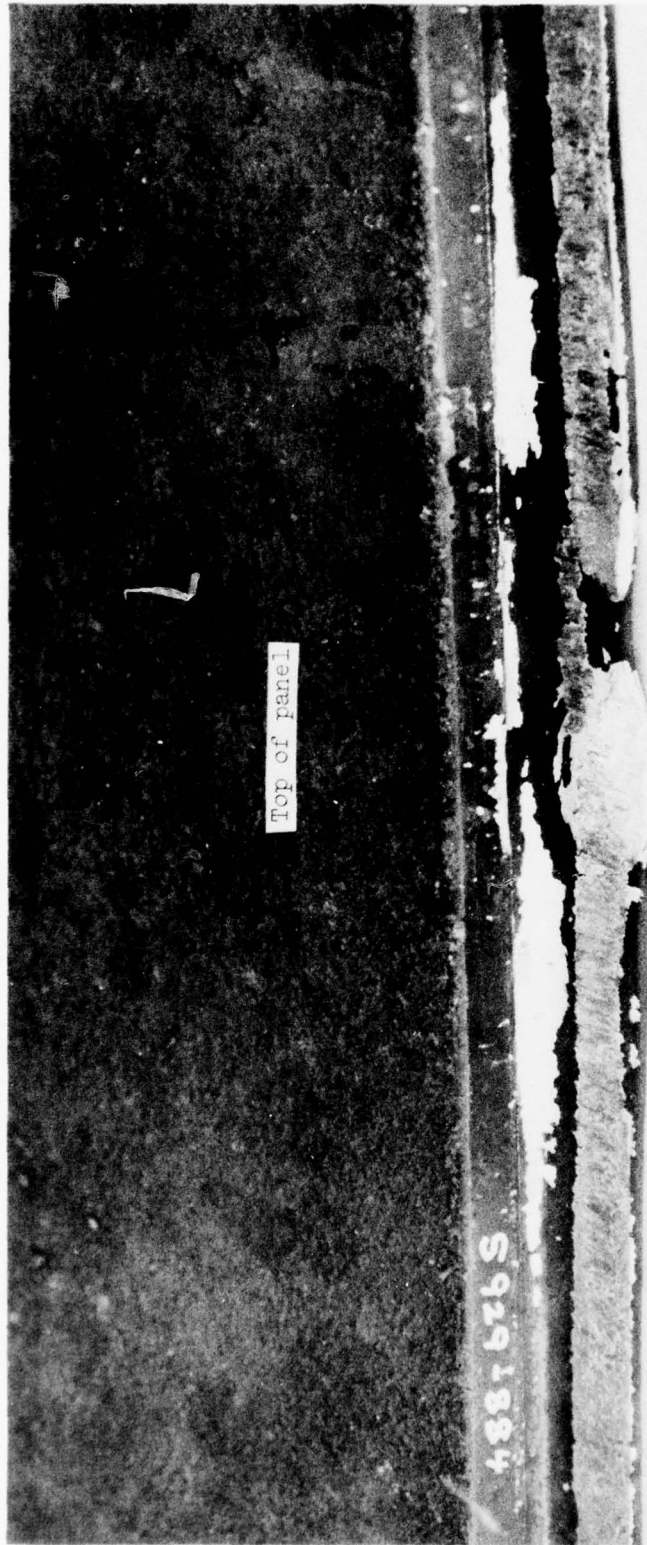
Wear and abrasion of female connector (at center of panel) after 240 coverages

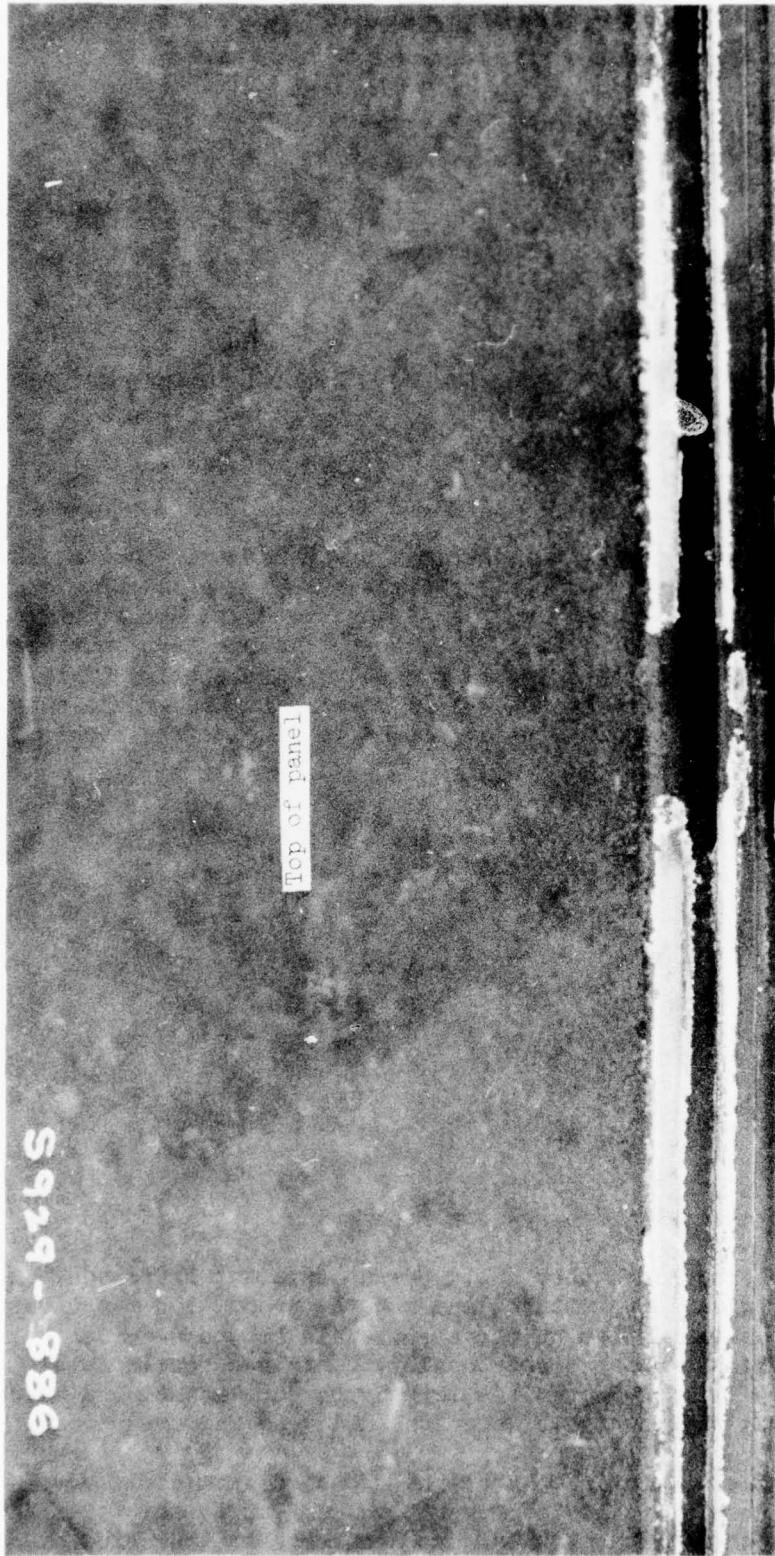
Wear and abrasion of male connector (at center of panel) after 240 coverages

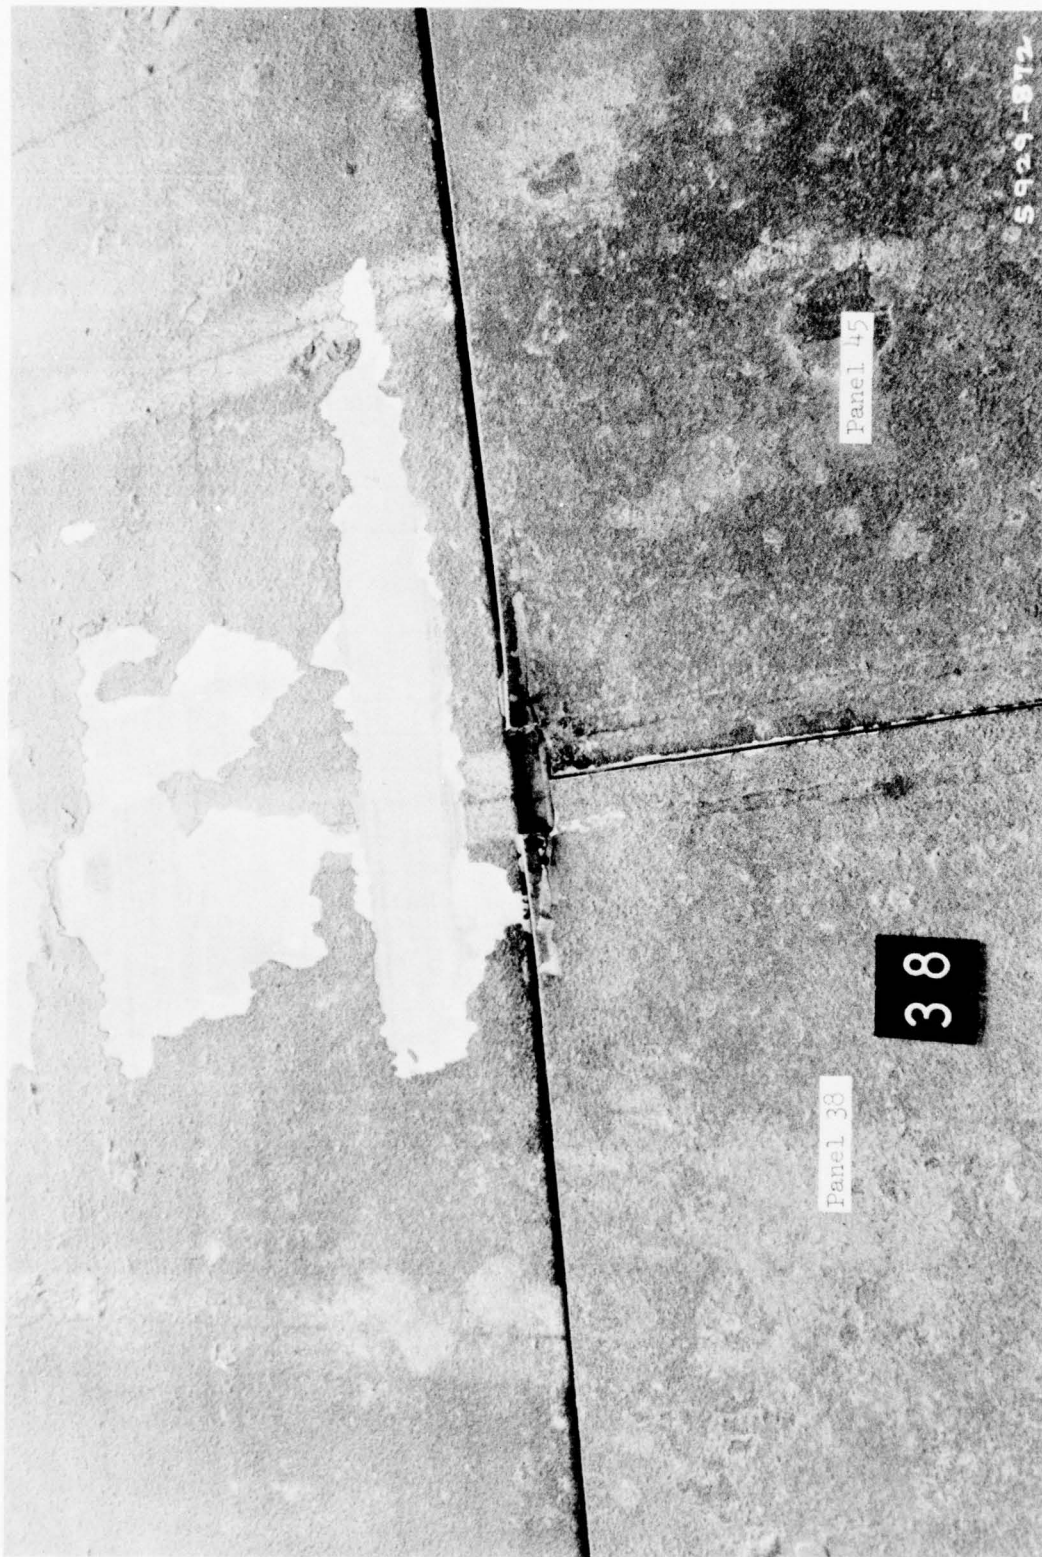
363 coverages of traffic. Both panels were considered failed after 500 coverages due to the splits along the female connector which were tire hazards. The female corners of panels 5 and 23, with 1/4-in. radii, are shown on Incl 29 after 363 channelized coverages. These panels were failed due to splits which were a tire hazard. The female corners of panels 20 and 28, with 1/2-in. radii, are shown on Incl 30 after 363 coverages. Panel 28 contained a split along the female lip and was a tire hazard. Panel 20 was failed after 690 coverages due to a split along the female lip. The end joint of panels 10a and 31 and panels 15 and 18 are shown on Incls 31 and 32, respectively, after 804 channelized coverages. These panels were not failed when traffic was discontinued at this point. The splits along the lips of panels 5, 20, 23, 28, 33, 38, 40, and 45 were cut off after they were tire hazards so traffic could continue on panels 10a, 15, 18, and 31. Subgrade data are given on Incl 6.

Split in panels 38 and 45 after 363 coverages of channelized traffic

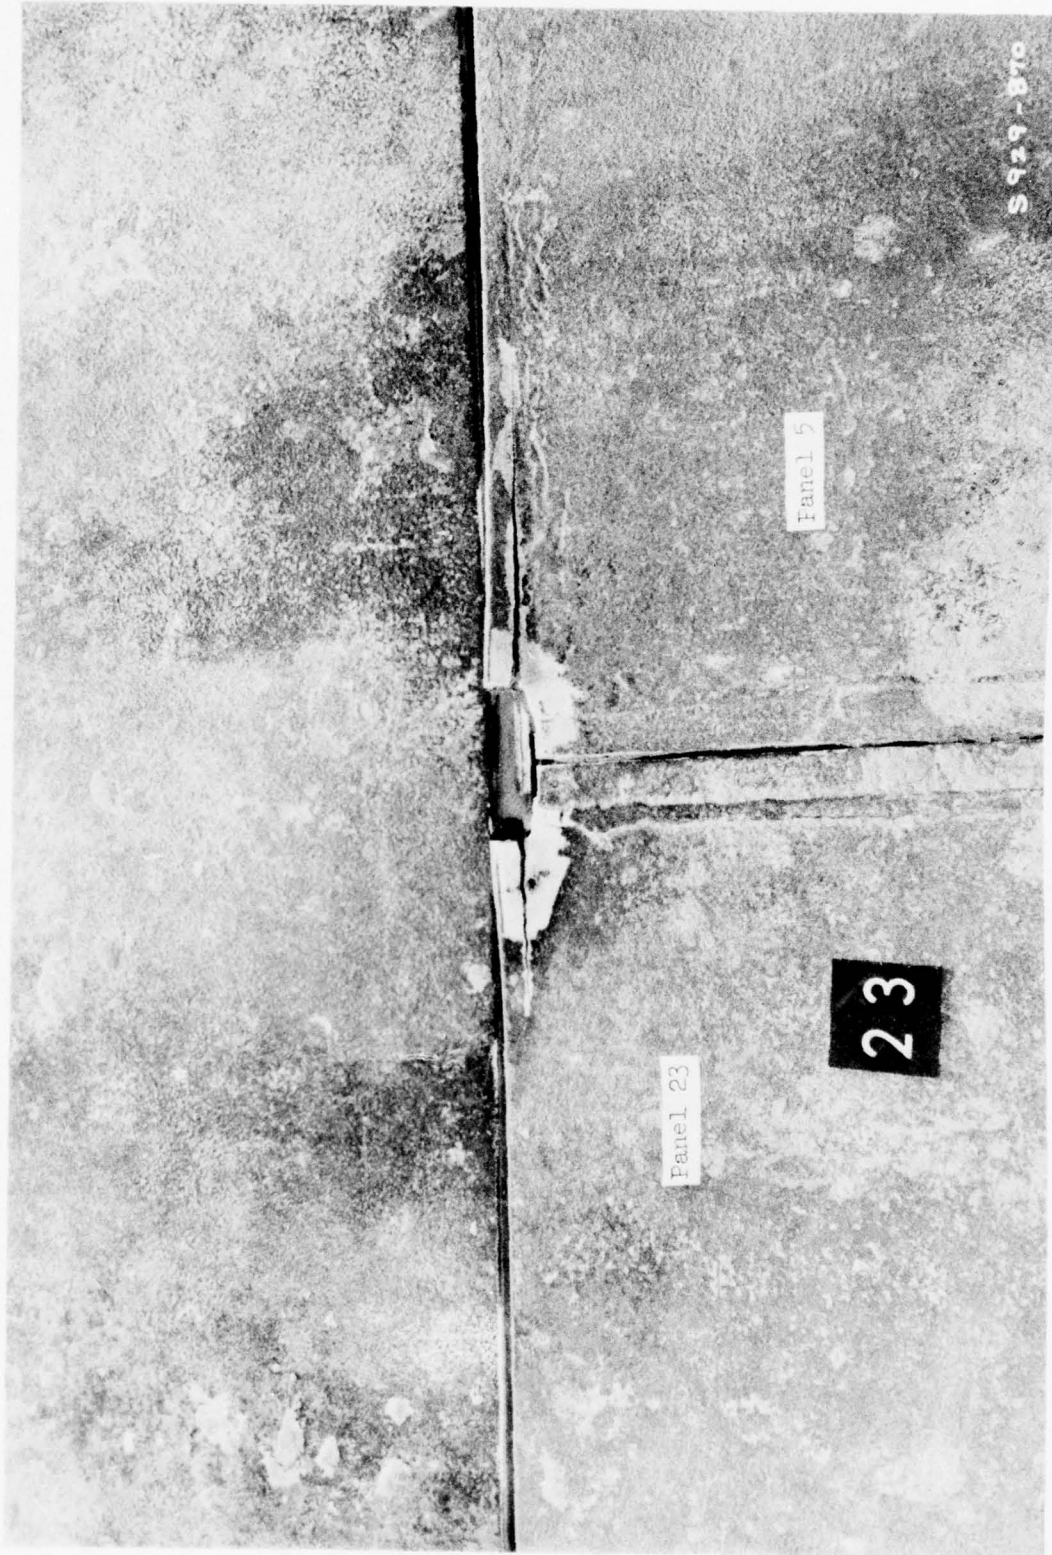
Panels 5 and 23 after 363 coverages of channelized traffic

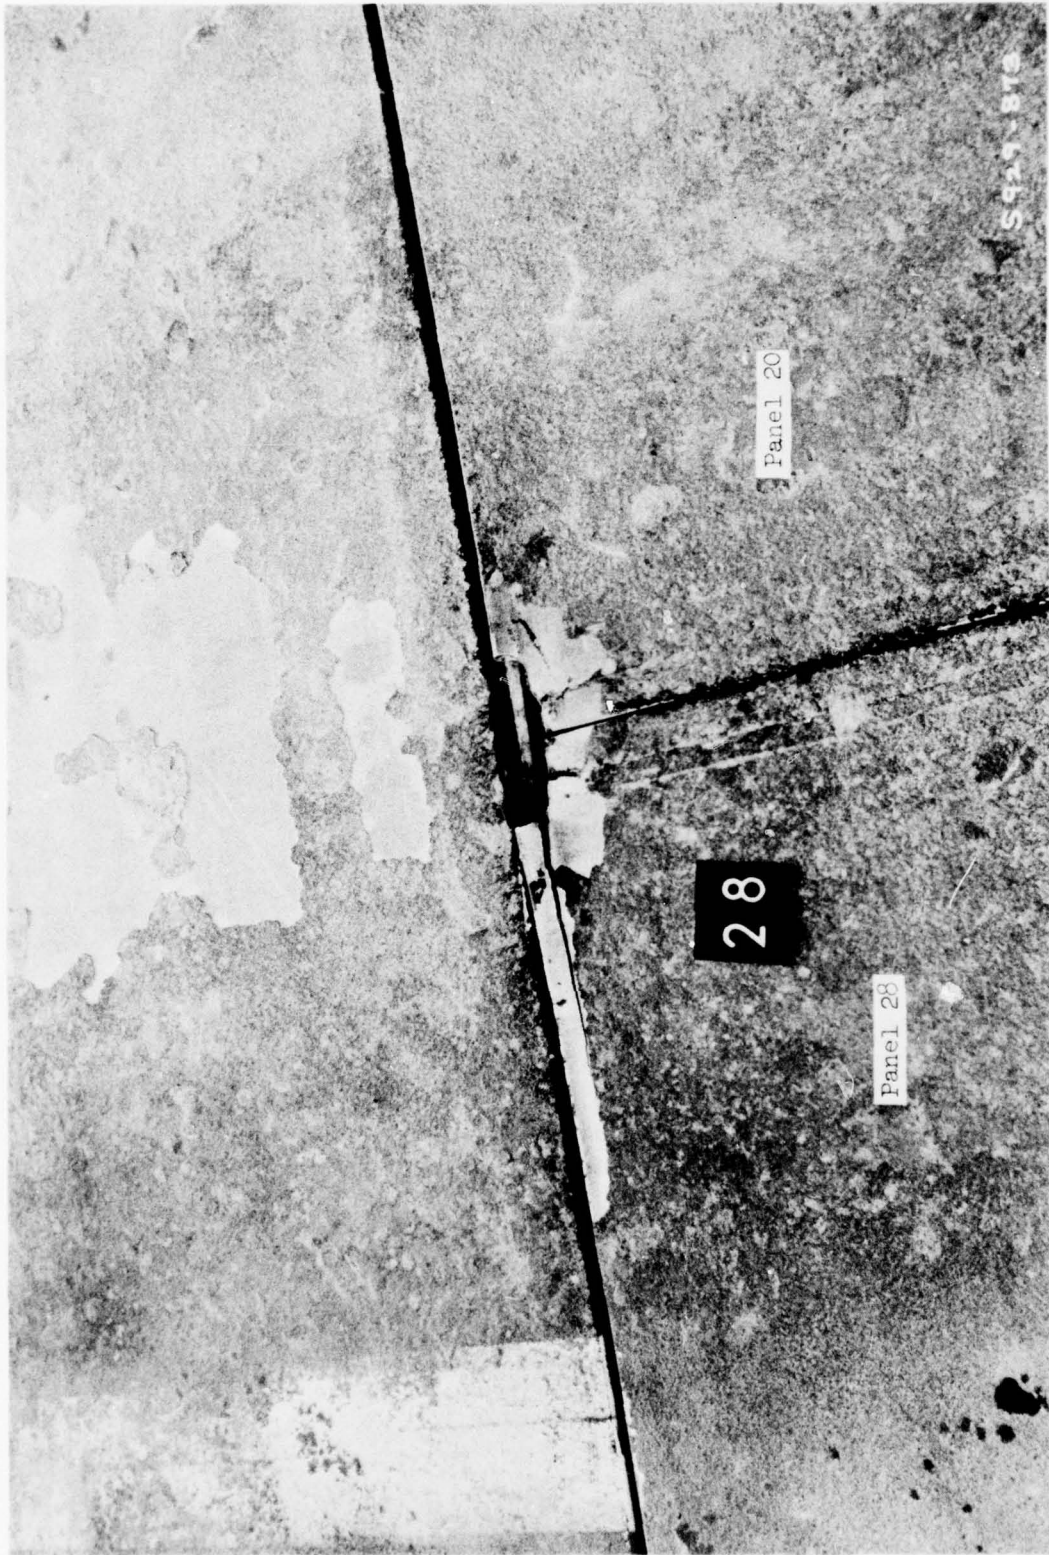
Panels 20 and 28 after 363 coverages of channelized traffic

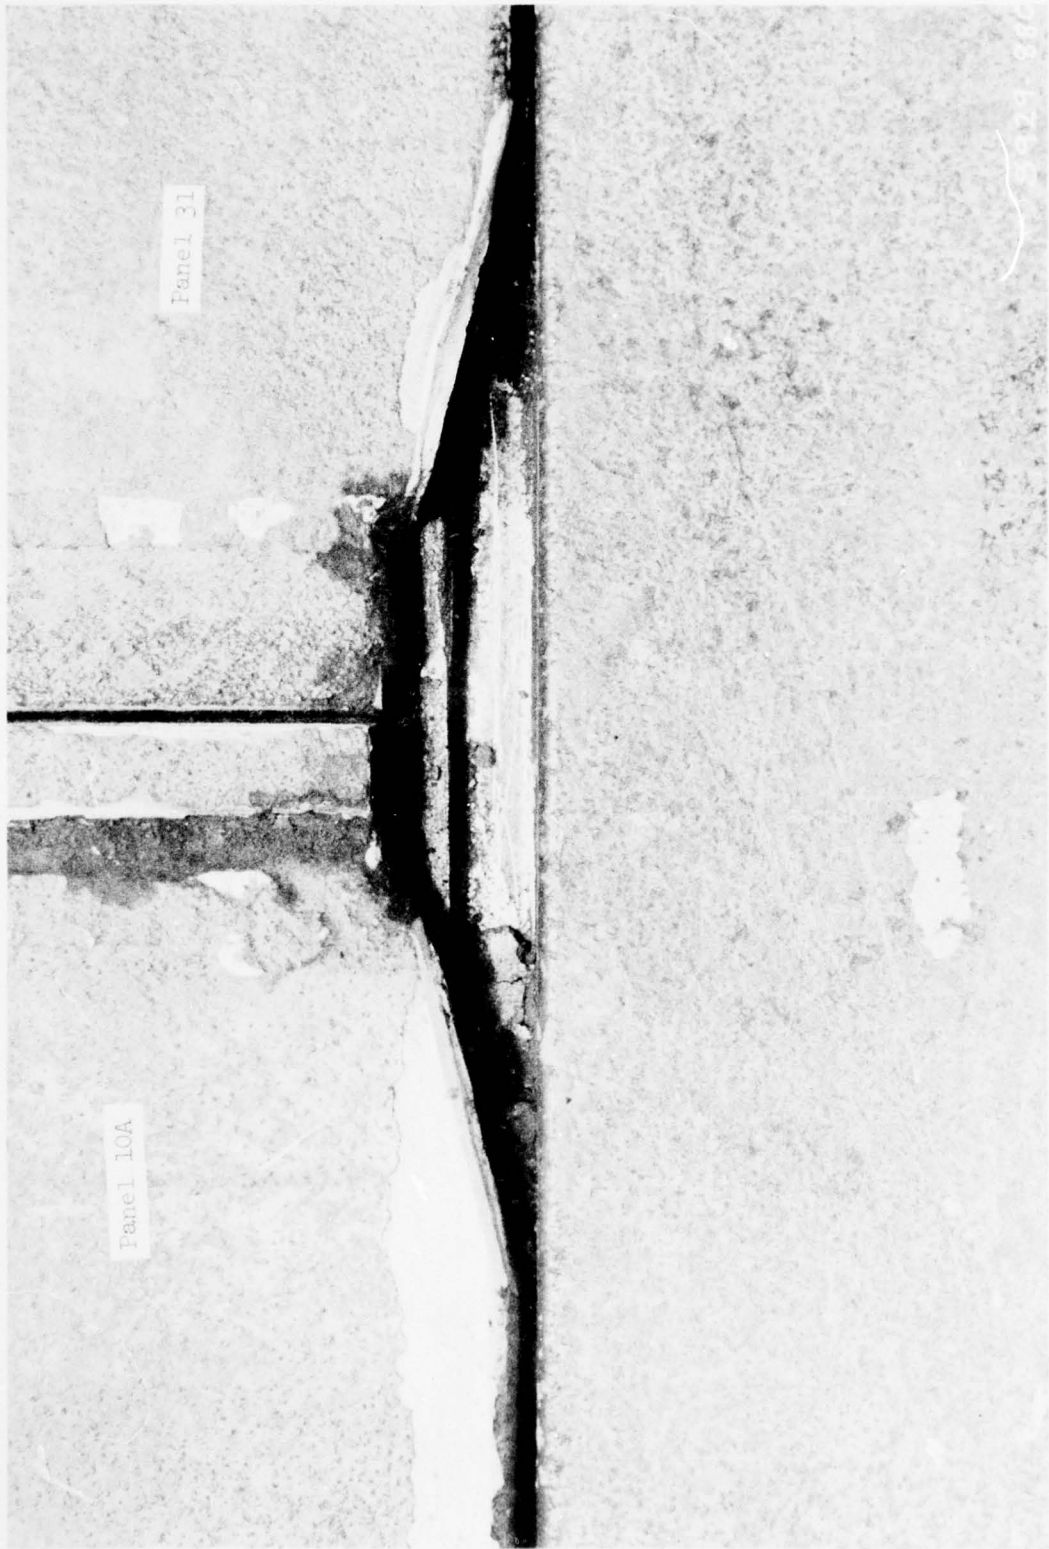
Panels 10A and 31 after 804 coverages of channelized traffic
