MISCELLANEOUS PAPER S-74-6

# EVALUATION OF DOW CHEMICAL PRODUCTION EXTRUDED TRUSS-WEB LANDING MAT

March 1974

Conducted by U. S. Army Engineer Waterways Experiment Station  
Soils and Pavements Laboratory  
Vicksburg, Mississippi

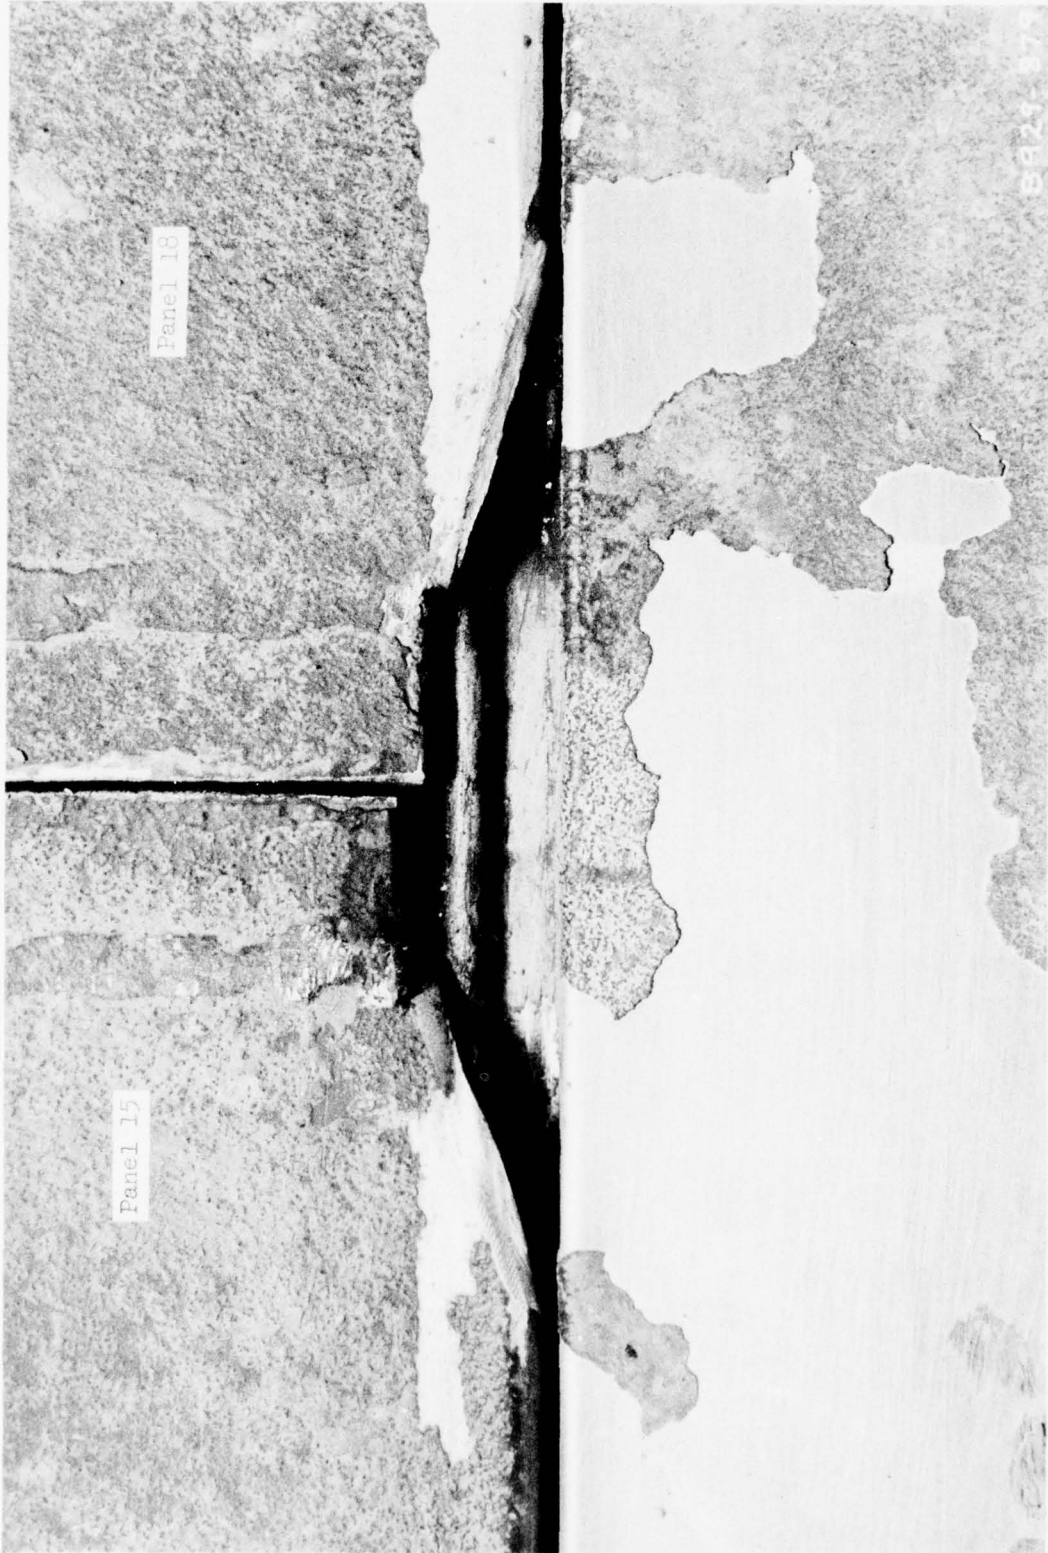
Panels 15 and 18 after 804 coverages of channelized traffic

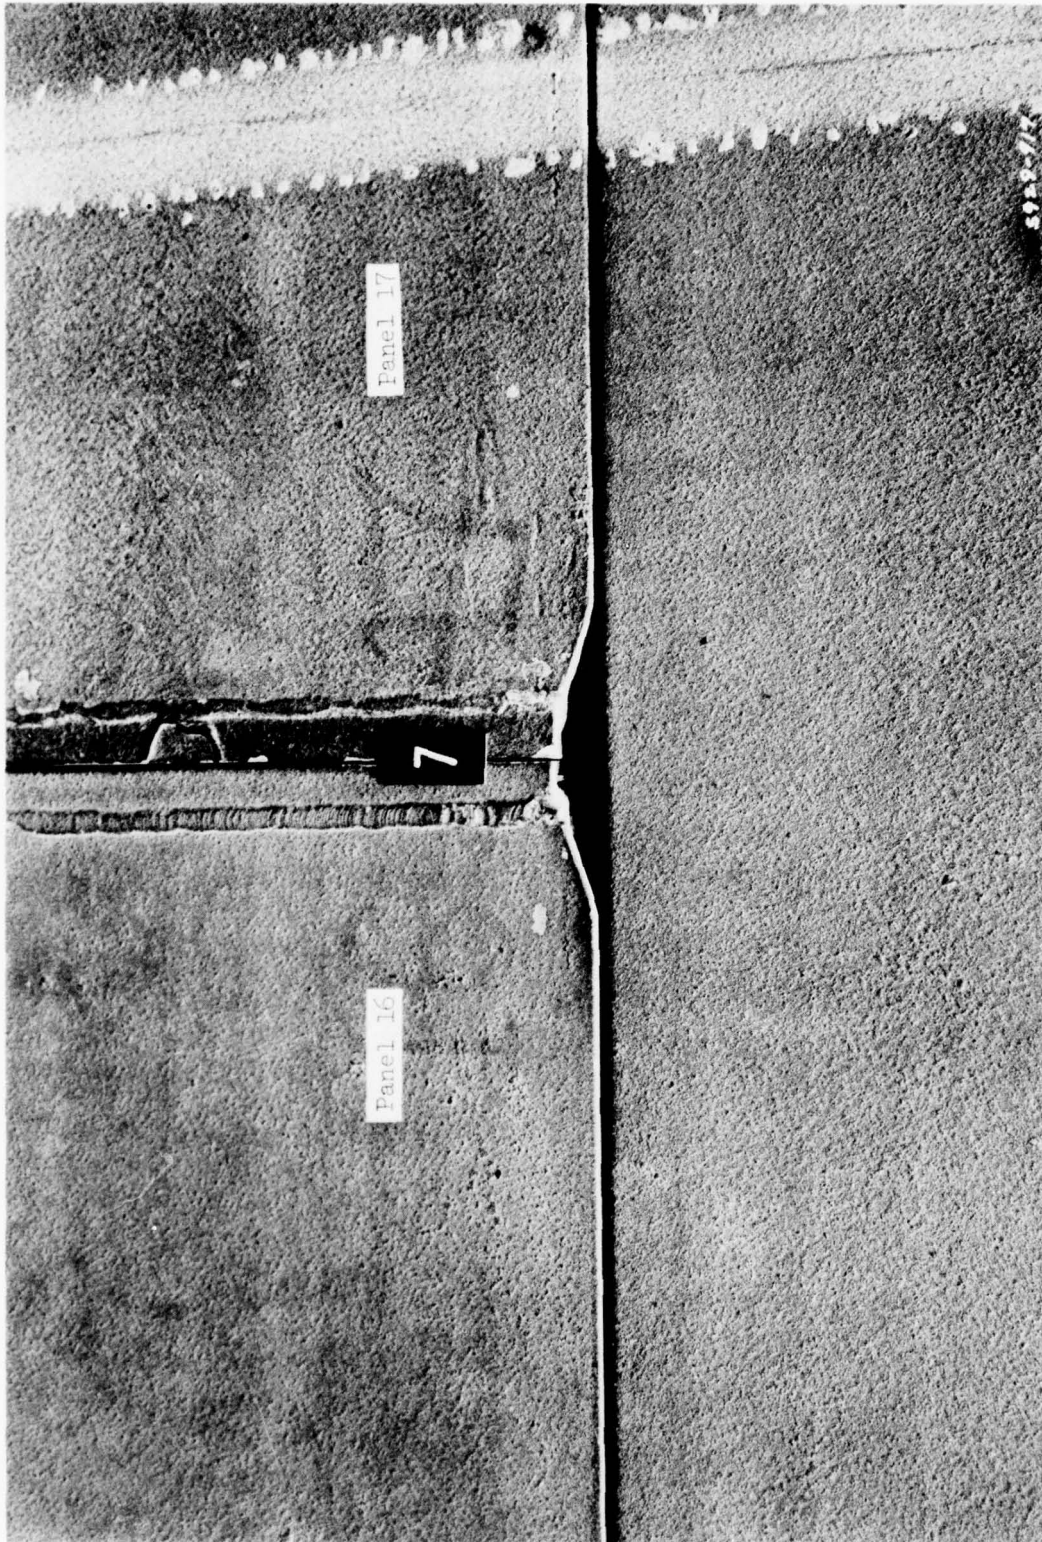
End joint of panels 16 and 17 after 160 coverages, Phase 1

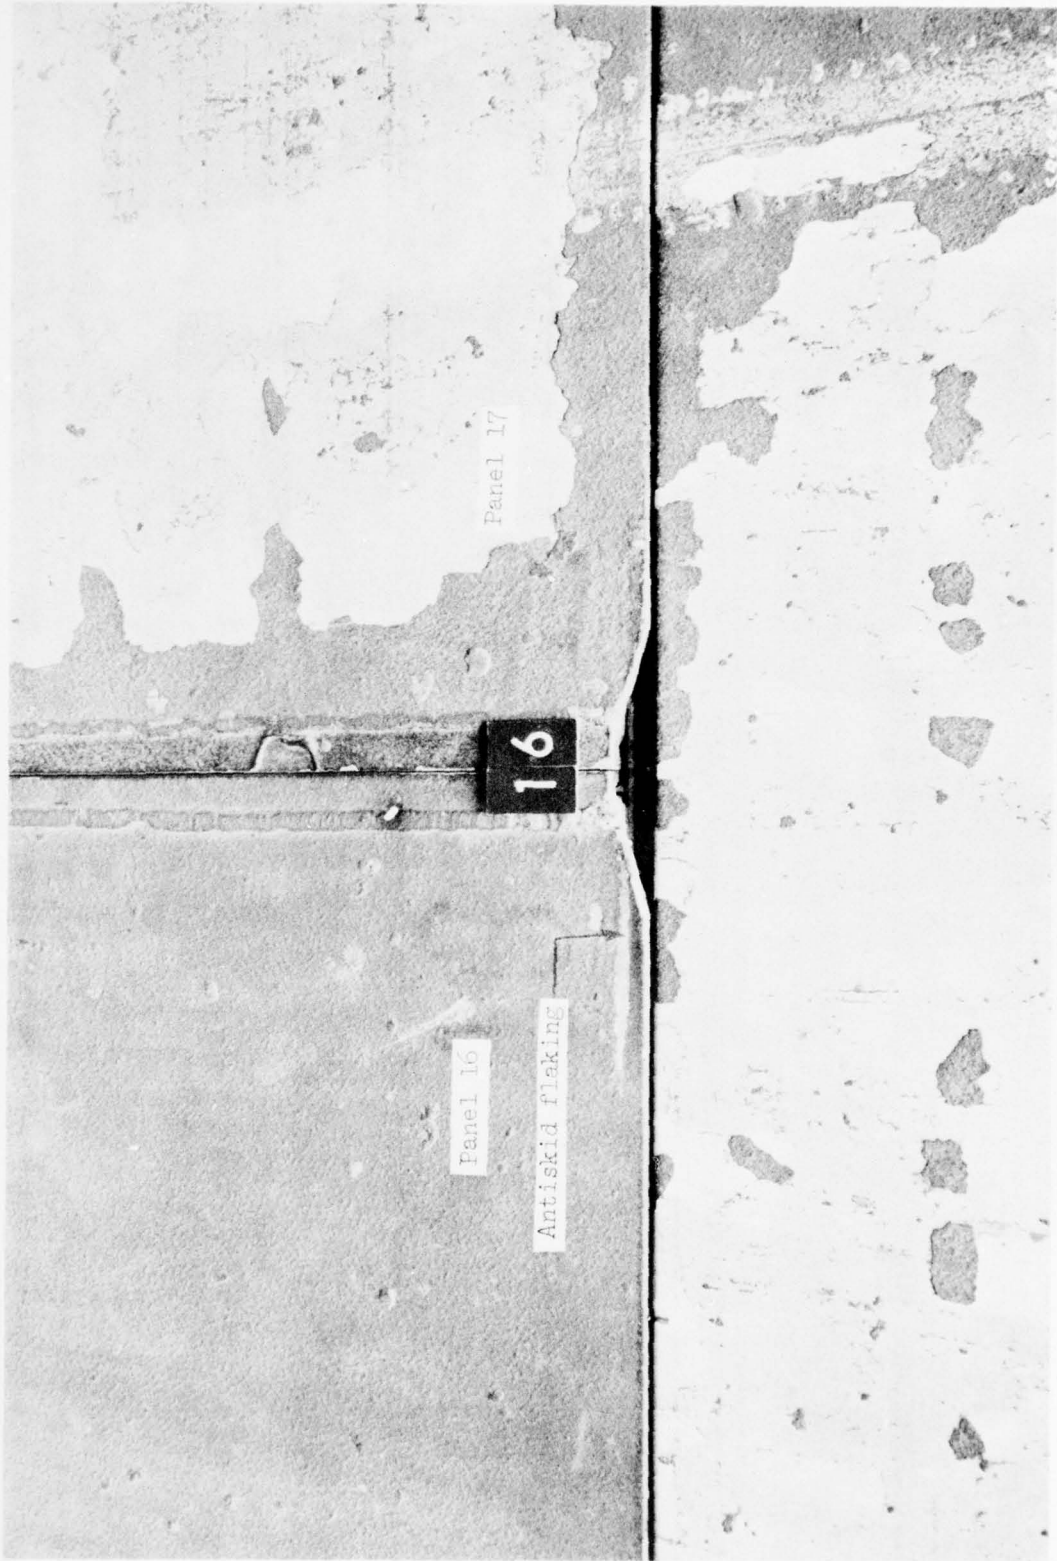
12. An overall view of the test section after 500 coverages is shown on Incl 42. The curl at the female corners of the panels had increased slightly (Incl 43). The increase in the curl on panel 16 caused the antiskid to flake from along the edge of the female connector. Several areas on the panels were bare of antiskid (Incl 44). This is attributed primarily to the spinning action of the drive wheels of the load cart prime mover. Between 400 and 500 coverages, a misty rain fell and due to relatively high wind, this rain was blown onto the mat test section (although the mat was located under a hangar). The mat surface therefore was wet and this caused the load cart prime mover to intermittently spin on the test section. As a result of the spinning and action of the load wheel on the mat, some antiskid flaked off.

Panels 16 and 17 after 500 coverages, Phase 1

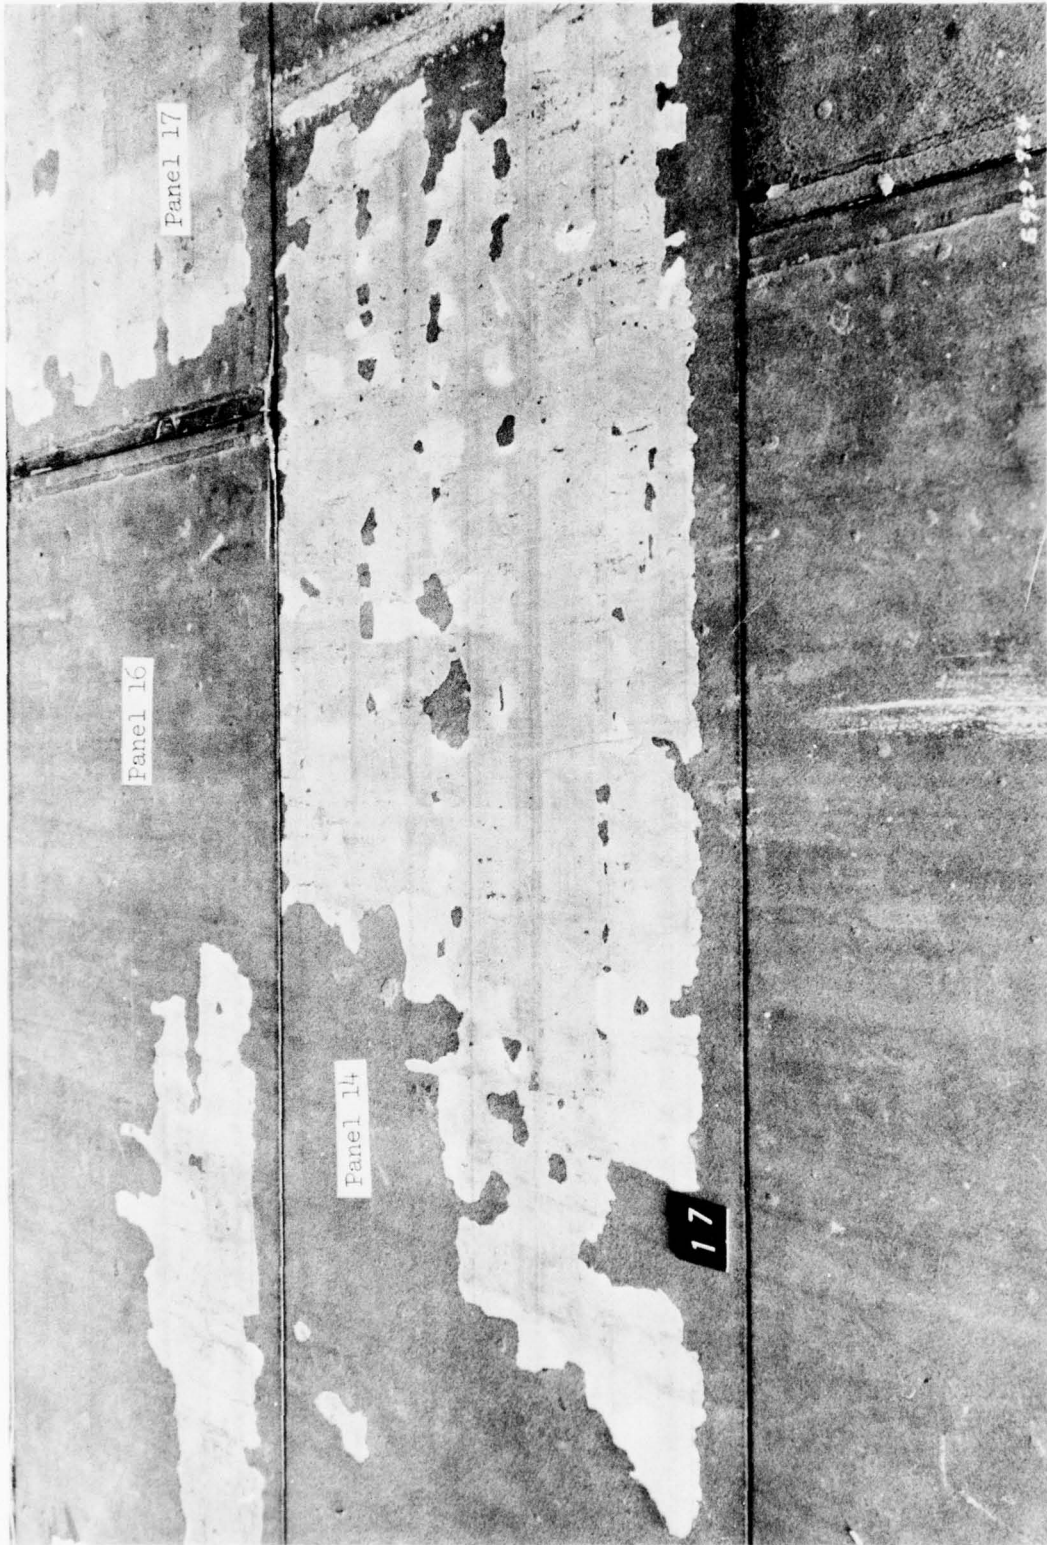
Bare areas on panels 14, 16, and 17 where antiskid had come off after 500 coverages, Phase 1

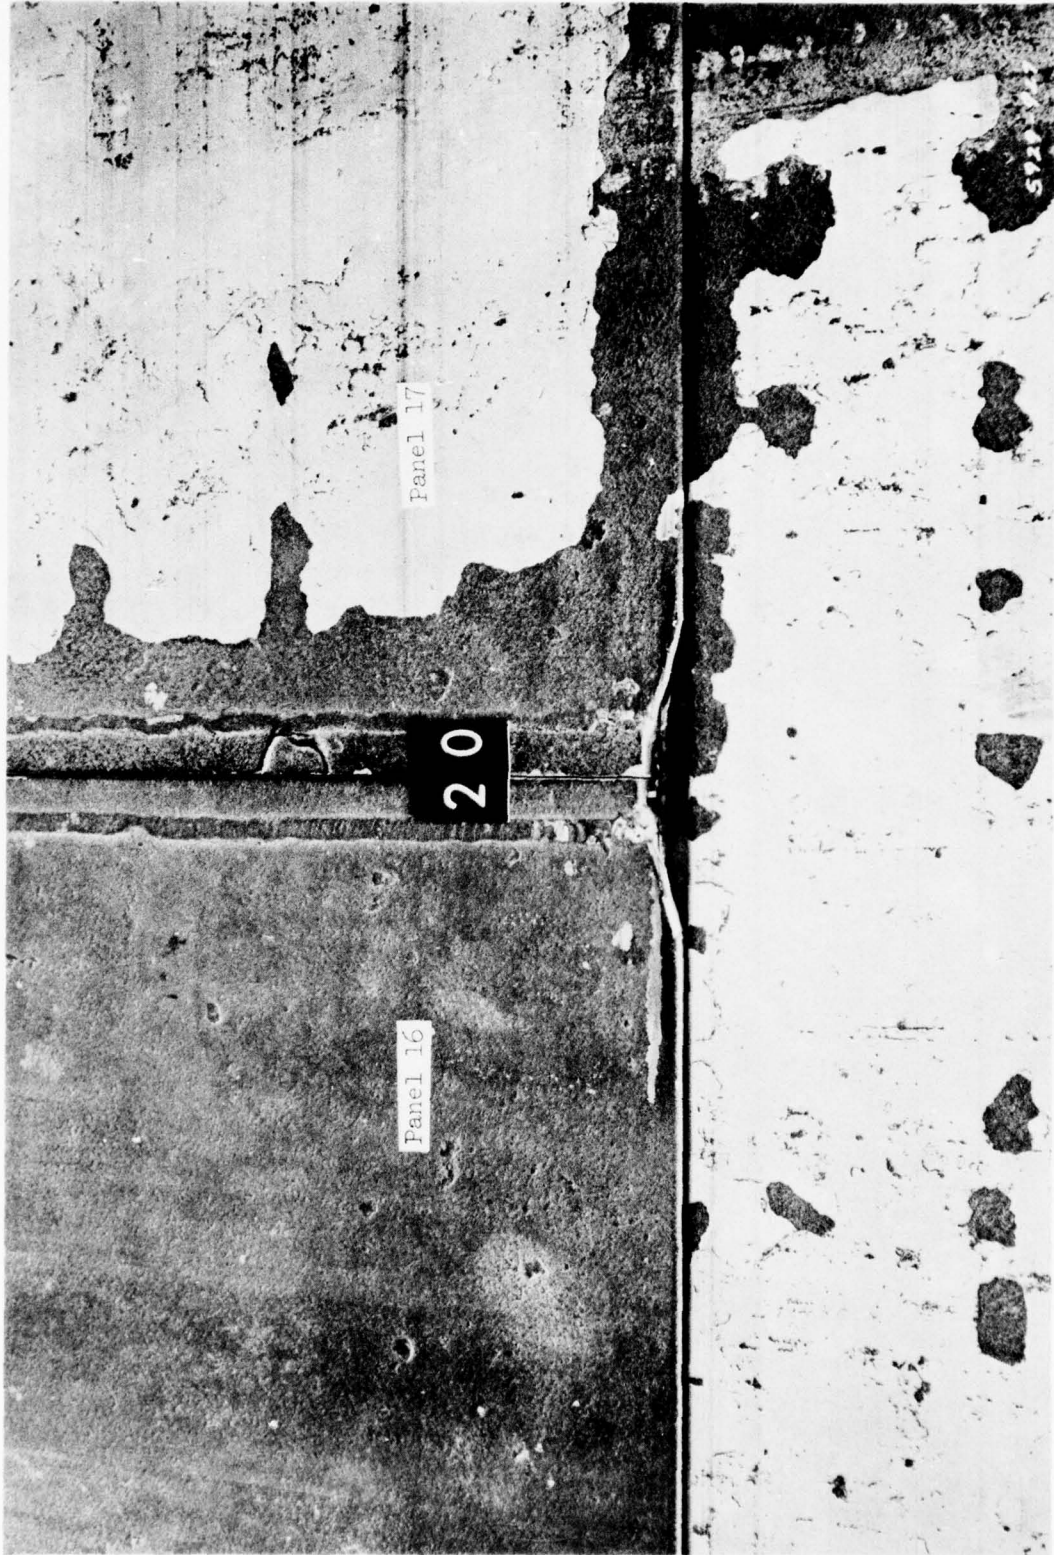
13. Traffic continued and the curl increased at the female corner of the panel end joints. Panels 16 and 17 after 760 coverages are shown on Incl 45. Panels 21, 31, and 32 contained splits along the female connector (Incls 46 and 47). Small cracks in the weld between the I-lock connector and panel extrusion at the male side of the panel were present in panels 41 and 46 after 760 coverages. After 770 coverages (Incl 48), the splits in panels 31 and 32 had become tire hazards due to the sharp edges of the split, and the sharp end of the taper at the corner had turned up. The split was 6-3/4 in. long on panel 31 and 6-1/2 in. long on panel 32. These panels were removed and CBR data taken. The CBR of the subgrade was 3.8 (Incl 37). The failed panels were replaced with new panels and traffic was continued.

Panels 16 and 17 after 760 coverages, Phase 1

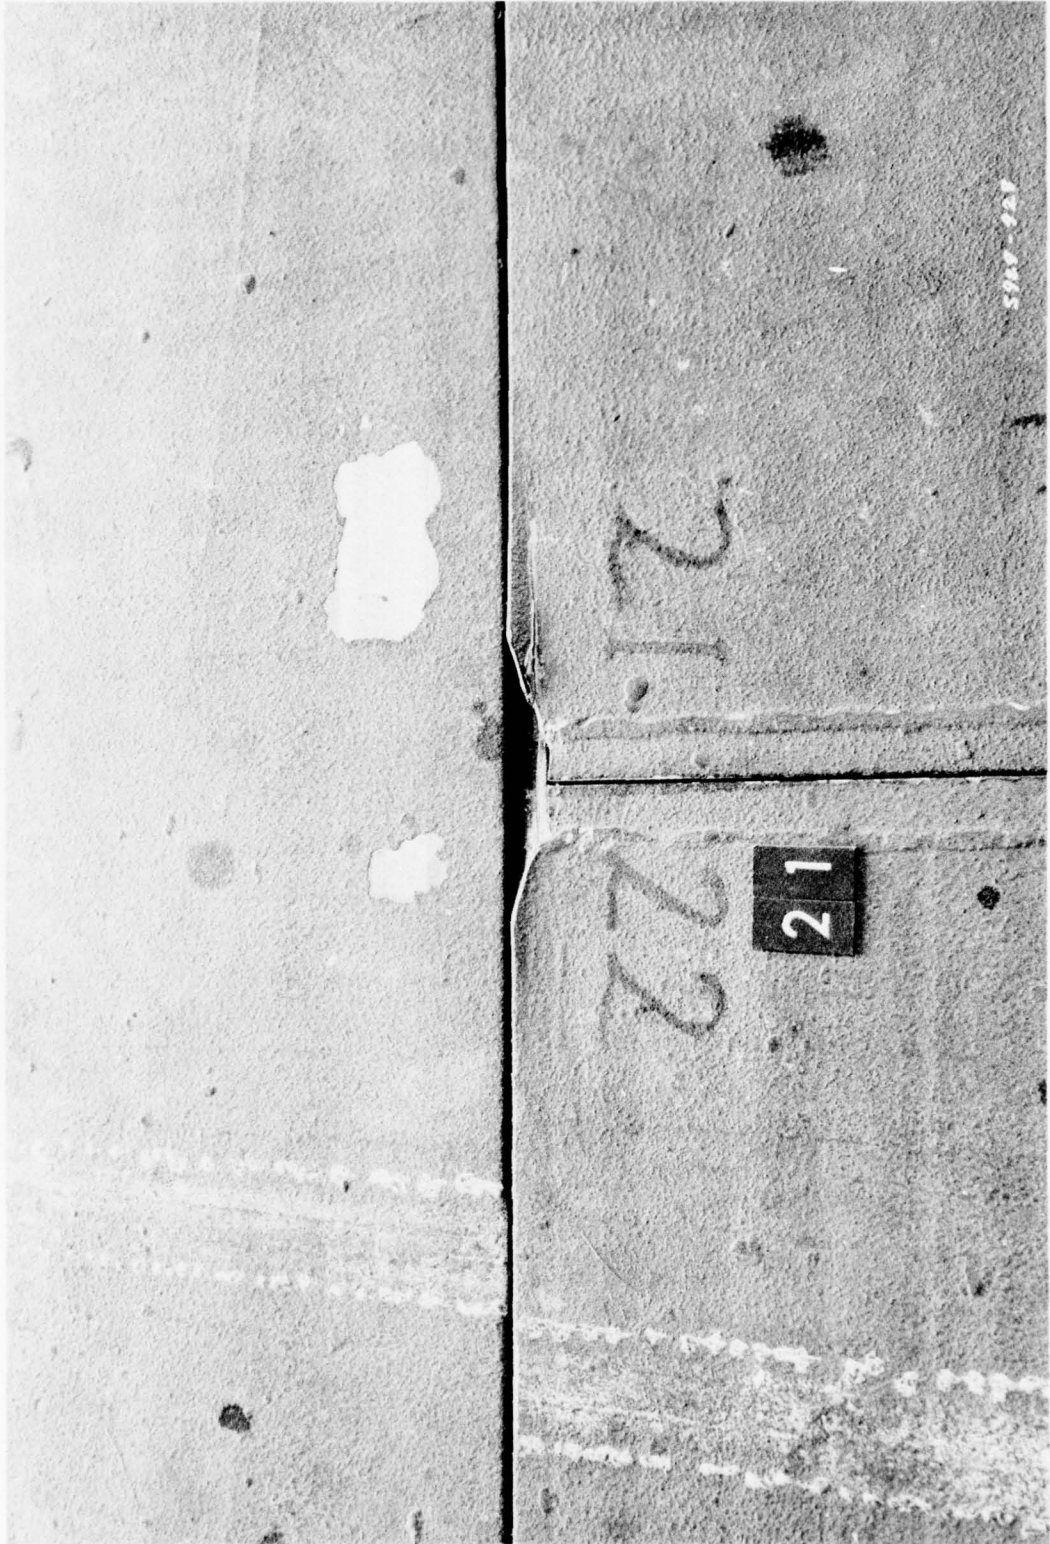
Split in female connector of panel 21 after 760 coverages, Phase 1

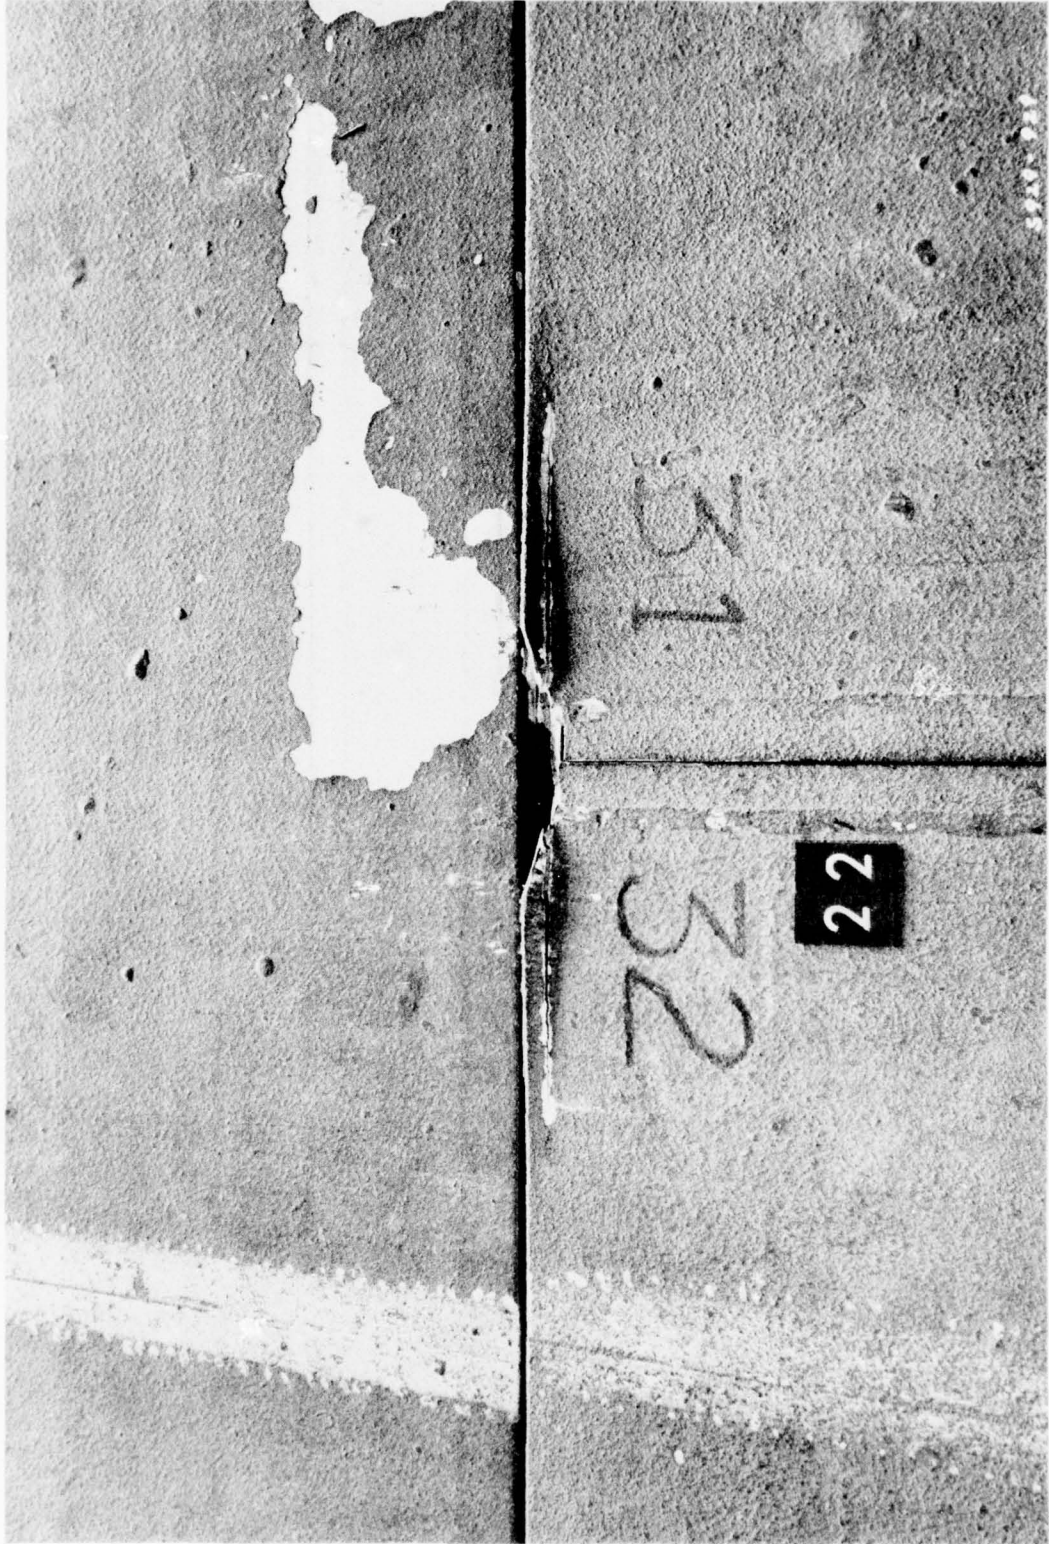
Split in female connector of panels 31 and 32 after 760 coverages, Phase 1

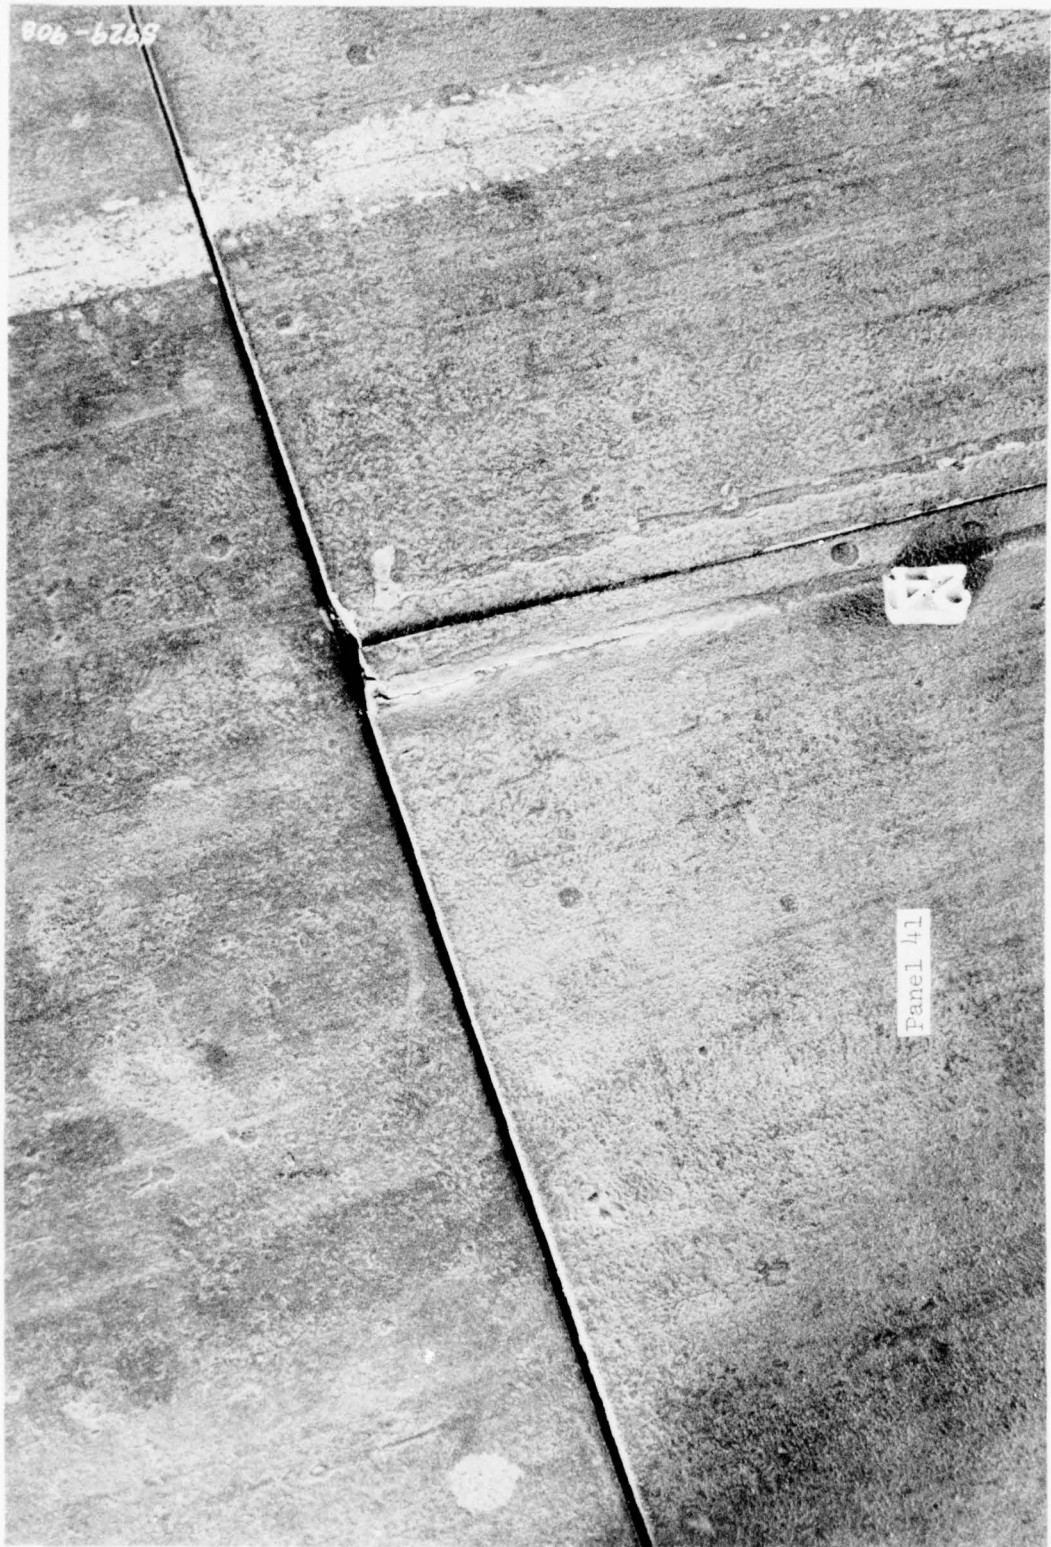
Weld crack at male I-lock corner of panel 41 after 1040 coverages, Phase 1

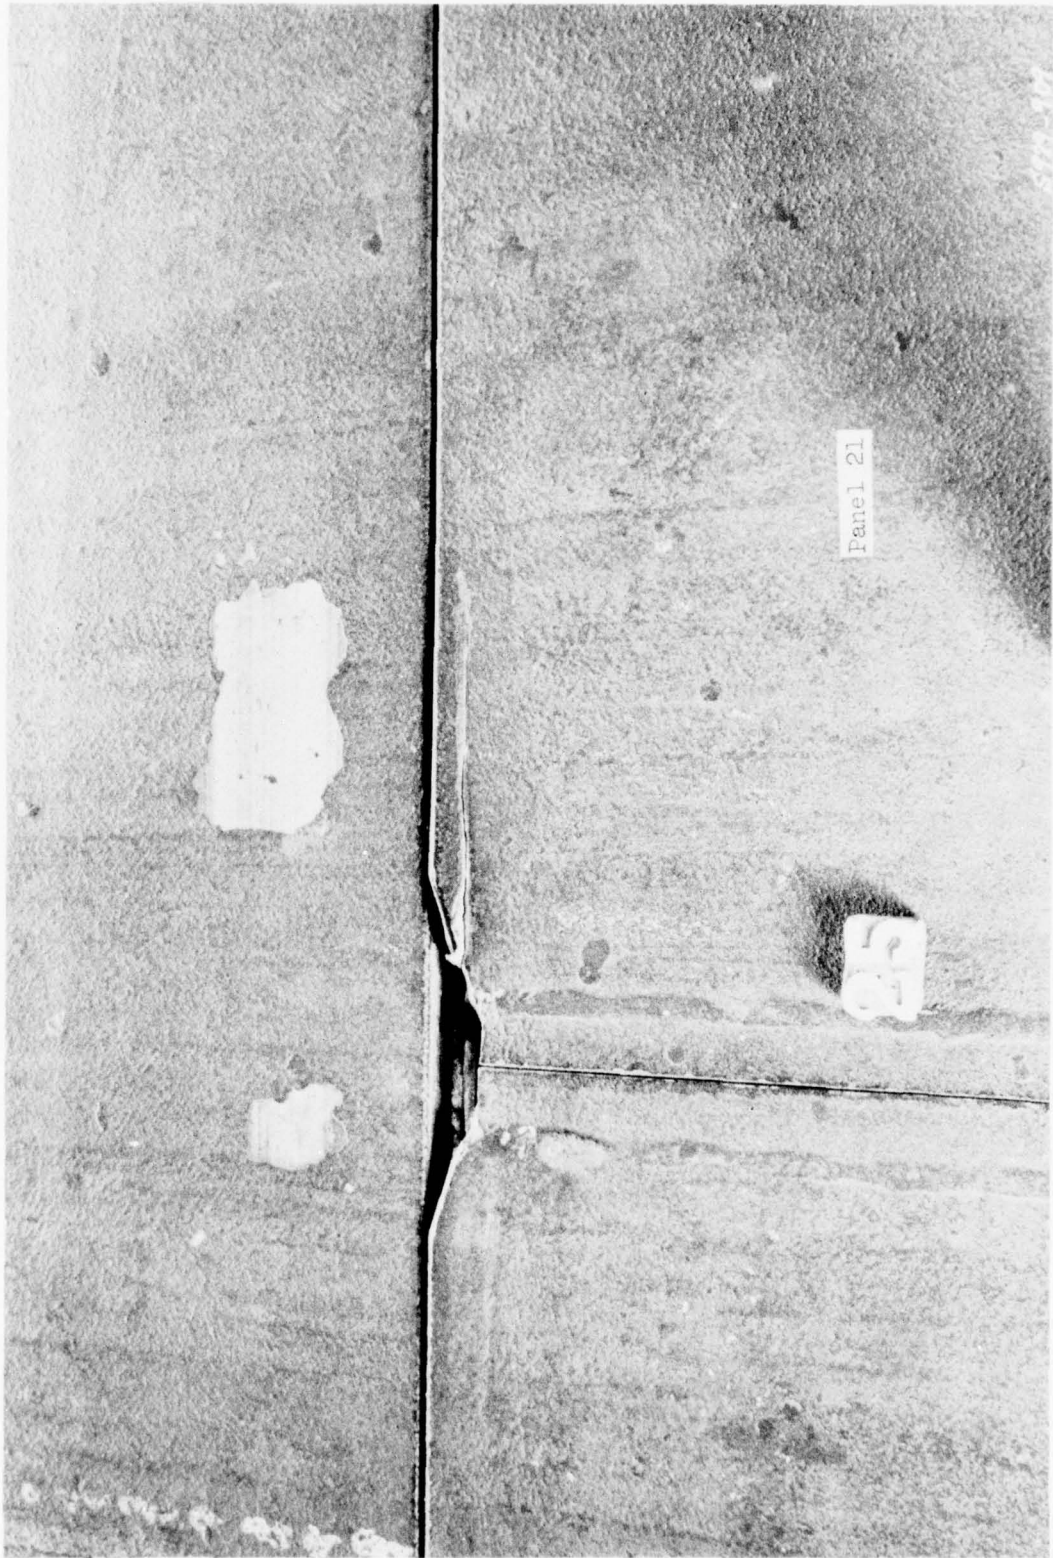
Split in female connector of panel 21 after 1040 coverages, Phase 1

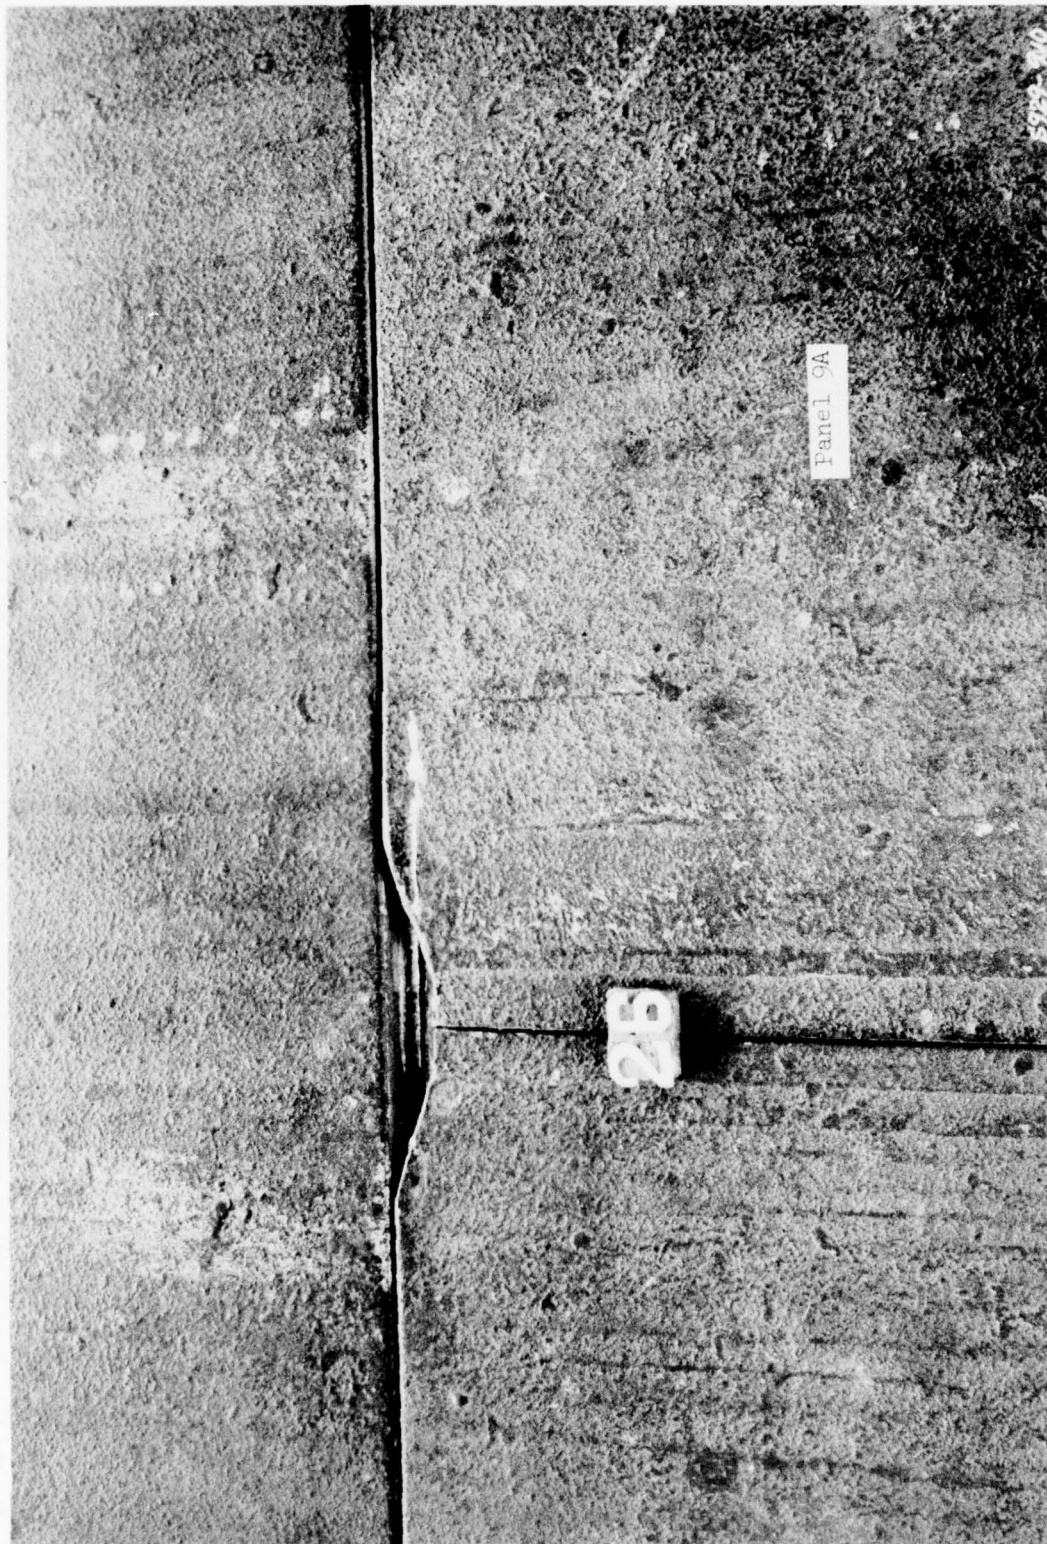
Panel 9A (half panel) after 1040 coverages, Phase 1

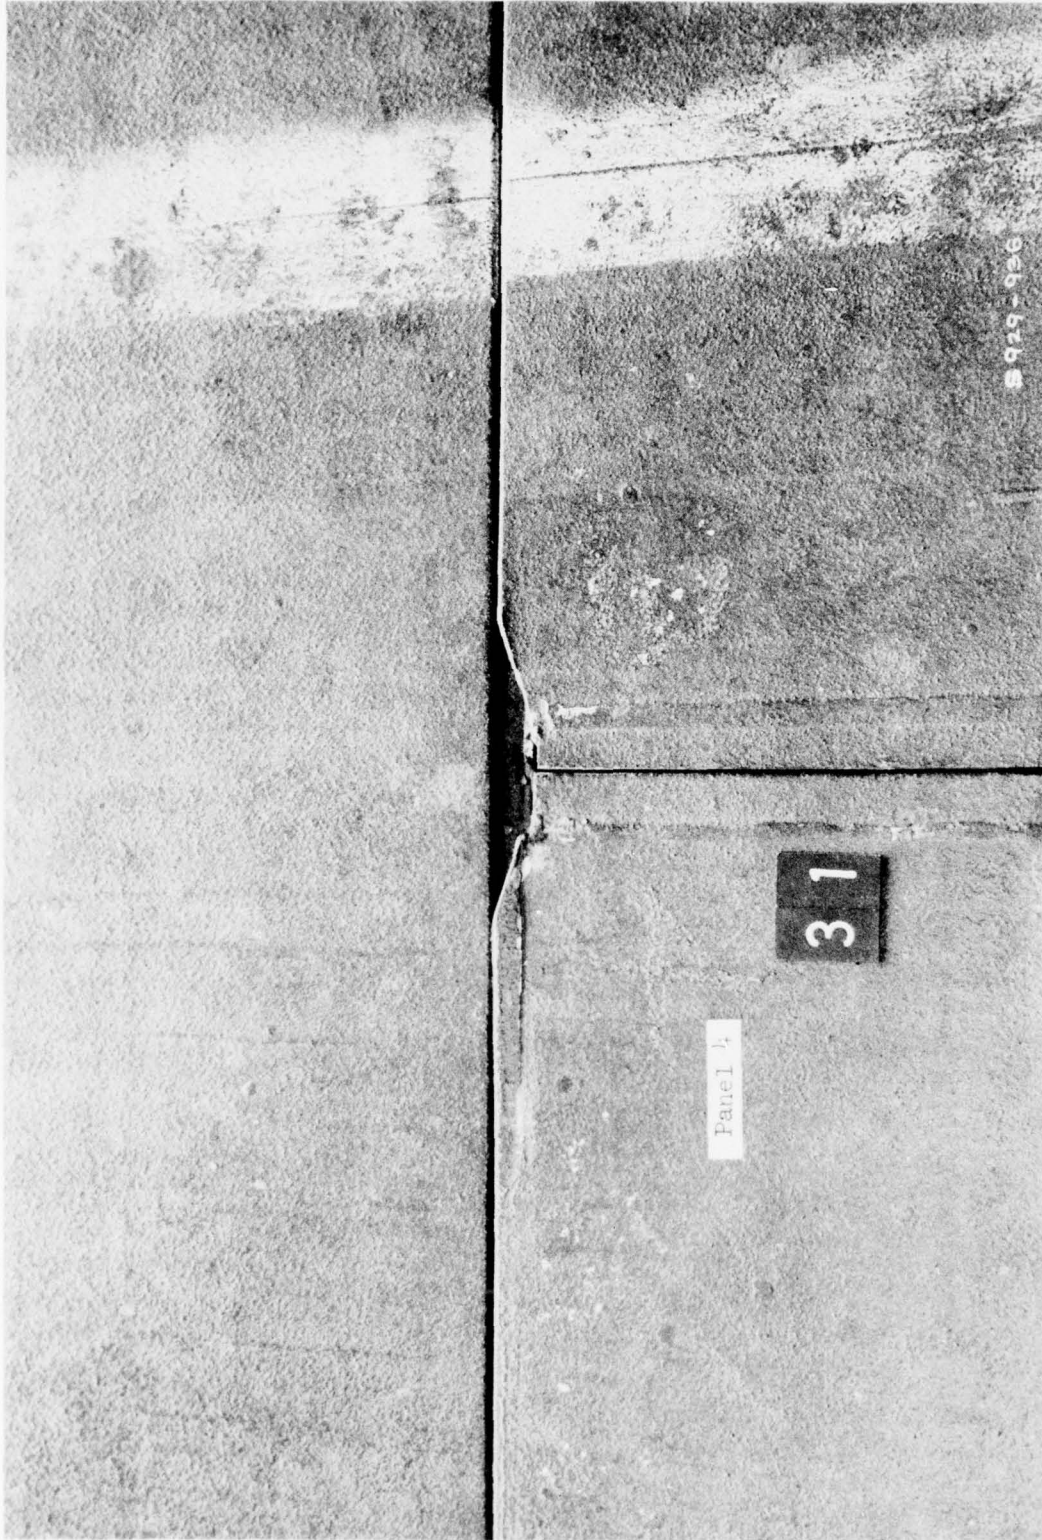
Split in the female connector of panel 4 after 832 coverages, Phase 2

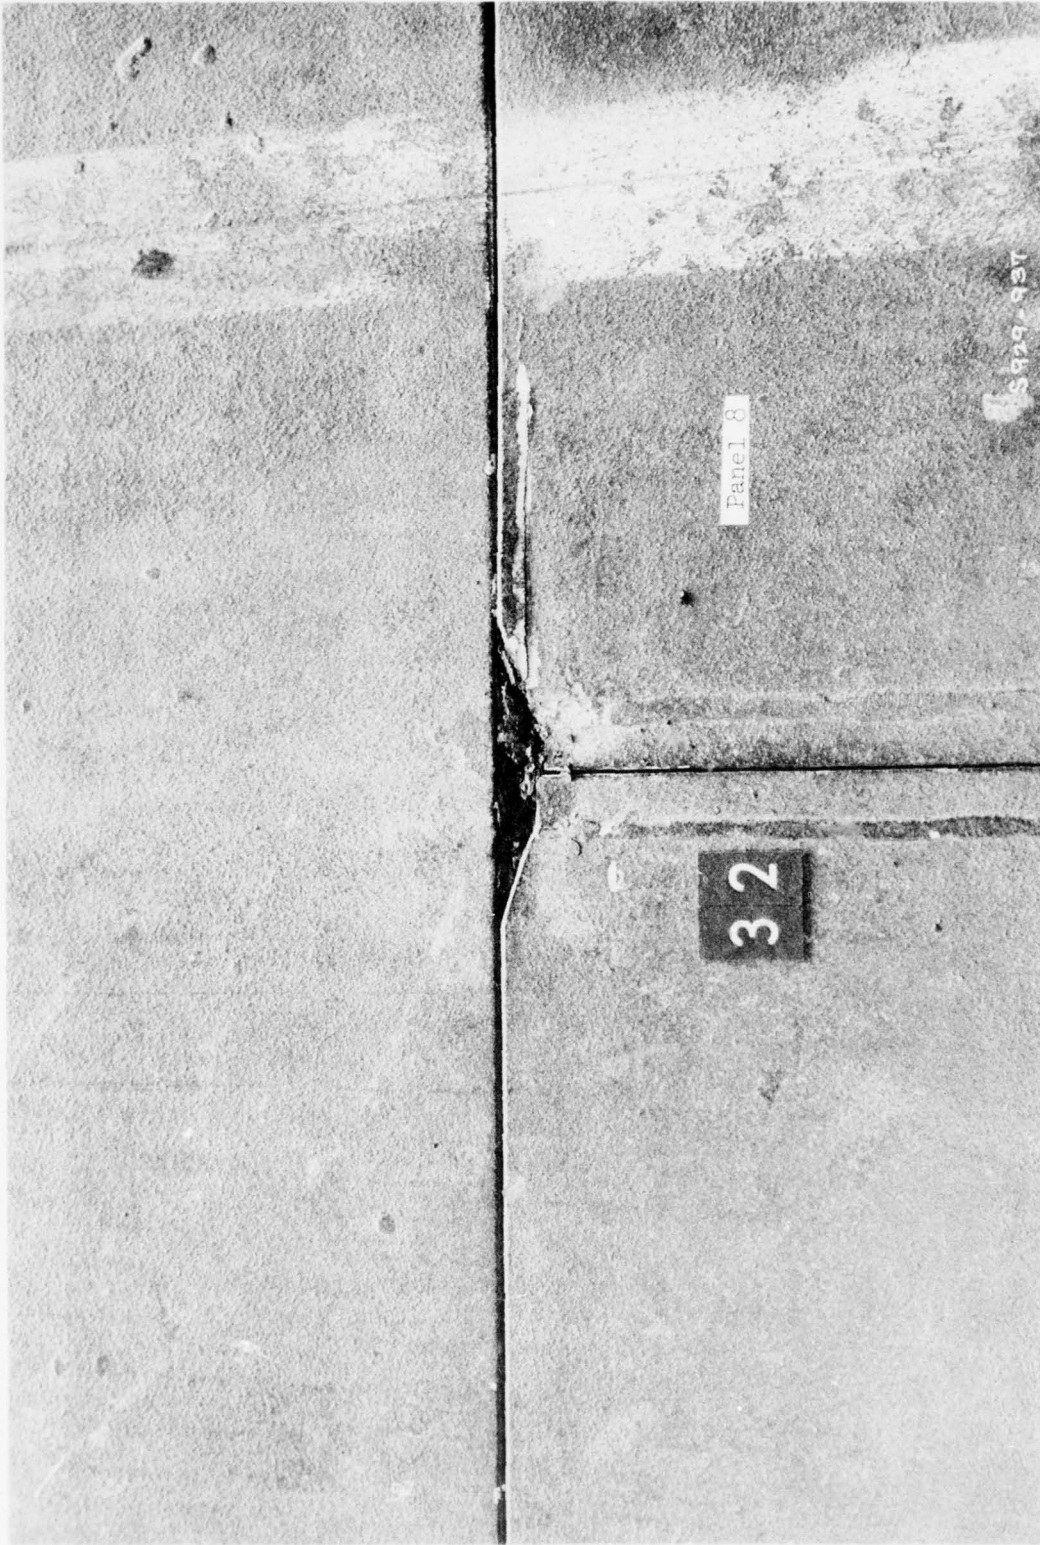
hazards at the female I-lock (Incl 67) and male I-lock (Incl 68) corners. The length of the split along the female connector was 7-3/4 in. The edge of the female connector had turned up, thus exposing sharp edges and the sharp end of the taper where it separated from the panel. The end of the I-lock connector also had turned up, thus exposing the sharp edges in the weld crack. Four other panels (panels 4, 13, 28, and 38) had splits along the female connector at the corner; however, none of these were tire hazards. The longest split was in panel 4 and it was 6-1/8 in. long (Incl 69). This split was at the west end of the panel (see Incl 36). Two panels (panels 18 and 38) had short cracks in the weld at the male side of the panels.

Split in the female connector of panel 8 after 832 coverages, Phase 2

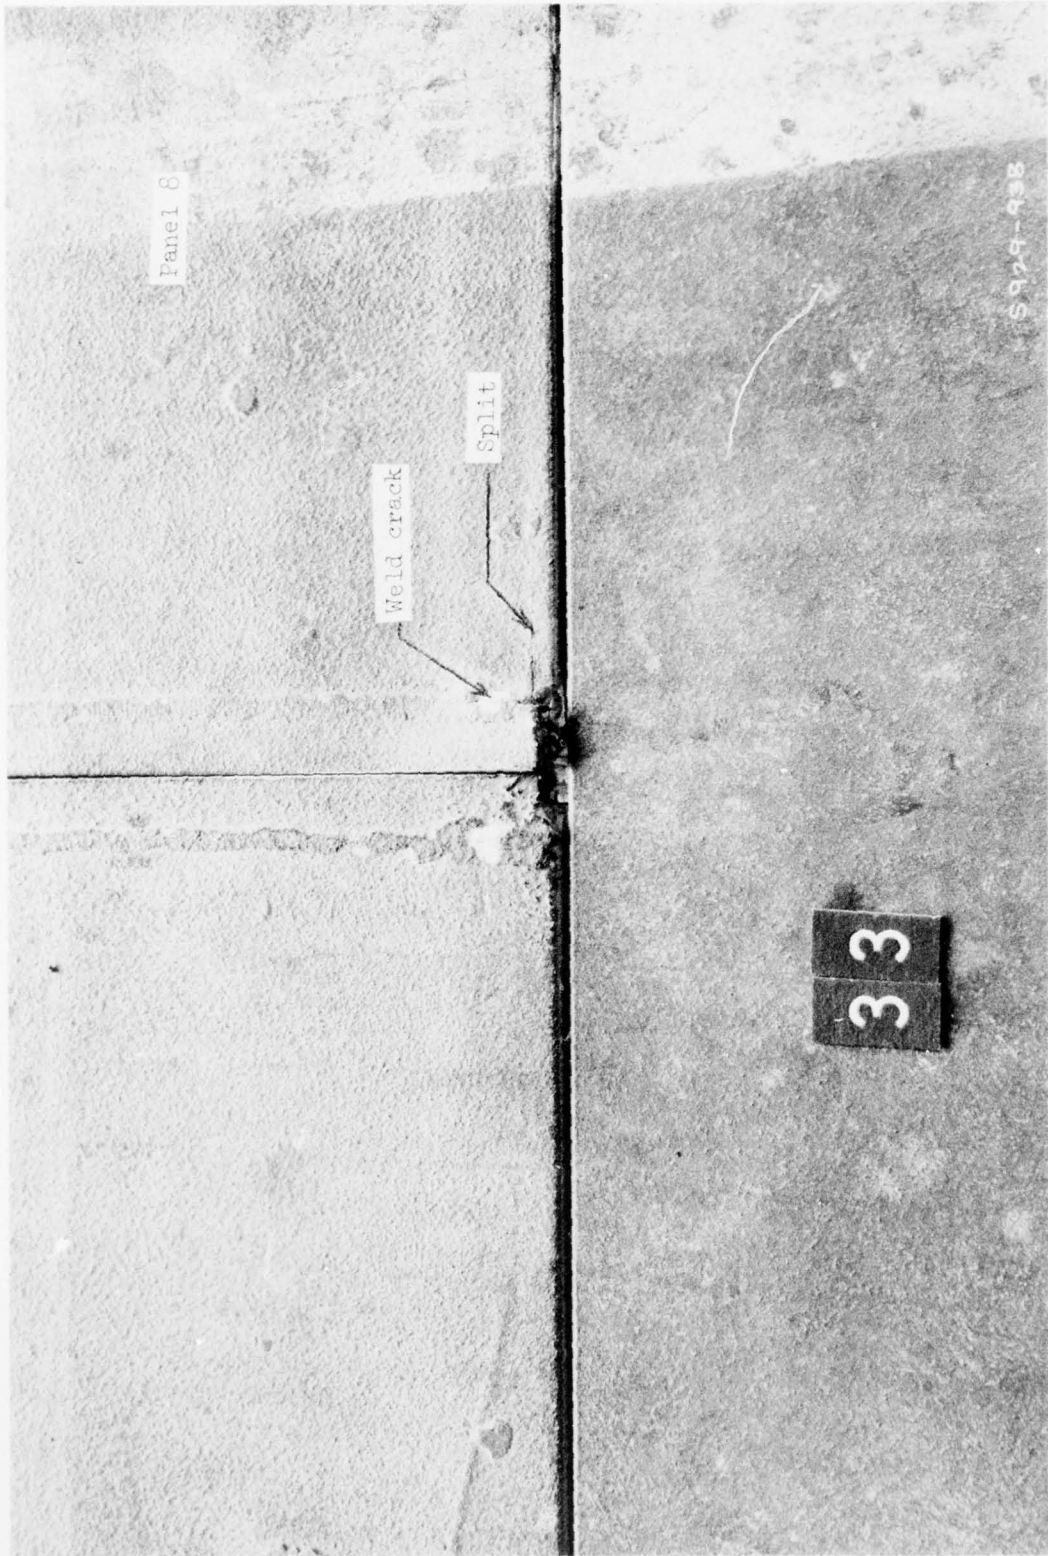
Crack in weld between I-lock and extrusion and split along male connector of panel 8 after 832 coverages, Phase 2
