MISCELLANEOUS PAPER S-74-6

# EVALUATION OF DOW CHEMICAL PRODUCTION EXTRUDED TRUSS-WEB LANDING MAT

March 1974

Conducted by U. S. Army Engineer Waterways Experiment Station  
Soils and Pavements Laboratory  
Vicksburg, Mississippi

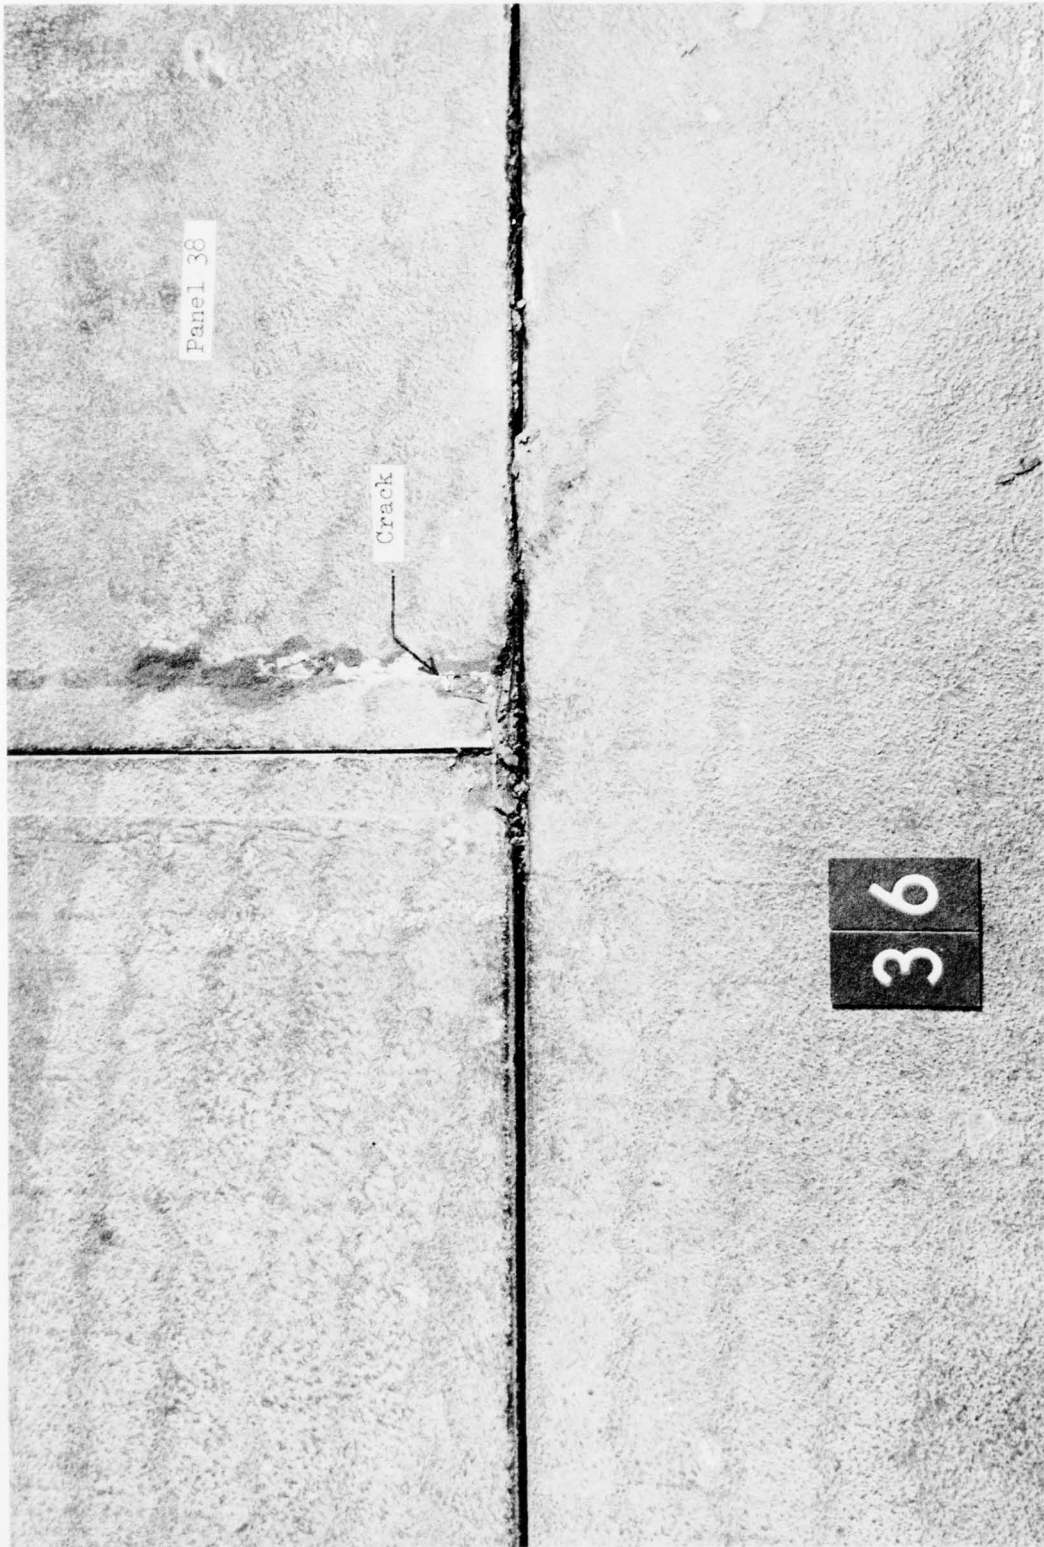
Crack in weld between I-lock connector and extrusion of panel 38 after 832 coverages, Phase 2

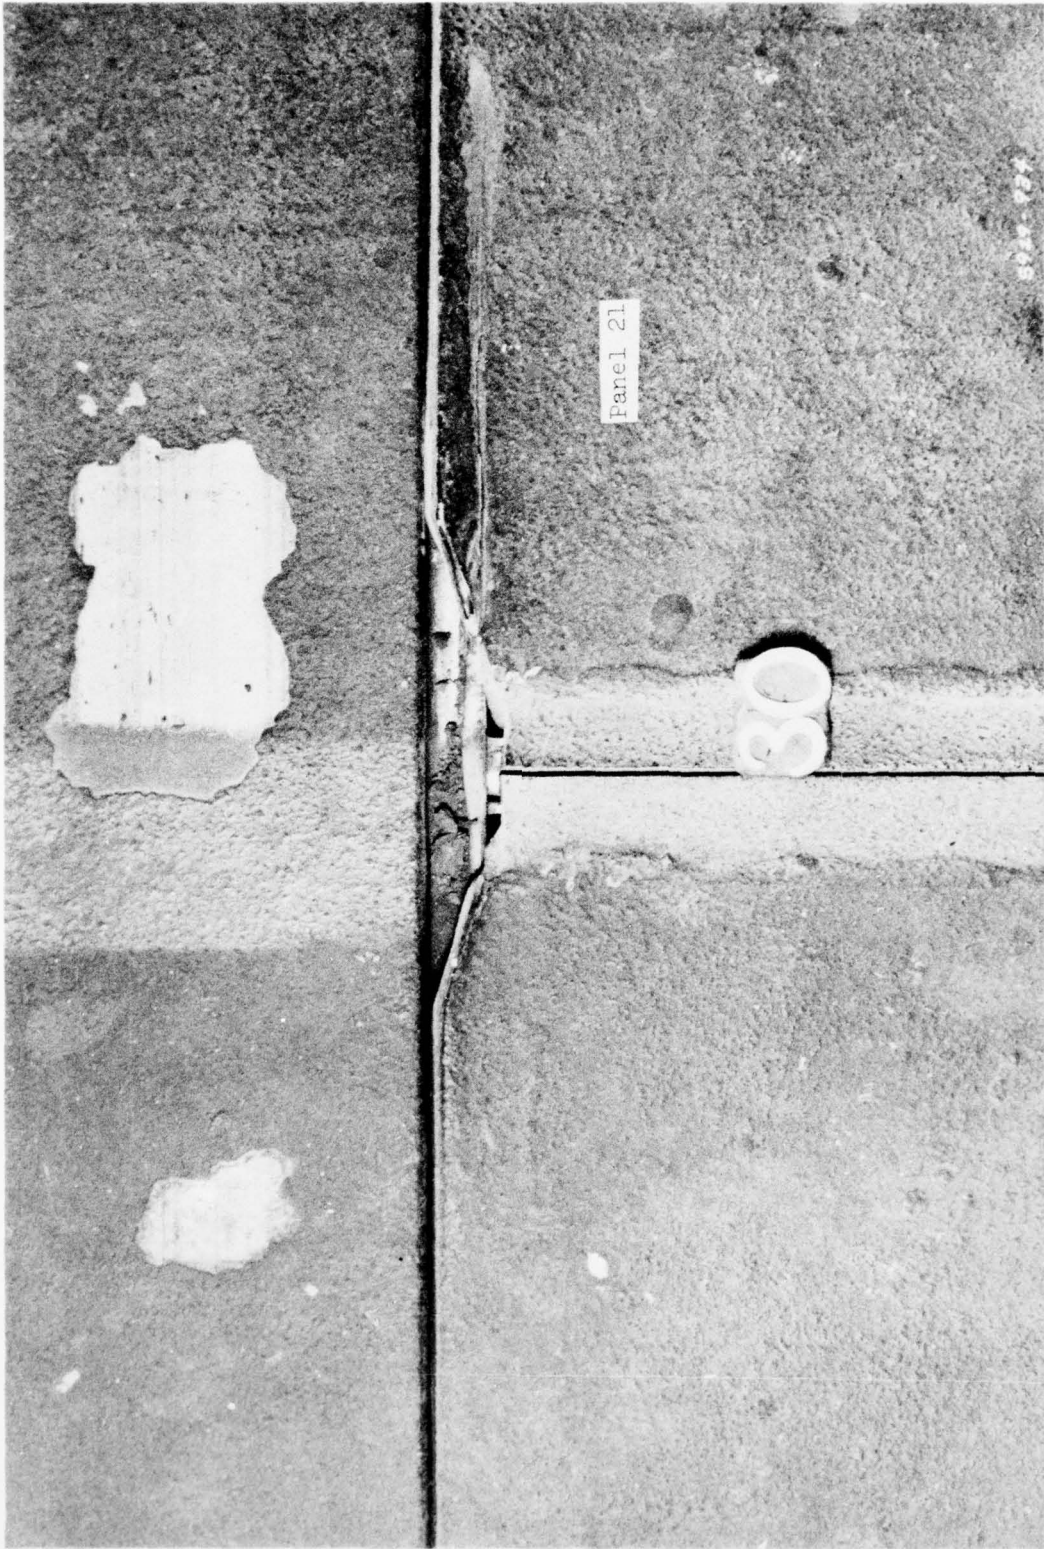
Panel 21

Split in the female connector of panel 21

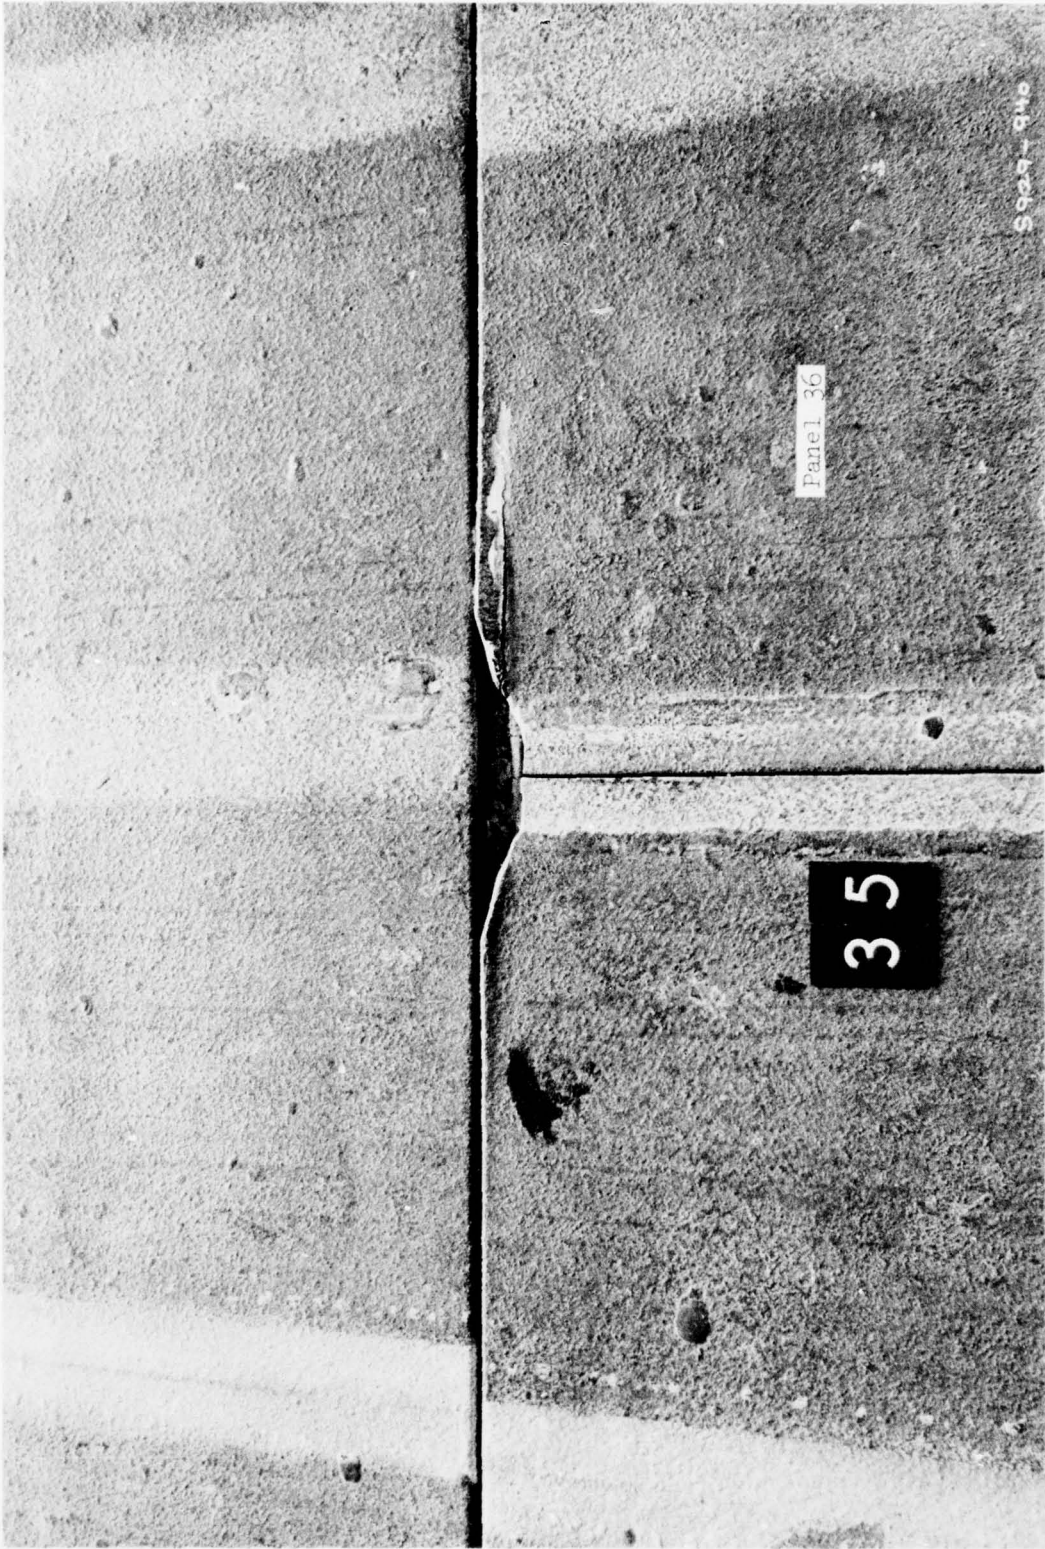
Split in the female connector of panel 36 after 832 coverages, Phase 2

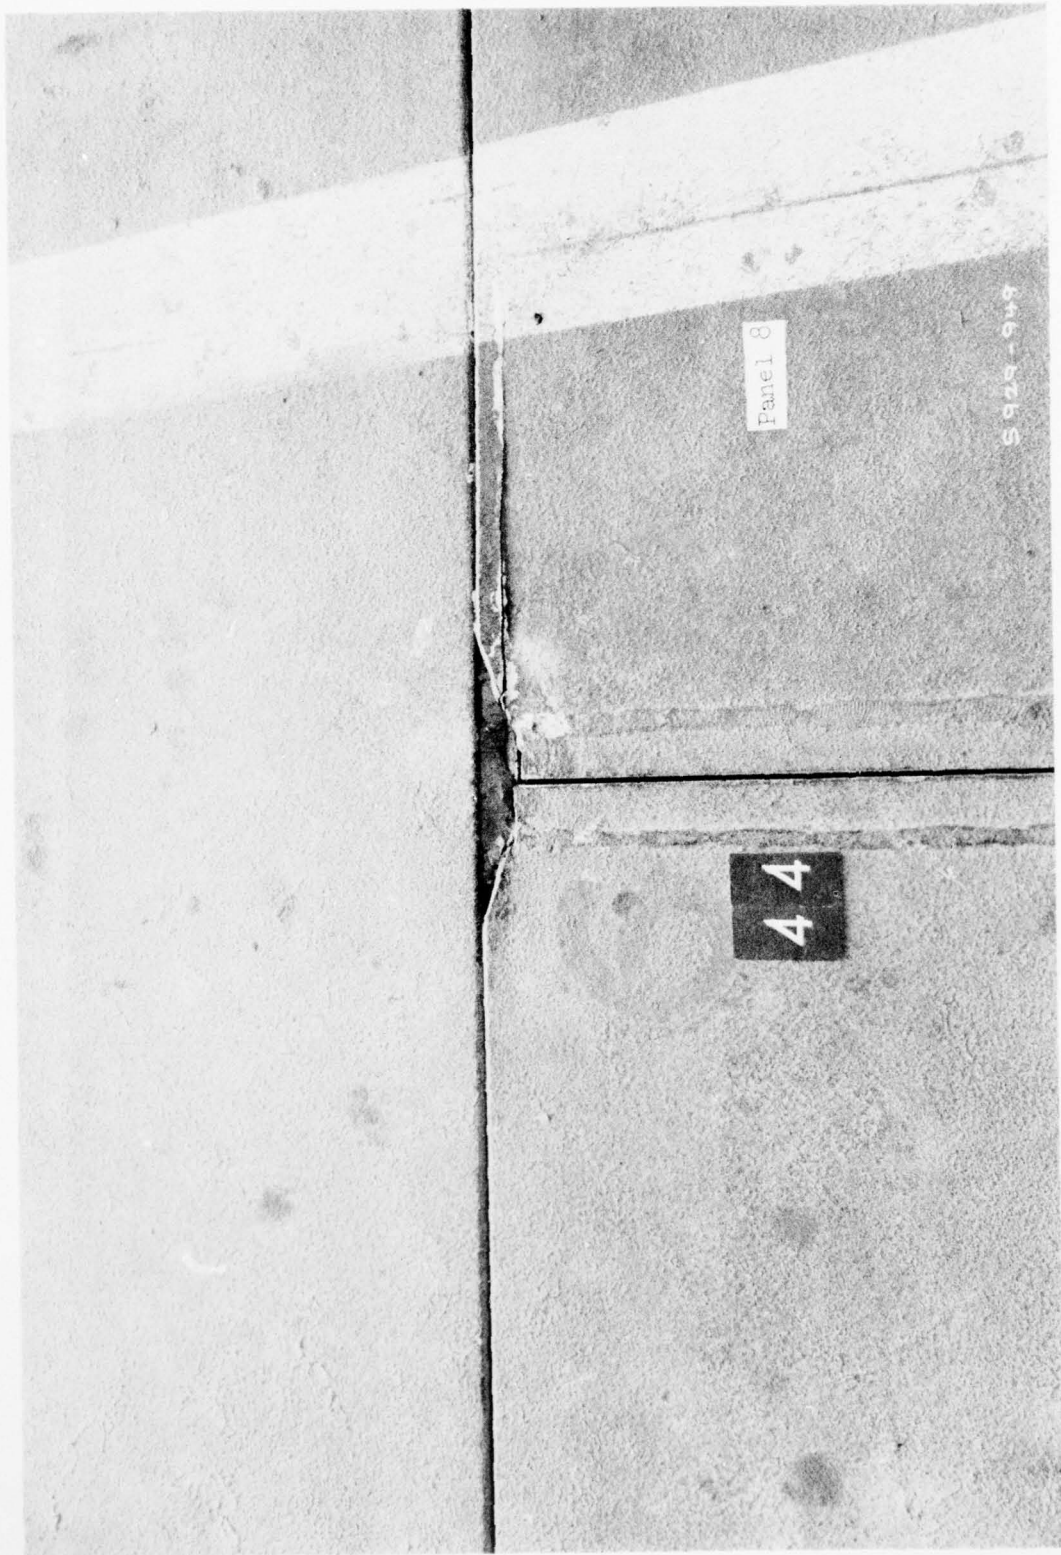
Split in female connector of panel 8 after 210 coverages, Phase 2, subgrade reprocessed

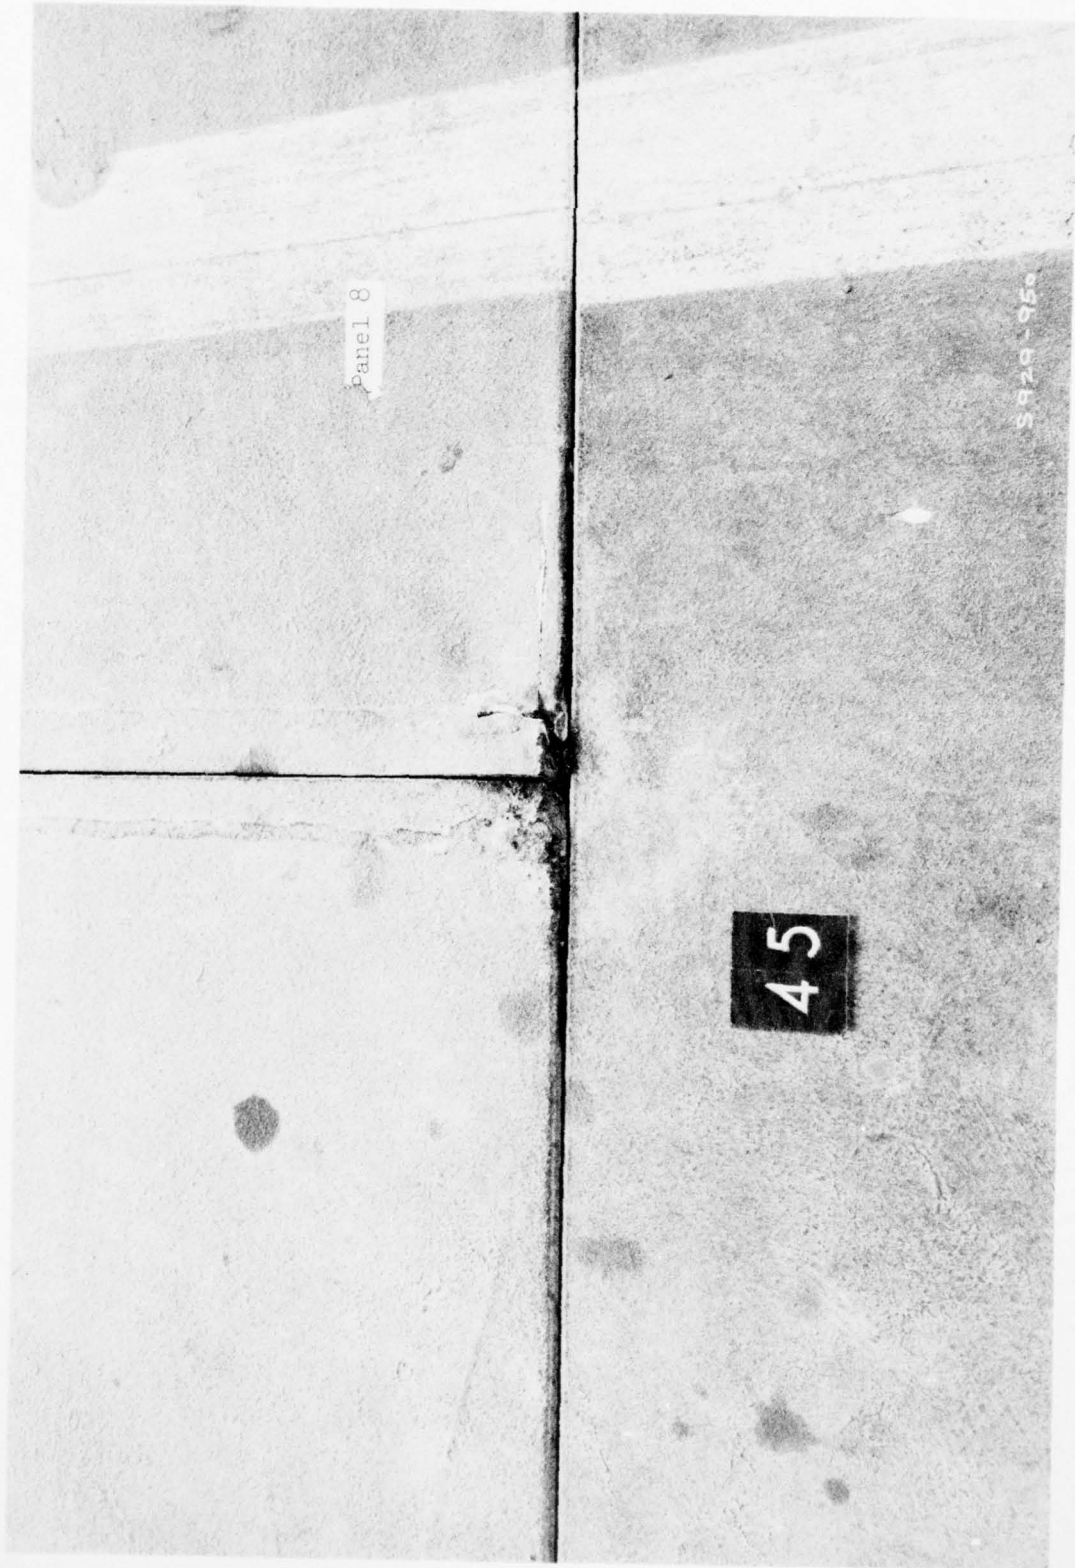
Crack in weld between I-lock and extrusion and split along male connector of panel 8 after 210 coverages, Phase 2, subgrade reprocessed

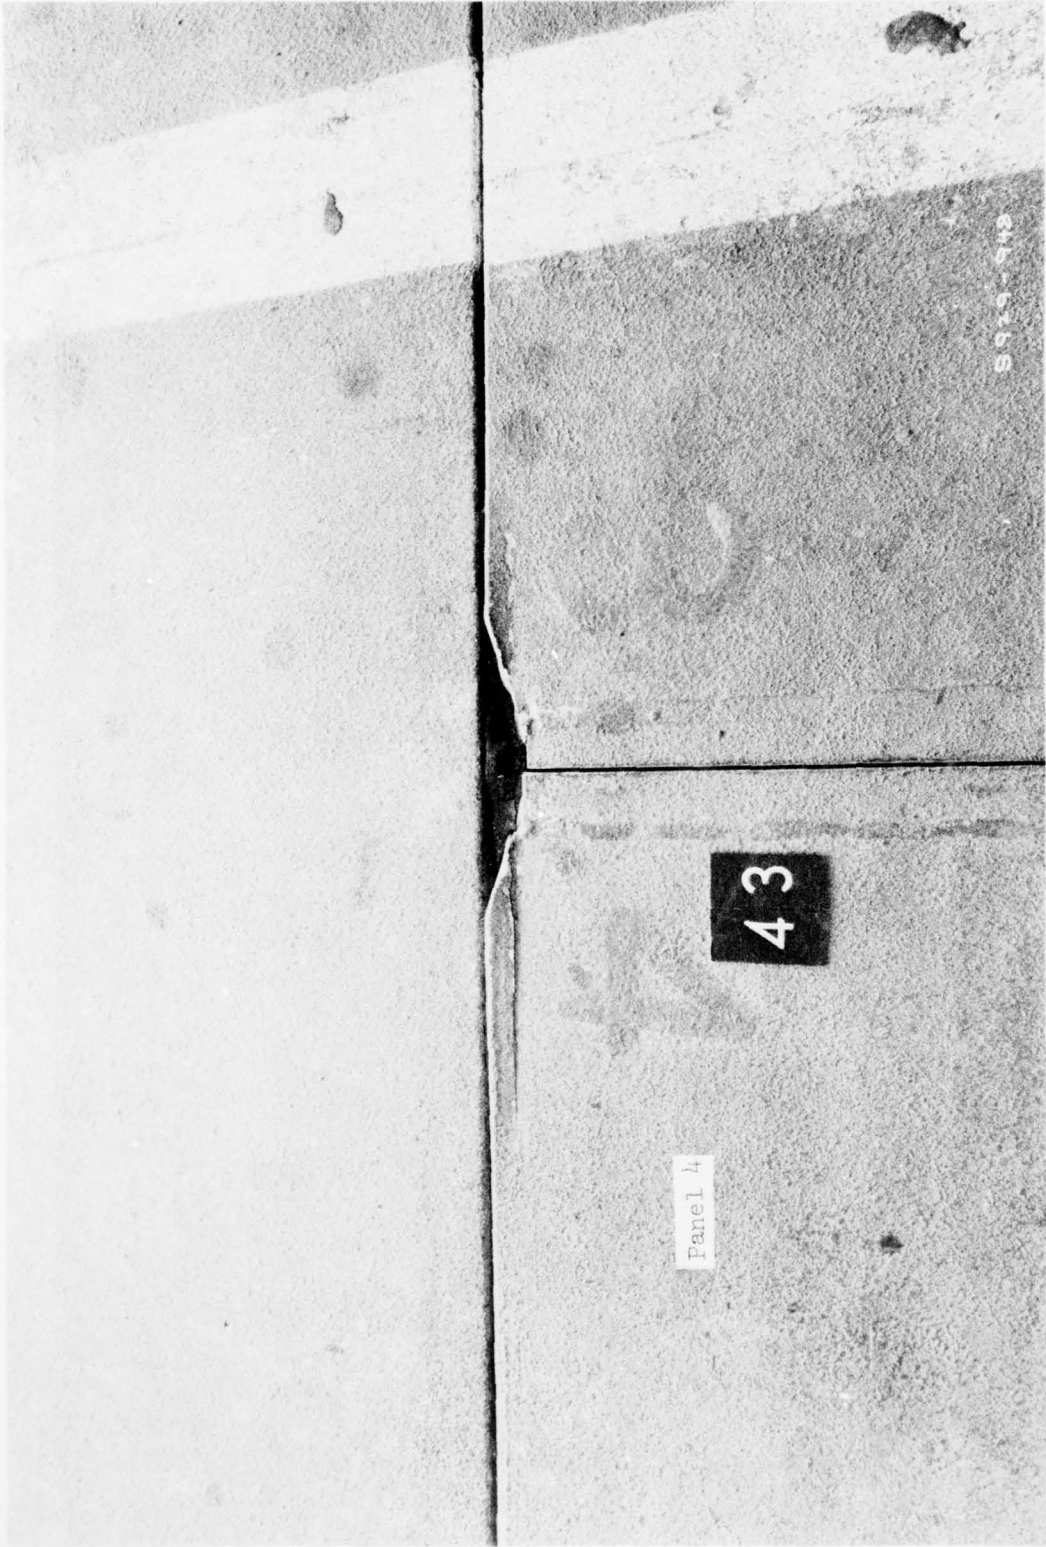
Split in female connector (west end) of panel 4 after 210 coverages, Phase 2, subgrade reprocessed

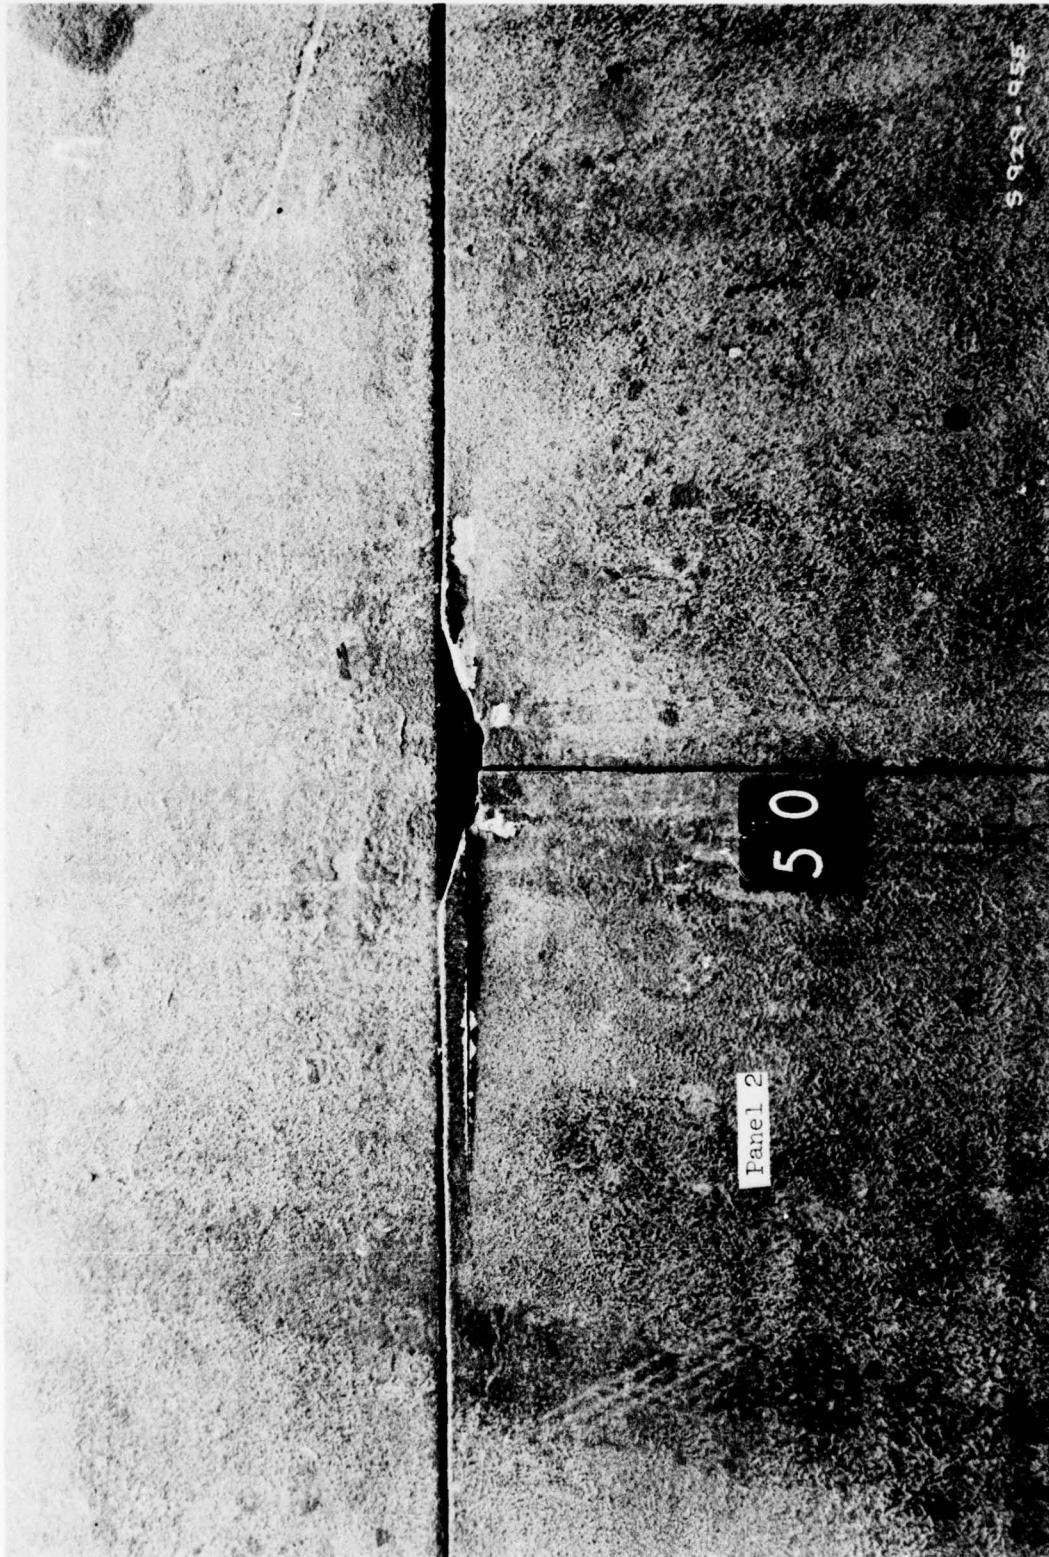
Split in female connector of panel 2 after 300 coverages, Phase 3

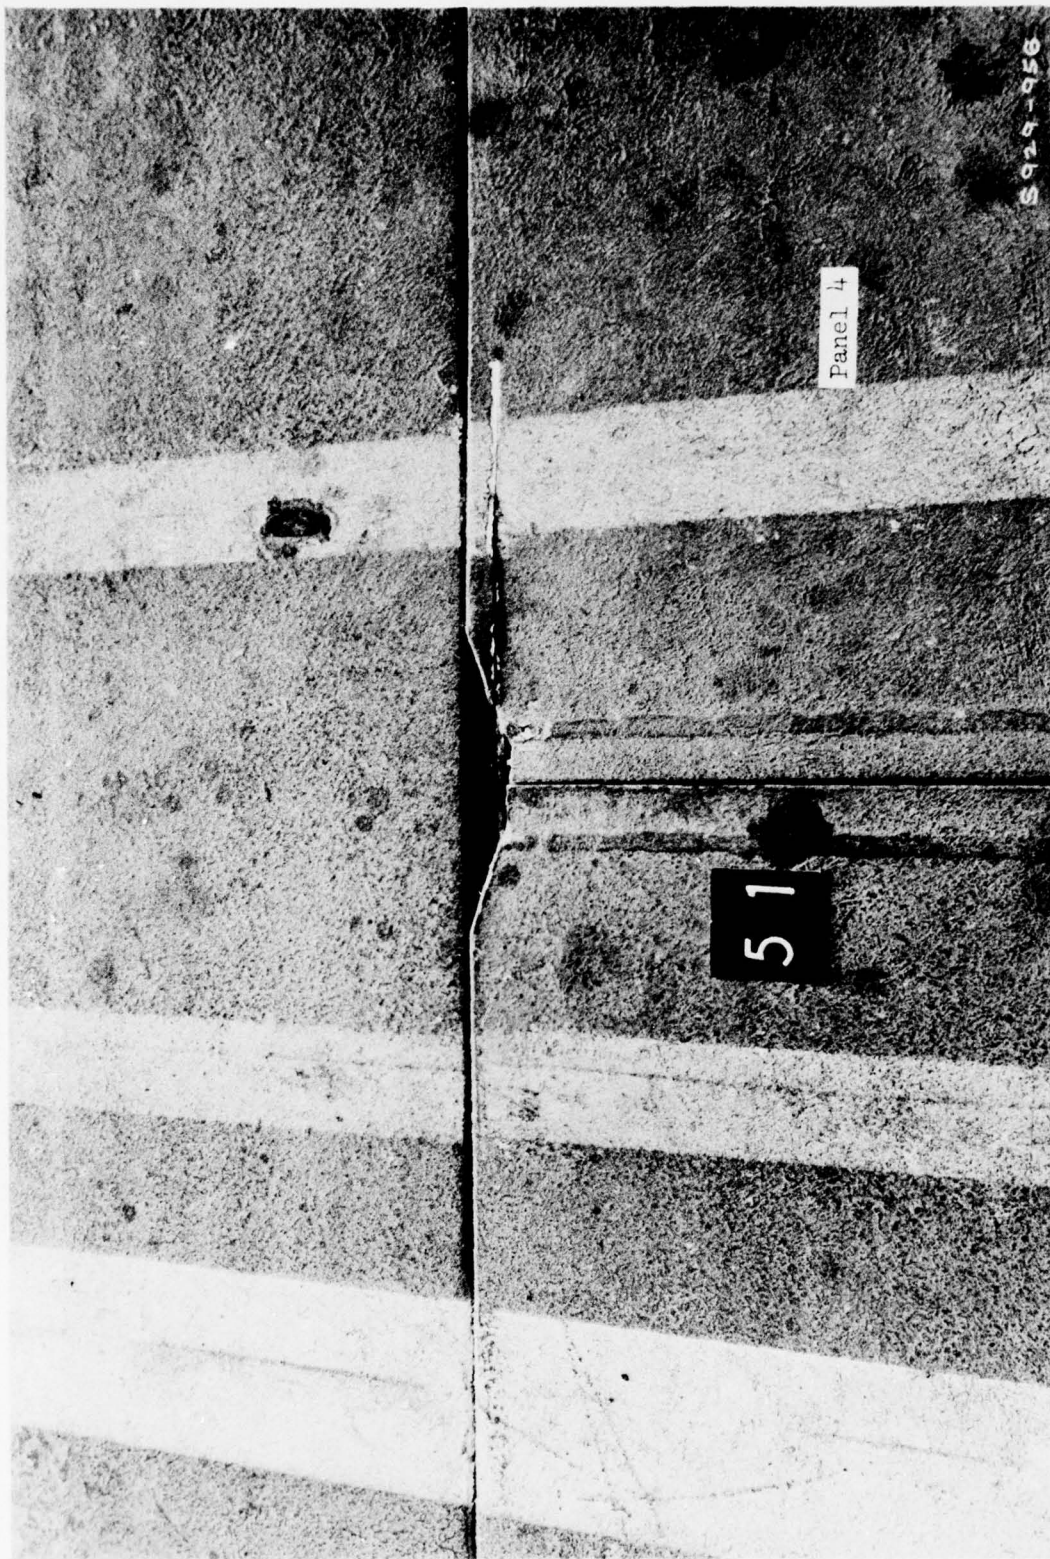
Split in female connector (east end) of panel 4 after 300 coverages, Phase 3

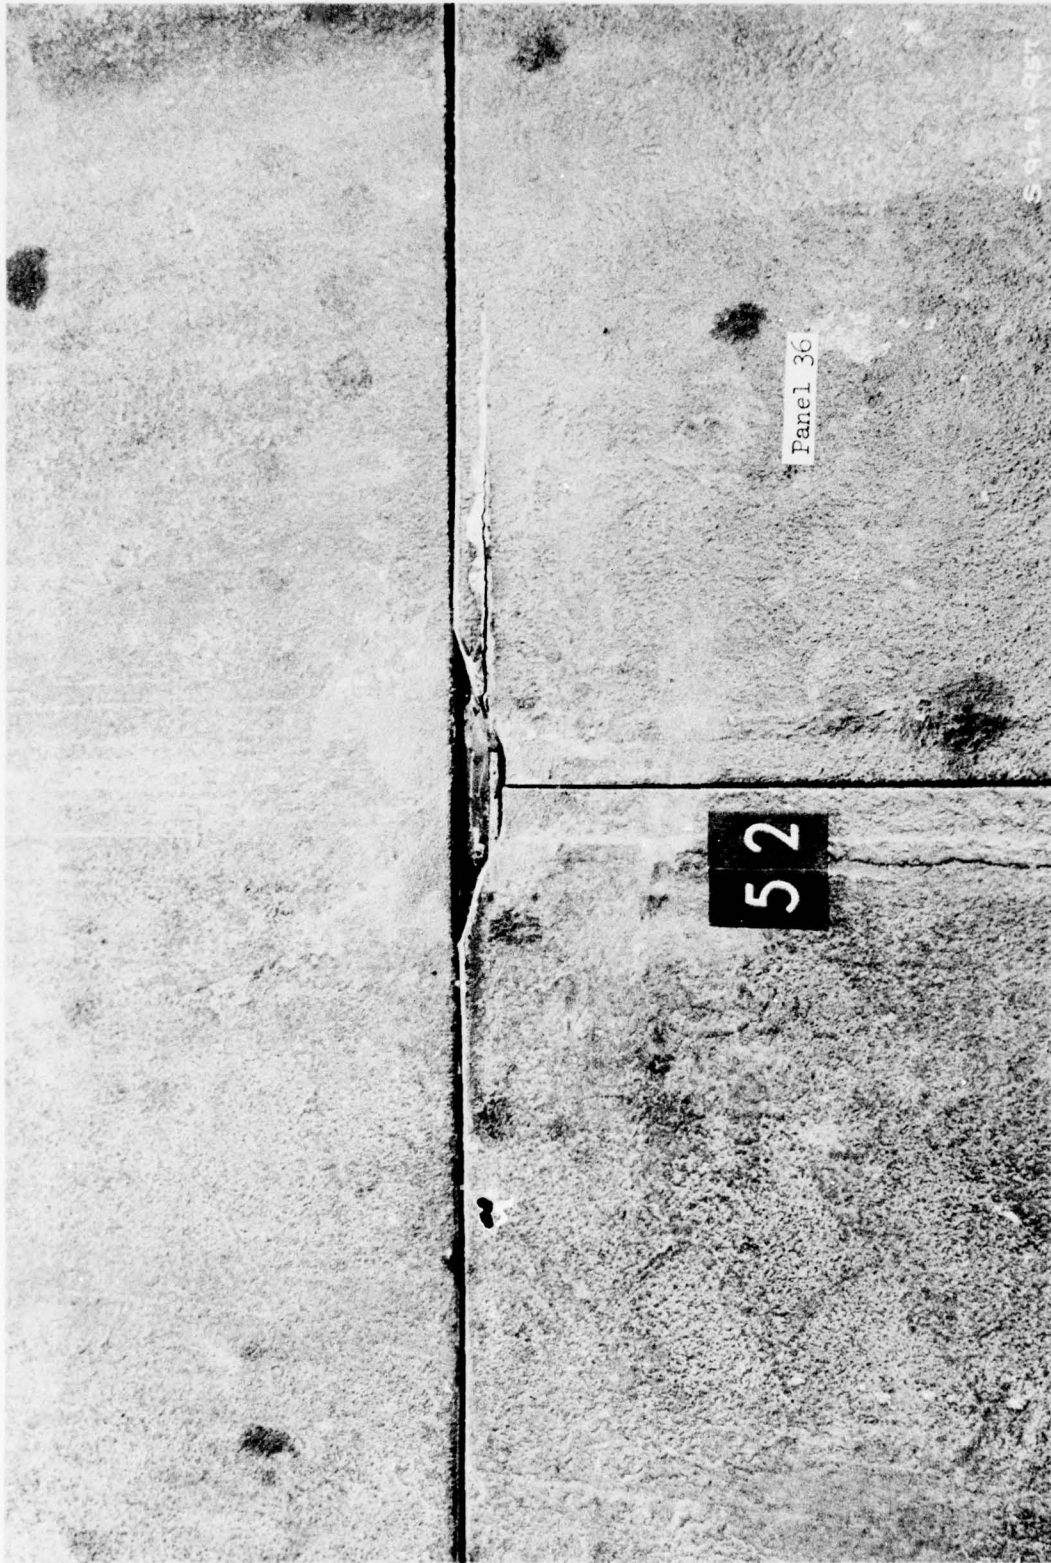
Split in female connector of panel 36 after 300 coverages, Phase 3

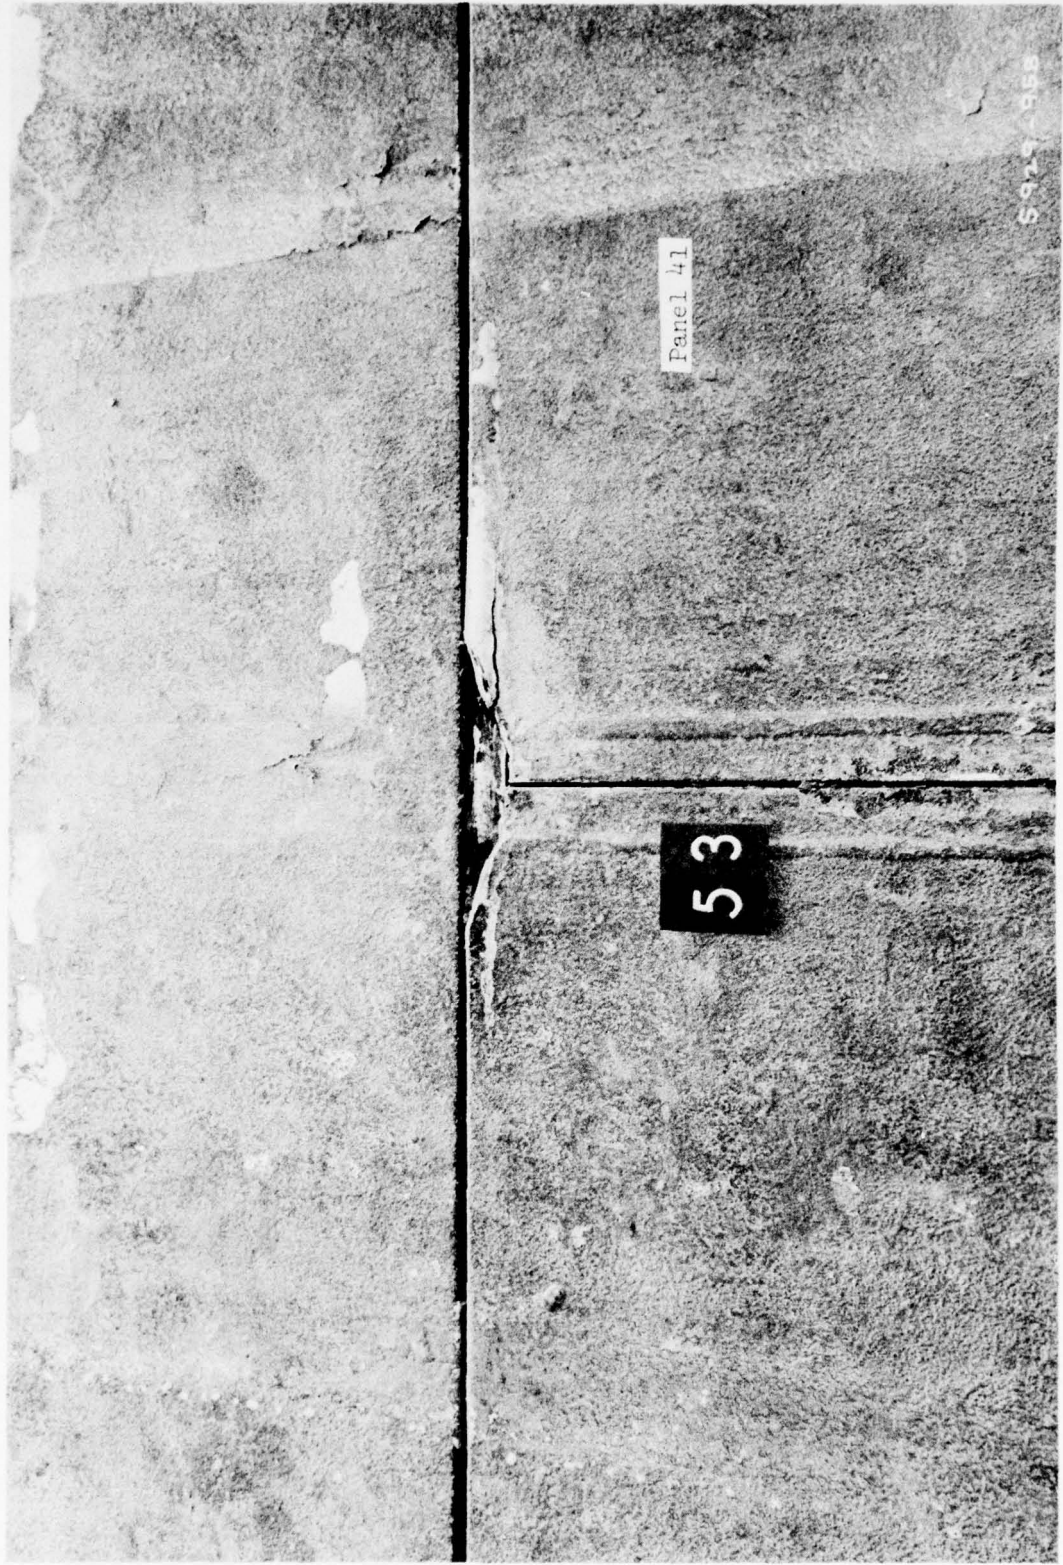
Split in female connector of panel 41 after 300 coverages, Phase 3

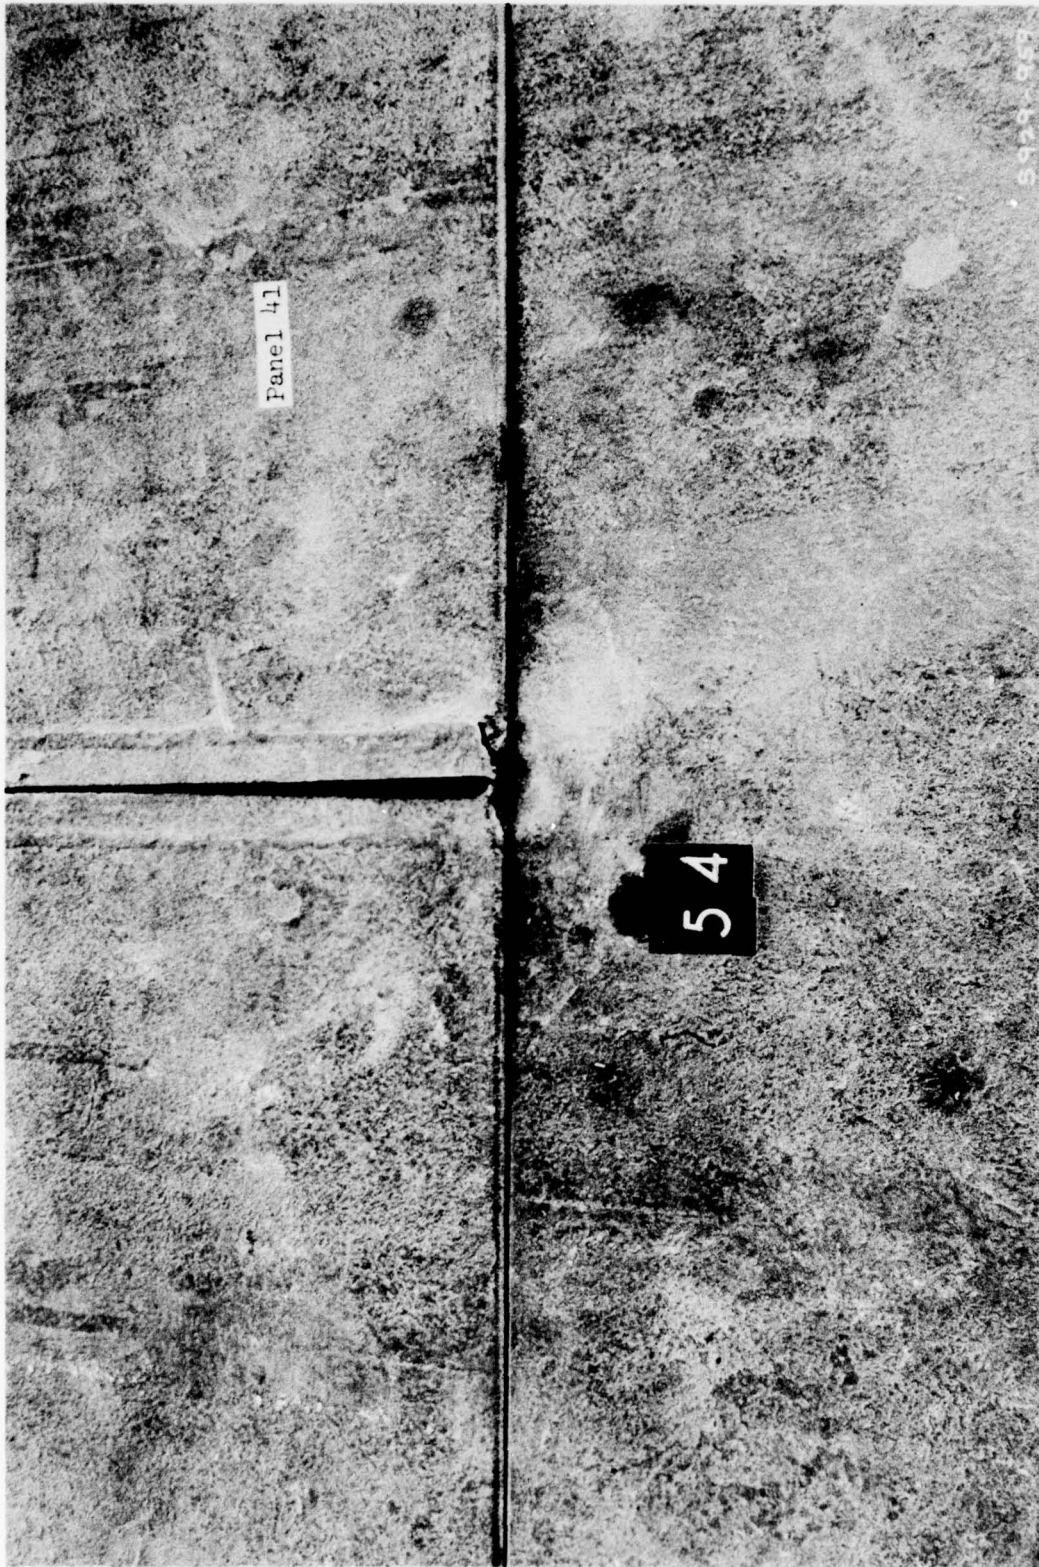
Crack in weld between I-lock and extrusion at male side of panel 41 after 300 coverages, Phase 3

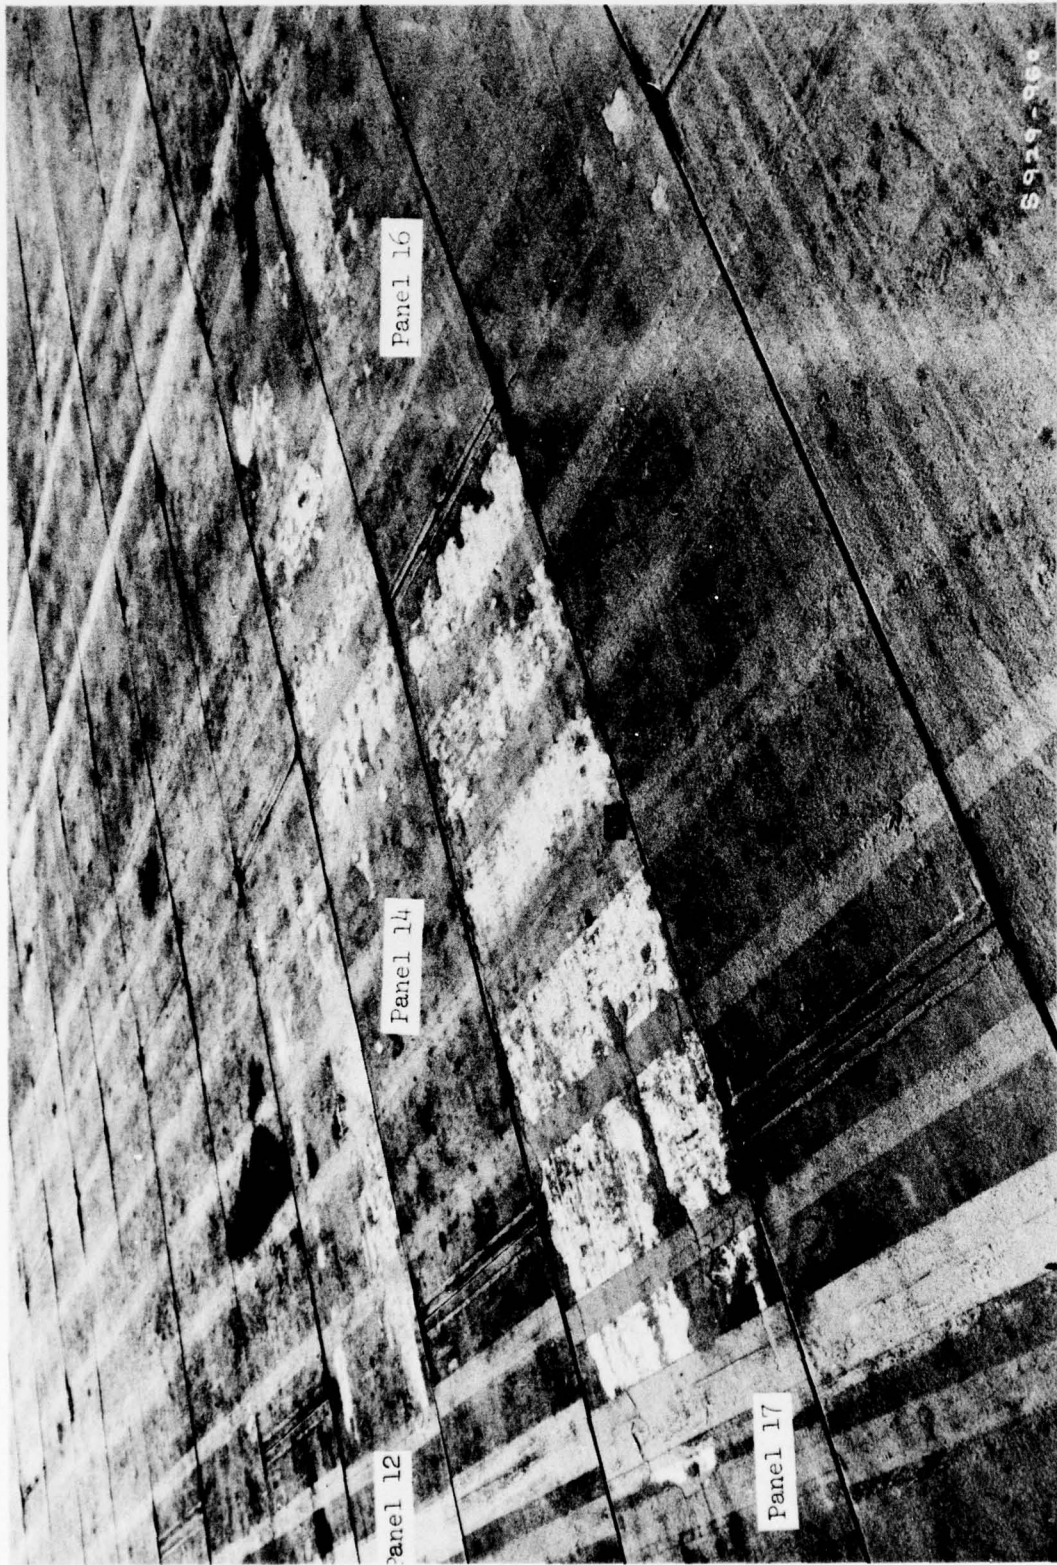
material had come off. Inclosure 77 shows the condition of the antiskid on panels 12, 14, 16, and 17 at the end of testing. In comparison with Incl 44, the majority of the antiskid material that came off these panels did so in the first 500 coverages of Phase 1. Several other panels had small areas where the antiskid had flaked off due to the load wheel and the action of the drive wheels of the load cart/prime mover.

Condition of antiskid on panels 12, 14, 16, and 17 at the end of traffic

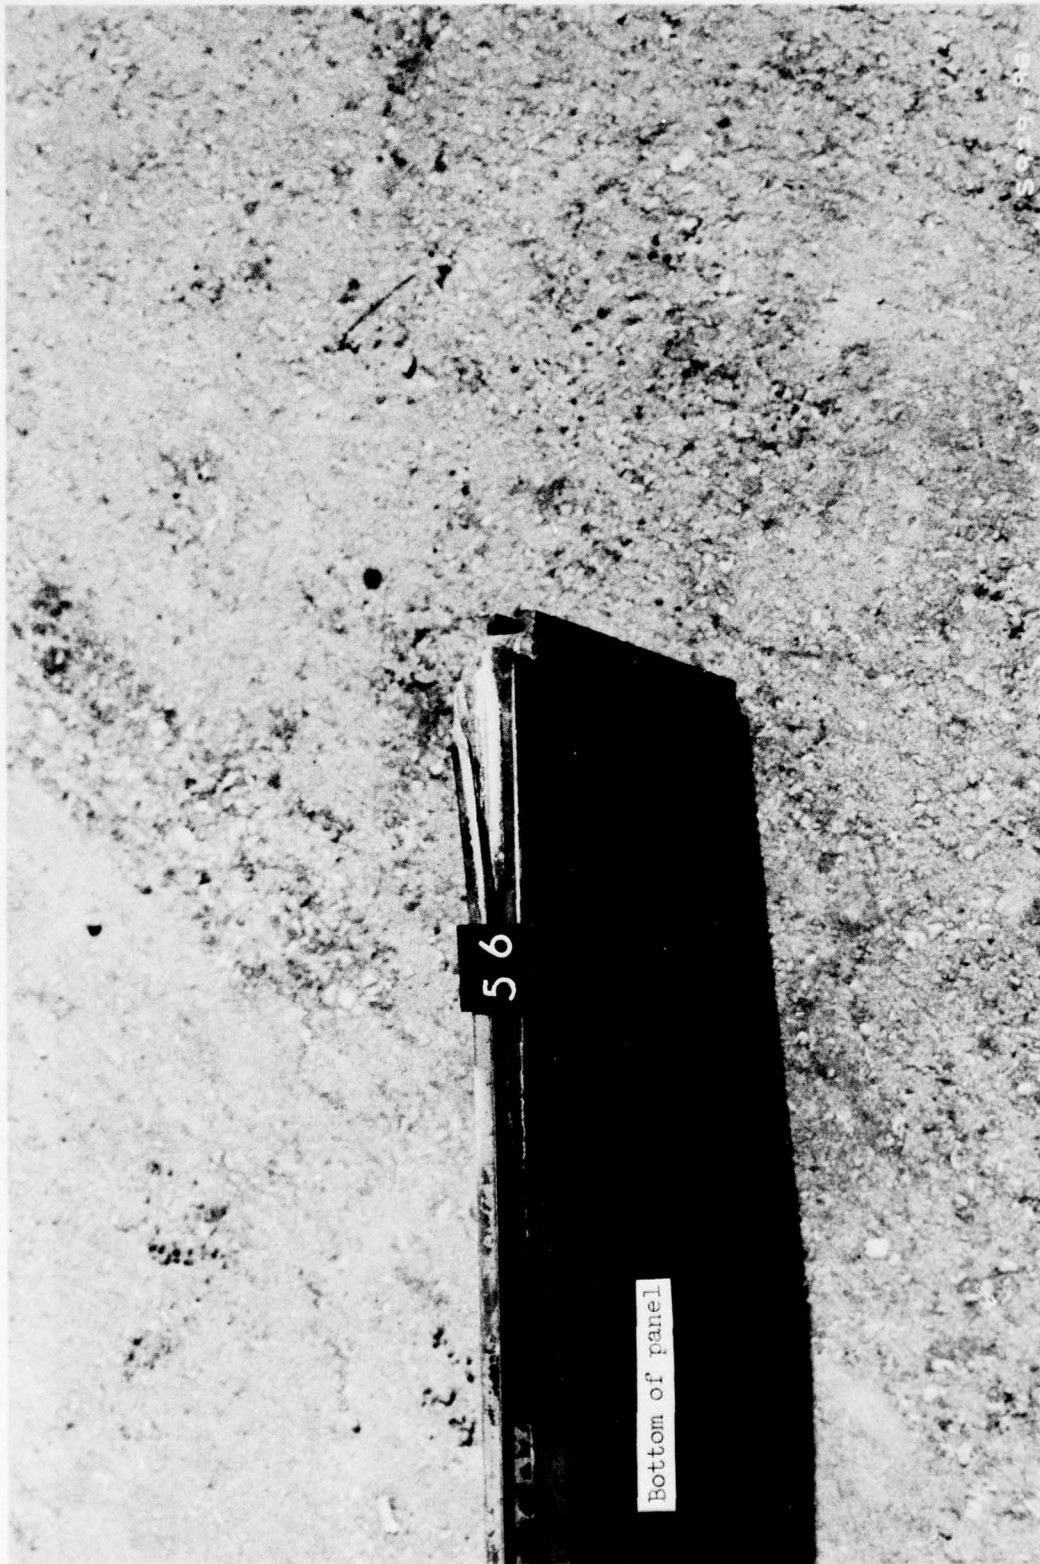
Typical panel failure due to a split at the female I-lock corner

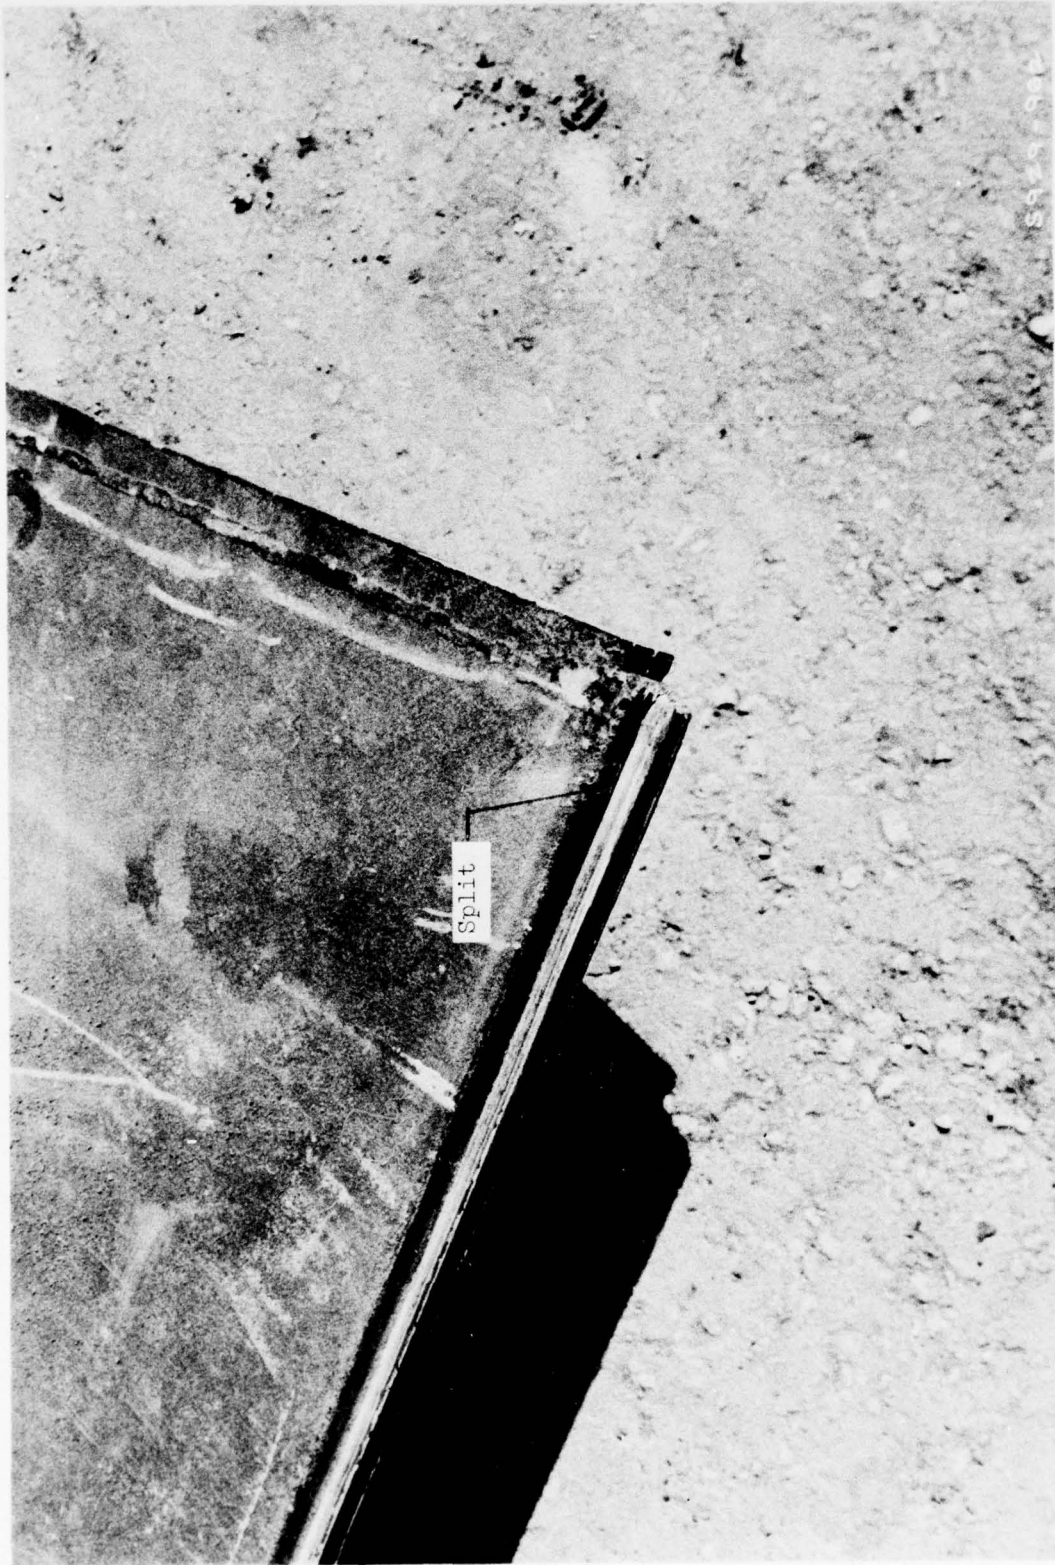
Split in male connector after 300 coverages, Phase 3
