MISCELLANEOUS PAPER S-74-6

# EVALUATION OF DOW CHEMICAL PRODUCTION EXTRUDED TRUSS-WEB LANDING MAT

March 1974

Conducted by U. S. Army Engineer Waterways Experiment Station  
Soils and Pavements Laboratory  
Vicksburg, Mississippi

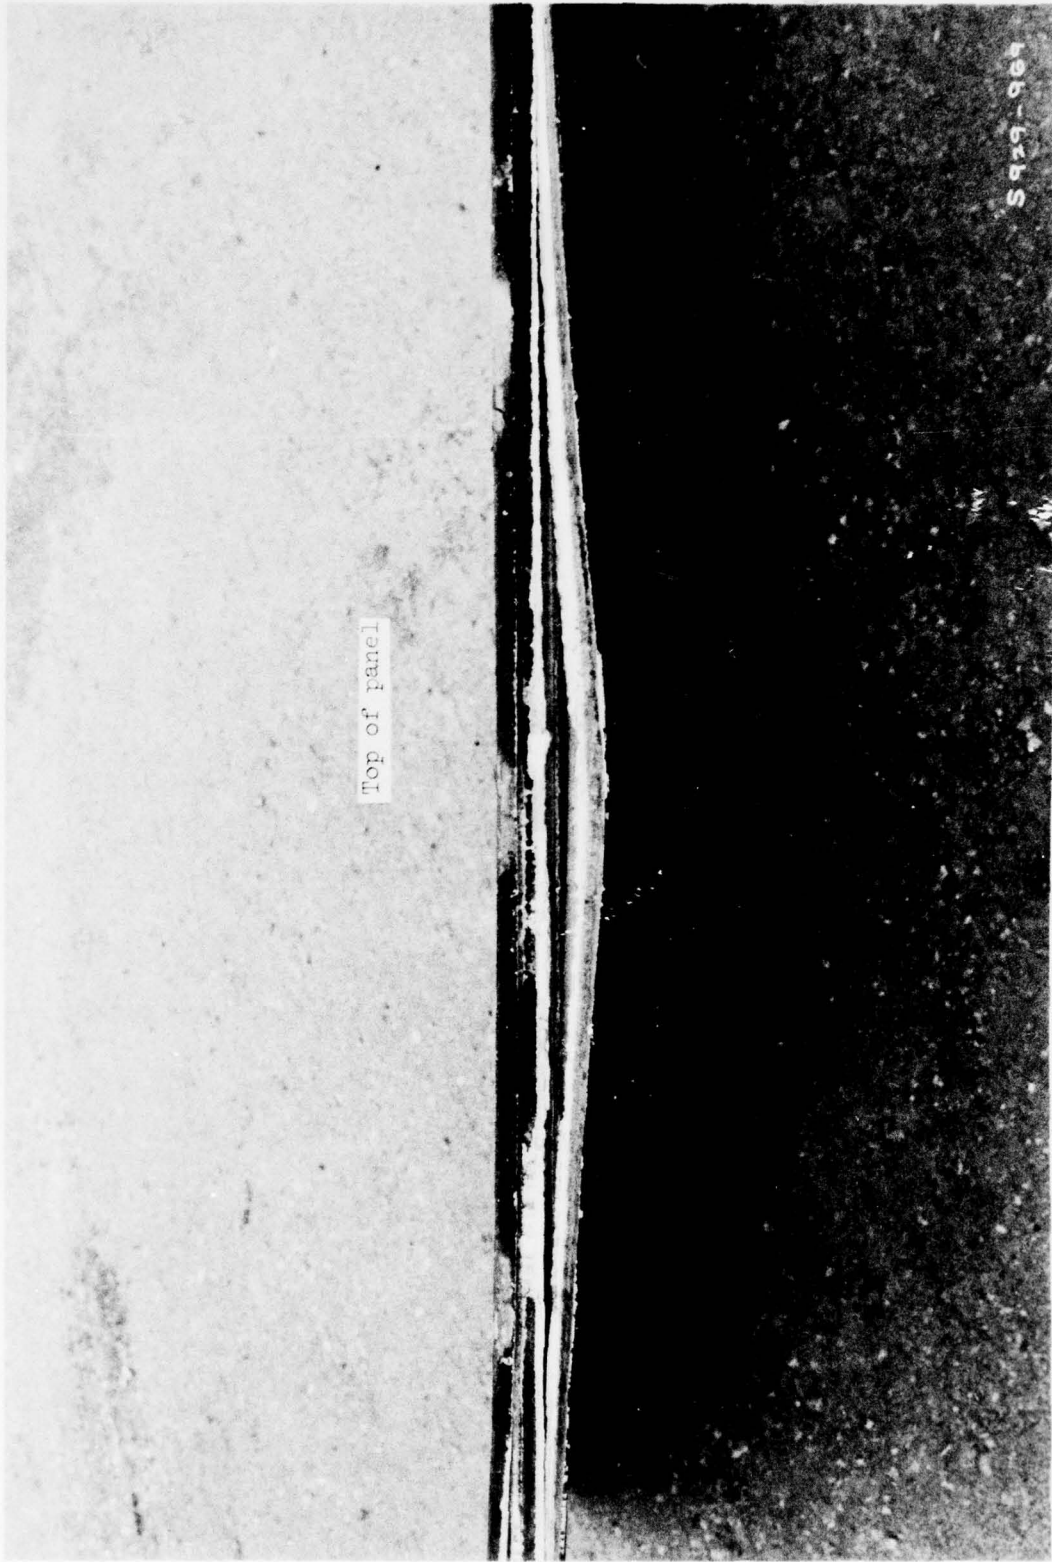
Split in slant rib of the female connector of panel 2 after 300 coverages, Phase 3

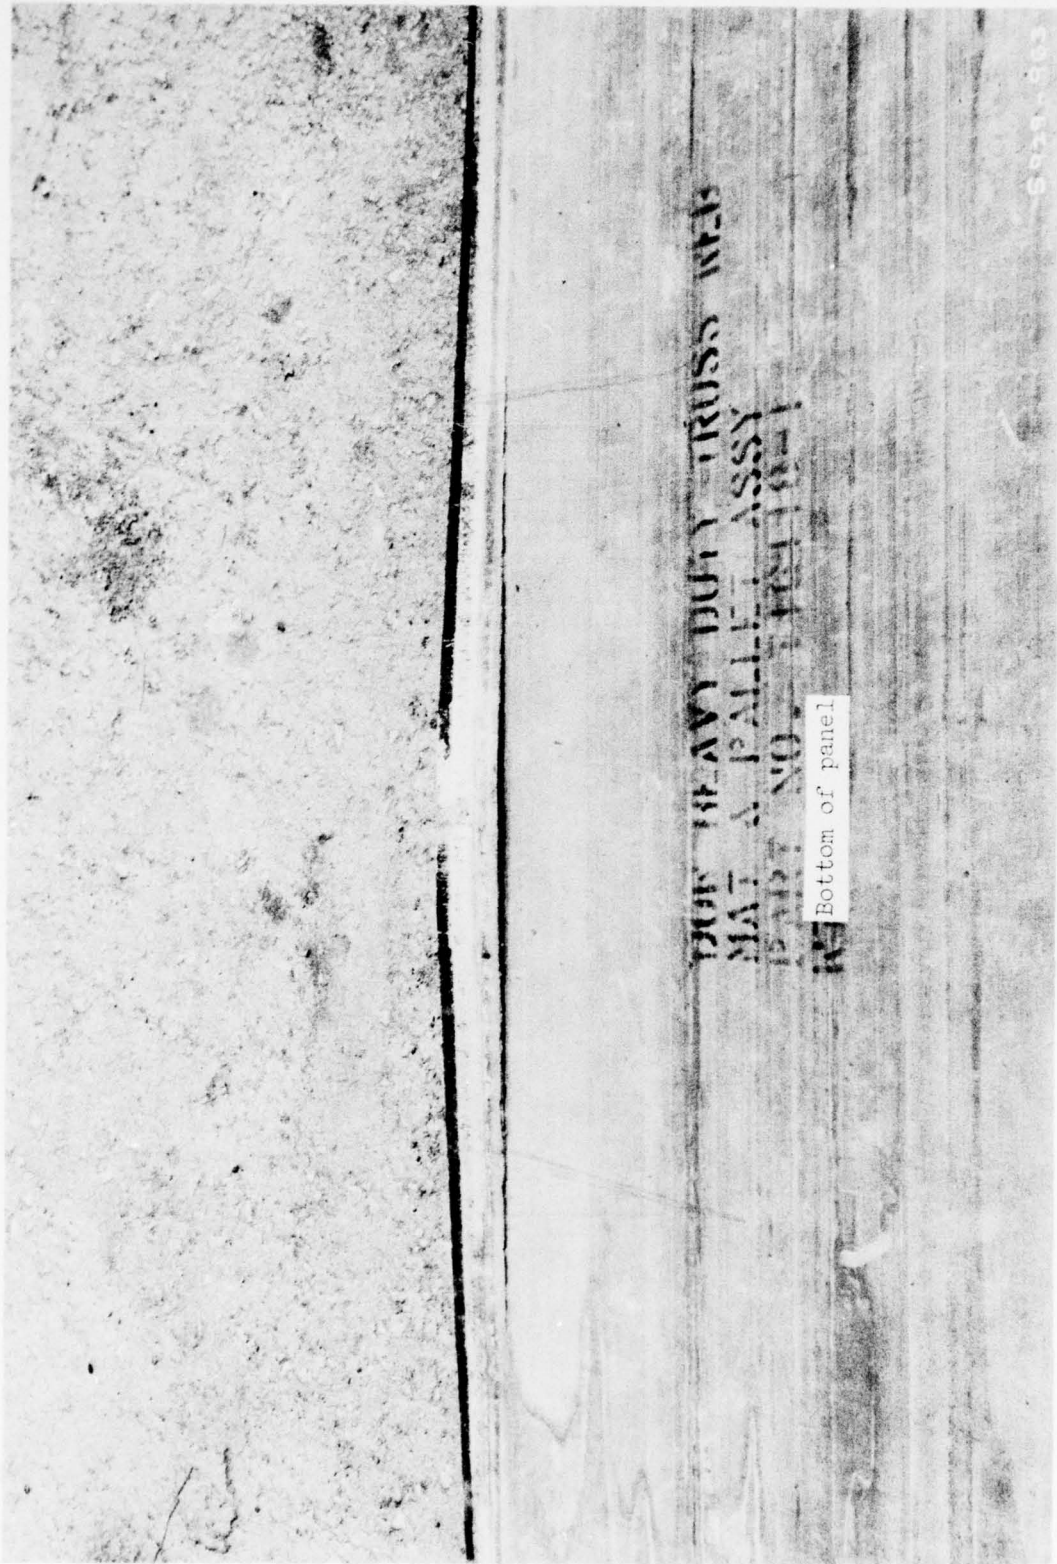
Split in bottom of panel 2 near the female connector after 300 coverages, Phase 3
