CONDITION SURVEY, ELLSWORTH AIR FORCE BASE, SOUTH DAKOTA

P. J. Vedros

April 1973

Conducted by U. S. Army Engineer Waterways Experiment Station
Soils and Pavements Laboratory
Vicksburg, Mississippi

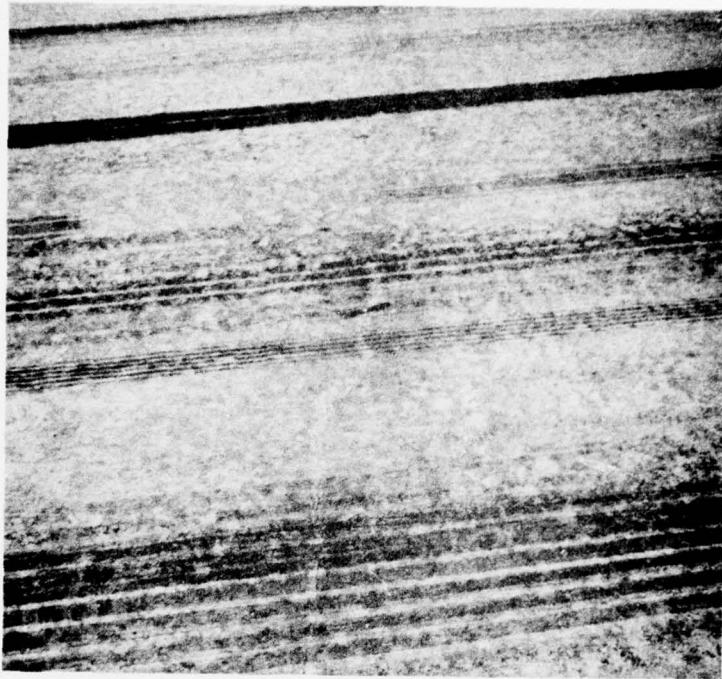
runway was considered to be excellent. The 1000-ft runway ends were in excellent condition with only two major structural defects recorded (table 3). The 75-ft inlay section of the interior portion of the runway from sta 40+06 to 65+06 (features RL2C, RL4C, and RL5C), which consisted of 18-in. reinforced portland cement concrete (PCC), had nine slabs that contained transverse cracks. The crack openings were very small and appeared to be held tightly together by the reinforcement (photo 1). The condition of this inlay section was rated as good.

Photo 1. Transverse crack in reinforced PCC slab of NW-SE runway

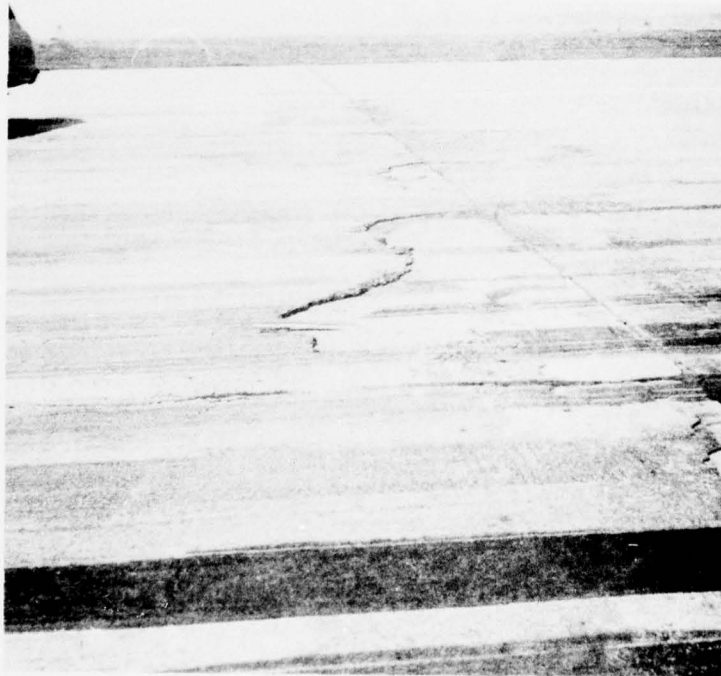
12. An asphaltic concrete (AC) overlay was placed on the runway from sta 135+30 to 160+03 in 1966 and from sta 65+06 to 135+30 in 1969; and, at the time of this survey, the overlay pavement was in excellent condition. There was evidence of some reflection cracking at the joints, with some free water in the cracks, probably from frost melting. The overlay was feathered at sta 165+03, and the edges of the overlay were raveling at this point (photo 2).

Photo 2. Raveling of feathered edge of AC at sta 165+03 of NW-SE runway

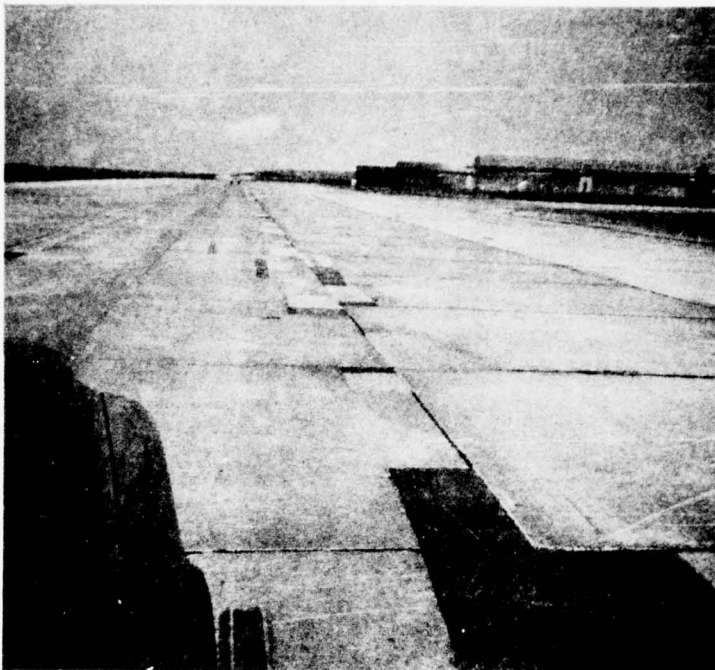
Photo 3. Patched joint spalls on taxiway 26 near parking apron. Note that patches are on each side of joint

27. Maintenance of the longitudinal spalls on the north end of taxiway 26 has consisted of sawing to a minimum depth of 2 in. in the sound concrete beyond the spalled area and chipping out the unsound concrete to the depth of the keyway. The exposed surface is then brushed with a tack coat, and hot-mix AC is used in the patch. When existing patches have settled 1/2 in. or more below the adjacent slab, additional hot-mix AC has been applied. These patches have been performing fairly well for the past 10 years. It was reported that, in the area of taxiway 26 that contained dowels, patching the spalls required the removal of only about 4 in. of unsound concrete (i.e., the depth of the patch was less than the depth of the dowel).
