MISCELLANEOUS PAPER S-73-13

CONDITION SURVEY, WURTSMITH AIR FORCE BASE, MICHIGAN

P. J. Vedros, H. T. Thornton, Jr.

April 1973

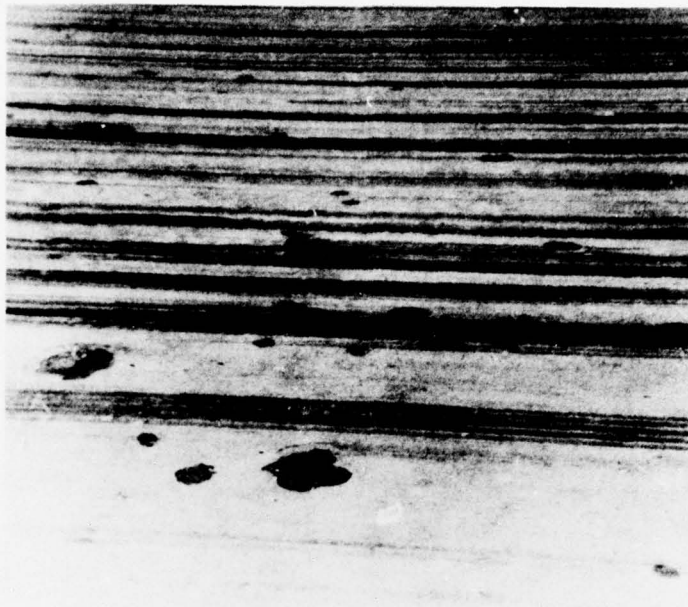
13. A detailed inspection (slab by slab) of the runway pavement indicated that it was in excellent structural condition. Eight slabs located in the 15-in.-thick pavement in the outside lane of the interior of the runway (feature R5D) contained the only major defects. However, as is shown in table 4, there were a considerable number of spalls and pop-outs, and some "D" cracking had occurred in the pavement surface. Every slab in the first 1000 ft of the southwest (O6) end and almost every slab in the runway interior contained pop-outs (photos 1 and 2). An investigation of the spalling condition on the runway at WAFB was performed in 1966, and the results were published in the report referenced in paragraph 9a. There has been a progression in the number of spalls on the longitudinal joints since the 1966 investigation. The spalls and pop-outs have been repaired with patches of a latex material or an epoxy concrete. Since the patching on the runway has to be accomplished between aircraft operations, a fast setting epoxy patch is used. In some cases a poor patching job has resulted because of the rush. The repair of spalls and pop-outs is a costly, major maintenance problem at this airfield.

Photo 1. Pop-outs in interior of runway

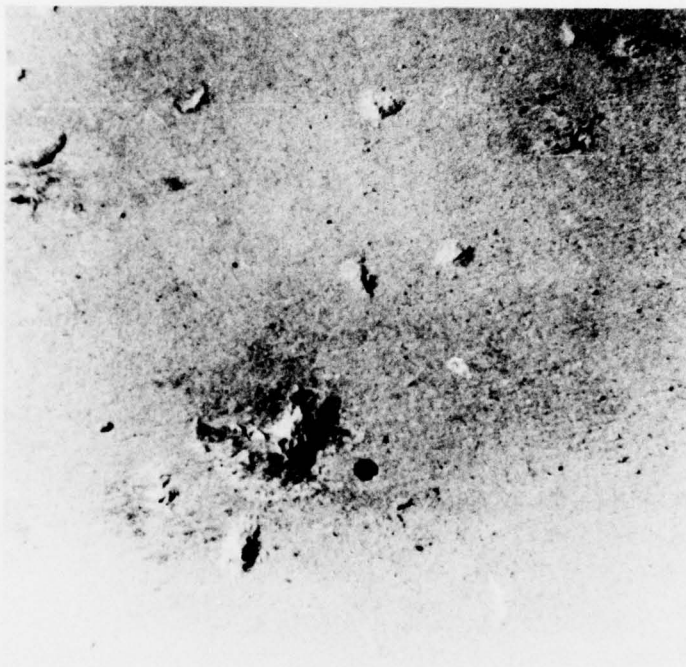
Photo 2. Pop-outs in traffic area D (outside edges of runway)

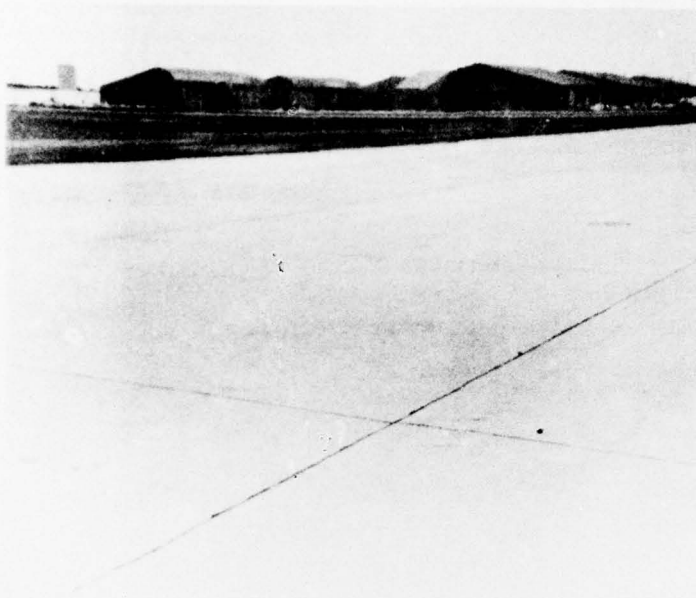
Photo 3. New 14-in. PCC surface on taxiway K

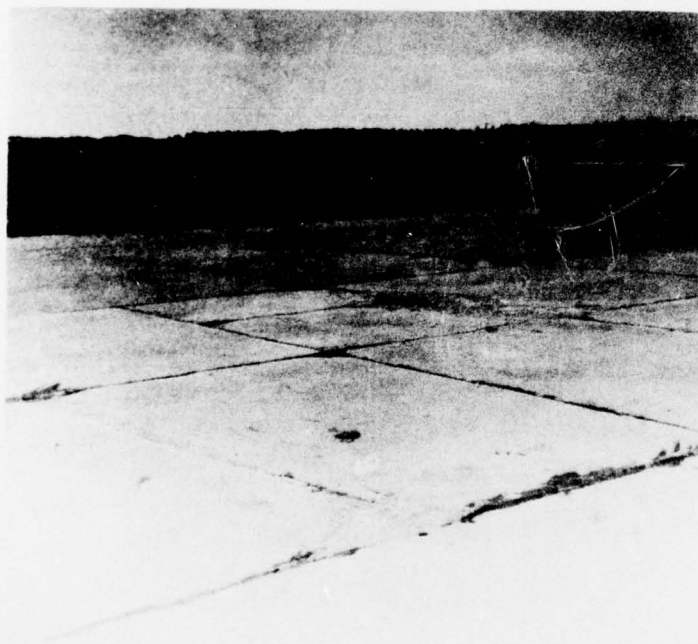
20. The remaining facilities were not selected for detailed inspection; however, a cursory inspection was made of the pavements. It was noted that taxiway K (the original NE-SW runway) was in excellent to poor condition. In 1970, a section of this taxiway (adjacent to taxiway J), which had an original pavement of 6 in. of PCC over 6 in. of soil cement, was replaced with 14 in. of PCC so that taxiway K could be used as a turnaround apron for unloading cargo. In 1971, a section of

Photo 4. Original pavement on taxiway K;
condition rated poor

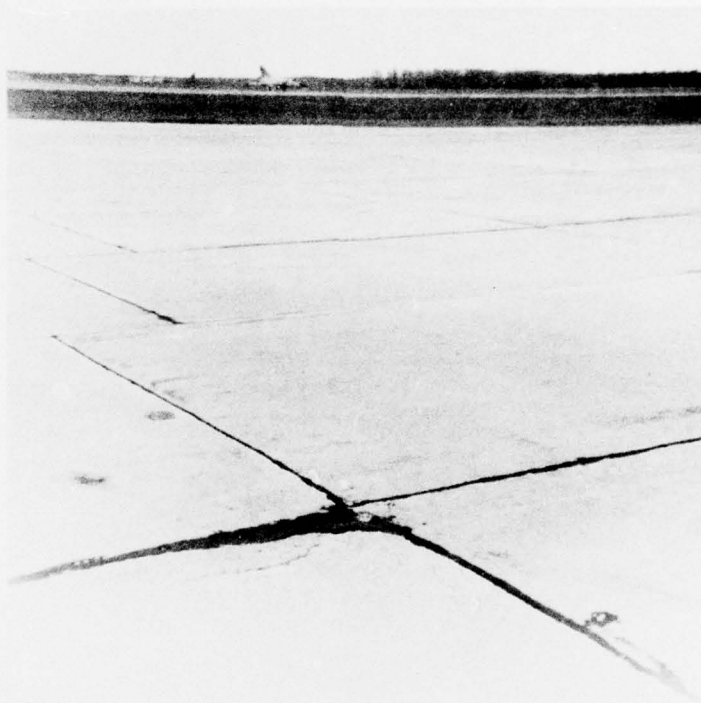
Photo 5. ADC operational apron
