MISCELLANEOUS PAPER S-73-14

# CONDITION SURVEY, ALTUS AIR FORCE BASE, OKLAHOMA

April 1973

Conducted by U. S. Army Engineer Waterways Experiment Station  
Soils and Pavements Laboratory  
Vicksburg, Mississippi

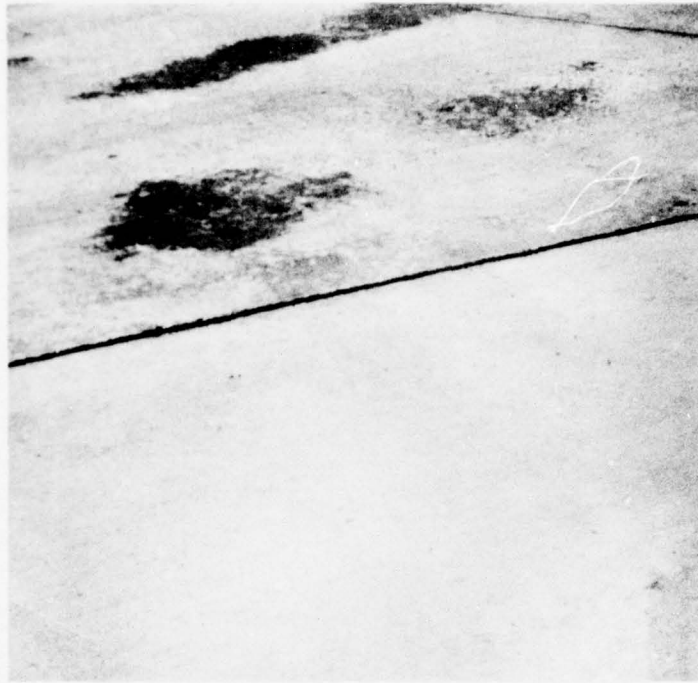
Photo 1. Scaling due to jet engine blast;  
south end of taxiway 5

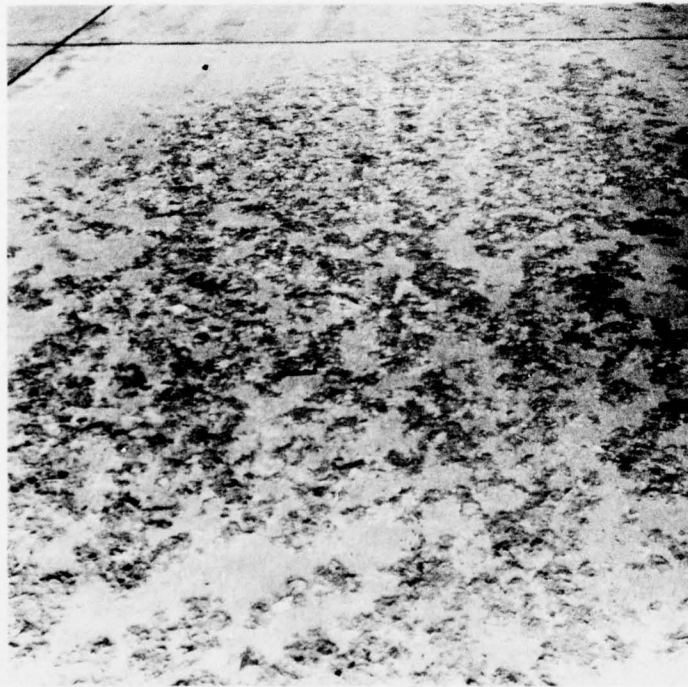
bonded PCC overlays, 1 to 3 in. thick, were applied to 24 slabs in the center apron (feature A4B) in 1962 to repair damage caused by a fire. Photo 2 shows the condition of one of the fire-damaged slabs. Most of the overlays contained small shrinkage cracks (see photos 3 and 4), and some were not completely bonded to the underlying slabs. The north warm-up apron (feature A12B) had only 5 slabs containing major defects, and its condition was rated as excellent. In 1965, 17 slabs were replaced in the north warm-up apron. The operational apron had 38 slabs replaced in 1965. It is reasonable to assume that this slab replacement was required because of channelized traffic.

Photo 2. Fire-damaged slab in center wing  
parking apron

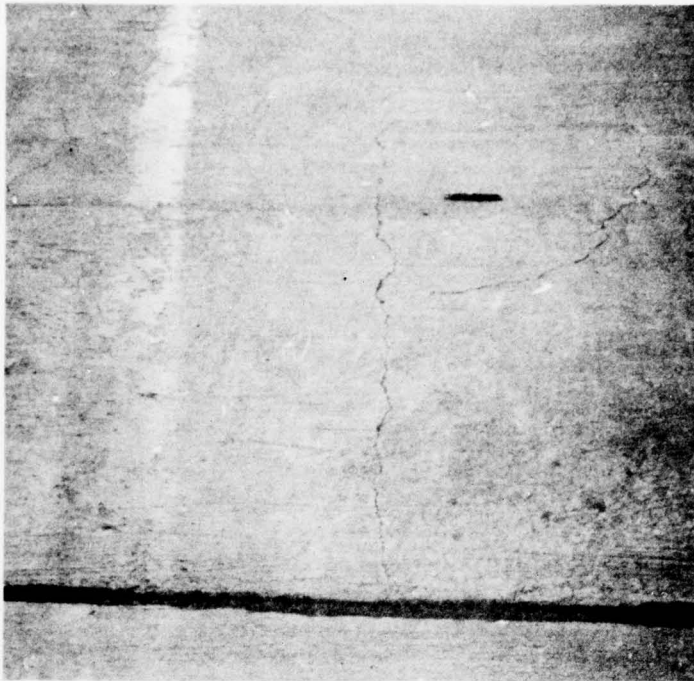
Photo 3. Thin bonded overlay on center wing parking apron

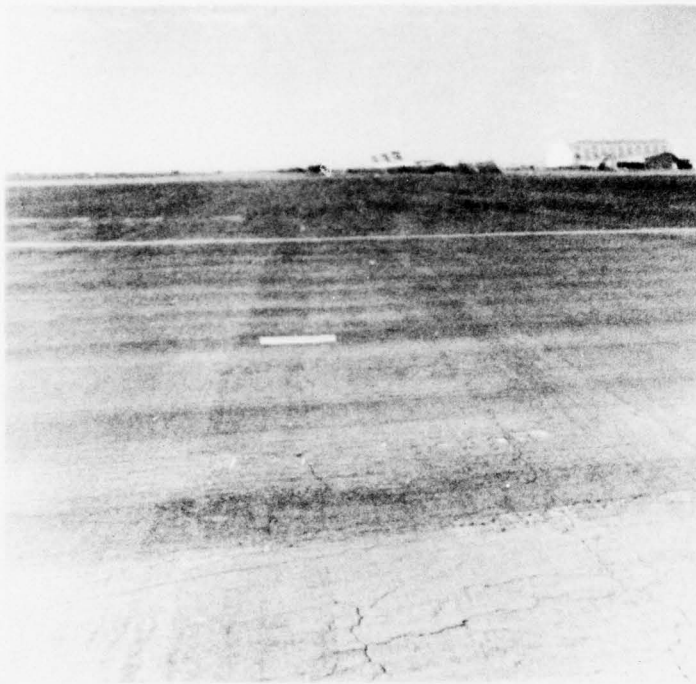
17. The asphaltic concrete (AC) portion of the runway on both sides of the 75-ft keel section was rated as being in good condition, even though there was some cracking. The AC area adjacent to the center wing parking apron and south of taxiway 2 was rated as being in poor condition due to cracking and rutting (photos 5 and 6). This area is scheduled for replacement in the near future. The remaining pavement features not specifically mentioned above were rated as being in good to excellent condition.

Photo 5. Cracking and rutting of AC pavement, south of taxiway 2 and adjacent to center wing parking apron

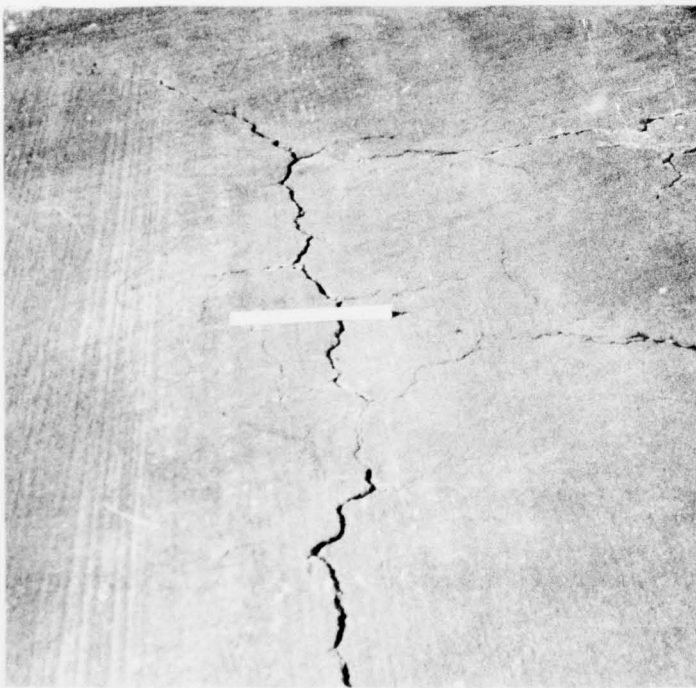
Photo 6. Cracking and rutting of AC pavement, south of taxiway 2 and adjacent to center wing parking apron
