MISCELLANEOUS PAPER S-73-16

# CONDITION SURVEY, ROBERT GRAY ARMY AIRFIELD, FORT HOOD, TEXAS

April 1973

Conducted by U. S. Army Engineer Waterways Experiment Station

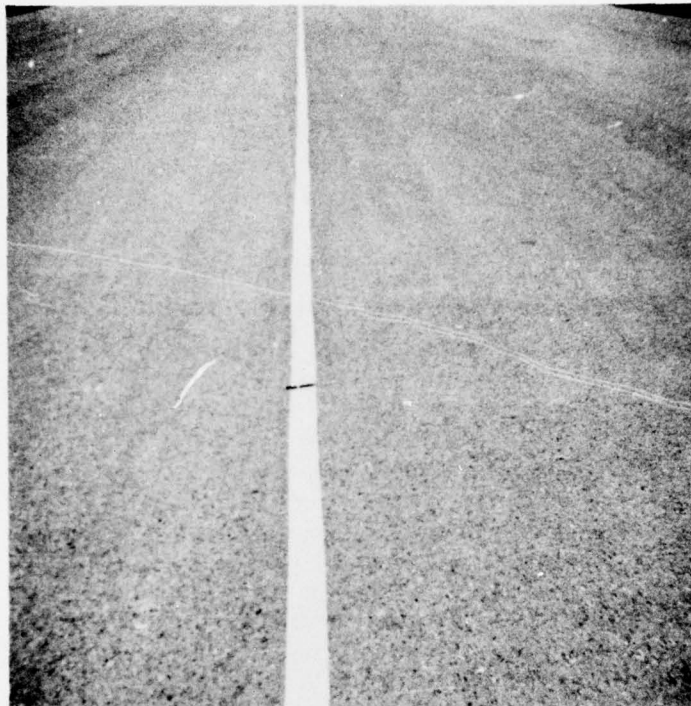
excellent condition. Photo 1 shows the generally good condition of the AC pavement of the runway (looking north from sta 56+00). Photo 2 shows a general view of the PCC pavement of the runway (looking south from sta 96+00), which was in excellent condition. A longitudinal paving lane crack near sta 56+00 is shown in photo 3. The AC portion of the parallel taxiway was in very good condition (photo 4), even though there were many skid marks from rotary-wing aircraft operations. The south parking apron was in good condition (photo 5). The north half of the PCC north parking apron was in excellent condition (photo 6). At the time of this inspection, the concrete was being poured for the south half of the apron. The pavement facilities not specifically mentioned above were in good to excellent condition.

Photo 1. AC pavement on runway looking north  
from sta 56+00

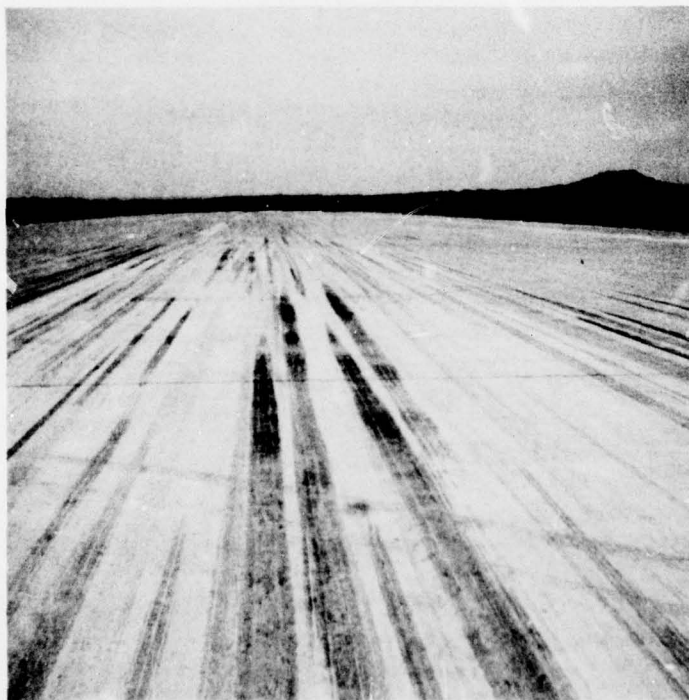
Photo 2. General view of PCC pavement on runway  
looking south from sta 96+00
