CONDITION SURVEY, MALMSTROM AIR FORCE BASE, MONTANA

R. D. Jackson

April 1973

Conducted by U. S. Army Engineer Waterways Experiment Station
Soils and Pavements Laboratory
Vicksburg, Mississippi

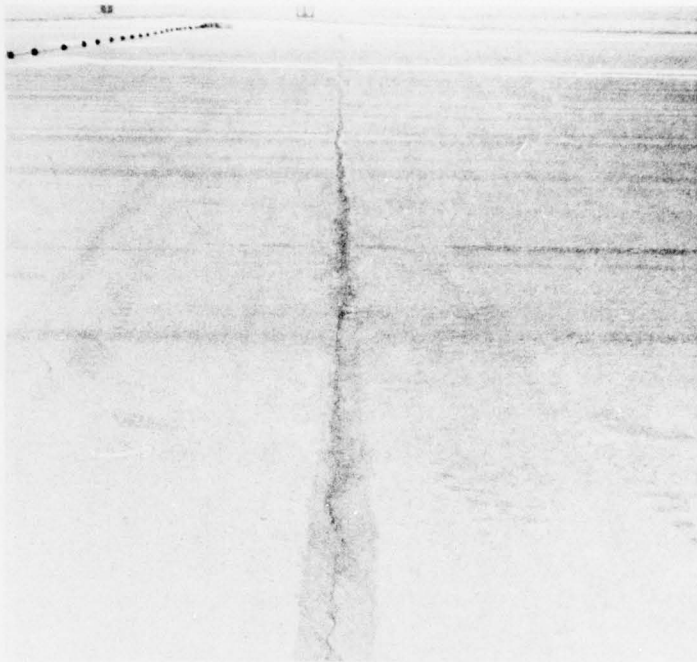
was in very good condition. The first 1000 ft of the NE (20) end (features R1A and R2B), which is also 16-in. PCC, was in excellent structural condition, and no major defects were noted. The joint sealing materials on both 1000-ft runway ends were in very poor condition and had completely deteriorated between several slabs at the southwest end. The asphaltic-concrete (AC) portion of the runway was in good condition, even though there were numerous longitudinal and transverse cracks that appeared to be reflection cracks (photos 1 and 2).

Photo 1. Transverse crack in runway near NE end

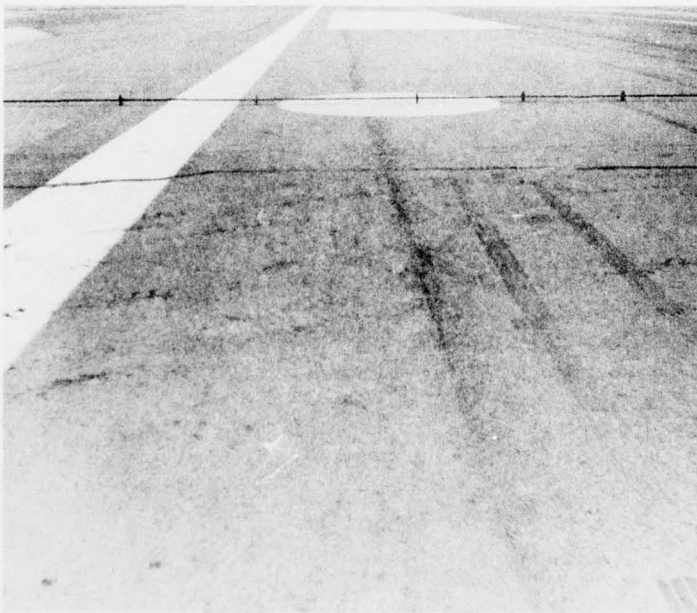
Photo 2. Longitudinal and transverse cracks
near NE end of runway

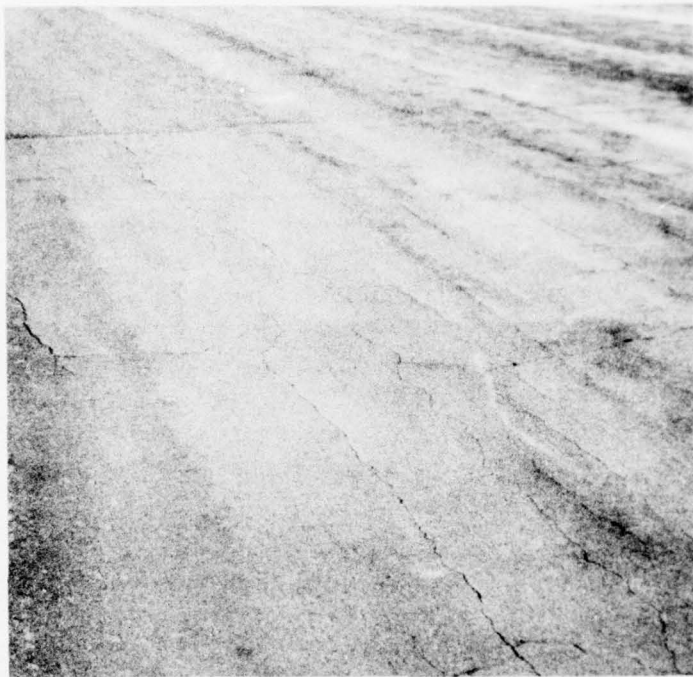
16. The primary taxiway system consists of taxiway T, the apron taxiway, and taxiway O. The southwest end of taxiway T (feature T1A) was in good condition. The AC portion of taxiway T was in poor condition (photo 3). The surface of this taxiway was uneven and contained numerous cracks and scales in the slurry seals placed in 1959 and 1965. The apron taxiway (features T3A and T7A) was in very good to excellent condition, even though there were a considerable number of minor defects. Taxiway O was in excellent condition.

Photo 3. View of AC portion of taxiway T

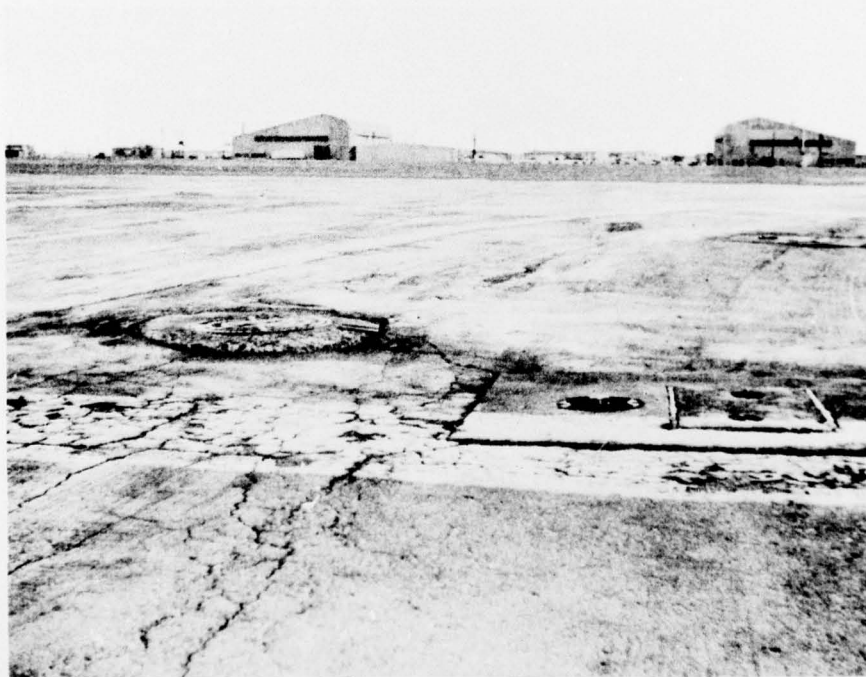
Photo 4. Taxiway R shoulder pavement. Note heaving adjacent to manhole on left

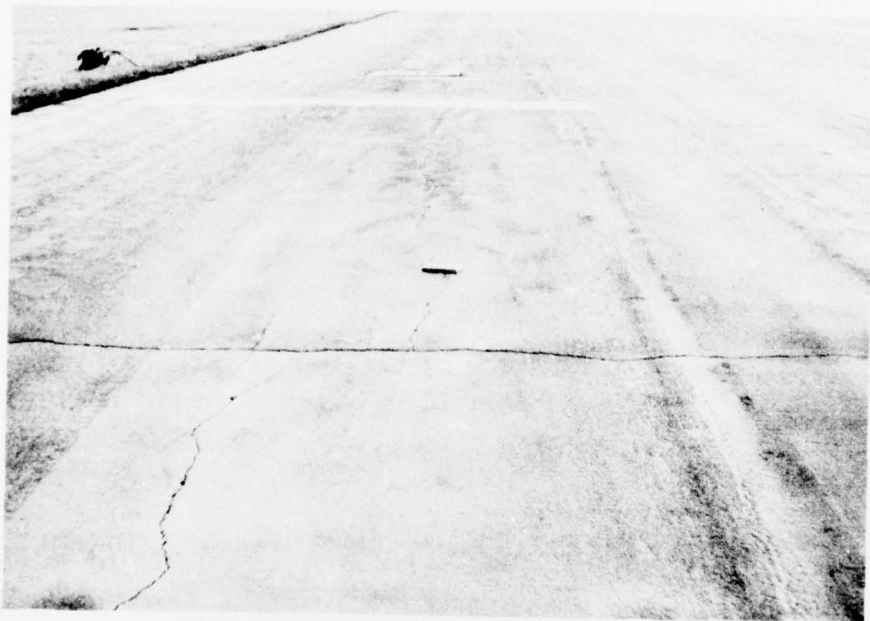
Photo 5. Taxiway T shoulder pavement
