MISCELLANEOUS PAPER S-73-23

CONDITION SURVEY, MINOT AIR FORCE BASE, NORTH DAKOTA

P. J. Vedros

April 1973

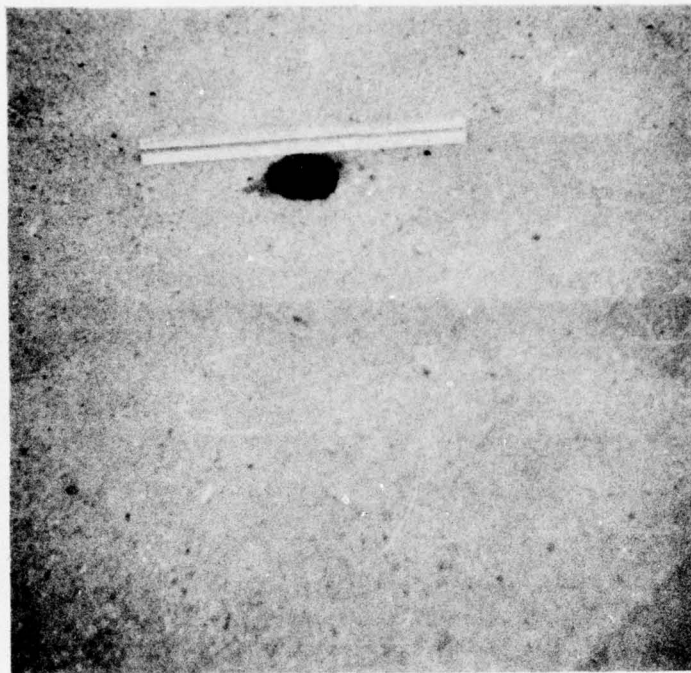
15. There were some aggregate pop-outs observed in the runway pavements, with the majority occurring in the interior section. The maximum size of the voids resulting from the pop-outs was about 3 in. in diameter (photo 1). These areas are kept free of debris by sweeping.

26. Pop-outs are occurring in some areas of the airfield, but they have not been considered a maintenance problem. The pop-outs are small in size (3-in.-diam, maximum), and patching is not required. Sweeping keeps any loose particles resulting from pop-outs off of the pavement surfaces.

Photo 1. Pop-out in runway interior
(approximately maximum size observed)

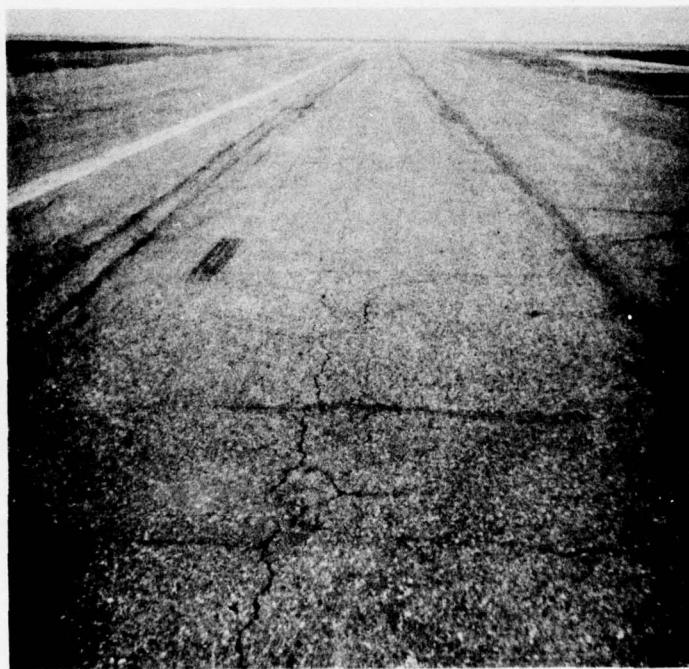
24. Both of these taxiways connecting the runway to the primary taxiway are of flexible pavement construction. The pavements were in fair condition, with random cracking in the surface (photo 2). Some longitudinal cracking occurred in taxiway C as a result of operations of aircraft during practice alerts. The taxiway was also used to park alert aircraft; and, because of the surface condition, Base Civil Engineering

Photo 2. Random cracking in taxiway C

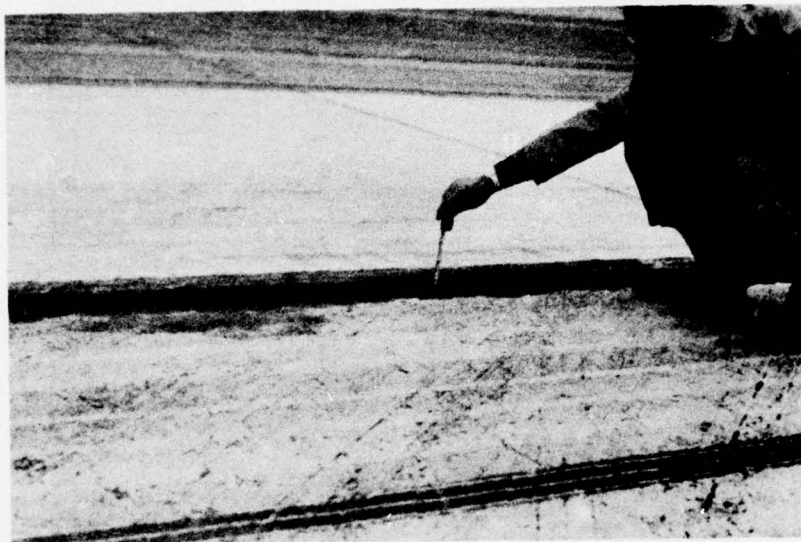
14. The AC pavement on each side of the PCC interior of the runway (feature R7D) was in fair condition, with transverse cracking occurring about every 10 to 15 ft. There was vertical displacement of from 1/2 to 2 in. (i.e., the PCC interior being higher than the AC edges) at the longitudinal joining of the two types of pavements. The cracking and vertical displacement were due to frost action, which is discussed in detail in paragraphs 28-41.

Photo 3. PCC runway keel heaved 2 in. above AC runway edge pavement near intersection of runway with taxiway C

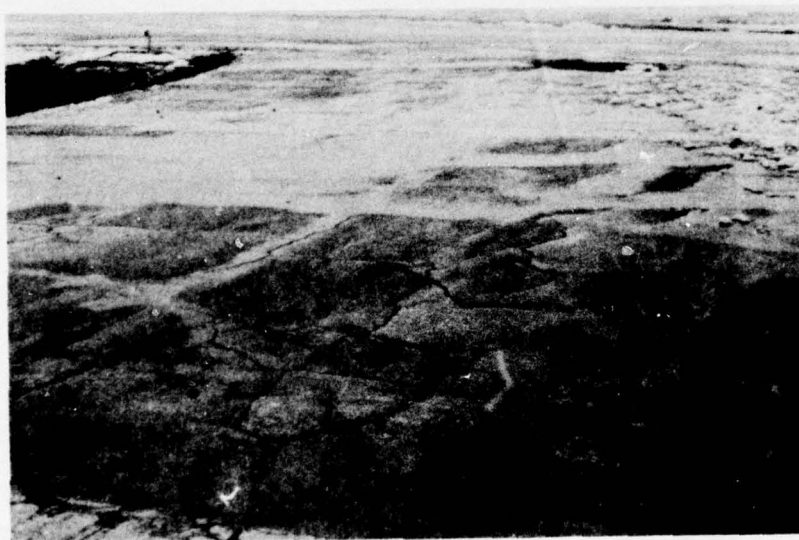
Photo 4. Random cracking of shoulder pavement at taxiway B caused by nonuniform frost heave

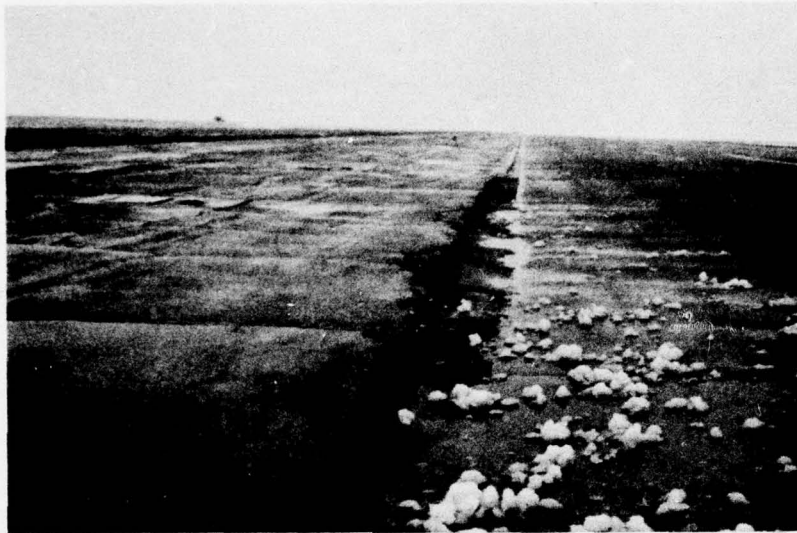
Photo 5. Shoulder pavement of parallel taxiway
heaved 1-1/2 in. above edge of feature T11A

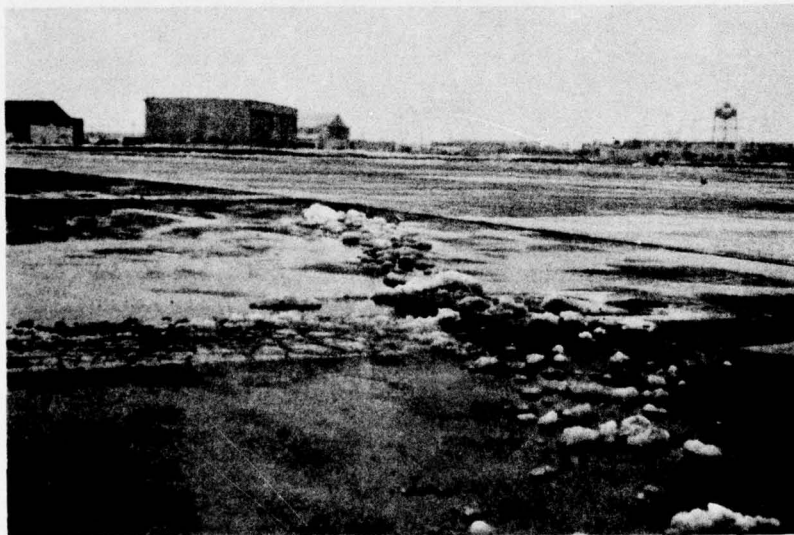
Photo 6. Differential frost heave at concrete
insert in shoulder of taxiway B

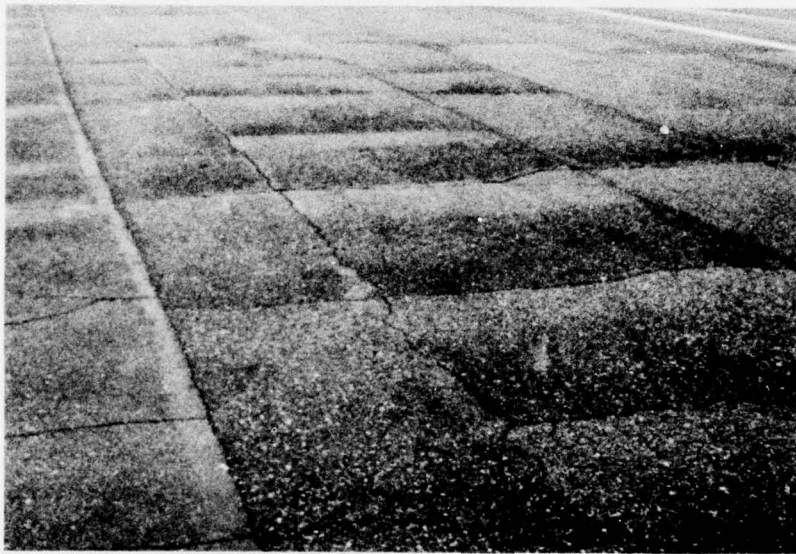
Photo 7. Transverse and longitudinal low-temperature contraction cracks at spacing of 10 to 15 ft in edge of primary taxiway (feature T11A)

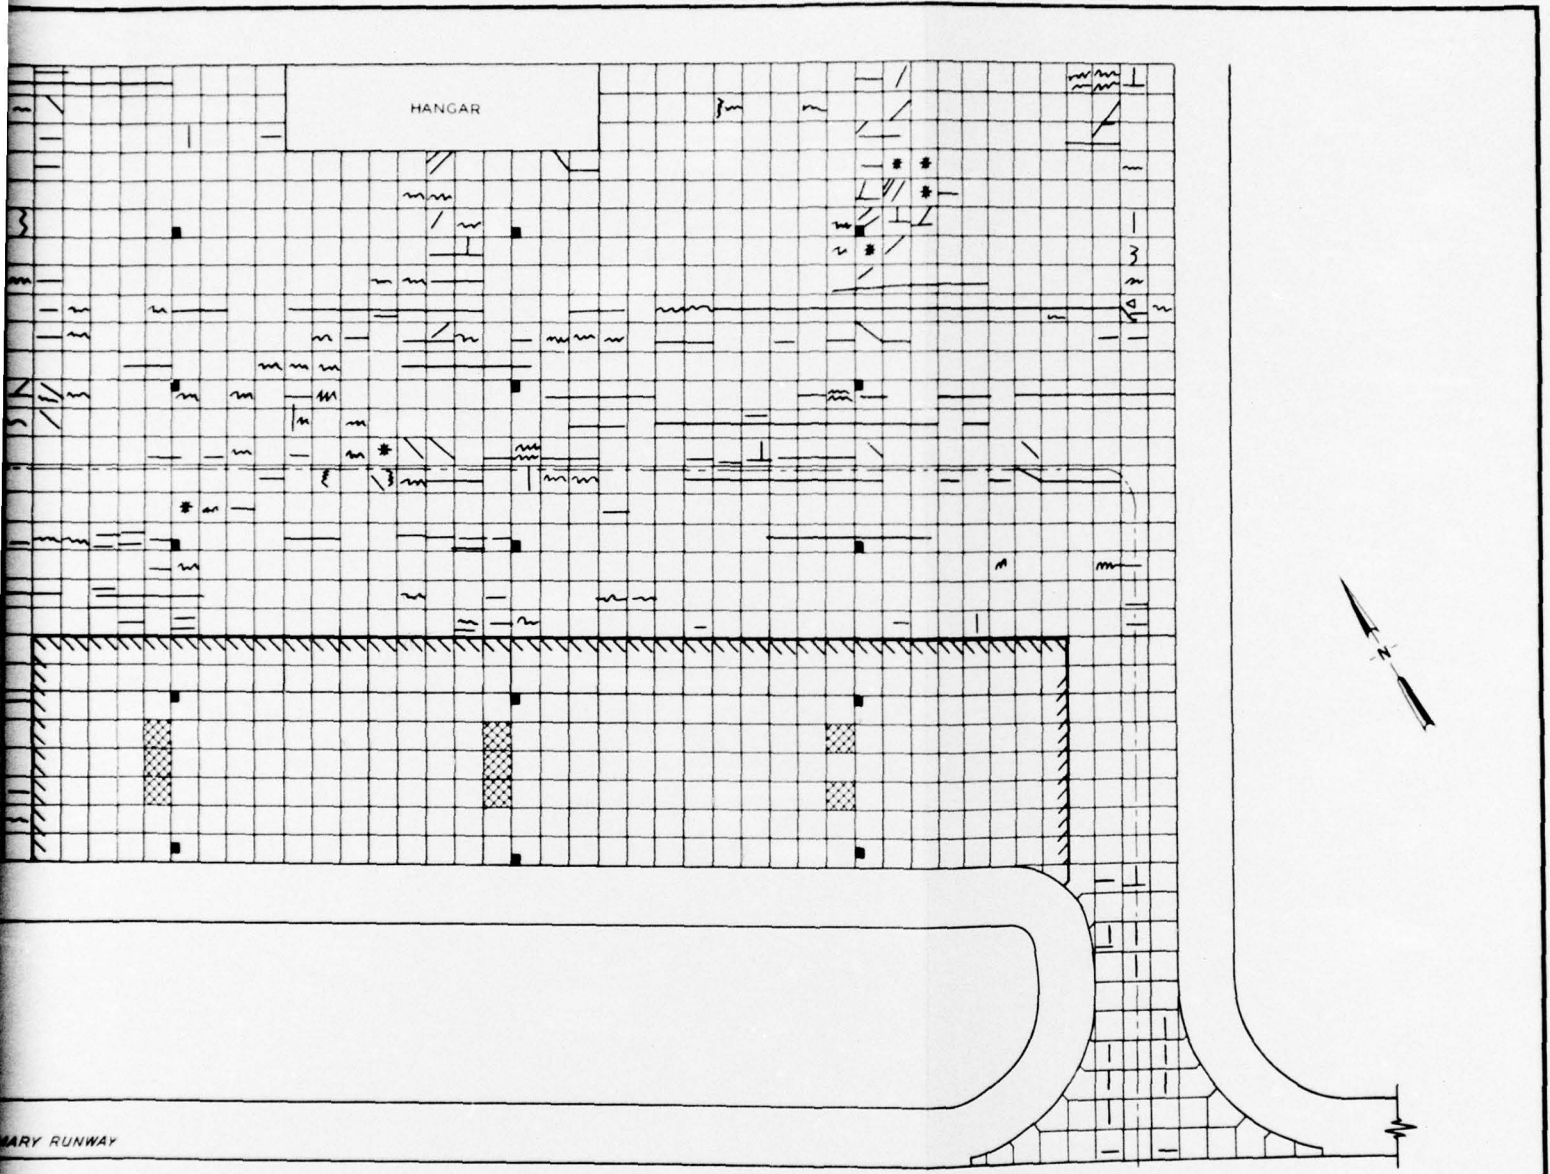
DEFECTS IN SAC
OPERATIONAL APRON
MINOT AFB, NORTH DAKOTA

20. The large operational apron consists of 15-in. PCC, with 25-by 25-ft slabs composing the original portion (feature A3B). The overall condition of the apron was very good, with approximately 19 percent of the slabs containing major defects. A comparison of the number of 1972 defects with the number of 1960 defects (table 4) indicates that the original apron (feature A3B) has had a significant increase in the number of defects. Plate 4 shows the locations and types of defects as observed in 1972. It was possible to survey only a few areas where alert aircraft parked. In these areas, considerable distress in the slabs had occurred, especially in those slabs on which aircraft wheels are usually located. Furthermore, vibrations are transferred from the aircraft to the slabs during run-up operations; and, in almost every parking spot, the slabs were shattered, and, in some cases, displacement and faulting had occurred.
