MISCELLANEOUS PAPER S-73-29

CONDITION SURVEY, MCCONNELL AIR FORCE BASE, KANSAS

R. D. Jackson

May 1973

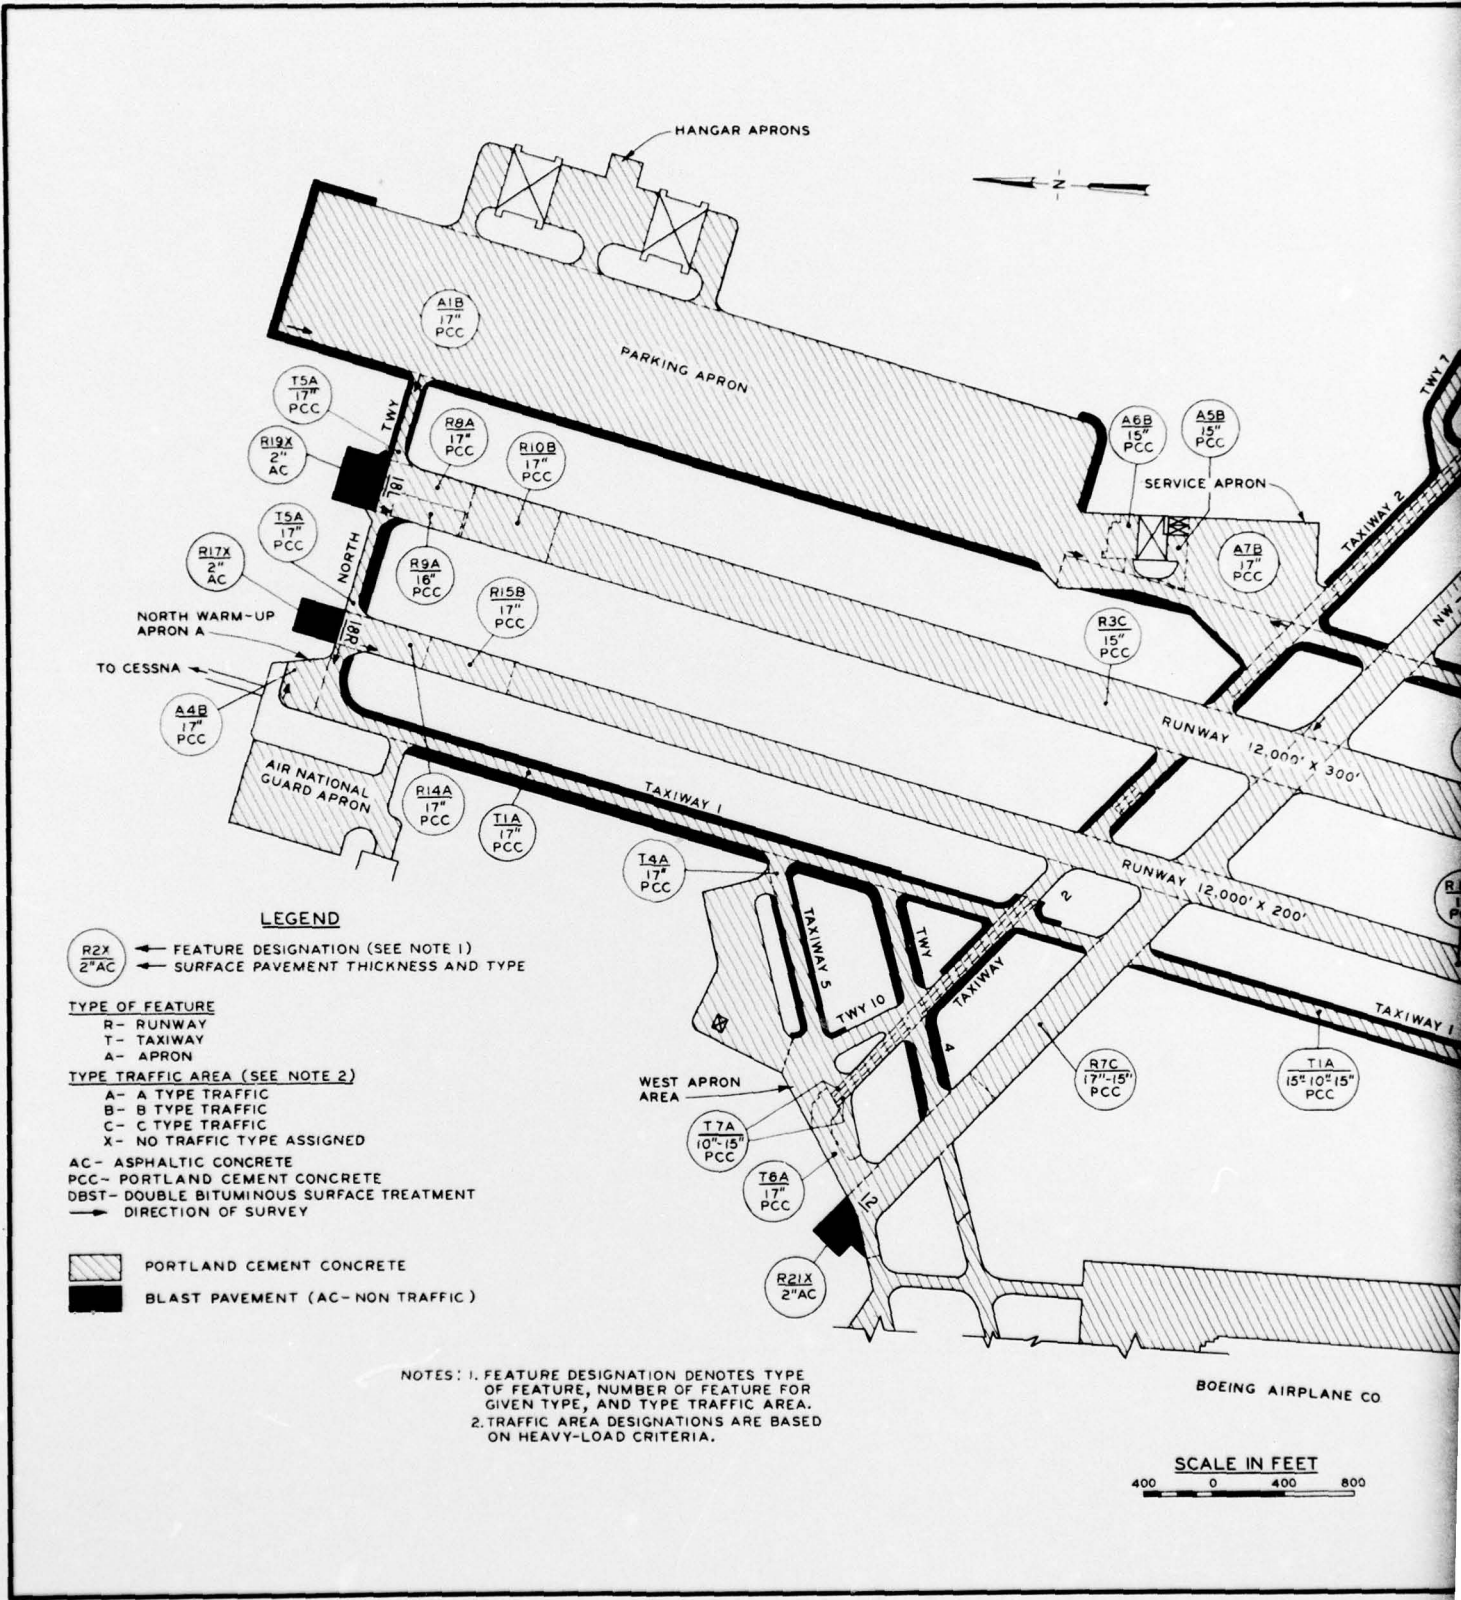
10. The following procedure was used in conducting the inspection of the rigid pavements. Representative features were selected for detailed inspection. The features were then inspected slab** by slab, and the defects were recorded. The locations of the individual pavement features, the inspection starting points, and the directions in which the pavements were inspected (shown by arrows) are indicated in plate 1.

23. Rigid pavements. The primary rigid pavement slab thicknesses are adequate for "normal" period operations of the present Air Force medium-load aircraft, except for a slight deficiency (1 in.) for traffic area A slabs (see plate 1). However, for frost condition operations under the same loadings, the traffic area A and B pavement slabs are from 3 to 5 in. deficient in thickness, while the area C pavements are still adequate (except for a portion of runway 18L-36R interior (feature R6C), which has 13-in.-thick slabs). The reduced subgrade strength design criteria specify, however, that, in areas where subgrade conditions are uniform and the design freezing index is less than 1000, a minimum base thickness of 4 in. must be used. Yet all of the rigid pavements at MAFB have been constructed directly on the subgrade, except for two taxiways (features T3A and T4A) and two aprons (features A1B and A2B), which have 6-in. sand bases. The field has not been subjected to B-52 traffic to any extent (see paragraph 9); and, as is indicated by
