CONDITION SURVEY, KINCHELOE AIR FORCE BASE, MICHIGAN

H. T. Thornton, Jr., P. J. Vedros

May 1973

Conducted by U. S. Army Engineer Waterways Experiment Station
Soils and Pavements Laboratory
Vicksburg, Mississippi

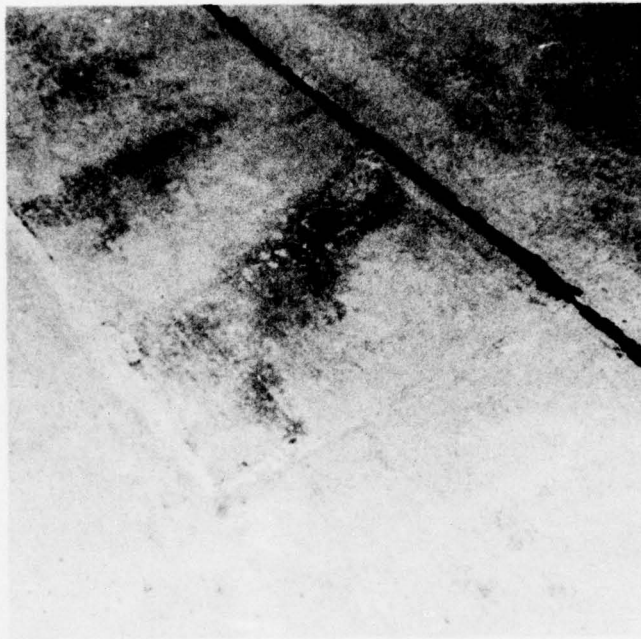
made with PCC and grout were more numerous from sta 10+00 to 50+00 than in other areas of the runway. Some of the repaired spalls were performing satisfactorily, and some were showing signs of slight deterioration (see photos 1 and 2). The pop-outs had also been patched with PCC.

Photo 1. Spall repaired with PCC (in good condition)

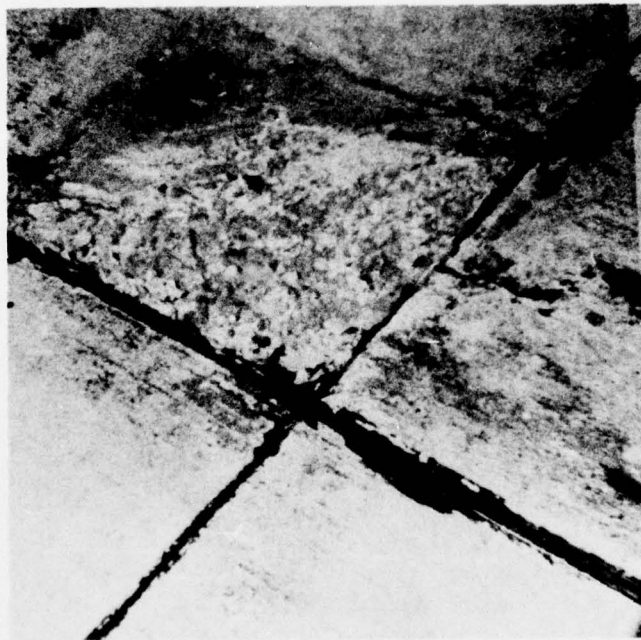
Photo 2. Spall repaired with PCC (deteriorating)

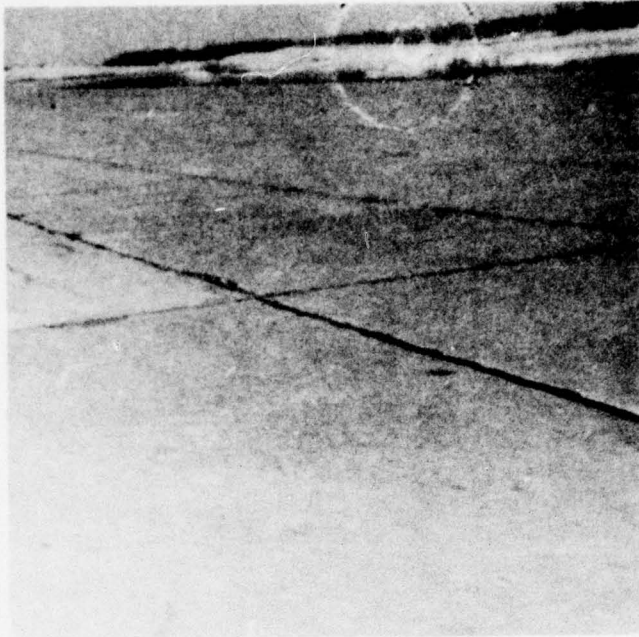
25. The ADC parking apron and operational apron were constructed in 1942 of 9-6-9-in. PCC. These aprons contained a moderate number of structural defects, pop-outs, and spalls. The PCC that has been used to patch the spalls and pop-outs has performed satisfactorily. Epoxy material has been tried on some of the spalls, but the patches have become unbonded and have had to be replaced. These aprons receive only light traffic and are considered to be in fair to poor condition (see photos 3-5).

Photo 3. Condition of ADC parking apron

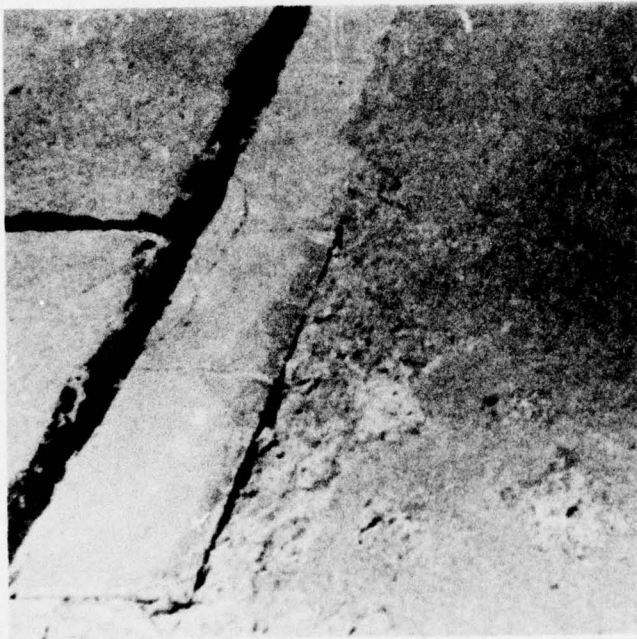
Photo 4. Spall repair on ADC parking apron

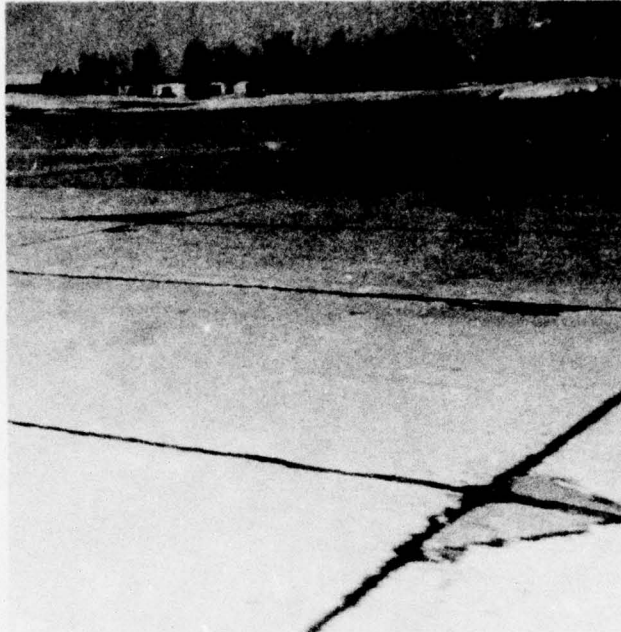
Photo 5. Condition of ADC operational apron

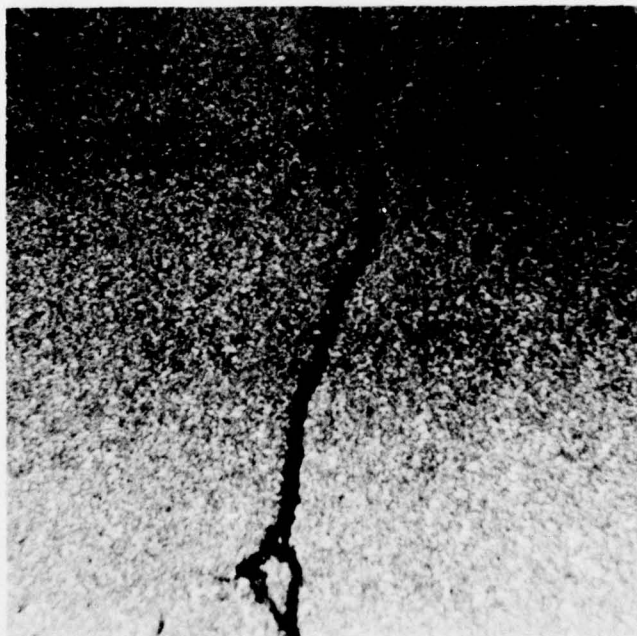
26. Taxiways 9 and 11 were surveyed in detail and were in excellent condition. The asphaltic concrete shoulders and blast pavements were in good condition, with only a minor amount of shrinkage cracking occurring. Some of the larger cracks, such as the longitudinal crack (photo 6) on the north overrun, need to be sealed.

Photo 6. Longitudinal crack in north overrun
