CONDITION SURVEY, GLASGOW AIR FORCE BASE, MONTANA

R. D. Jackson

May 1973

Conducted by U. S. Army Engineer Waterways Experiment Station
Soils and Pavements Laboratory
Vicksburg, Mississippi

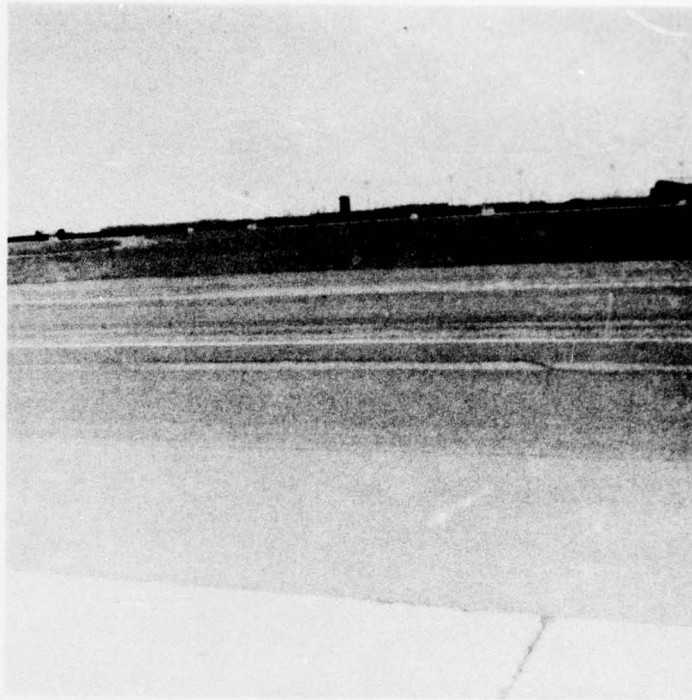
14. The portland cement concrete (PCC) pavement of the runway was in very good condition (except for two areas), even though the number of defects had increased considerably since the 1960 survey. The 17-in.-thick pavement from sta 78+75 to 88+75 was rated as being in poor condition, because the number of major defects had more than doubled since the 1960 survey. The 14-in.-thick edges of the runway ends (features R5D and R6D) were considered to be in poor condition. The flexible pavement edges of the runway interior (feature R8D), however, were considered to be in good condition (see photo 1).

Photo 1. General view of AC pavement of outer edge of runway interior (feature R8D) near sta 45+00

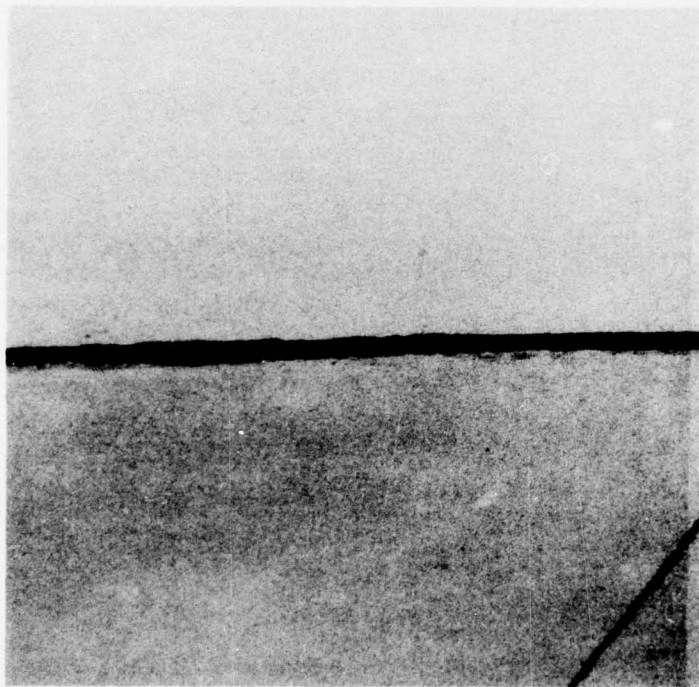
15. There was evidence of settlement of several slabs in the runway interior between sta 65+00 and 70+00 (feature R7C). It was reported that unsuccessful mud jacking had been performed in this area in 1966 and 1967. An epoxy surface patch approximately 115 ft long and 6 to 8 in. wide was installed to smooth out the transition area onto the settled slabs. There was no evidence that movement of these slabs had occurred since the installation of the patch. Photo 2 shows the condition of the patch. Numerous grouted drill holes (photo 2) were noted in runway features R3C and R4C, indicating that mud jacking had been performed at some previous time. Some settlement of slabs was noted near sta 45+00 (photo 3).

Photo 3. Settlement of slab near
sta 45+00 of runway
