MISCELLANEOUS PAPER S-73-34

# CONDITION SURVEY, PEASE AIR FORCE BASE, NEW HAMPSHIRE

May 1973

Conducted by U. S. Army Engineer Waterways Experiment Station  
Soils and Pavements Laboratory  
Vicksburg, Mississippi

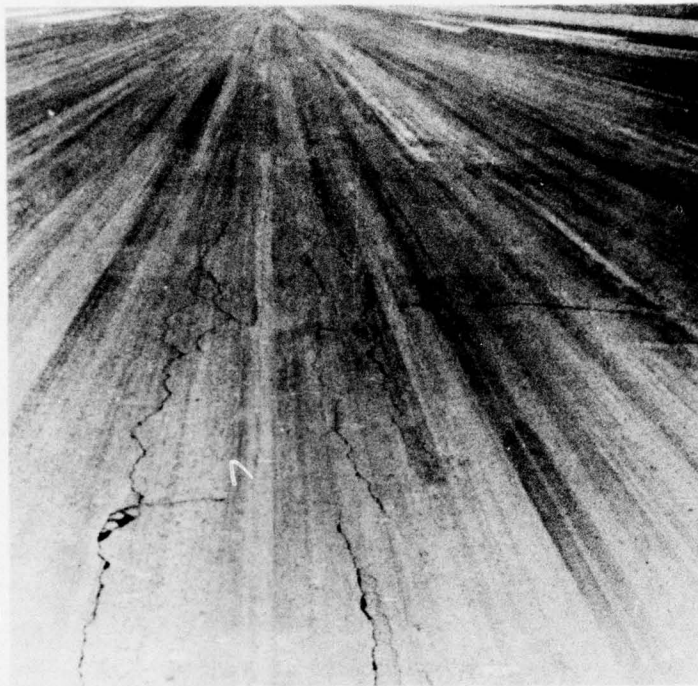
12. The NW end of the runway (features R1A and R2B) was structurally in very good condition based on the percentage of slabs containing no major defects. A total of 26 major defects were noted in feature R1A, all of which were longitudinal cracks. Of the 26 defects, 12 were in the two outer lanes on each side, and the other 14 were about equally divided among the other 8 lanes. Feature R2B contained 46 major defects, 45 longitudinal cracks and 1 transverse crack. Twenty-eight of the defects were located in the two outer lanes on each side; the other 18 were about equally divided among the other eight lanes. The asphaltic concrete (AC) interior portion of the runway (feature R3C) between the 1000-ft portland cement concrete (PCC) ends was in only fair condition because of longitudinal cracking (photos 1 and 2) and slight rutting. (This feature should now be in good condition, since a 3/4-in. friction overlay has been applied.) The SE end of the runway (features R5A and R4B) was in a poor to failed condition based on the number of slabs containing major defects. These two features contained a total of 332 major defects, of which 209 were located in the two outer lanes on each side. Twenty-seven slabs are scheduled for replacement in these features. Photo 3 shows the condition of the PCC pavement at the junction of the AC pavement at the SE end of the runway. The general conditions of the PCC pavements in features R5A and R4B (SE end of the runway) are shown in photos 4 and 5.

Photo 1. General view of cracking on runway approximately  
2500 ft from NW end

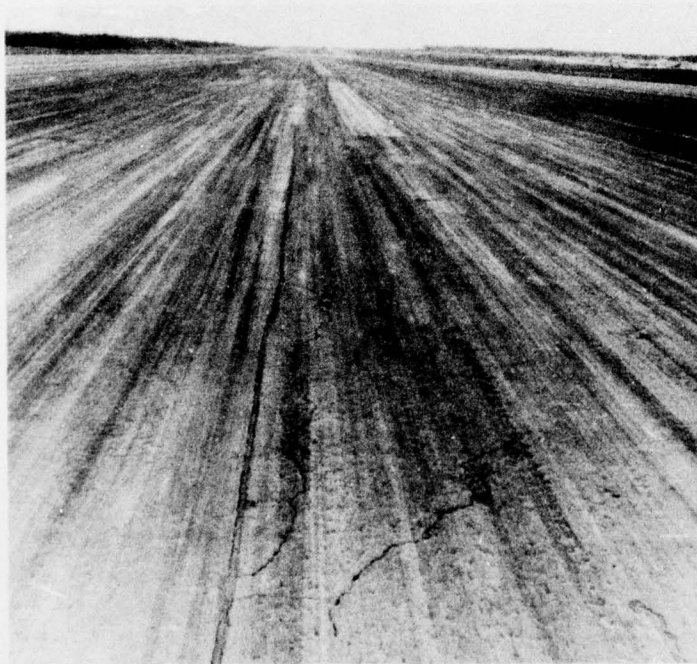
Photo 2. General view of runway near SE end  
of AC pavement

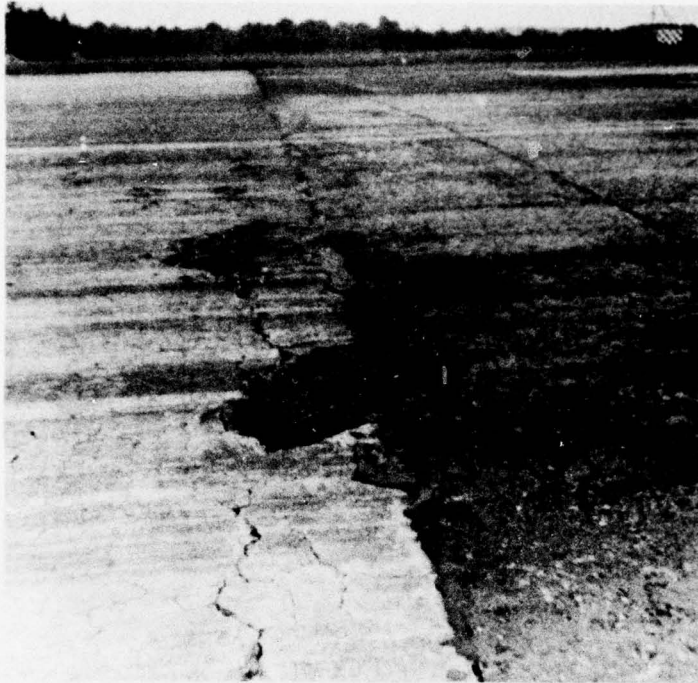
Photo 3. Pavement condition at junction of  
PCC and AC at SE end of runway

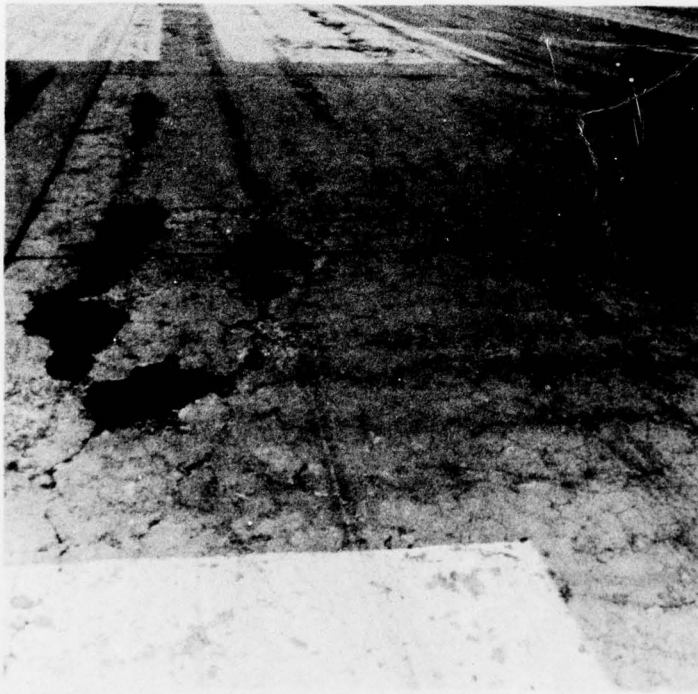
Photo 4. AC surface patches on PCC pavement  
at SE end of runway

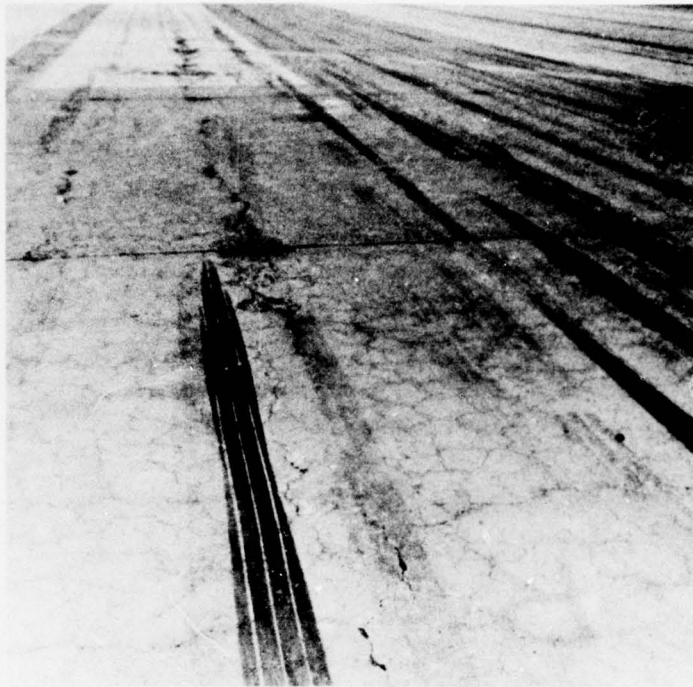
criteria for limited subgrade frost penetration design, and no reduction in the evaluations for frost condition operation is warranted (table 4). The runway interior pavement, however, is deficient by 3 in. in the thickness of the crushed-stone base course relative to current normal (nonfrost) heavy-load design criteria (265,000-lb gear loads). Similarly, the two taxiways are deficient by 1 in. in pavement thickness and by 4 in. in crushed-stone base course thickness. All of these pavements show some load-induced defects, principally shallow rutting and longitudinal cracking, as shown in photos 1 and 2. Rigid pavement slab thicknesses of primary pavements are also from 3 to 4 in. less than those required by current normal (nonfrost) heavy-load design criteria, and load-induced defects were noted in all of these features to degrees roughly proportional to exposure to traffic channelization (photo 5).

Photo 5. General view of PCC pavement at  
SE end of runway

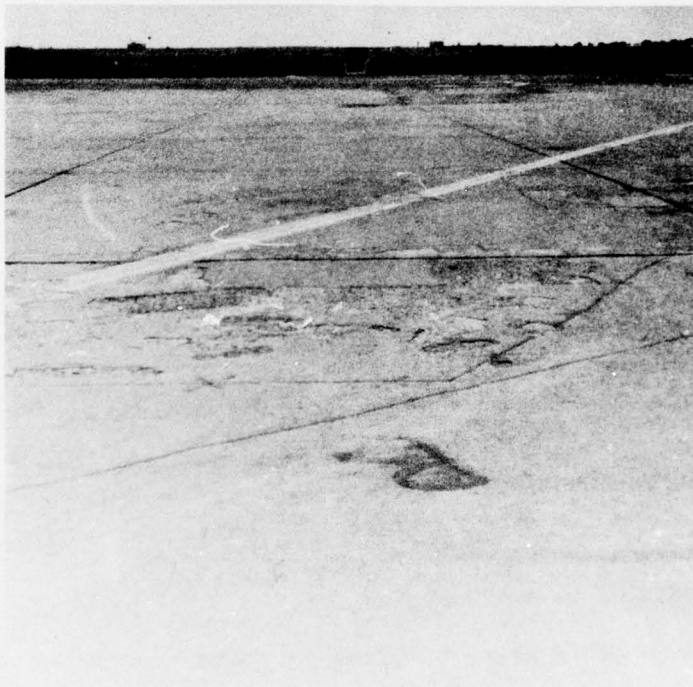
14. The north warm-up apron (feature A1B) was in very good condition based on the percentage of slabs containing no major defects. Jet blast had caused scaling on approximately 10 percent of the slabs. Photo 6 shows some of the scaling in feature A1B. The south warm-up apron (feature A2B) was in fair condition. There were 110 major defects in this feature, of which 100 were longitudinal cracks. Most of the longitudinal cracks were of the type shown in photo 7. They appeared to be caused by the manner in which the pavement had been placed rather than by overloading. Scaling was also prevalent in this feature, with approximately 20 percent of the slabs containing this defect (photo 8). Parking aprons A and B (features A3B and A4B) were in very good condition based on the percentages of slabs containing no major defects. Approximately 10 percent of the slabs in these features contained longitudinal cracks, which were the predominant defect. A large percentage of these longitudinal cracks were of the type shown in photo 9, and they did not appear to be load related. Considerable expansion of these aprons has resulted in upheaval of the shoulder pavements (photo 10) and the removal of the PCC pavement around embedded features, such as the fueling hydrants and drainage structures (photo 11).

Photo 6. Sealing of slabs in north warm-up apron

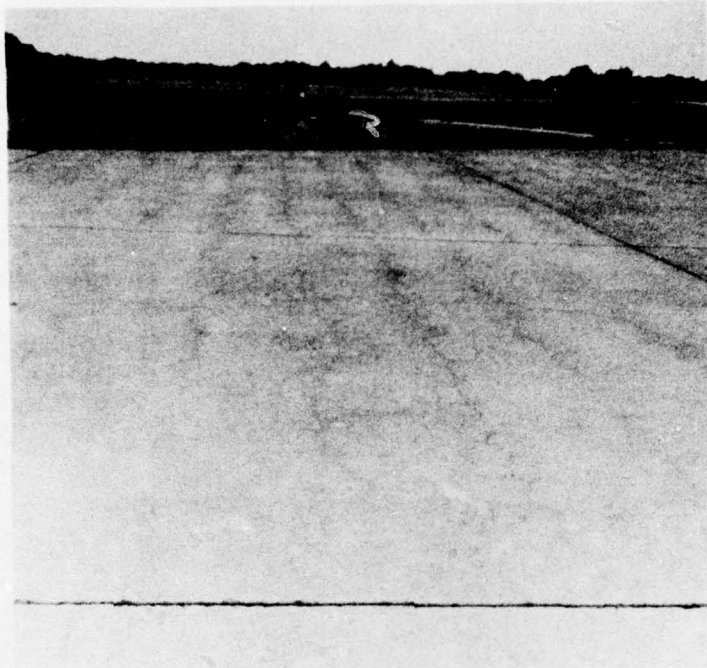
Photo 7. Longitudinal cracks in south warm-up apron

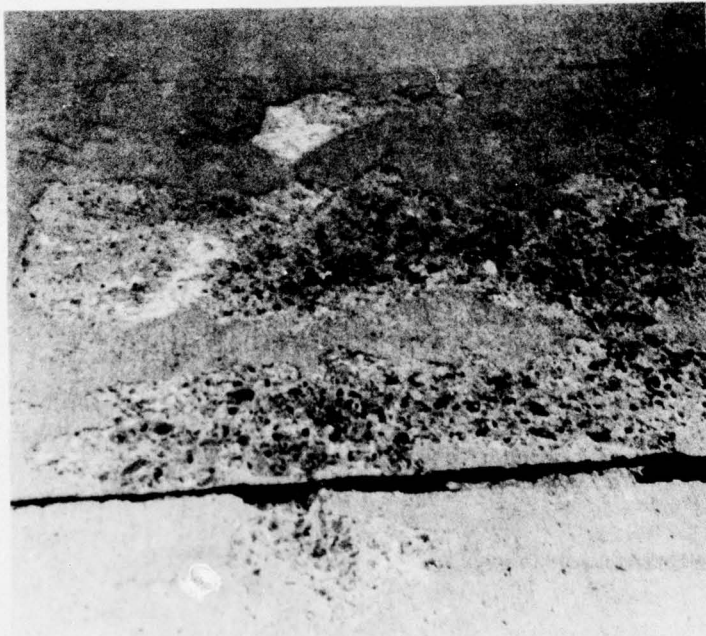
Photo 8. Scaling of slabs in south warm-up apron

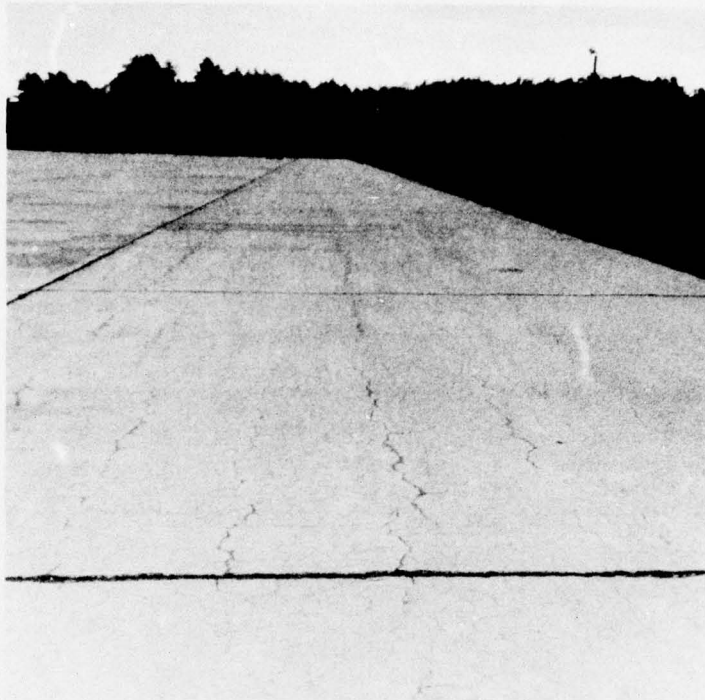
Photo 9. Typical longitudinal cracking  
(as in parking aprons A and B)

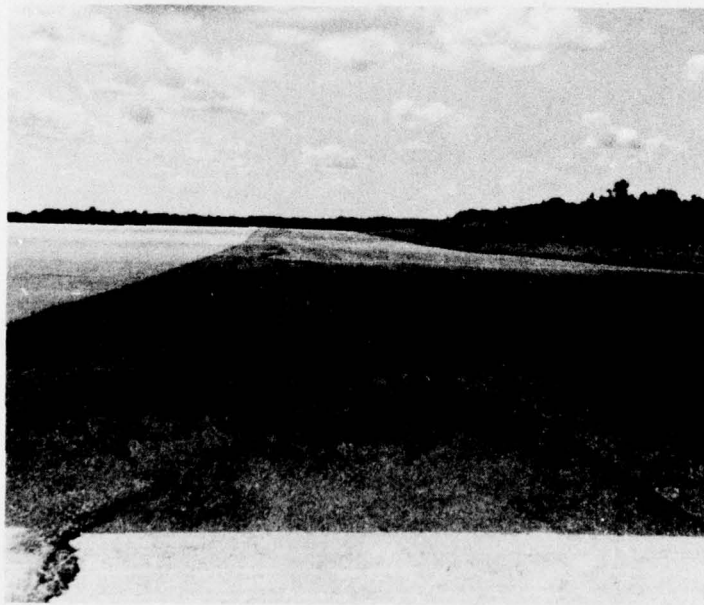
Photo 10. Upheaval of shoulder pavement at  
north end of parking apron A

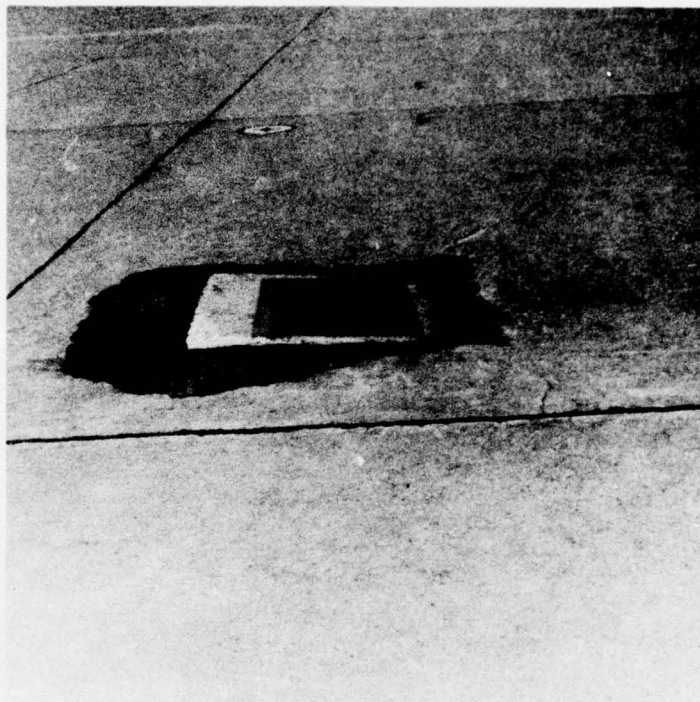
- d. Expansion of the PCC pavements of the aprons had caused upheaval of the shoulder pavements and displacement of drainage structures and fueling facilities. The PCC pavement around some of these facilities had been removed and replaced with AC pavement.
- e. Around some of the drainage structures, polyurethane foam was used to replace the PCC pavement.
- f. Spall repair has generally been accomplished by removing the damaged pavements and replacing them with new PCC.
- g. Evidence of detrimental effects of frost action was observed in only one area, the shoulder of taxiway D. (The water table in this area was within 5 ft of the pavement surface.)

Photo 11. AC replacement of PCC pavement  
at drainage structure

24. Maintenance of the airfield pavements at PAFB generally has consisted of seal coating the AC pavements and sealing joints and patching spalls in the PCC pavements. However, continued movement of the PCC pavements of the aprons due to horizontal expansion has caused an increase in the cost of maintenance. This type of movement necessitates the removal of the PCC pavements around an embedded feature and replacement with a flexible material such as the AC shown in photo 11. As an experiment, polyurethane foam has been recently used as a fill material between embedded features and the PCC pavements. A tabulation
