CONDITION SURVEY, MARCH AIR FORCE BASE, CALIFORNIA

R. D. Jackson

June 1973

Conducted by U. S. Army Engineer Waterways Experiment Station
Soils and Pavements Laboratory
Vicksburg, Mississippi

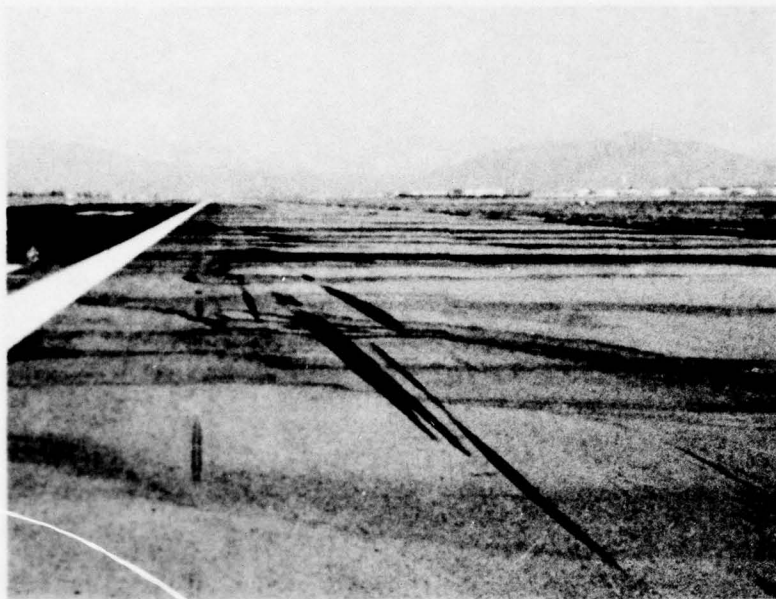
14. The portland cement concrete (PCC) portions of the NW-SE runway (features R1A, R2B, R3C, R4C, R6B, and R7A) were in excellent structural condition, with only a small percentage of the slabs containing major defects. Only four major defects were noted in the entire runway. Feature R5D, the asphaltic concrete (AC) portion, was in very good condition (photos 1 and 2).

Photo 1. AC portion of NW-SE runway near SE end

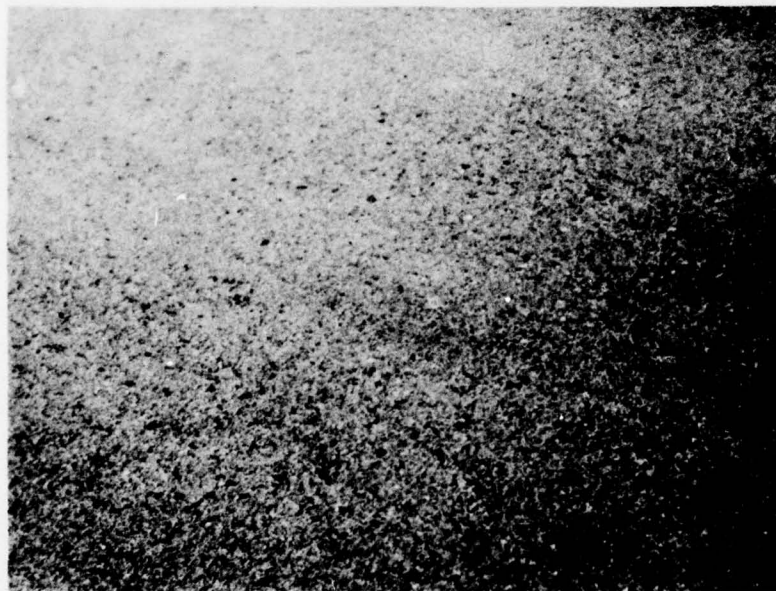
Photo 2. Close-up of AC portion of NW-SE runway near SE end

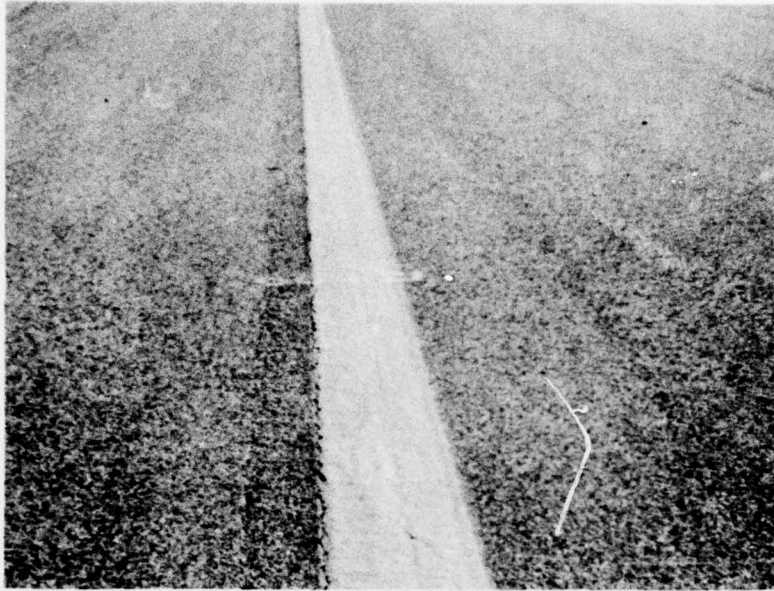
15. Taxiway 1 (features T1A, T2A, T3A, and T4A) was in excellent structural condition, since no major defects were noted. Only seven minor defects were found in the entire taxiway. Features T5A and T6A (taxiway 5) were also in excellent condition. The outer ramp taxiway (features T7A and T8A) was in excellent structural condition based on the percentage of slabs containing no defects. Feature T9A (the outer ramp taxiway extension) was in very good condition. This feature contained 18 major defects, of which 17 were longitudinal cracks in one paving lane. The taxi stripe runs down the edge of this lane, a fact which would seem to indicate that the cracks were load related. Taxiway 5 (features T5A and T6A) contained no major defects and only one minor defect and therefore was rated as being in excellent condition. Taxiways 3 and 4 (features T15C and T16C) were in fair condition (photos 3 and 4).

Photo 3. Typical condition of taxiway 3

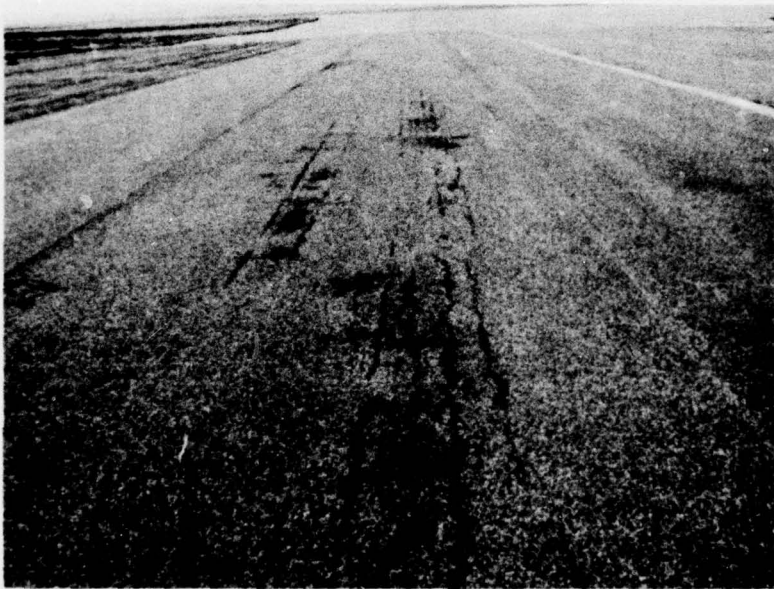
Photo 4. Typical condition of taxiway 4

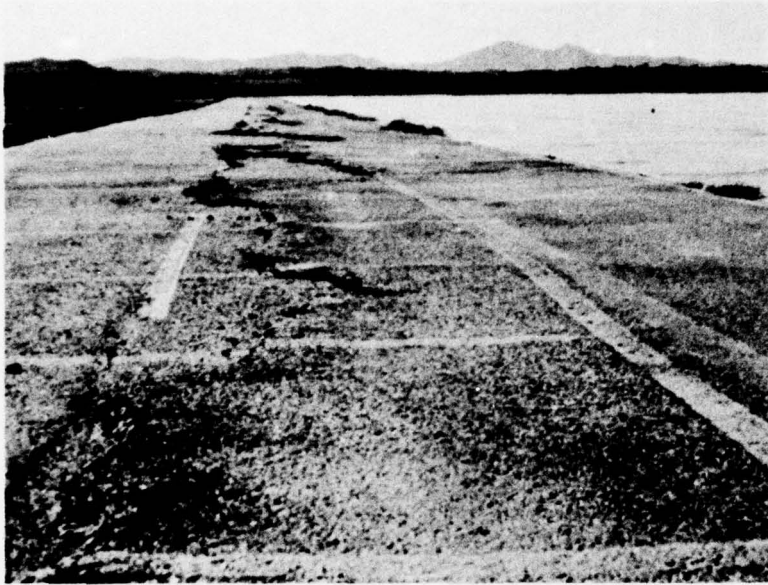
the south and east sides of the south end of the parking apron was noted (photos 5 and 6). Photo 7 shows the upheaval of the shoulder pavement along the east side of the south end of this apron. The shoving and upheaval occurred during 1972 and were apparently caused by expansion of the PCC pavement. Typical cracking of the AC pavement in the refueling area of the apron is shown in photo 8. Photo 9 shows the typically poor condition of the AC pavement on the transient apron.

Photo 5. Showing of shoulder pavement along south end
of parking apron

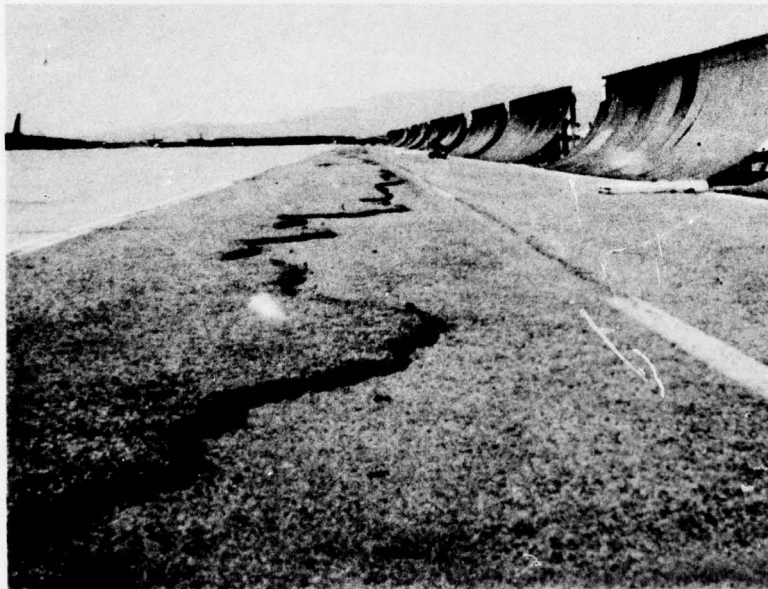
Photo 6. Showing of shoulder pavement along east side
of parking apron near south end

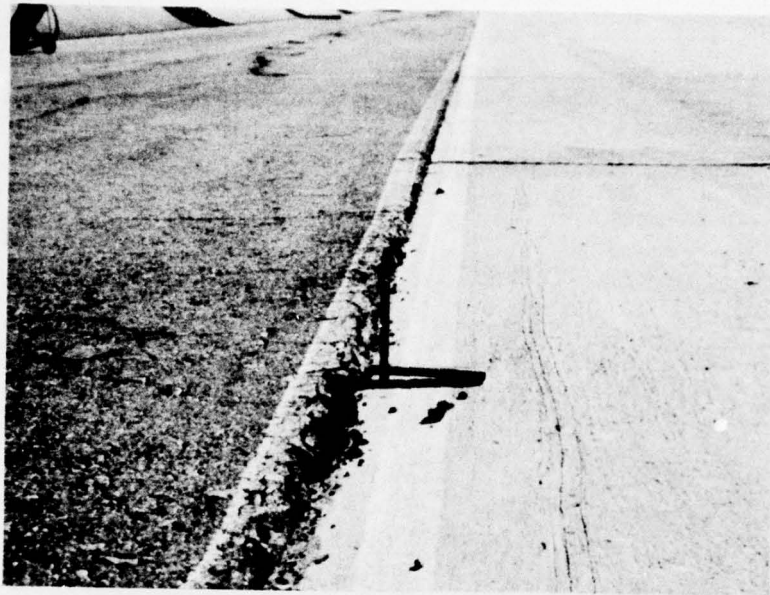
Photo 7. Upheaval of shoulder pavement along east side of parking apron near south end

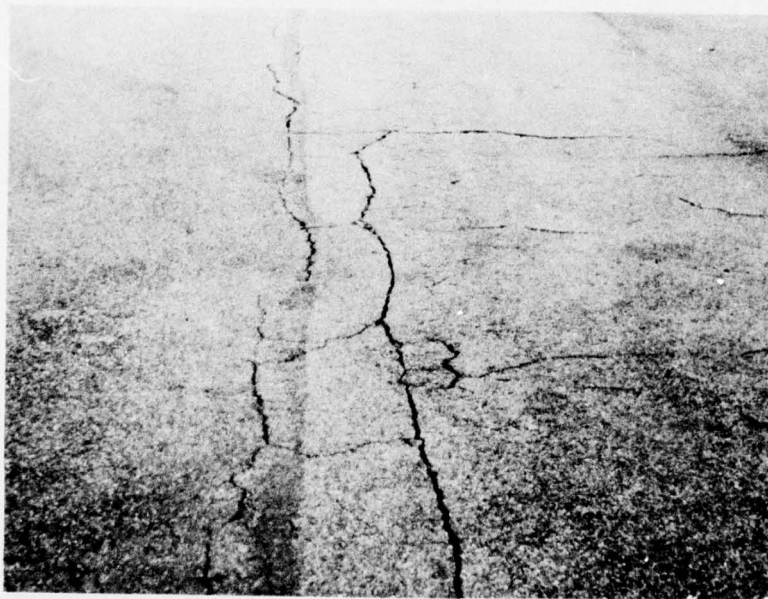
Photo 8. Typical cracks in AC pavement of refueling portion of parking apron

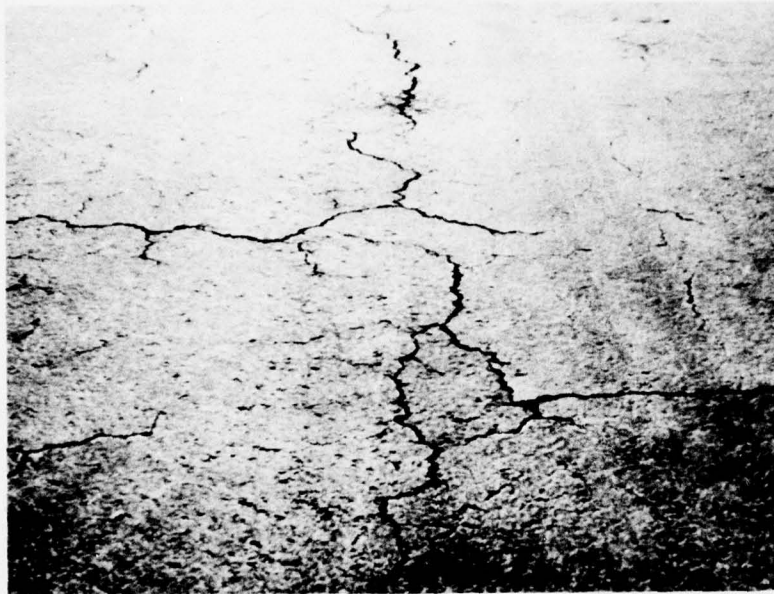
Photo 9. Typical poor condition of AC of transient apron
