MISCELLANEOUS PAPER S-73-39

CONDITION SURVEY, CARSWELL AIR FORCE BASE, TEXAS

June 1973

Conducted by U. S. Army Engineer Waterways Experiment Station
Soils and Pavements Laboratory
Vicksburg, Mississippi

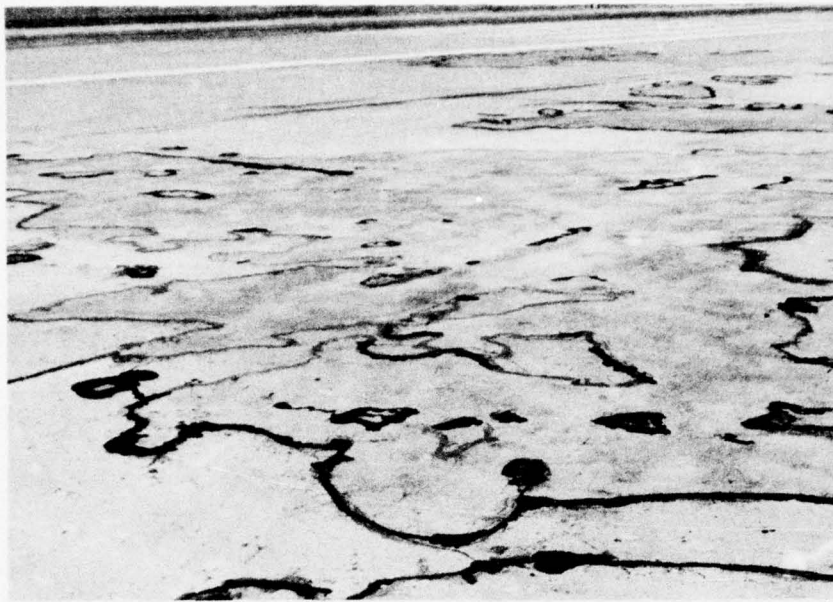
14. All the 15-, 16-, and 18-in. portland cement concrete (PCC) pavements, features R1A, R2B, R5C, R6C, R7C, R8B, R9A, and R10D, were in excellent structural condition, with only 18 major defects noted. Photo 1 shows epoxy patches used to correct surface irregularities in several slabs near the south end of the runway. These irregularities resulted from an aircraft having burned at this location. Features R4C and R3C, which had been overlaid with asphaltic-concrete (AC) pavement, were in good condition. At the time of the overlay, a french drain was installed along the west side of the runway. The drain seems to have cured the problem of slab settlement. Photos 2 and 3 show the condition of the AC pavement on the runway.

Photo 1. Epoxy patches near south end of runway

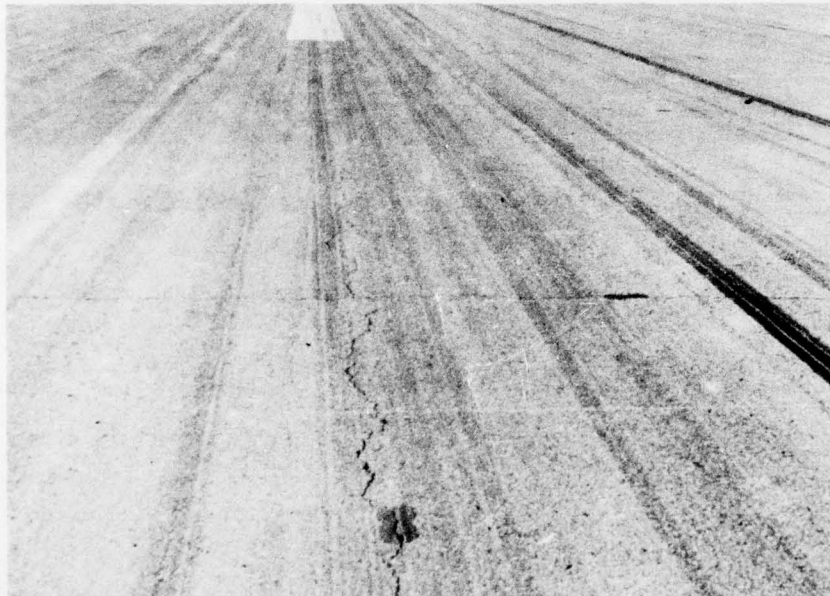
Photo 2. General view of runway looking south
from sta 60+00

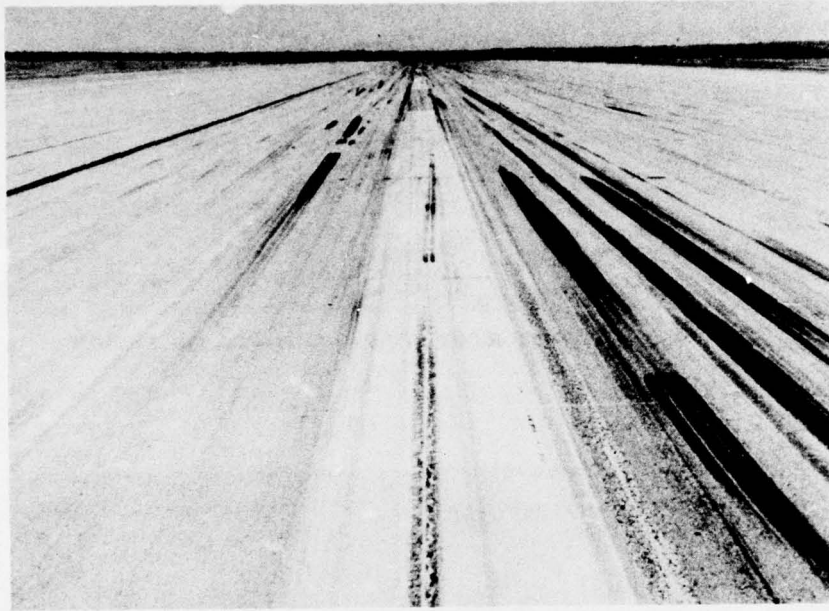
Photo 3. General view of runway looking north
from sta 60+00
