MISCELLANEOUS PAPER 5-73-41

**CONDITION SURVEY, WESTOVER AIR
FORCE BASE, MASSACHUSETTS**

June 1973

10 R. D. Jackson,
H. H. Baker
G. D. Gilman

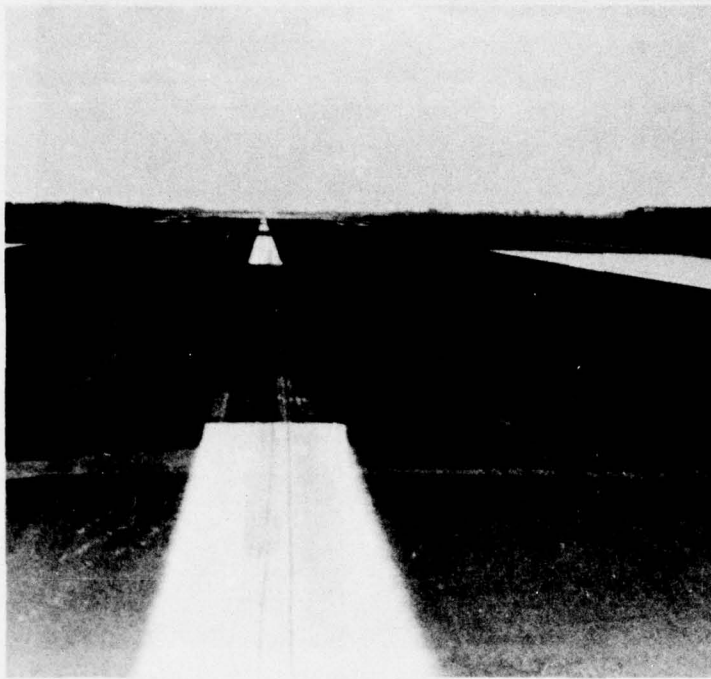
NE end (15-in. PCC pavement), features R5A and R4B, was also in excellent condition, with only five major defects noted. The interior AC portion was in very good condition (photos 1 and 2); a slurry seal had been applied during 1972 before this condition survey was performed. Photo 3 shows a closeup view of this slurry seal on the NE-SW runway. The NW-SE (15-33) runway pavement, which is AC over PCC, appeared to be in only fair condition, with considerable reflection and random cracking (photos 4 and 5).

Photo 1. General view of NE-SW (05-23) runway
looking southwest from NE end of AC pavement

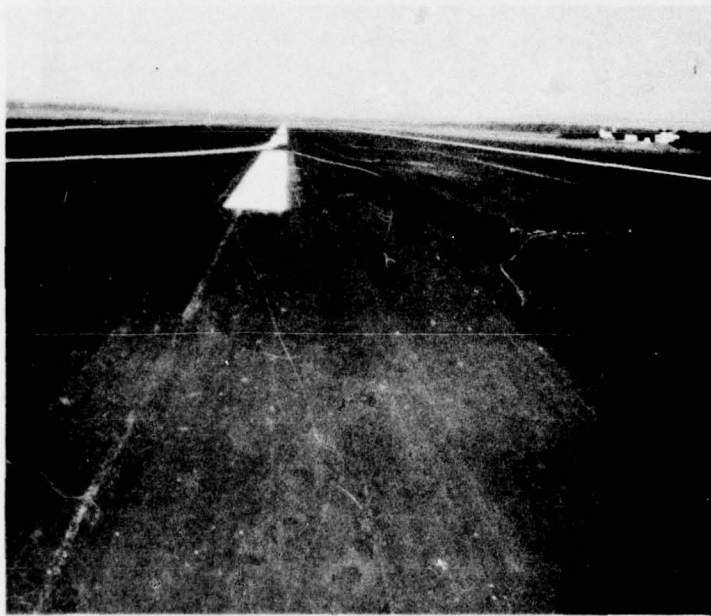
Photo 2. General view of NE-SW (05-23) runway
looking northeast from taxiway N

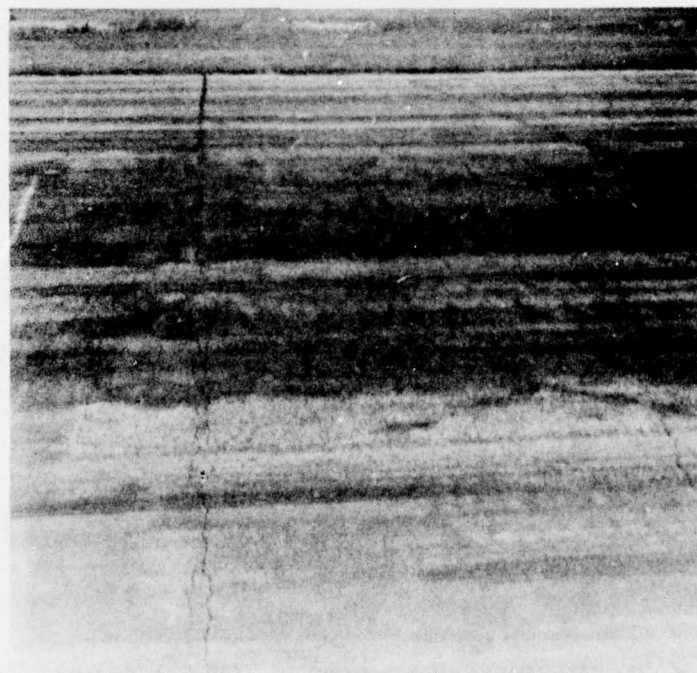
Photo 4. General view of NW-SE (15-33) runway
northwest of taxiway G

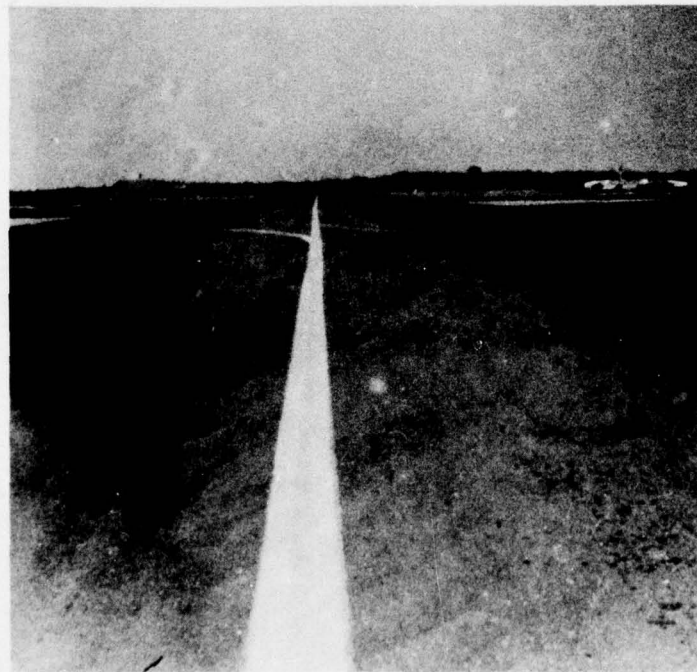
Photo 6. General view of taxiway S looking
southwest from stub 9

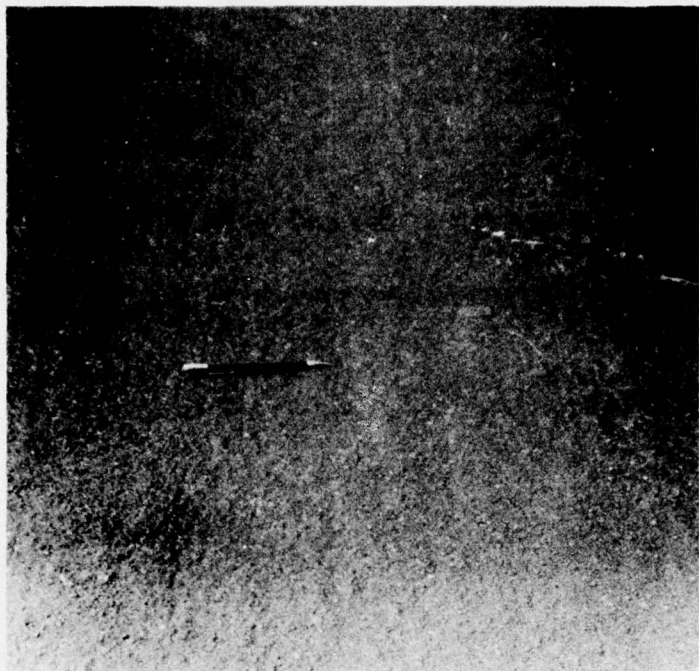
Photo 7. Closeup view of slurry seal on shoulder of taxiway S at parking stub 9

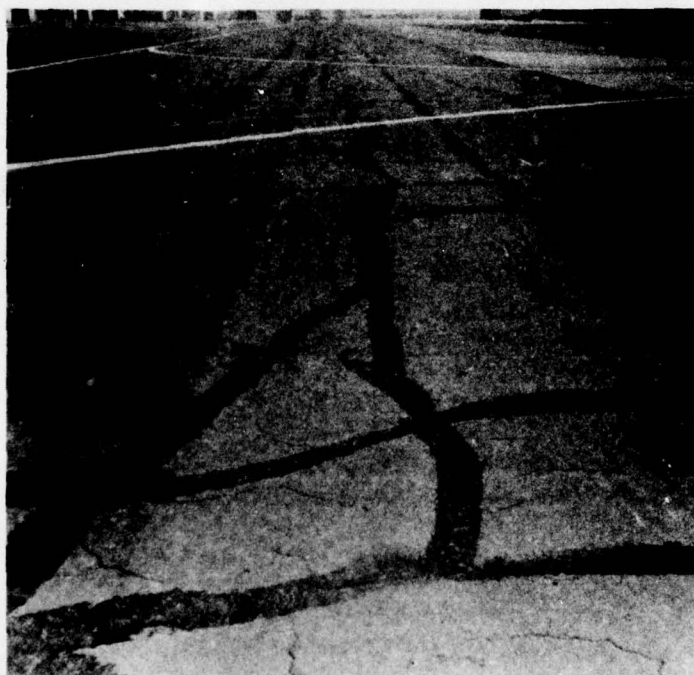
Photo 8. View of shoulder of taxiway S without slurry seal

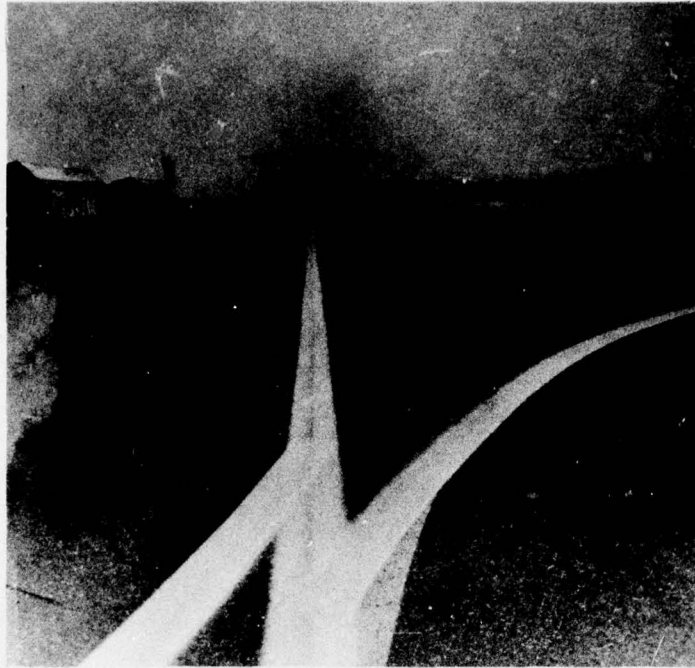
Photo 9. General view of taxiway G along SAC operational parking apron

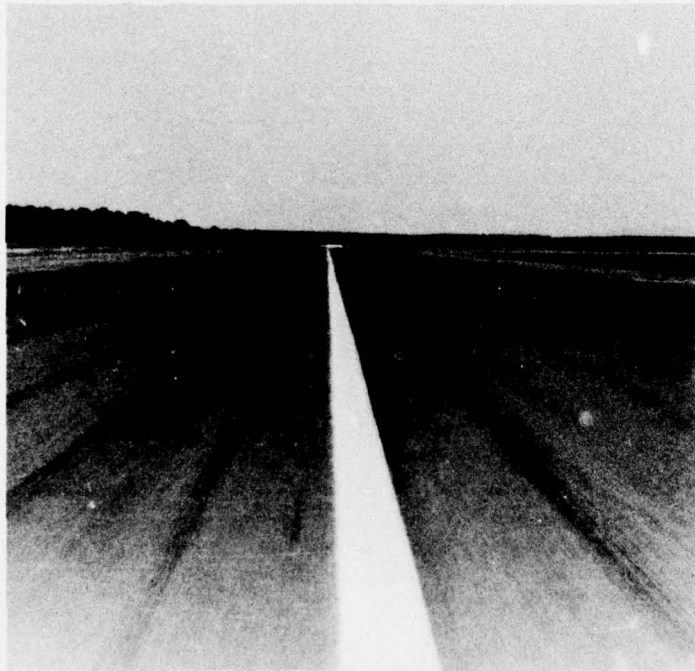
Photo 10. Typical view of NE end taxiway G opposite calibration hardstand
