MISCELLANEOUS PAPER S-73-44

CONDITION SURVEY, FORBES AIR FORCE BASE, KANSAS

June 1973

Conducted by U. S. Army Engineer Waterways Experiment Station
Soils and Pavements Laboratory
Vicksburg, Mississippi

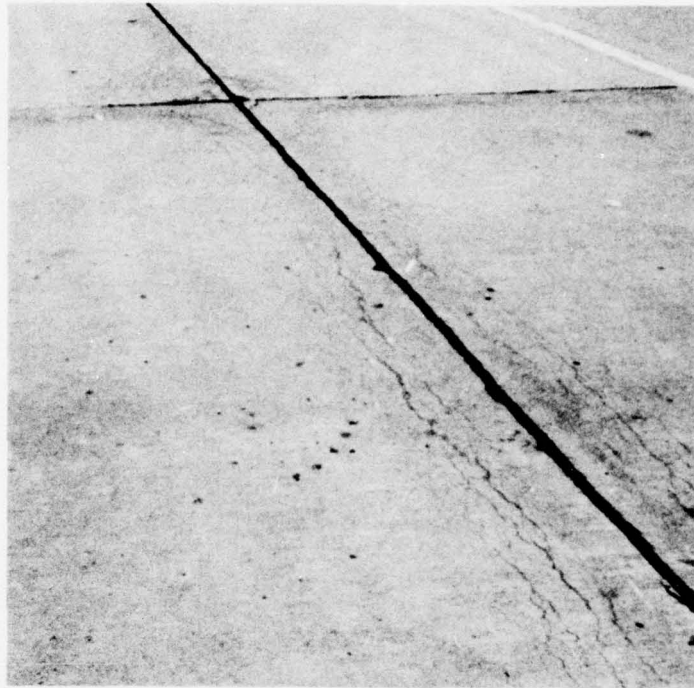
- a. The PCC pavements were in good to excellent condition based on the percentages of slabs containing major defects; (2)
- b. D-cracking was very prevalent, with practically all slabs containing some degree of this defect; (3)
- c. Some reflection cracking was noted in the 1969 AC overlay areas; and (4) asphaltic concrete (AC)
- d. Thaw weakening of the subgrade has not been a significant factor in pavement performance.

Photo 1. "D" cracking on parking apron

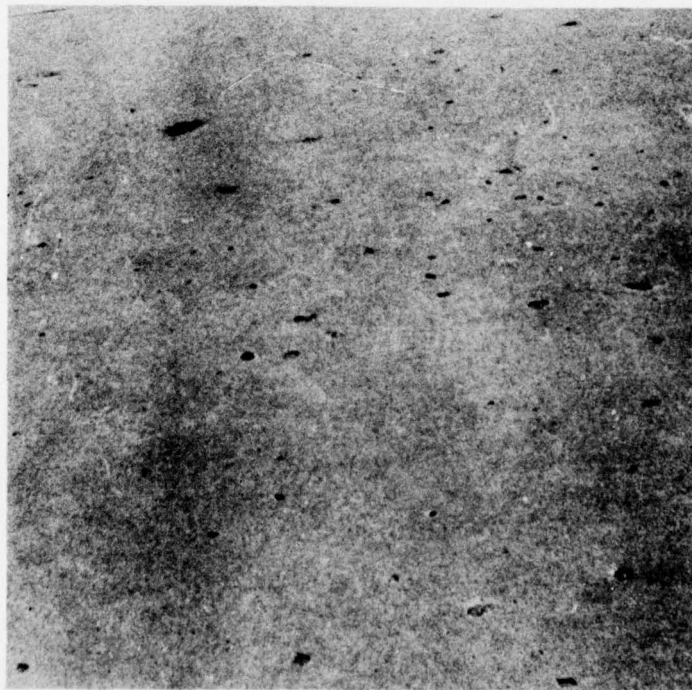
Photo 2. Pop-outs on parking apron

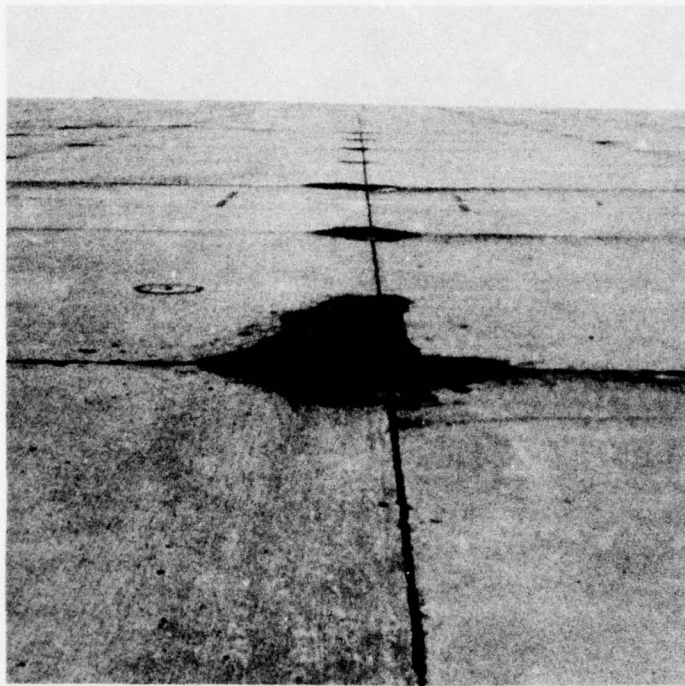
14. The parking aprons were in very good condition, even though the number of major defects had increased considerably since the 1960 survey. The distressed area along the east side of the apron north of taxiway 2 referred to in the 1965 condition survey was overlaid with asphaltic concrete (AC) in 1969. This area was in very good condition, even though there was some reflection cracking. Another area referred to in the 1965 survey, located along the east side of the parking apron between taxiways 3 and 4, was overlaid in 1969 with AC in some areas and with tar rubber (TR) in other areas. Even though some reflection cracking had begun in this area, it was in very good condition. In 1971, a portion of the parking apron was overlaid with TR to cover an area that contained a considerable amount of "D" cracking and a large number of spalls. The remainder of the parking apron was in good to very good structural condition, even though "D" cracking and pop-outs were prevalent (photos 1 and 2). Photo 3 shows AC patches at the corners of slabs of the parking apron. Portland cement concrete (PCC) patches along joints in the apron (photo 4) had been placed to repair areas that contained "D" cracking.

Photo 3. AC repairs at slab corners
of parking apron

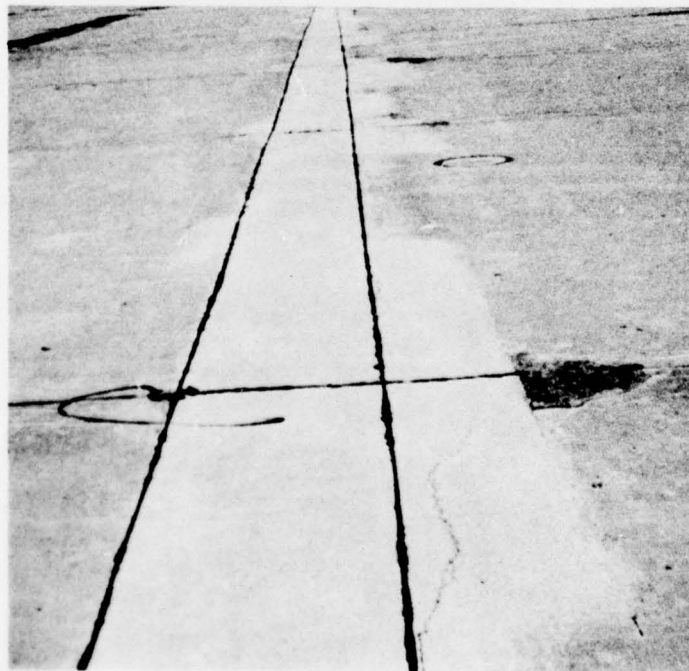
Photo 4. PCC repairs along joints in
parking apron
