MISCELLANEOUS PAPER S-73-45

CONDITION SURVEY, WHITEMAN AIR FORCE BASE, MISSOURI

June 1973

Conducted by U. S. Army Engineer Waterways Experiment Station
Soils and Pavements Laboratory
Vicksburg, Mississippi

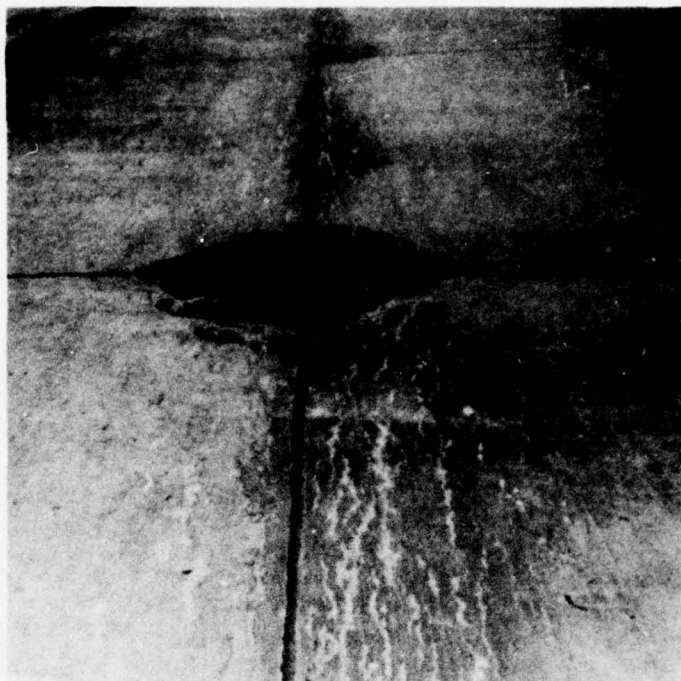
16. Taxiways 16A and 16B. These taxiways (feature T10A), which service the south end of the runway, consist of 17-19-17-in.-thick pavement. About 3 percent of the slabs contained major defects. Every slab in this feature contained "D" cracking. The cracking had developed to the point that spalling had become a problem, and about 16 percent of the slabs had had spalls repaired (photo 1).

Photo 1. "D" cracking and corner spall repair
on taxiway 16A

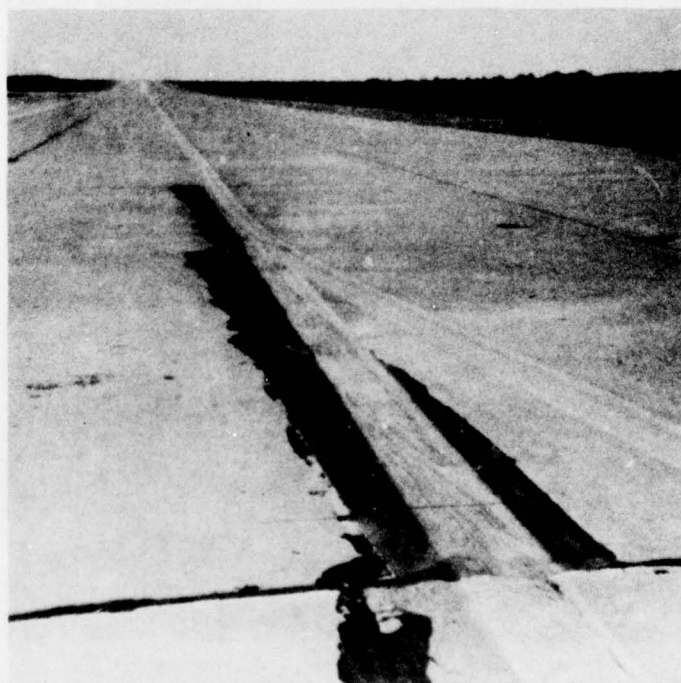
defect, and a majority of the slabs contained pop-outs. The center lane of the taxiway contained most of the major defects, and the most common defect was longitudinal cracking adjacent to the center line (photo 2). There has been a progression of this longitudinal cracking from 10 slabs in 1960 (based on the 1960 condition survey, paragraph 6) to 16 slabs in 1972. Slabs containing pop-outs have increased from 111 in 1960 to 581 in 1972.

Photo 2. Patched longitudinal crack on taxiway 11A

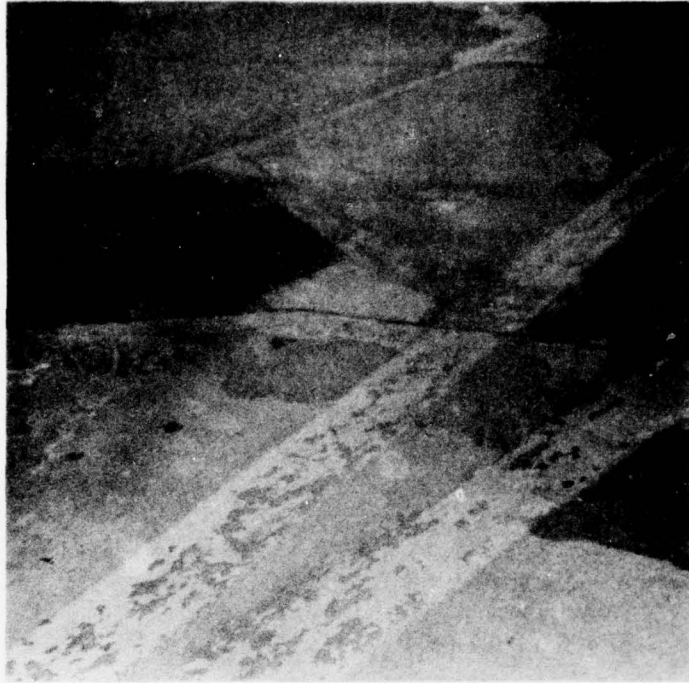
Photo 3. Water seepage through joints in apron

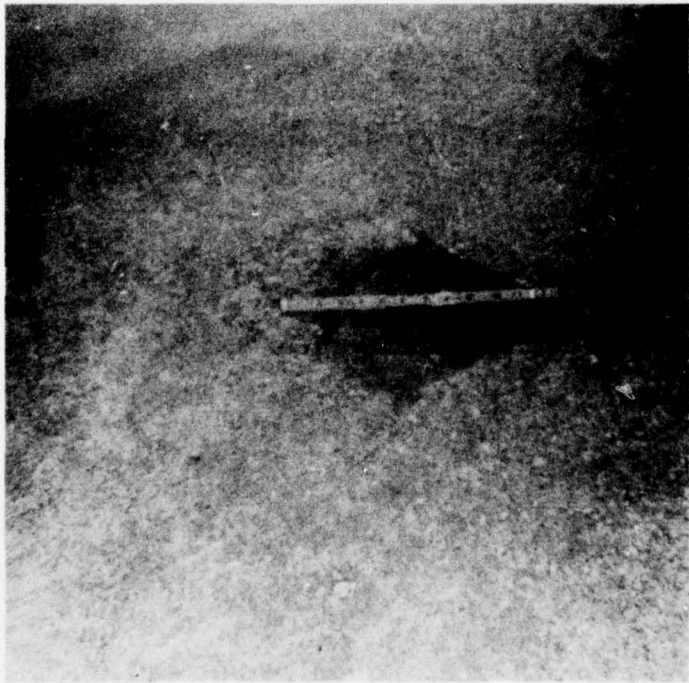
Photo 4. Pop-out on apron area

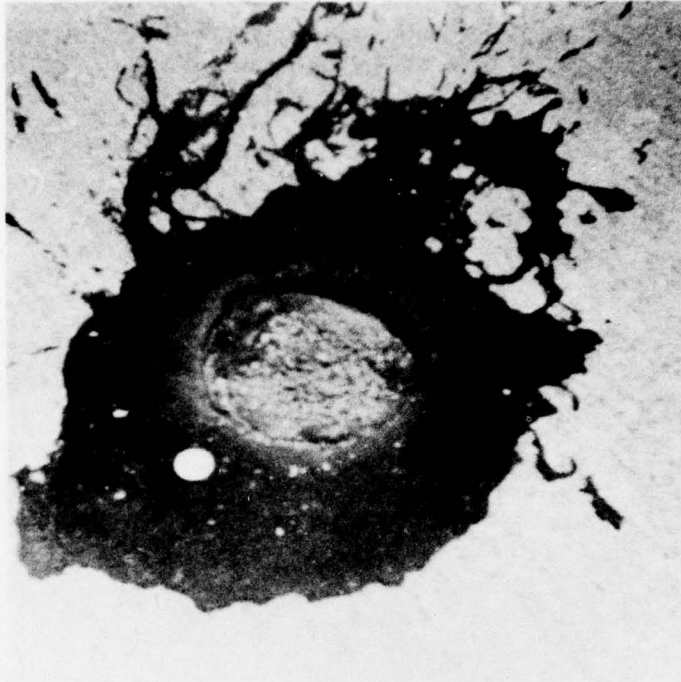
25. The north warm-up apron (feature A11B), which is 18-in.-thick pavement, was in very good condition. However, every slab contained pop-outs (photo 5), and a few slabs contained spalls. The shoulder pavements adjacent to the north warm-up apron were in fair condition, with transverse cracks and open paving joints apparent (photo 6). In the south warm-up apron (feature A10B), which is 17-in.-thick pavement, only about 4 percent of the slabs contained major defects. However, every slab had evidence of "D" cracking (photo 7), and approximately 34 percent of the slabs had spalls that had been repaired. The east warm-up apron (feature A9B), which is 18-in.-thick pavement, was in very good condition; however, every slab contained pop-outs, and a few slabs contained spalls.

Photo 5. Repaired pop-out on north warm-up apron

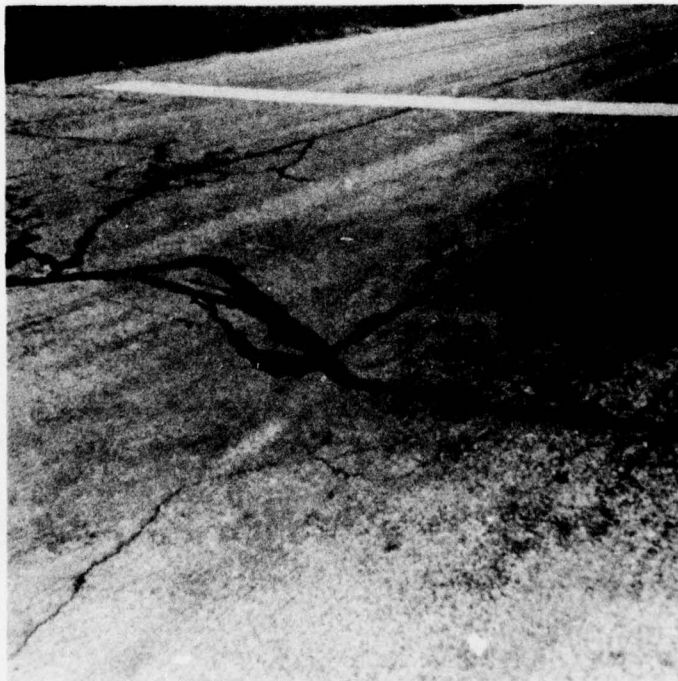
Photo 6. Condition of shoulder area adjacent to north warm-up apron

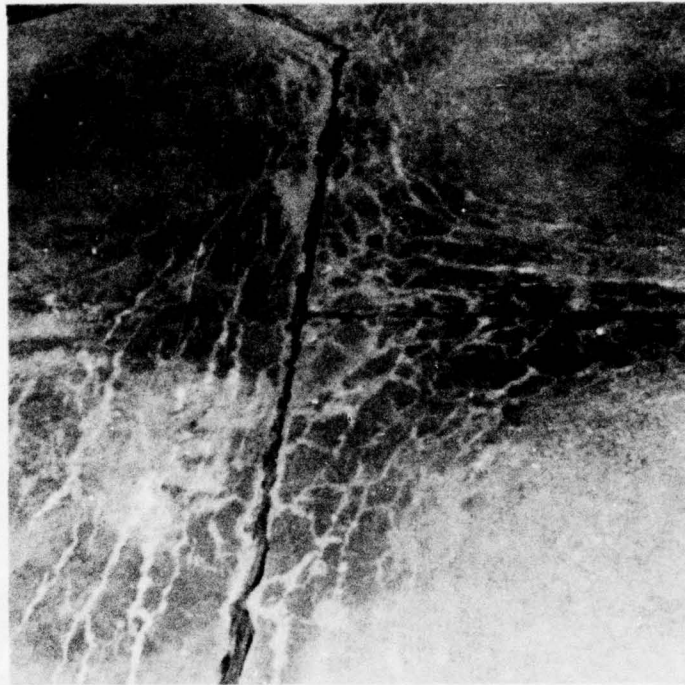
Photo 7. Severity of "D" cracking on south warm-up apron

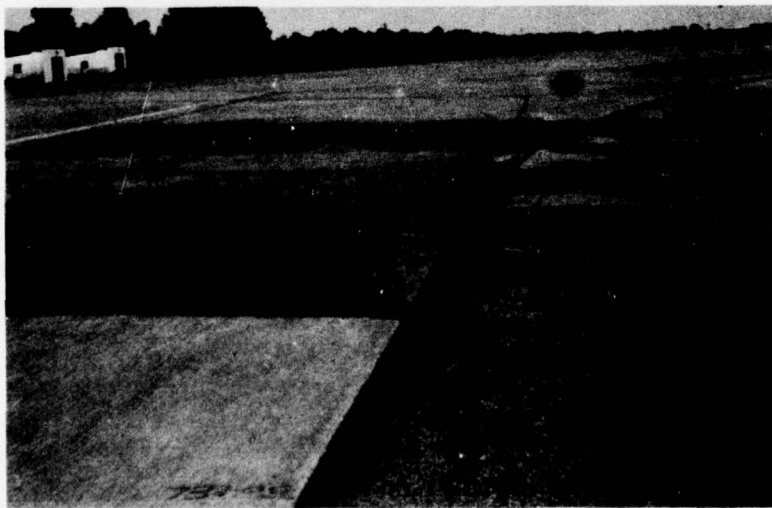
- a. The alert taxiway, where water was observed flowing from the rigid pavement joints (northeast end of apron, see photos 8 and 9) and from the junction of the taxiway pavement (24-in. PCC over 12-in. crushed stone) and the shoulder (2-in. AC over 16-in. crushed stone).
- b. Taxiway 17, where water was observed flowing from the rigid pavement joints, from cracks in the flexible shoulder pavement, from under the shoulders, and from around a light fixture.
- c. The shoulder along the west side of taxiway 11A, where water was observed flowing from the exposed base course at the edge of the shoulder.

Photo 8. Alert taxiway; note water stains from seepage through pavement joints

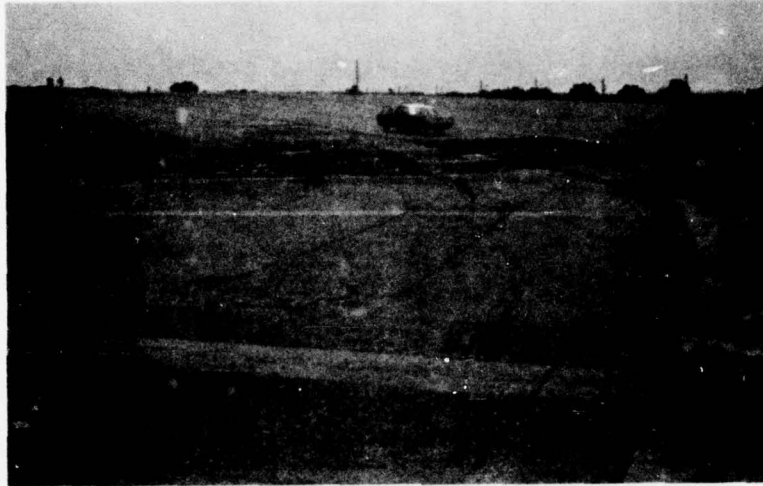
Photo 9. Alert taxiway and shoulder pavements at northeast end of apron shoulders approximately 1/2 to 2 in. lower than PCC pavement

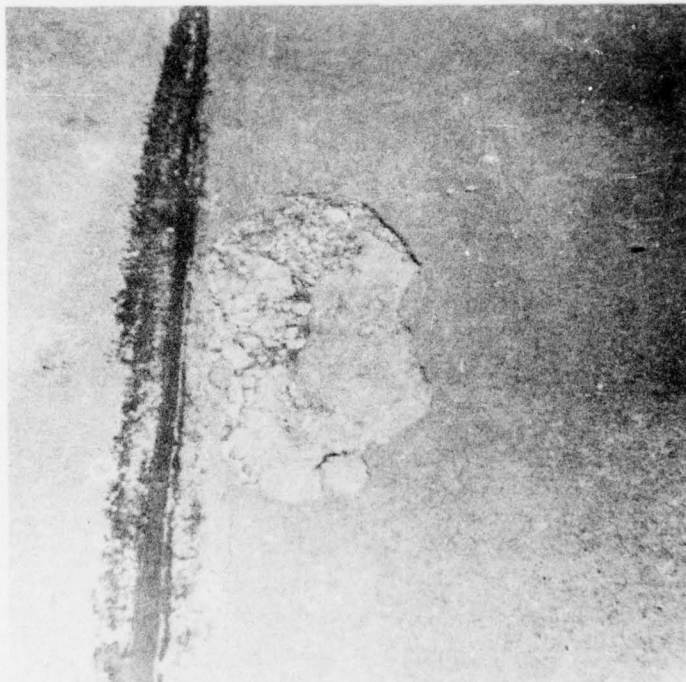
42. Based on the 1972 survey, pop-outs and spalling along joints constitute the major maintenance problems at WAFB. Pop-outs were found in most of the pavement features, as is indicated in table 4, with especially high concentrations observed in the parking apron. "D" cracking was prevalent at several locations and constituted a serious problem on the south end of the alert apron, taxiways 1, 2, 16A, and 16B, the south end of the runway, and the south warm-up apron where cracking had progressed (or soon will progress) to the point that scaling and spalling will occur. The spalls have been patched with epoxy and mortar, bituminous cold mix, or PCC with epoxy bonding. In some cases, they have been sealed with joint seal material (photos 10 and 11).

Photo 10. Scaling along joints from "D" cracking

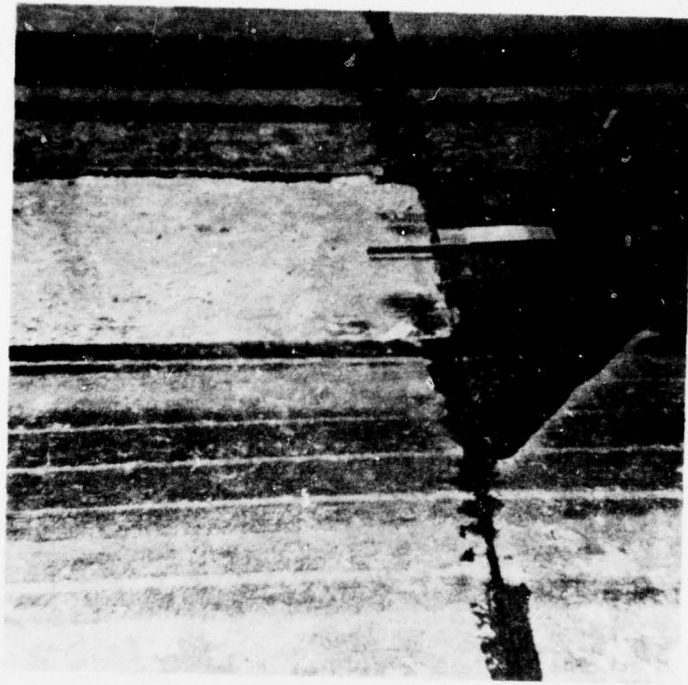
Photo 11. Epoxy patches of spalls with and without
joint seal
