# CONDITION SURVEY, PLATTSBURGH AIR FORCE BASE, NEW YORK

by  
R. D. Jackson

June 1973

Conducted by U. S. Army Engineer Waterways Experiment Station  
Soils and Pavements Laboratory  
Vicksburg, Mississippi

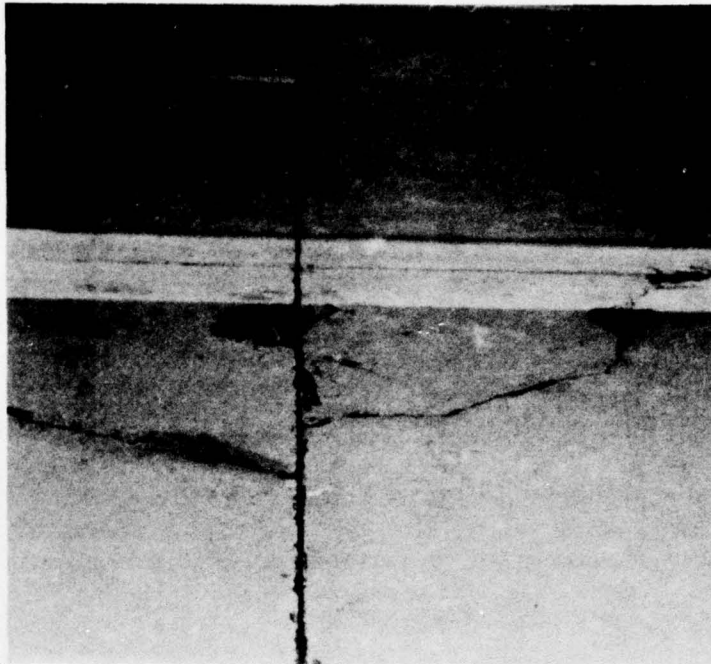
11. The first 1000 ft of the SE (35) end of the runway (features R1A and R2B) was in excellent condition, with only two major defects noted. Features R5A and R4B, the first 1000 ft of the NW (17) end, were in very good condition. Twelve major defects were noted in these features, nine of which were diagonal cracks, with seven of these being in the two center lanes. The interior portion of the runway (feature R3C), which had a total of 56 major defects (47 of which were in the center 120 ft), was in excellent condition. Photo 1 shows diagonal cracks in four slabs in the center of the runway, approximately 6000 ft from the SE end.

Photo 1. Diagonal cracks in four slabs in center of runway, approximately 6000 ft from SE end

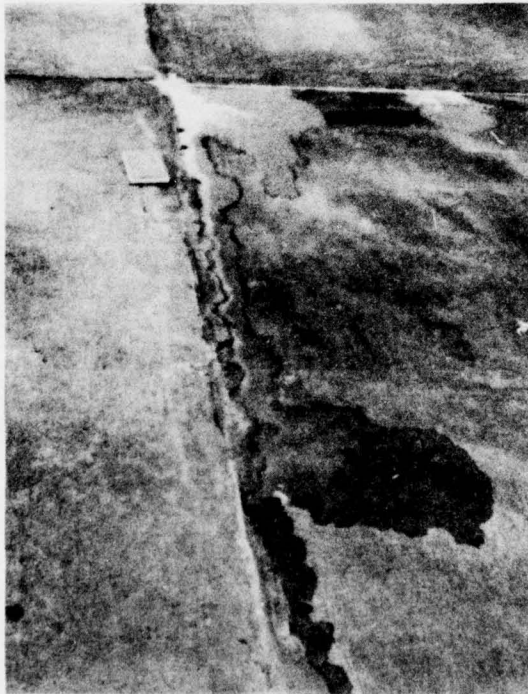
200 by 500 ft in which a large percentage of the slabs were discolored from the effects of water rising through the slab joints. Even though water was standing on the surface of some of this area, the survey revealed no abnormal number of defects for this area as compared with the number of defects in areas where there was no evidence of water. The north warm-up apron (feature A2B) contained 27 major defects, 11 of which were in the outer lane. This feature was in very good condition. The south warm-up apron (feature A3B) was in very good condition, with approximately 15 percent of the slabs containing either major or minor defects.

groundwater may be located at or near the pavement surface. Evidence of high groundwater was noted at the SE end of the parking apron where water was bleeding from some of the joints (photo 2) and in the shoulder of the south warm-up apron where water was bleeding from around a light base (photo 3).

Photo 2. Water bleeding from joints in SE end of parking apron

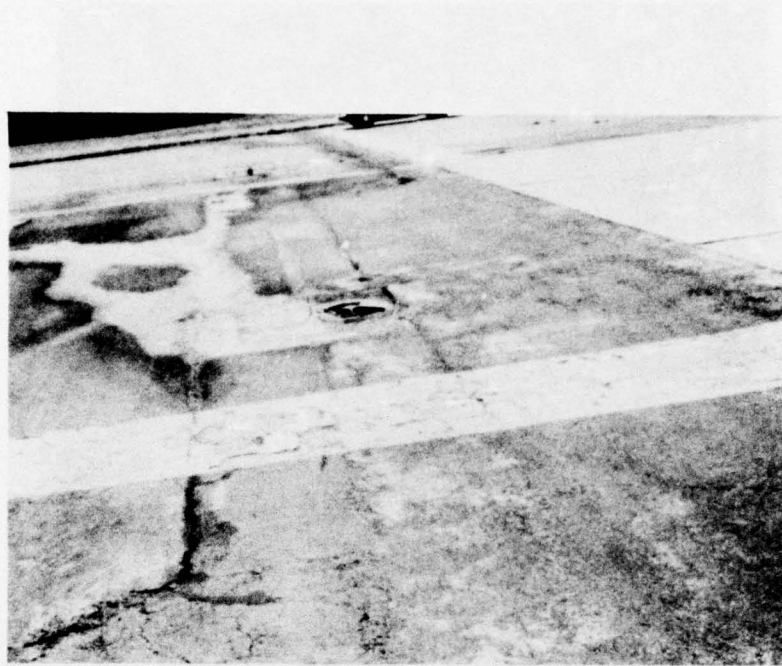
Photo 3. Water bleeding from around light base in shoulder of south warm-up apron

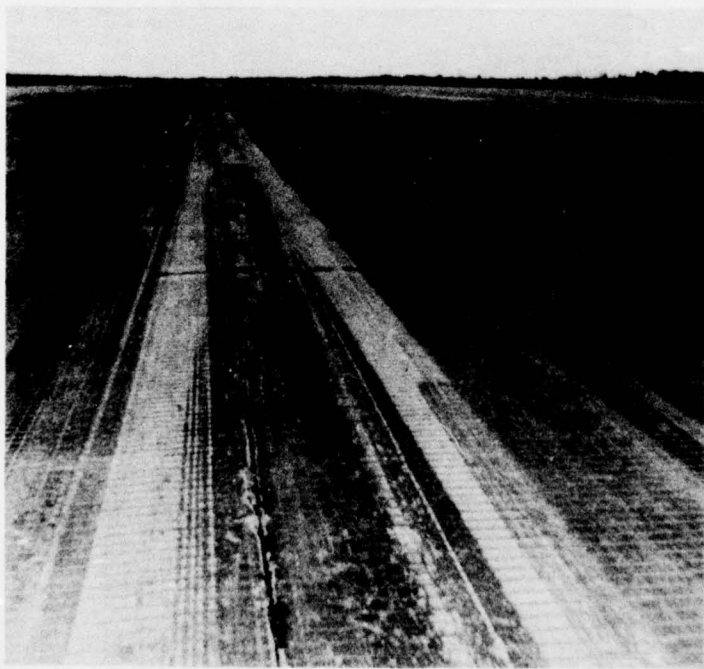
Photo 4. View of grooved pavement looking down runway

During the time of this survey, a spall repair program was in progress. In addition, the runway was being grooved for a distance of 70 ft either side of the center line to create a more skid resistant surface and alleviate the danger of hydroplaning. The joints on the runway were to be sealed at the conclusion of the grooving operation. Photos 4 and 5 show views of the grooved pavements.

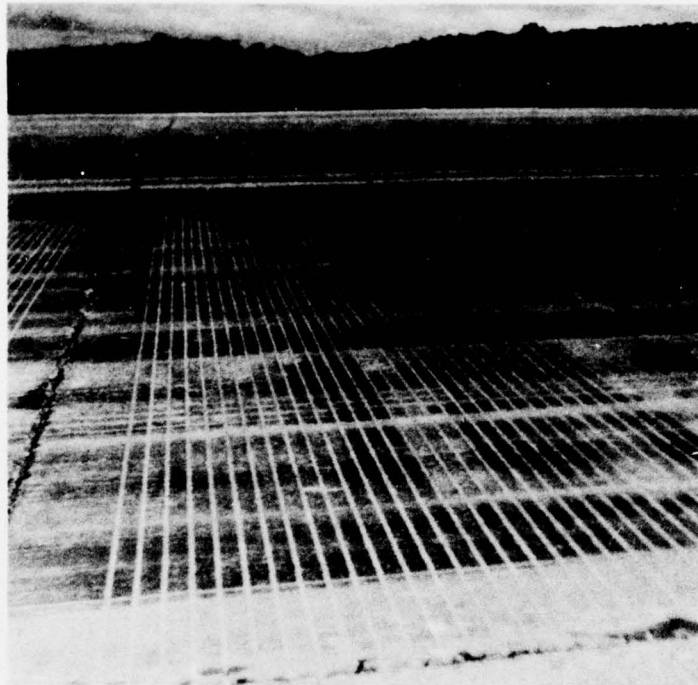
Photo 5. View of grooved pavement  
looking across runway
