MISCELLANEOUS PAPER S-73-50

CONDITION SURVEY, LAGUNA ARMY AIRFIELD YUMA PROVING GROUND, ARIZONA

P. J. Vedros, R. D. Jackson, S. J. Alford

June 1973

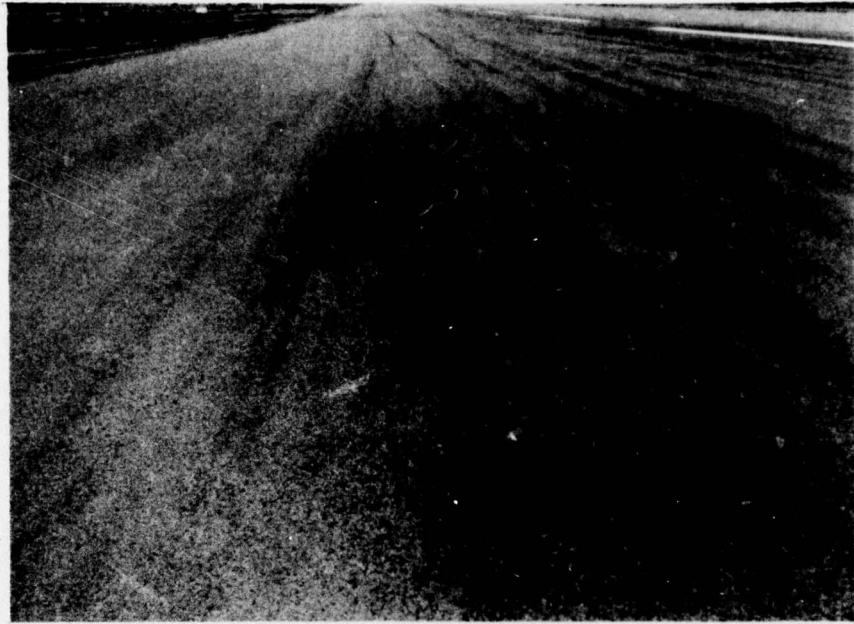
Photo 1. Cracking in longitudinal construction joint on N-S runway

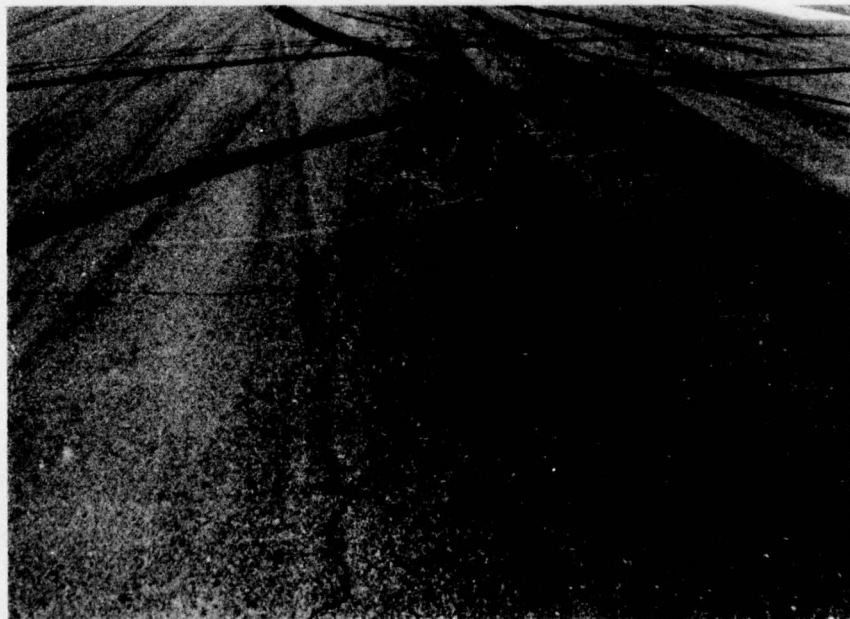
Photo 2. Reflection cracking in surface on N-S runway

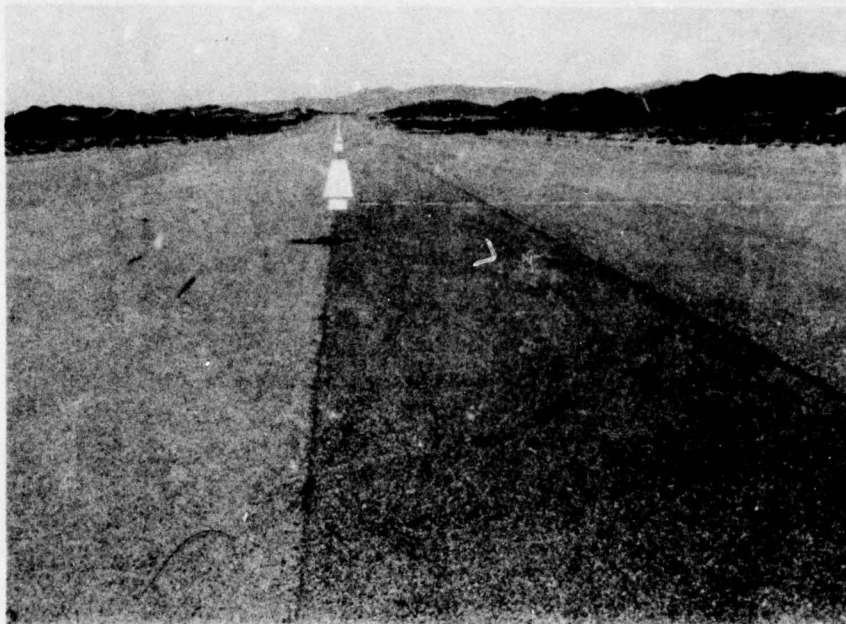
Photo 3. General view of E-W runway

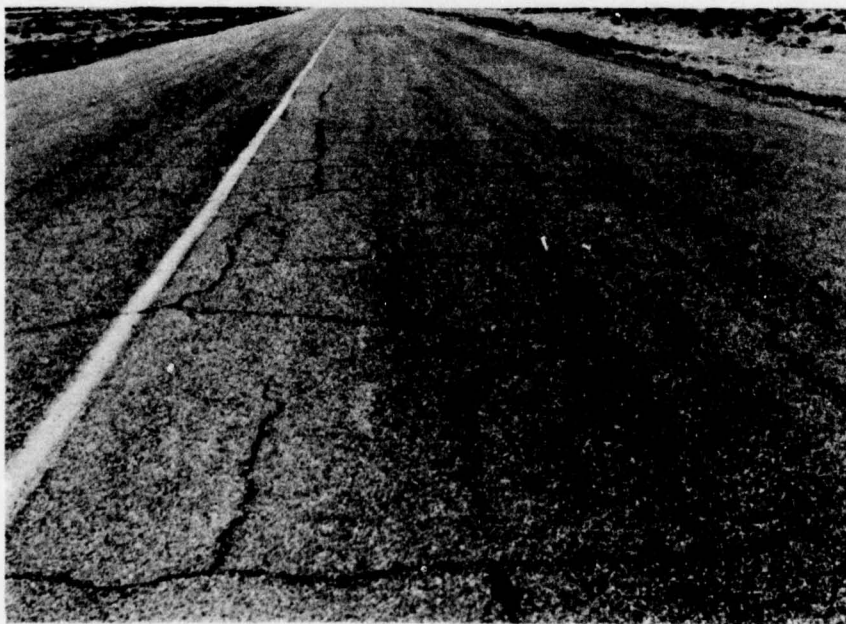
18. The load-carrying capacities of the pavements at LAAF are presented in table 5. As is noted in this table, the basic field evaluation for the primary pavements is controlled by the carrying capacity of the north end of the N-S taxiway (feature T2B). The surface condition of this feature was poor. Occasional use of the pavement facilities by aircraft having gross weights greater than those allowable under the basic evaluation may be necessary. Table 6 shows the allowable loading of such aircraft operating at frequencies of one cycle per day, one cycle per week, and one cycle per month. The evaluation presented in table 6 applies only to the ability of the pavement to withstand a load. It is beyond the scope of this evaluation to determine the capability of the airfield to handle aircraft from the standpoint of the length of runway required, etc.

Photo 4. Surface condition of N-S taxiway (feature T2B).
Area has not been overlaid

- a. The N-S runway was in good condition, with the exception of the first 500 ft of the north end, which was considered to be in only fair condition.
- b. The E-W runway was in only fair condition.
- c. The taxiways were in good condition, with the exception of the north end of the N-S taxiway (feature T2B), which was in poor condition.
- d. Feature T2B, the north end of the N-S taxiway, should be overlaid to upgrade its condition to the load-carrying capacity of the other facilities at the airfield.

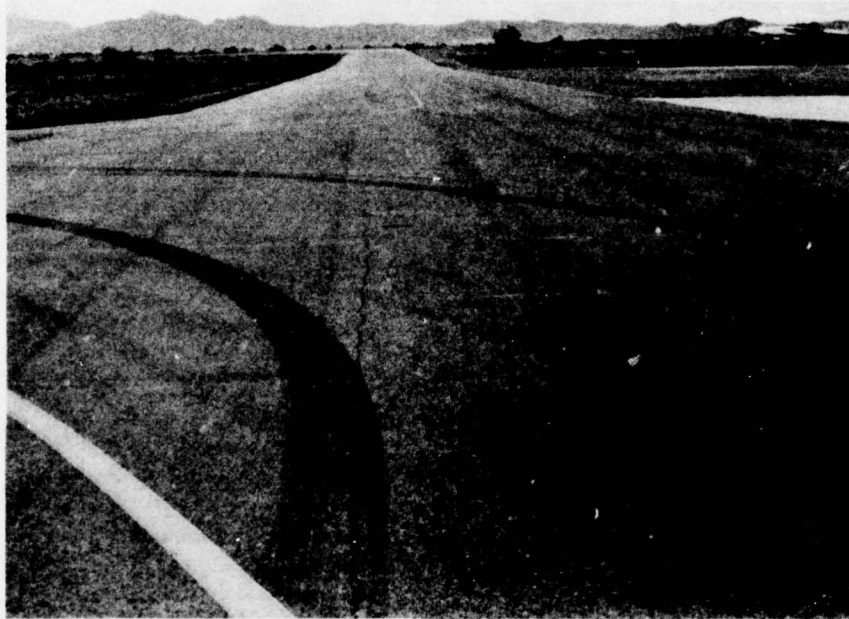
Photo 5. Surface condition of N-S taxiway (feature T3B).
Overlay was placed in 1971
