**CONDITION SURVEY  
BANGOR INTERNATIONAL AIRPORT  
BANGOR, MAINE**

R. D. Jackson

June 1973

Conducted by U. S. Army Engineer Waterways Experiment Station  
Soils and Pavements Laboratory  
Vicksburg, Mississippi

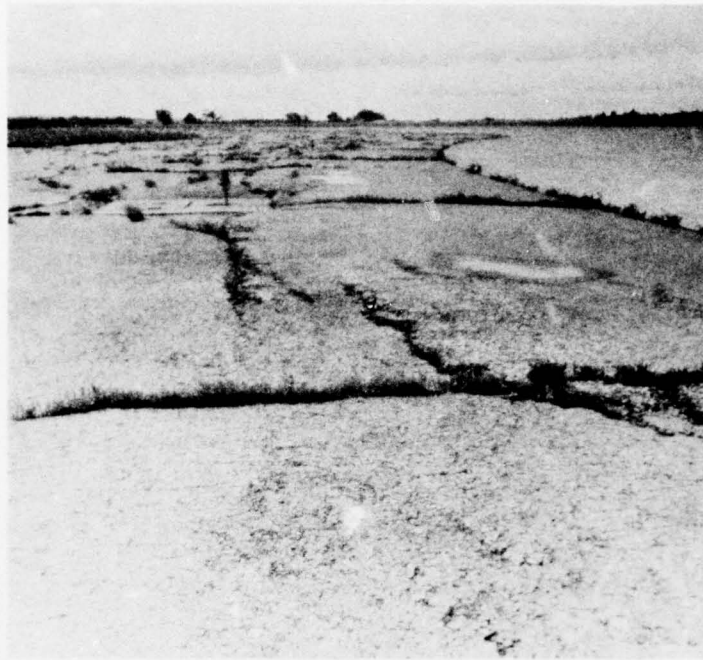
11. The 19-in. PCC pavement of the north connecting taxiway (feature T1A) was in excellent condition. The NW end of the parallel taxiway (feature T2A), which is 19-21-19-in. PCC pavement, was in only fair condition. The major defects in this feature were longitudinal cracks, and the minor defects were principally longitudinal shrinkage cracks that will probably develop into major defects. The 19-in. PCC pavement in the parallel taxiway at the intersection of taxiway L (feature T3A) was in a poor to failed condition. This section had 21 slabs that contained longitudinal cracks; 15 of the 16 slabs in the center lane contained longitudinal cracks. Feature T4A, which is asphaltic concrete (AC), was in only fair condition. This area had several contraction cracks and contained some slight rutting. Feature T5A was also in a poor to failed condition. Of 165 slabs in this area, 106 contained at least one major defect. Only two slabs in the 17-in. pavement adjoining the apron did not have a major defect. The center lane, which is 19-in. pavement, had 42 slabs with major defects, but the west lane (17-in. pavement) had only 11 slabs with major defects. Feature T6A (AC pavement) was in fair condition. The area of the parallel taxiway at sta 20+27 to 24+02 was in very good condition. Plate 3 shows a comparison of defects (i.e., between those observed in this survey and those in the 1959 and 1961 surveys) in the NW end of the NW-SE parallel taxiway and in the north connecting taxiway. Feature T8A was in excellent condition; this area had recently been overlaid (photo 1). The south connecting taxiway (feature T9A), which is 17-19-17-in. RPCC pavement, was in excellent condition. Only 10 major defects were noted, and these cracks were held tightly together by the reinforcement. Photos 2 and 3 show the movement of the south connecting taxiway in the curve near the SE end of the parallel taxiway. Taxiways L and K were in

Photo 3. General view of movement of south connecting taxiway

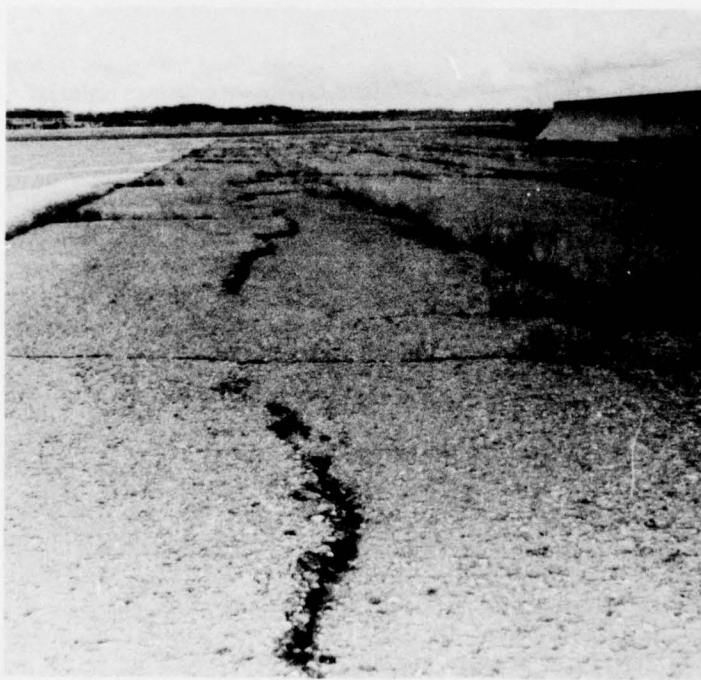
Photo 6. Shoving of shoulder pavement along heavy-load operational apron extension
