CONDITION SURVEY, LOCKBOURNE AIR FORCE BASE, OHIO

R. D. Jackson

June 1973

created by U. S. Army Engineer Waterways Experiment Station
Soils and Pavements Laboratory
Vicksburg, Mississippi

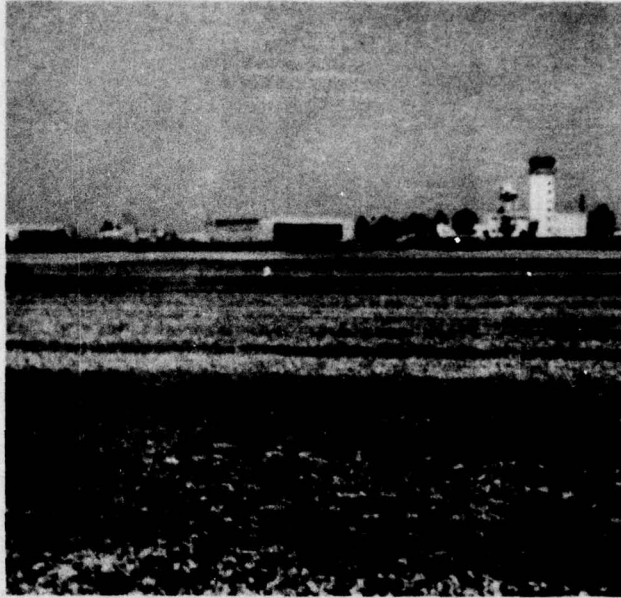
12. NE-SW runway 2 was in excellent condition based on the percentage of slabs containing no major defects. The first 1000 ft of the NE end (features R1A and R2B) contained only 3 major defects. The first 1000 ft of the SW end (features R1A and R2B) contained only 14 major defects. Feature R3C (the interior portion of the runway) contained 66 major defects. The entire runway contained 395 corner spalls that had resulted from "D" cracking**. Practically all slabs on the runway contained "D" cracking to some degree. NE-SW runway 1 was in generally poor condition; however, the portland cement concrete (PCC) ends were in very good condition. The interior portion, which is 8-in. PCC overlaid with 6 in. of AC, was in poor condition. As a result of continued deterioration and expansion of the underlying PCC pavement along the slab joints, both longitudinal and transverse blowups have occurred (see photos 1-3). At the time of this survey, NE-SW runway 1 was closed.

Photo 1. View of NE-SW runway 1 between taxiways C and D

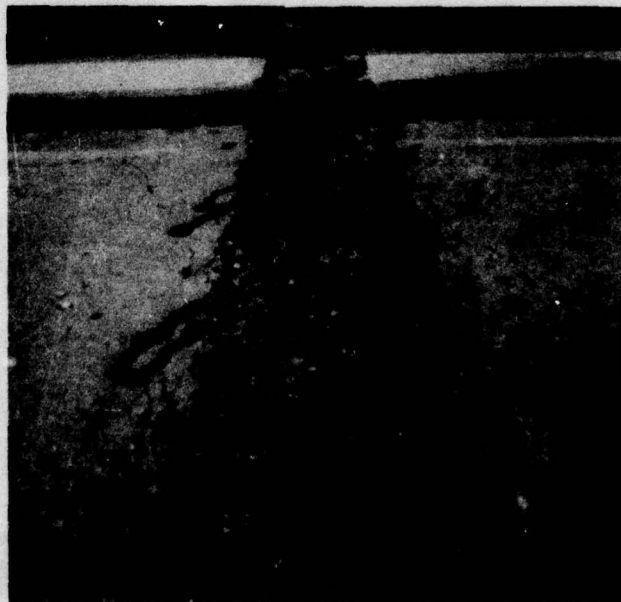
Photo 2. Poor joint in NE-SW runway 1, north of taxiway E

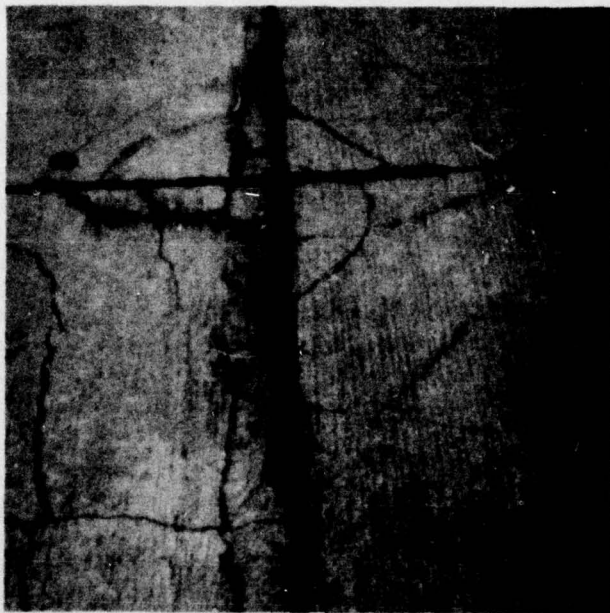
Photo 5. Cracks at corners of four slabs of ANG apron

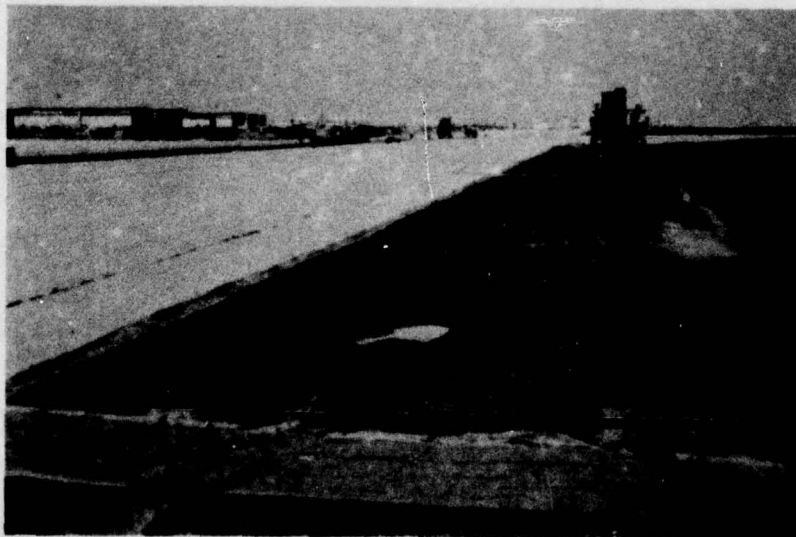
rigid pavement is 45 in.) The shoulder pavements (combined thickness of 17 in.) were relatively free of evidence of frost effects, with the exception of the shoulders of the parking apron extension taxiway, and generally were in fair to good condition. The shoulder of the apron extension taxiway (see photo 6) was somewhat wavy, with some longitudinal, transverse, and map cracking. This unevenness is probably the result of frost action.

Photo 6. Cracking and unevenness in shoulder of parking apron extension taxiway

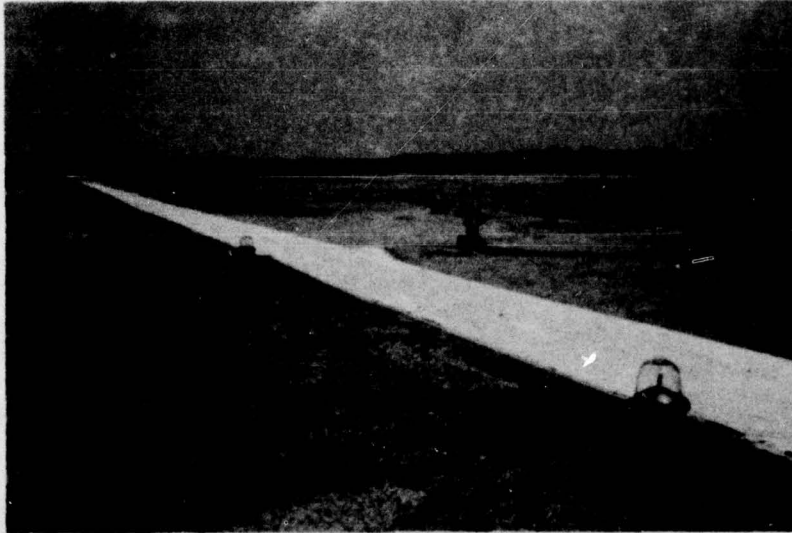
- a. Intersection of taxiway C and NE-SW runway 1. About 100 ft of the runway pavement (6-in. AC over 8-in. PCC on a 6-in. gravel base) had heaved about 4 or 5 in. in a pattern following the underlying PCC pavement joints. This blowup resulted from the expansion of the rigid pavement. Water was flowing onto the pavement surface from one of the joints. (See photos 7 and 8.)
- b. NE-SW runway 1, between taxiway C and sta 70+79. The junction between the rigid pavement and the flexible shoulder on the northeast side showed water stains.
- c. NE-SW runway 1 (3-in. AC over 11-in. PCC on a clay subgrade), between sta 70+79 and 95+00. There was evidence of bleeding joints.
- d. NE parking apron (12-in. PCC on a clay subgrade). This apron had been abandoned because of extensive blowups and spalling. There was also evidence of bleeding joints in this area.

Photo 7. Blowup at intersection of taxiway C
and NE-SW runway 1

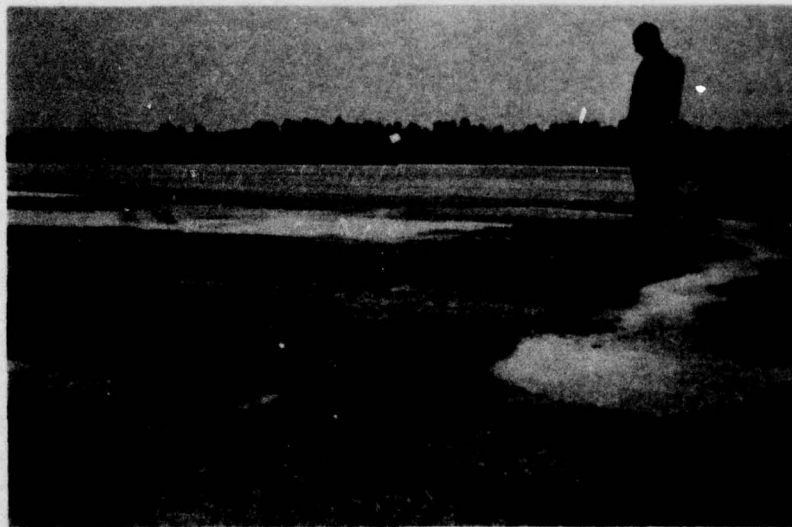
Photo 8. Water flowing from joint at intersection
of taxiway C and NE-SW runway 1
